Profile/Photo Observation Report

| Street: | W 40th ave | Flow Control: | Not Controlled |
| City: | Hobart, IN | Year Renewed: | |

| US MH: | M-503-072 | DS MH: | M-503-072.1 |

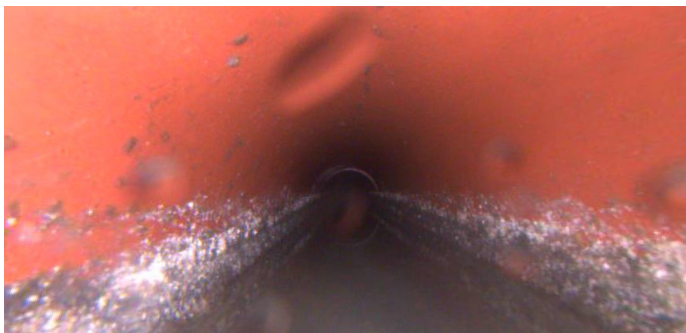
Code: **AMH**
Description: **Manhole**

Distance (ft): **.0**
Structural Grade: **0**
O&M Grade: **0**
Clock Start/From:
Clock To:
1st Value:
2nd Value:
Value Percent:
Continuous Index:
Within 8" of Joint: **NO**
Remarks: **M-503-072**

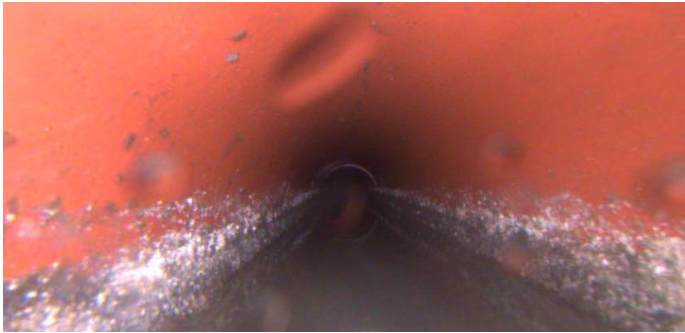
| Code: | MWL |
| Description: | Water Level |

| Value Percent: | 20.000 |

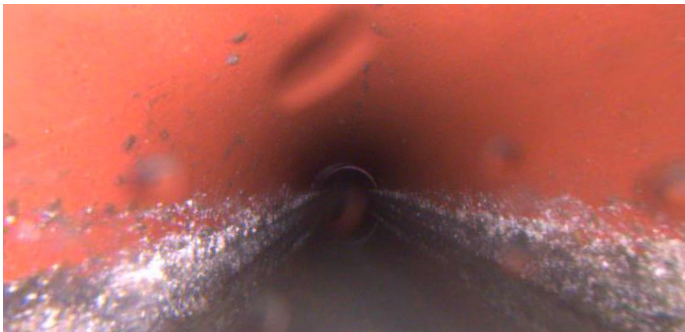
| Code: | DAGS |
| Description: | Deposits Attached Grease |

| O&M Grade: | 2 |
| Clock Start/From: | 8 |
| Clock To: | 4 |
| Value Percent: | 5.000 |

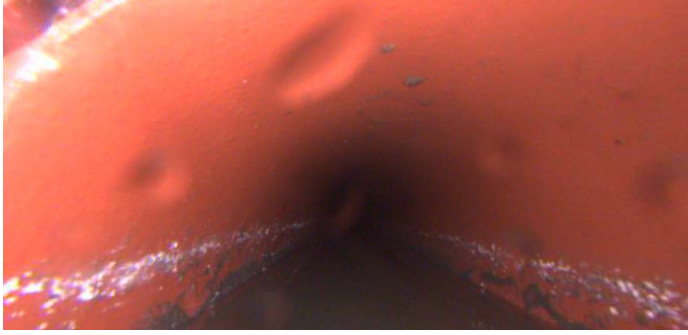
| Code: | MSA |
| Description: | Abandoned Survey |
| Distance (ft): | 4.5 |
| Remarks: | debris under water |
