## Profile/Photo Observation Report

Date:	<b>10/20/2021</b>	Weather:		Coding:	<b>PACP 7.0</b>
Pipe Length (ft):	<b>317.2</b>	Owner:	<b>City of Hobart</b>	Pre Clean:	<b>Heavy Cleaning</b>
P.O.#:	<b>YES502259</b>	Surveyor:	<b>S. Bucklin</b>	PSR:	<b>P-503-074-073</b>
Customer:	<b>City of Hobart</b>	Clean Date:	<b>08/23/2021</b>	Shape:	<b>C</b>

Street:	<b>North Colorado Street</b>	Flow Control:	<b>Not Controlled</b>
City:	<b>Hobart, IN</b>	Year Renewed:	
Location:	<b>Local rural streets with light traffic, t</b>	Tape/Media #:	
Purpose:	<b>Routine Assessment</b>	Dia/Height:	<b>12"</b>
Use:	<b>Sanitary Sewage Pipe</b>	Material:	<b>VCP</b>
Drain Area:		Lining:	
Category:	<b>NA</b>		
Comment:			
Location Details:		Direction of Survey:	<b>Downstream</b>
US MH:	<b>M-503-074</b>	DS MH:	<b>M-503-073</b>
		Total Length Surveyed (ft):	<b>317.2</b>

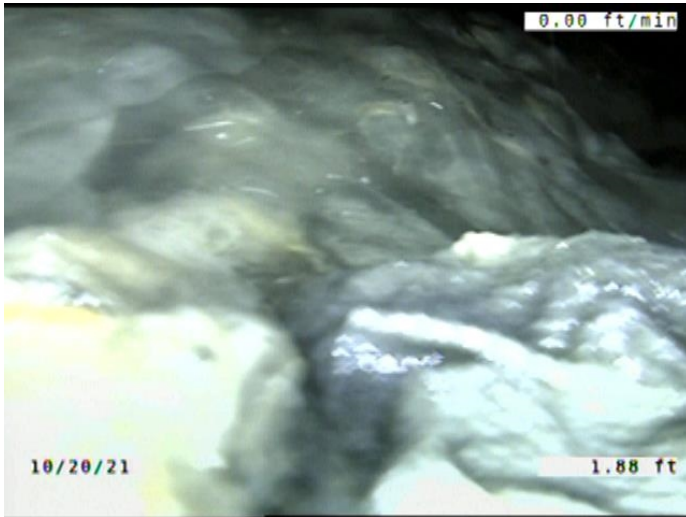
Code:	<b>DAR</b>
Description:	<b>Deposits Attached Ragging</b>
Distance (ft):	<b>1.9</b>
Structural Grade:	<b>0</b>
O&M Grade:	<b>3</b>
Clock Start/From:	<b>4</b>
Clock To:	<b>8</b>
1st Value:	
2nd Value:	
Value Percent:	<b>15.000</b>
Continuous Index:	
Within 8" of Joint:	<b>YES</b>
Remarks:

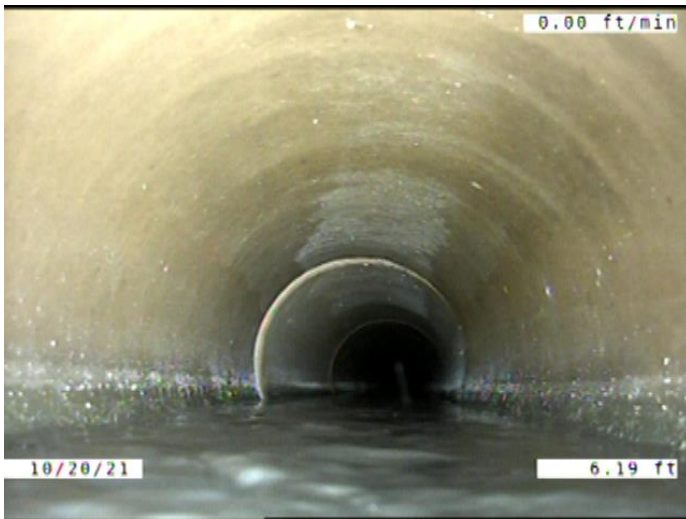
Code:	<b>MWL</b>
Description:	<b>Miscellaneous Water Level</b>
Distance (ft):	<b>6.2</b>
Structural Grade:	<b>0</b>
O&M Grade:	<b>0</b>
Clock Start/From:	
Clock To:	
1st Value:	
2nd Value:	
Value Percent:	<b>15.000</b>
Continuous Index:	
Within 8" of Joint:	<b>NO</b>
Remarks:

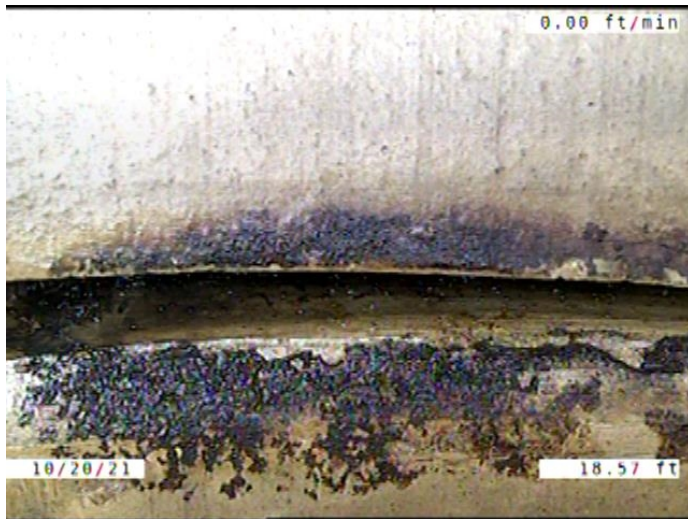
Code: **ISJ**  
 Description: **Infiltration Stain Joint**

Distance (ft): **18.6**  
 Structural Grade: **0**  
 O&M Grade: **1**  
 Clock Start/From: **9**  
 Clock To: **3**  
 1st Value:  
 2nd Value:  
 Value Percent:  
 Continuous Index:  
 Within 8" of Joint: **YES**  
 Remarks:

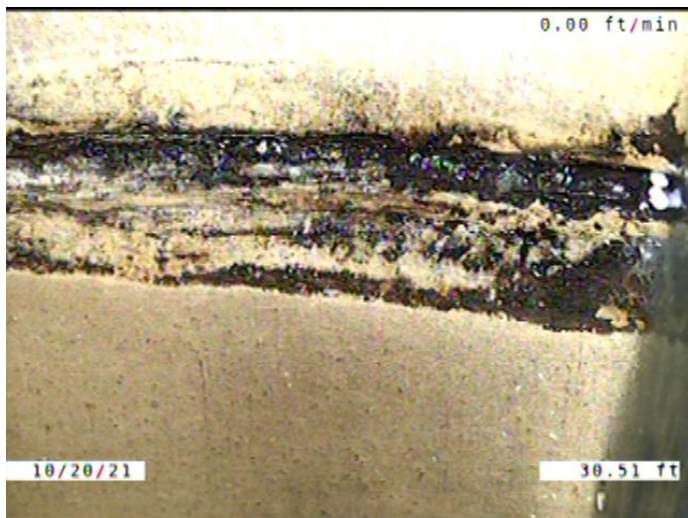
Code: **ISJ**  
 Description: **Infiltration Stain Joint**

Distance (ft): **30.5**  
 Structural Grade: **0**  
 O&M Grade: **1**  
 Clock Start/From: **9**  
 Clock To: **3**  
 1st Value:  
 2nd Value:  
 Value Percent:  
 Continuous Index: **S01**  
 Within 8" of Joint: **YES**  
 Remarks:

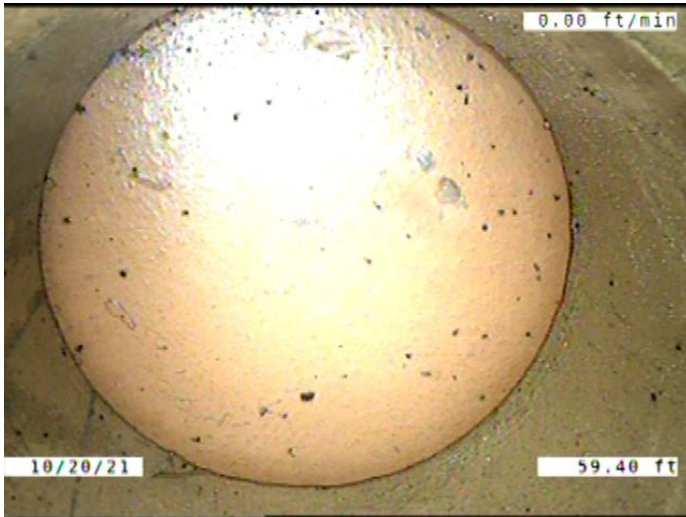
Code: **TFC**  
 Description: **Tap Factory Capped**

Distance (ft): **59.4**  
 Structural Grade: **0**  
 O&M Grade: **0**  
 Clock Start/From: **11**  
 Clock To:  
 1st Value: **6.000**  
 2nd Value:  
 Value Percent:  
 Continuous Index:  
 Within 8" of Joint: **YES**  
 Remarks:

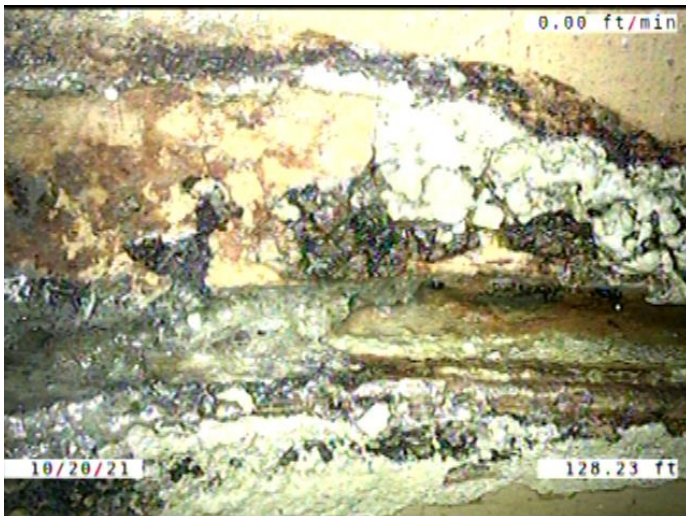
Code: **DAE**  
 Description: **Deposits Attached Encrustation**

Distance (ft): **128.2**  
 Structural Grade: **0**  
 O&M Grade: **2**  
 Clock Start/From: **8**  
 Clock To: **4**  
 1st Value:  
 2nd Value:  
 Value Percent: **5.000**  
 Continuous Index:  
 Within 8" of Joint: **YES**  
 Remarks:

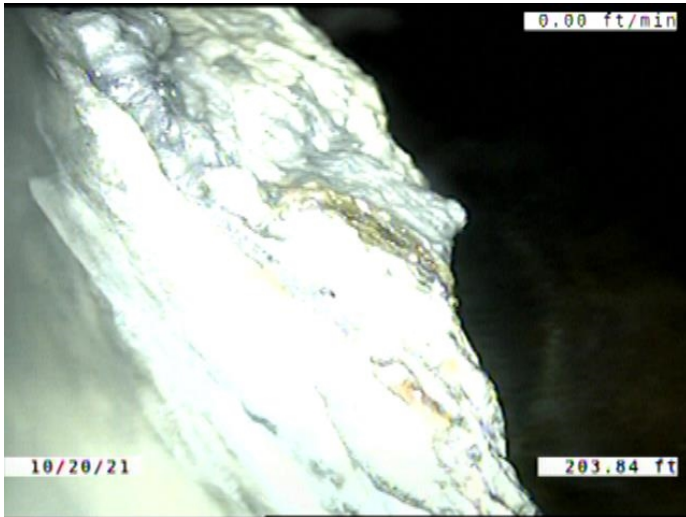
Code: **OBB**  
Description: **Obstruction Brick or Masonry**

Distance (ft): **203.8**  
Structural Grade: **0**  
O&M Grade: **2**  
Clock Start/From: **4**  
Clock To: **6**  
1st Value:  
2nd Value:  
Value Percent: **5.000**  
Continuous Index:  
Within 8" of Joint: **YES**  
Remarks:

Code: **DAR**  
Description: **Deposits Attached Ragging**

Distance (ft): **203.8**  
Structural Grade: **0**  
O&M Grade: **2**  
Clock Start/From: **5**  
Clock To: **7**  
1st Value:  
2nd Value:  
Value Percent: **5.000**  
Continuous Index:  
Within 8" of Joint: **YES**  
Remarks:

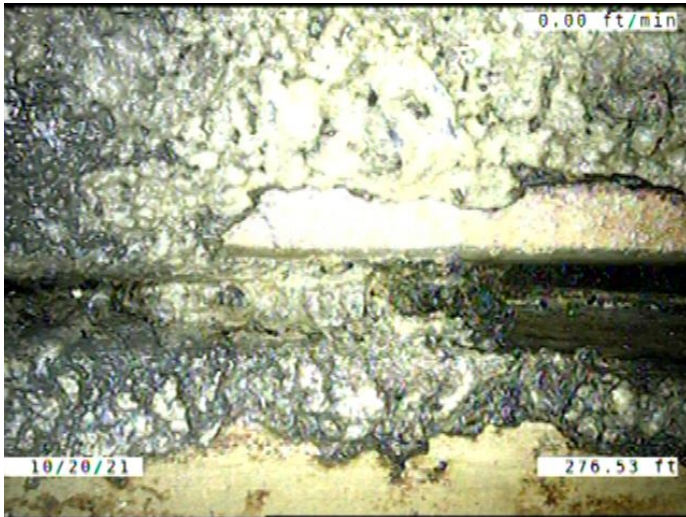
Code: **DAE**  
 Description: **Deposits Attached Encrustation**

Distance (ft): **276.5**  
 Structural Grade: **0**  
 O&M Grade: **2**  
 Clock Start/From: **8**  
 Clock To: **4**  
 1st Value:  
 2nd Value:  
 Value Percent: **5.000**  
 Continuous Index:  
 Within 8" of Joint: **YES**  
 Remarks:

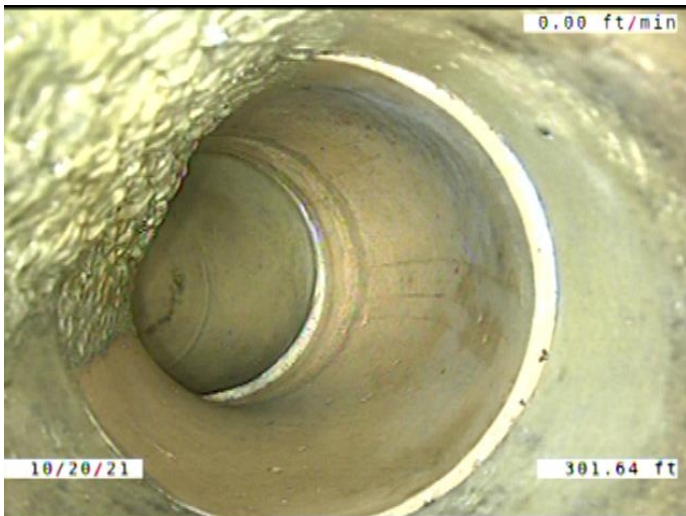
Code: **TF**  
 Description: **Tap Factory**

Distance (ft): **301.6**  
 Structural Grade: **0**  
 O&M Grade: **0**  
 Clock Start/From: **11**  
 Clock To:  
 1st Value: **6.000**  
 2nd Value:  
 Value Percent:  
 Continuous Index:  
 Within 8" of Joint: **YES**  
 Remarks: **ENCrustation COMING OUT THE TAP INTO THE MAIN**

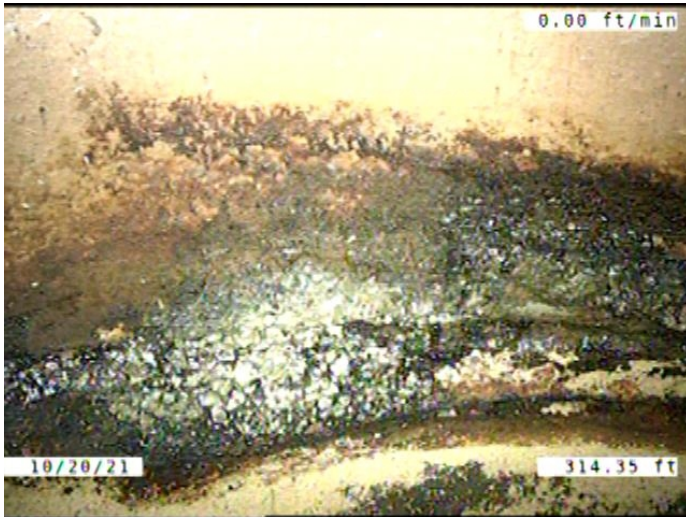
Code: **DAE**  
 Description: **Deposits Attached Encrustation**

Distance (ft): **314.4**  
 Structural Grade: **0**  
 O&M Grade: **2**  
 Clock Start/From: **8**  
 Clock To: **4**  
 1st Value:  
 2nd Value:  
 Value Percent: **5.000**  
 Continuous Index:  
 Within 8" of Joint: **YES**  
 Remarks:

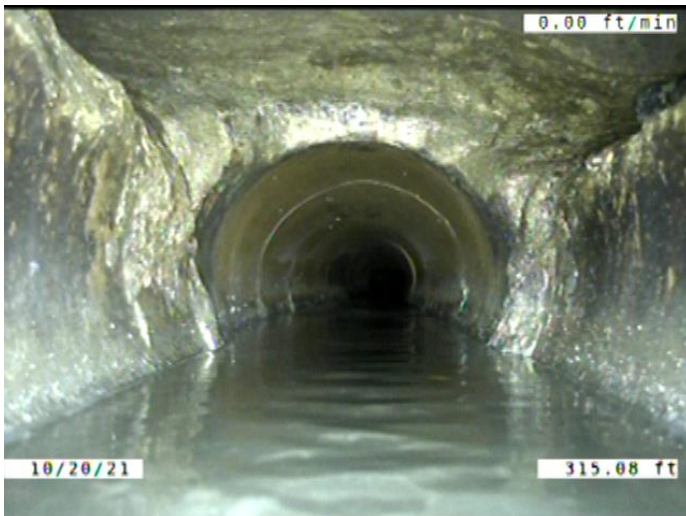
Code: **ISJ**  
 Description: **Infiltration Stain Joint**

Distance (ft): **315.1**  
 Structural Grade: **0**  
 O&M Grade: **1**  
 Clock Start/From: **9**  
 Clock To: **3**  
 1st Value:  
 2nd Value:  
 Value Percent:  
 Continuous Index: **F01**  
 Within 8" of Joint: **YES**  
 Remarks:

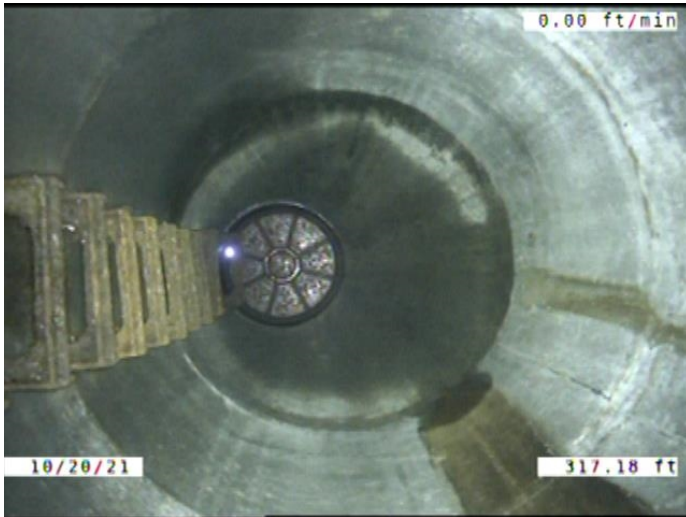
Code:	<b>AMH</b>
Description:	<b>Manhole</b>
Distance (ft):	<b>317.2</b>
Structural Grade:	<b>0</b>
O&M Grade:	<b>0</b>
Clock Start/From:	
Clock To:	
1st Value:	
2nd Value:	
Value Percent:	
Continuous Index:	
Within 8" of Joint:	<b>NO</b>
Remarks:	<b>M-503-073</b>
