Profile/Photo Observation Report

Date:	10/20/2021	Weather:		Coding:	PACP 7.0
Pipe Length (ft):	317.2	Owner:	City of Hobart	Pre Clean:	Heavy Cleaning
P.O.#:	YES502259	Surveyor:	S. Bucklin	PSR:	P-503-074-073
Customer:	City of Hobart	Clean Date:	08/23/2021	Shape:	C

Street:	North Colorado Street	Flow Control:	Not Controlled
City:	Hobart, IN	Year Renewed:	
Location:	Local rural streets with light traffic, t	Tape/Media #:	
Purpose:	Routine Assessment	Dia/Height:	12"
Use:	Sanitary Sewage Pipe	Material:	VCP
Drain Area:		Lining:	
Category:	NA		
Comment:			
Location Details:		Direction of Survey:	Downstream
US MH:	M-503-074	DS MH:	M-503-073
		Total Length Surveyed (ft):	317.2

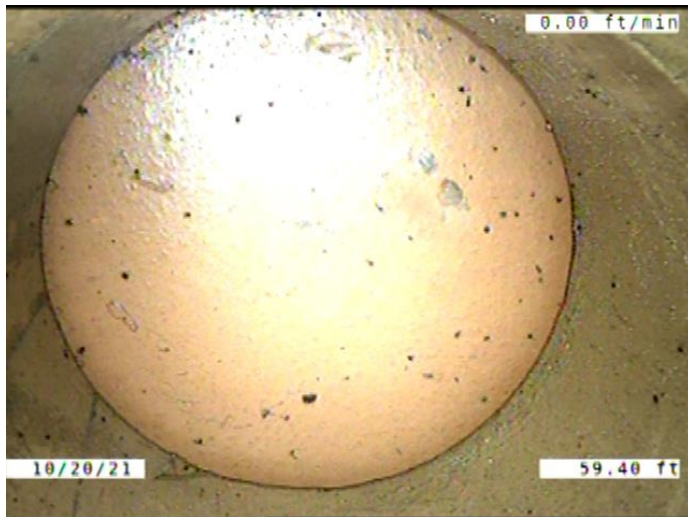
Code: **TFC**
 Description: **Tap Factory Capped**

Distance (ft): **59.4**
 Structural Grade: **0**
 O&M Grade: **0**
 Clock Start/From: **11**
 Clock To:
 1st Value: **6.000**
 2nd Value:
 Value Percent:
 Continuous Index:
 Within 8" of Joint: **YES**
 Remarks:

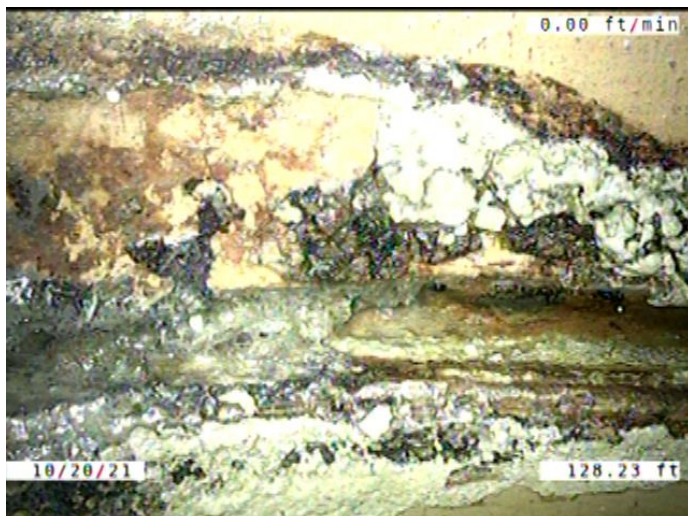
Code: **DAE**
 Description: **Deposits Attached Encrustation**

Distance (ft): **128.2**
 Structural Grade: **0**
 O&M Grade: **2**
 Clock Start/From: **8**
 Clock To: **4**
 1st Value:
 2nd Value:
 Value Percent: **5.000**
 Continuous Index:
 Within 8" of Joint: **YES**
 Remarks:
