Profile/Photo Observation Report

| Street: | W 40th ave | Flow Control: | Not Controlled |
| City: | Hobart, IN | Year Renewed: | |

| US MH: | M-503-074 | DS MH: | M-503-075 |

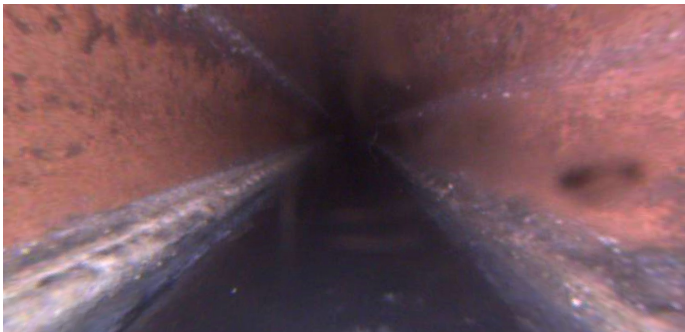
| Code: | DAGS |
| Description: | Deposits Attached Grease |

| Distance (ft): | .0 |
| O&M Grade: | 2 |
| Clock Start/From: | 8 |
| Clock To: | 4 |
| Value Percent: | 5.000 |

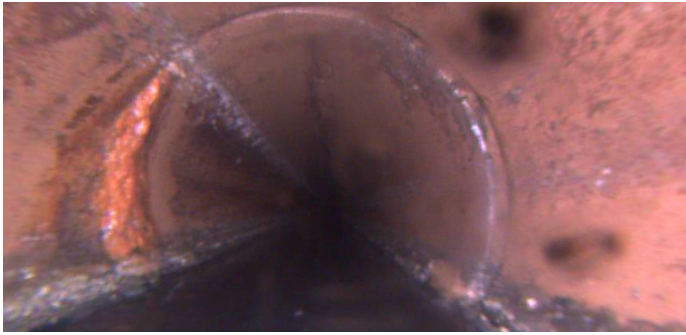
Code: **IW**
Description: **Infil Weeper**

Distance (ft): **9.3**
Structural Grade: **0**
O&M Grade: **2**
Clock Start/From: **8**
Clock To: **10**
1st Value:
2nd Value:
Value Percent:
Continuous Index:
Within 8" of Joint: **YES**
Remarks:

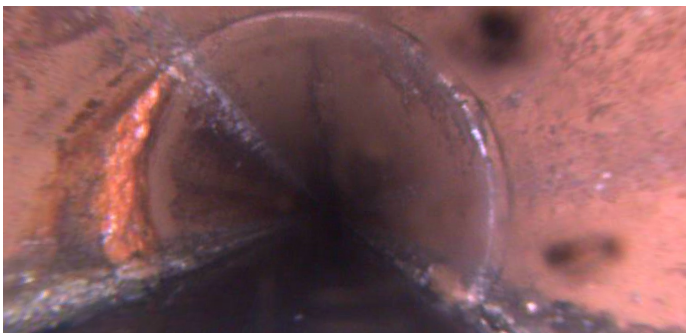
Code: **DAE**
Description: **Deposits Attached Encrustation**

Distance (ft): **9.3**
Structural Grade: **0**
O&M Grade: **2**
Clock Start/From: **8**
Clock To: **10**
1st Value:
2nd Value:
Value Percent: **5.000**
Continuous Index:
Within 8" of Joint: **YES**
Remarks:

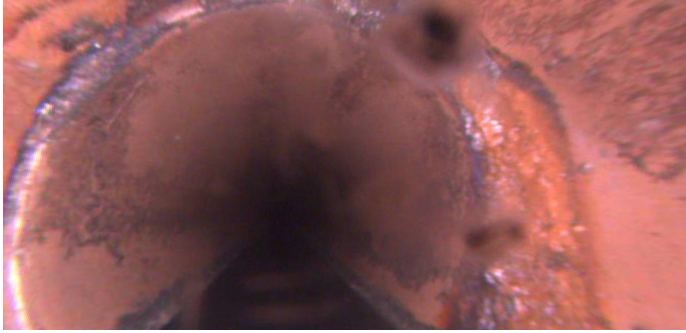
Code: **IW**
Description: **Infil Weeper**

Distance (ft): **49.3**
Structural Grade: **0**
O&M Grade: **2**
Clock Start/From: **1**
Clock To: **4**
1st Value:
2nd Value:
Value Percent:
Continuous Index:
Within 8" of Joint: **YES**
Remarks:

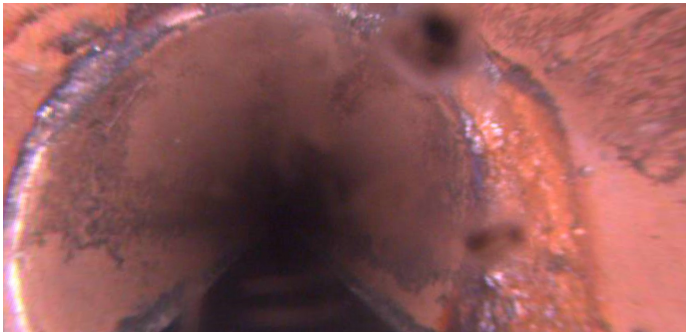
Code: **DAE**
Description: **Deposits Attached Encrustation**

Distance (ft): **49.3**
Structural Grade: **0**
O&M Grade: **2**
Clock Start/From: **1**
Clock To: **4**
1st Value:
2nd Value:
Value Percent: **5.000**
Continuous Index:
Within 8" of Joint: **YES**
Remarks:

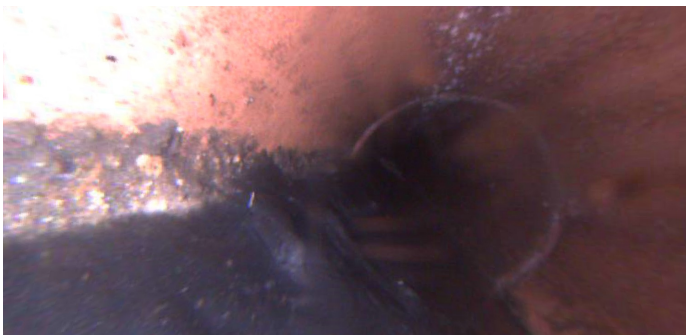
Code: **MSA**
Description: **Abandoned Survey**

Distance (ft): **60.5**
Structural Grade: **0**
O&M Grade: **0**
Clock Start/From:
Clock To:
1st Value:
2nd Value:
Value Percent:
Continuous Index:
Within 8" of Joint: **NO**
Remarks: **overturned**

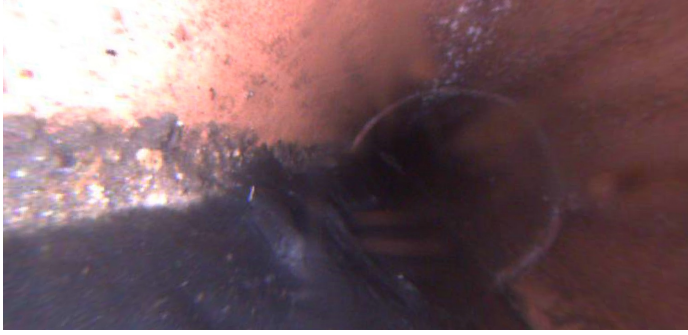
| Code: | DAGS |
| Description: | Deposits Attached Grease |
| Distance (ft): | 60.5 |
| O&M Grade: | 2 |
| Clock Start/From: | 8 |
| Clock To: | 4 |
| Value Percent: | 5.000 |
