Profile/Photo Observation Report

Date:	08/21/2021	Weather:		Coding:	PACP 7.0
Pipe Length (ft):	156.1	Owner:	City of Hobart	Pre Clean:	Light Cleaning
P.O.#:	YES502259	Surveyor:	S. Bucklin	PSR:	P-503-075-074
Customer:	City of Hobart	Clean Date:	08/16/2021	Shape:	C

Street:	North Colorado Street	Flow Control:	Not Controlled
City:	Hobart, IN	Year Renewed:	
Location:	Local rural streets with light traffic, t	Tape/Media #:	
Purpose:	Routine Assessment	Dia/Height:	10"
Use:	Sanitary Sewage Pipe	Material:	VCP
Drain Area:		Lining:	
Category:	NA		
Comment:			
Location Details:		Direction of Survey:	Downstream
US MH:	M-503-074	DS MH:	M-503-075
		Total Length Surveyed (ft):	156.1

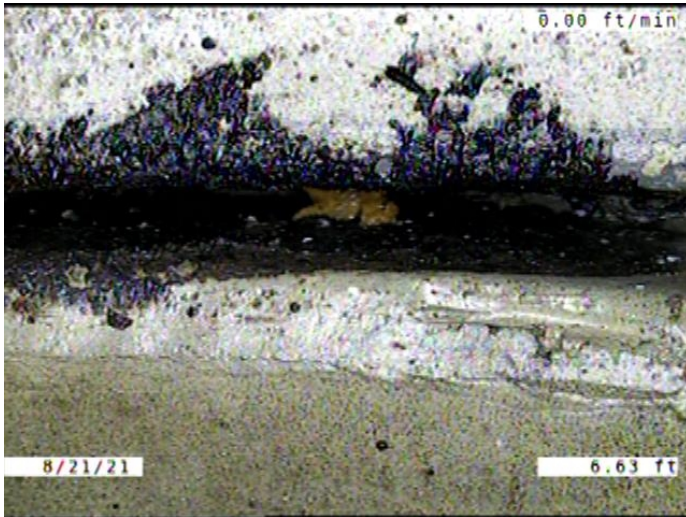
Code: **ISJ**
 Description: **Infiltration Stain Joint**

Distance (ft): **6.6**
 Structural Grade: **0**
 O&M Grade: **1**
 Clock Start/From: **2**
 Clock To: **4**
 1st Value:
 2nd Value:
 Value Percent:
 Continuous Index:
 Within 8" of Joint: **YES**
 Remarks:

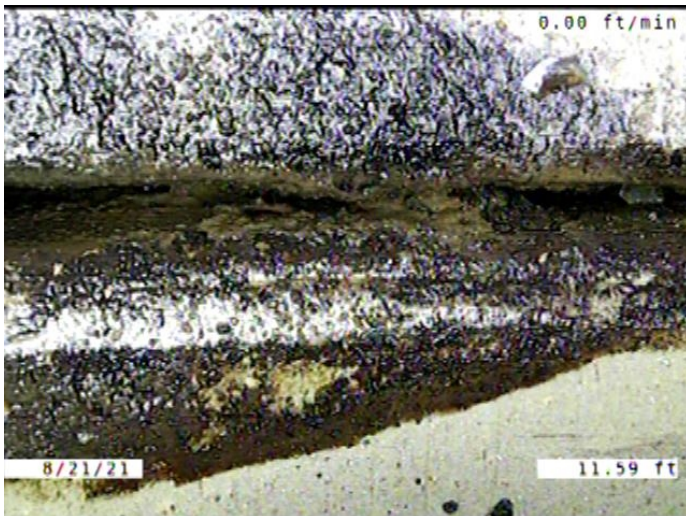
Code: **ISJ**
 Description: **Infiltration Stain Joint**

Distance (ft): **11.6**
 Structural Grade: **0**
 O&M Grade: **1**
 Clock Start/From: **8**
 Clock To: **10**
 1st Value:
 2nd Value:
 Value Percent:
 Continuous Index:
 Within 8" of Joint: **YES**
 Remarks:

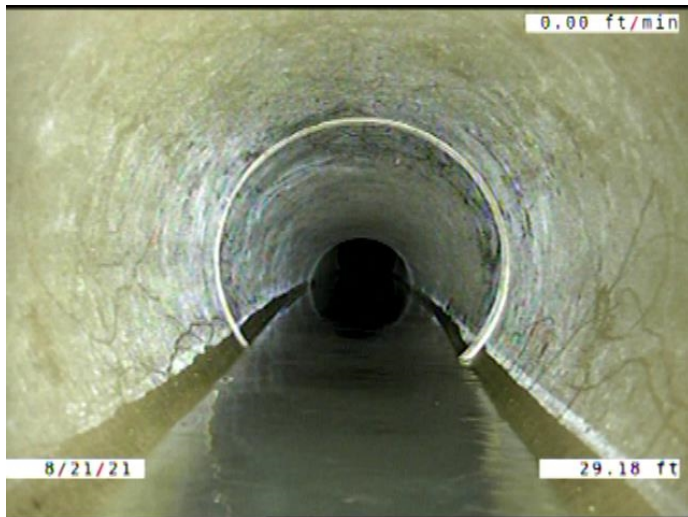
Code: **MWLS**
 Description: **Miscellaneous Water Level Sag**

Distance (ft): **29.2**
 Structural Grade: **2**
 O&M Grade: **0**
 Clock Start/From:
 Clock To:
 1st Value:
 2nd Value:
 Value Percent: **15.000**
 Continuous Index: **S02**
 Within 8" of Joint: **NO**
 Remarks:

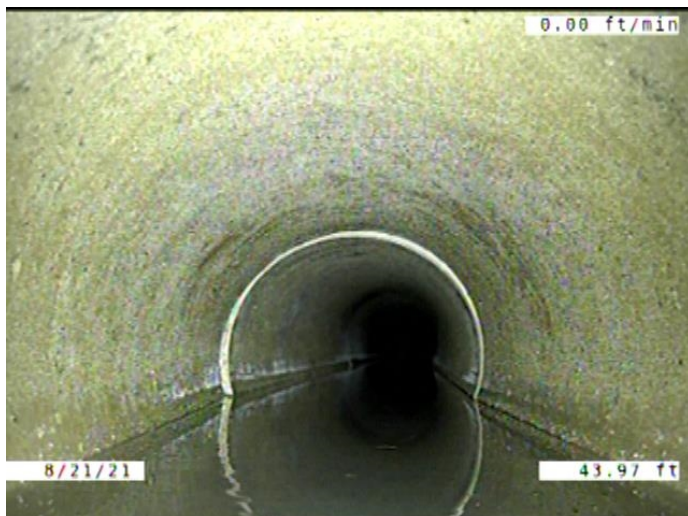
Code: **MWLS**
 Description: **Miscellaneous Water Level Sag**

Distance (ft): **44.0**
 Structural Grade: **2**
 O&M Grade: **0**
 Clock Start/From:
 Clock To:
 1st Value:
 2nd Value:
 Value Percent: **15.000**
 Continuous Index: **F02**
 Within 8" of Joint: **NO**
 Remarks:

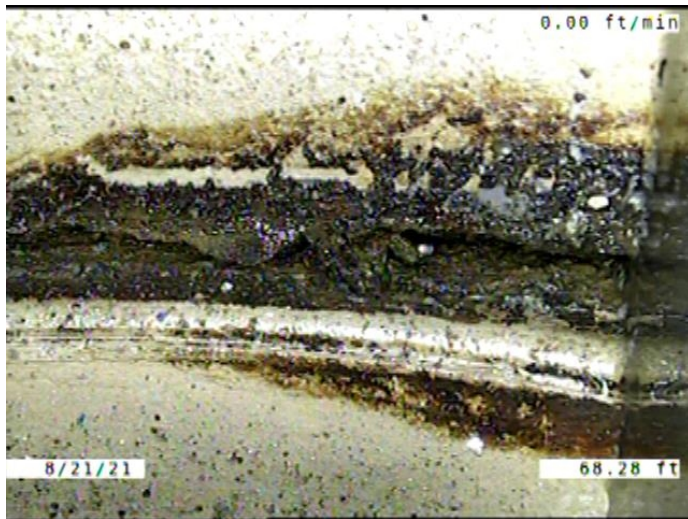
Code: **ISJ**
Description: **Infiltration Stain Joint**

Distance (ft): **68.3**
Structural Grade: **0**
O&M Grade: **1**
Clock Start/From: **9**
Clock To: **3**
1st Value:
2nd Value:
Value Percent:
Continuous Index:
Within 8" of Joint: **YES**
Remarks:

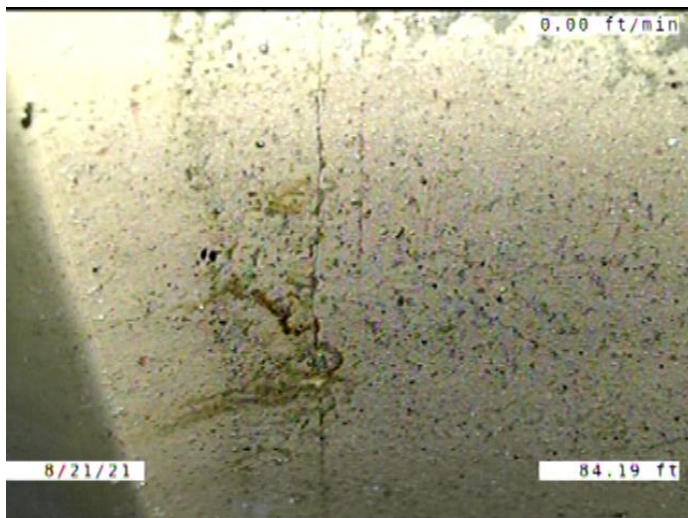
Code: **CM**
Description: **Crack Multiple**

Distance (ft): **84.2**
Structural Grade: **3**
O&M Grade: **0**
Clock Start/From: **8**
Clock To: **4**
1st Value:
2nd Value:
Value Percent:
Continuous Index:
Within 8" of Joint: **YES**
Remarks:

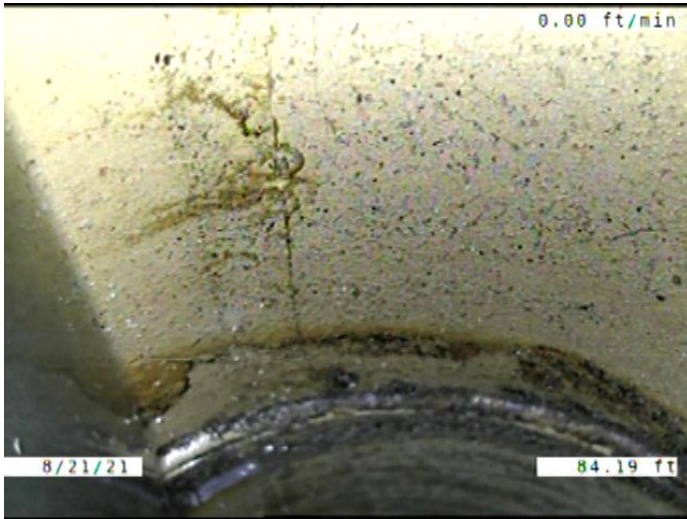
Code: **ISB**
Description: **Infiltration Stain Barrel**

Distance (ft): **84.2**
Structural Grade: **0**
O&M Grade: **1**
Clock Start/From: **8**
Clock To: **4**
1st Value:
2nd Value:
Value Percent:
Continuous Index:
Within 8" of Joint: **YES**
Remarks:

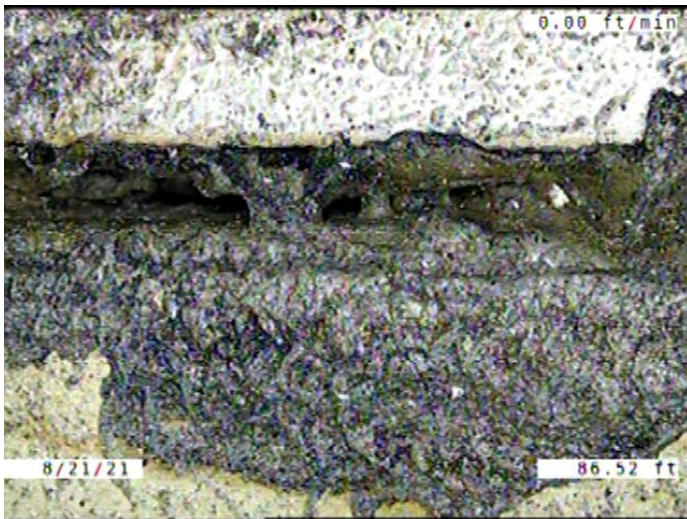
Code: **ISJ**
Description: **Infiltration Stain Joint**

Distance (ft): **86.5**
Structural Grade: **0**
O&M Grade: **1**
Clock Start/From: **8**
Clock To: **4**
1st Value:
2nd Value:
Value Percent:
Continuous Index:
Within 8" of Joint: **YES**
Remarks:

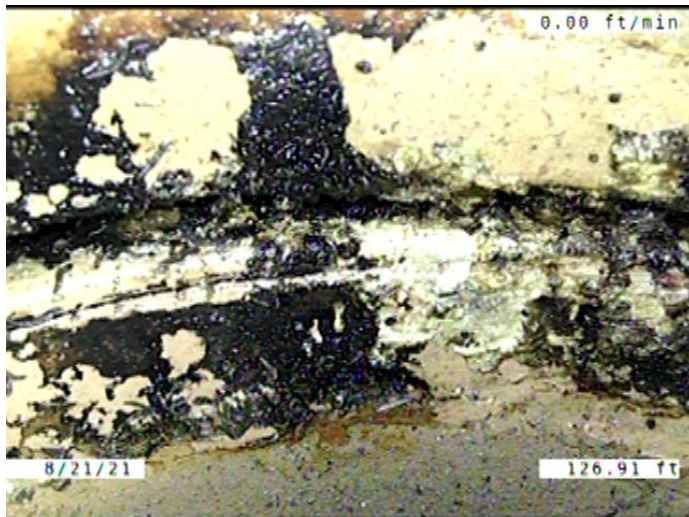
Code: **ISJ**
 Description: **Infiltration Stain Joint**

Distance (ft): **126.9**
 Structural Grade: **0**
 O&M Grade: **1**
 Clock Start/From: **9**
 Clock To: **3**
 1st Value:
 2nd Value:
 Value Percent:
 Continuous Index:
 Within 8" of Joint: **YES**
 Remarks:

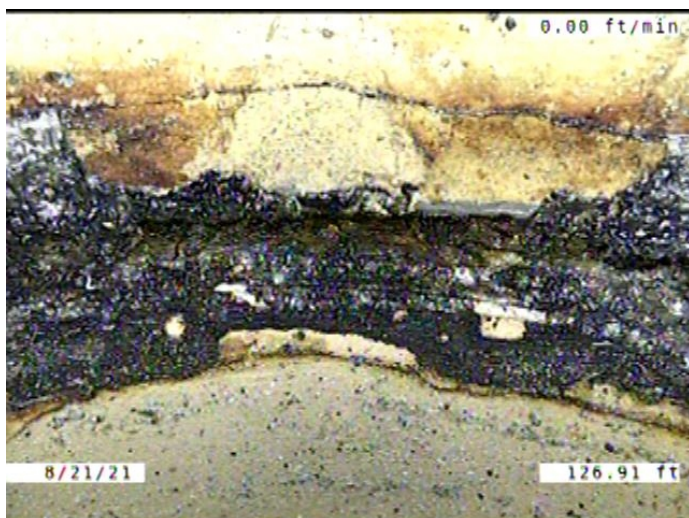
Code: **CM**
 Description: **Crack Multiple**

Distance (ft): **126.9**
 Structural Grade: **3**
 O&M Grade: **0**
 Clock Start/From: **9**
 Clock To: **3**
 1st Value:
 2nd Value:
 Value Percent:
 Continuous Index:
 Within 8" of Joint: **YES**
 Remarks:

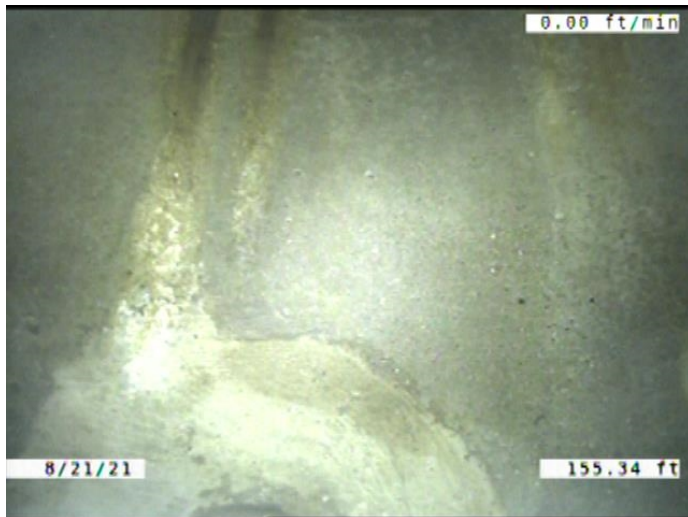
Code: **DSF**
 Description: **Deposits Settled Fine**

Distance (ft): **155.3**
 Structural Grade: **0**
 O&M Grade: **2**
 Clock Start/From: **5**
 Clock To: **7**
 1st Value:
 2nd Value:
 Value Percent: **5.000**
 Continuous Index: **F01**
 Within 8" of Joint: **YES**
 Remarks:
