Profile/Photo Observation Report

Date:	08/21/2021	Weather:		Coding:	PACP 7.0
Pipe Length (ft):	156.1	Owner:	City of Hobart	Pre Clean:	Light Cleaning
P.O.#:	YES502259	Surveyor:	S. Bucklin	PSR:	P-503-075-074
Customer:	City of Hobart	Clean Date:	08/16/2021	Shape:	C

Street:	North Colorado Street	Flow Control:	Not Controlled
City:	Hobart, IN	Year Renewed:	
Location:	Local rural streets with light traffic, t	Tape/Media #:	
Purpose:	Routine Assessment	Dia/Height:	10"
Use:	Sanitary Sewage Pipe	Material:	VCP
Drain Area:		Lining:	
Category:	NA		
Comment:			
Location Details:		Direction of Survey:	Downstream
US MH:	M-503-074	DS MH:	M-503-075
		Total Length Surveyed (ft):	156.1

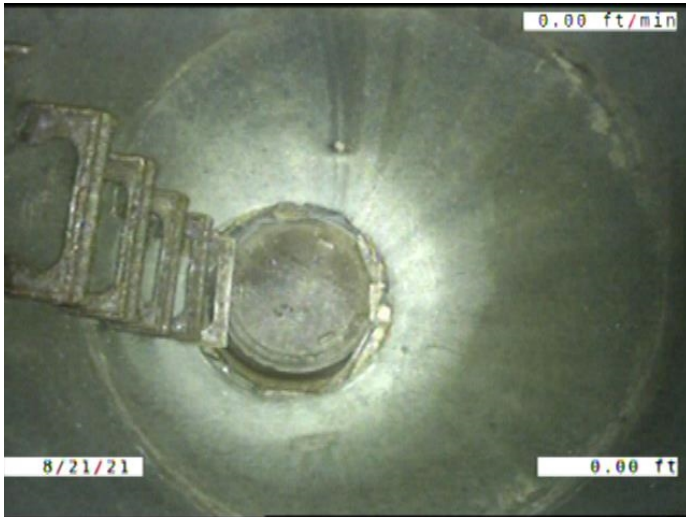
Code: **AMH**
 Description: **Manhole**

Distance (ft): **.0**
 Structural Grade: **0**
 O&M Grade: **0**
 Clock Start/From:
 Clock To:
 1st Value:
 2nd Value:
 Value Percent:
 Continuous Index:
 Within 8" of Joint: **NO**
 Remarks: **M-503-074**

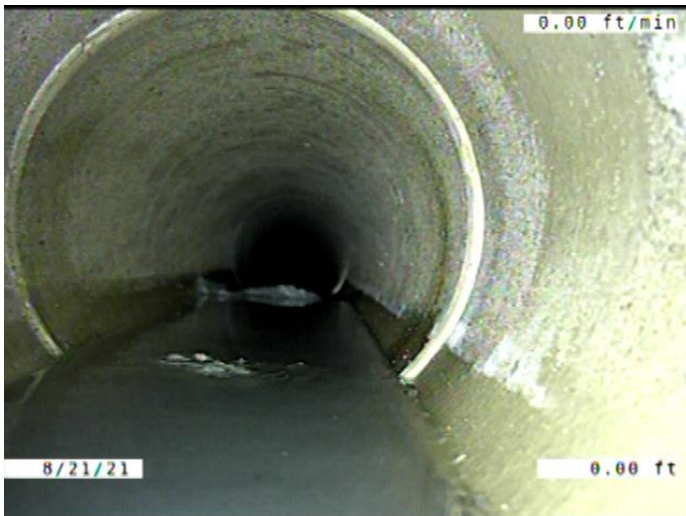
Code: **MWL**
 Description: **Miscellaneous Water Level**

Distance (ft): **.0**
 Structural Grade: **0**
 O&M Grade: **0**
 Clock Start/From:
 Clock To:
 1st Value:
 2nd Value:
 Value Percent: **5.000**
 Continuous Index:
 Within 8" of Joint: **NO**
 Remarks:

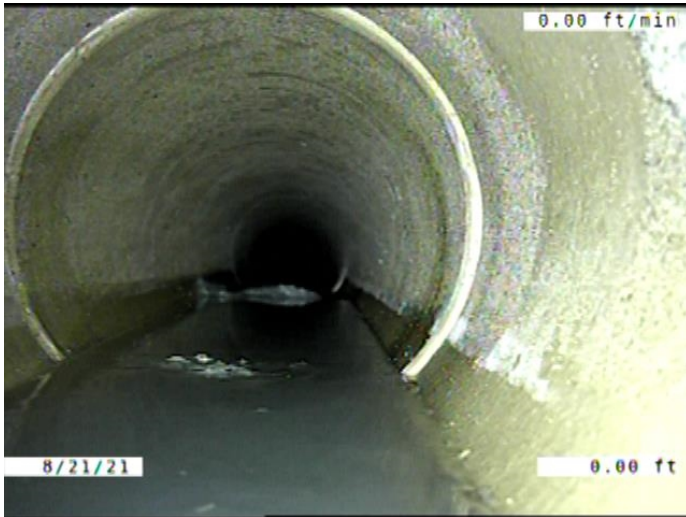
Code: **DSF**
 Description: **Deposits Settled Fine**

Distance (ft): **.0**
 Structural Grade: **0**
 O&M Grade: **2**
 Clock Start/From: **5**
 Clock To: **7**
 1st Value:
 2nd Value:
 Value Percent: **5.000**
 Continuous Index: **S01**
 Within 8" of Joint: **YES**
 Remarks:

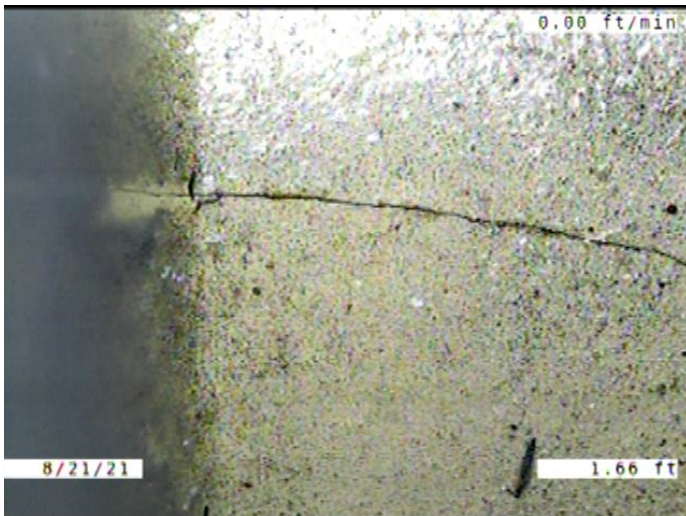
Code: **CS**
 Description: **Crack Spiral**

Distance (ft): **1.7**
 Structural Grade: **2**
 O&M Grade: **0**
 Clock Start/From: **8**
 Clock To: **11**
 1st Value:
 2nd Value:
 Value Percent:
 Continuous Index:
 Within 8" of Joint: **YES**
 Remarks:

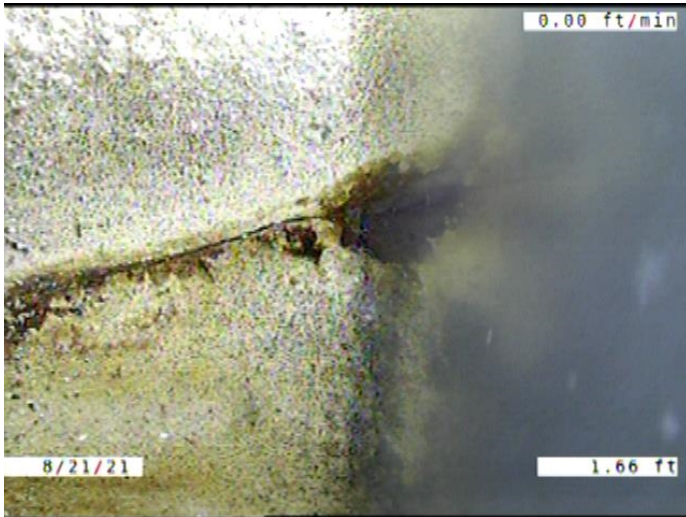
Code: **CS**
Description: **Crack Spiral**

Distance (ft): **1.7**
Structural Grade: **2**
O&M Grade: **0**
Clock Start/From: **1**
Clock To: **5**
1st Value:
2nd Value:
Value Percent:
Continuous Index:
Within 8" of Joint: **YES**
Remarks:

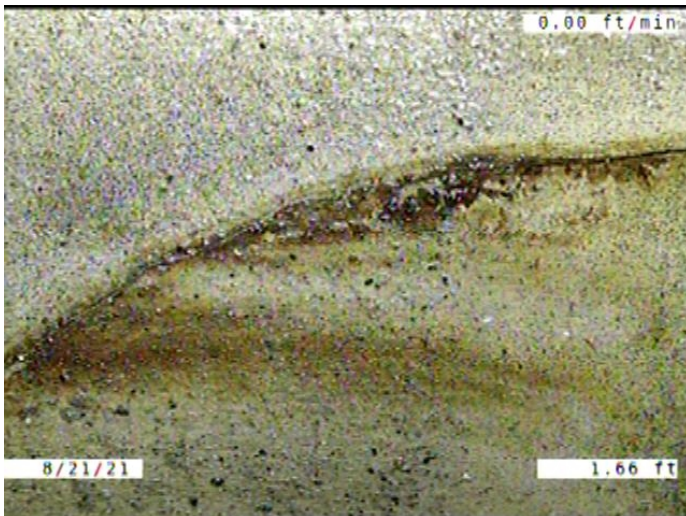
Code: **ISB**
Description: **Infiltration Stain Barrel**

Distance (ft): **1.7**
Structural Grade: **0**
O&M Grade: **1**
Clock Start/From: **2**
Clock To: **5**
1st Value:
2nd Value:
Value Percent:
Continuous Index:
Within 8" of Joint: **YES**
Remarks:

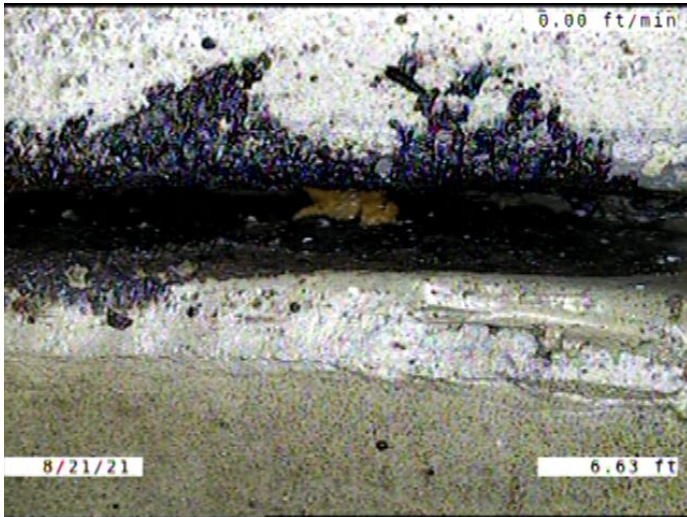
Code: **ISJ**
 Description: **Infiltration Stain Joint**

Distance (ft): **6.6**
 Structural Grade: **0**
 O&M Grade: **1**
 Clock Start/From: **2**
 Clock To: **4**
 1st Value:
 2nd Value:
 Value Percent:
 Continuous Index:
 Within 8" of Joint: **YES**
 Remarks:

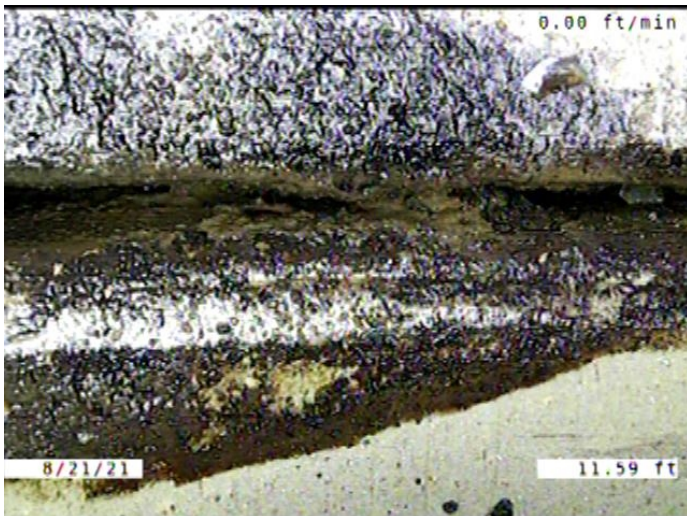
Code: **ISJ**
 Description: **Infiltration Stain Joint**

Distance (ft): **11.6**
 Structural Grade: **0**
 O&M Grade: **1**
 Clock Start/From: **8**
 Clock To: **10**
 1st Value:
 2nd Value:
 Value Percent:
 Continuous Index:
 Within 8" of Joint: **YES**
 Remarks:

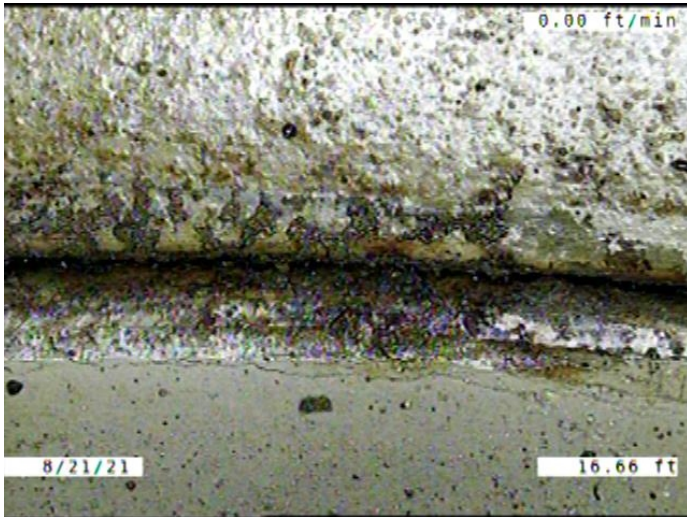
Code: **ISJ**
 Description: **Infiltration Stain Joint**

Distance (ft): **16.7**
 Structural Grade: **0**
 O&M Grade: **1**
 Clock Start/From: **12**
 Clock To: **4**
 1st Value:
 2nd Value:
 Value Percent:
 Continuous Index:
 Within 8" of Joint: **YES**
 Remarks:

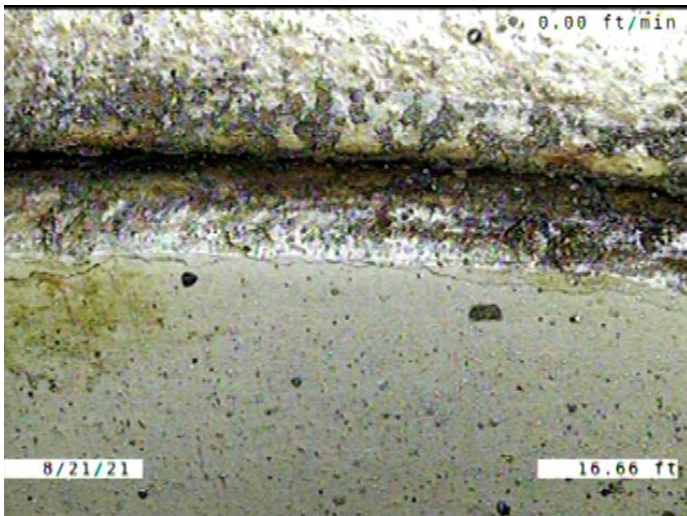
Code: **CM**
 Description: **Crack Multiple**

Distance (ft): **16.7**
 Structural Grade: **3**
 O&M Grade: **0**
 Clock Start/From: **8**
 Clock To: **4**
 1st Value:
 2nd Value:
 Value Percent:
 Continuous Index:
 Within 8" of Joint: **YES**
 Remarks:

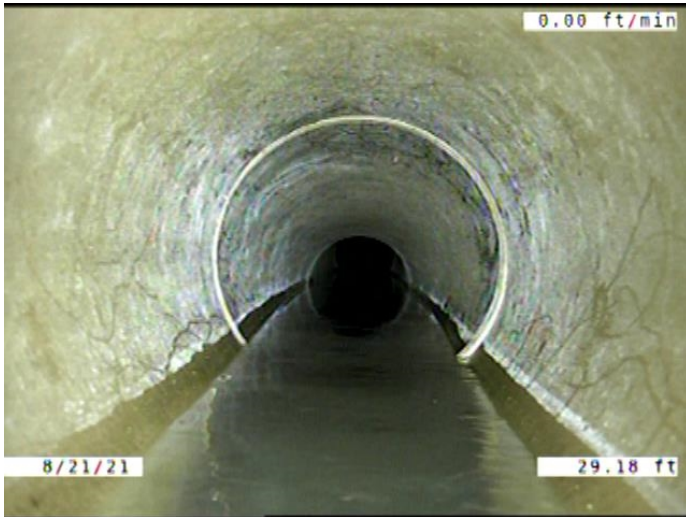
Code: **MWLS**
 Description: **Miscellaneous Water Level Sag**

Distance (ft): **29.2**
 Structural Grade: **2**
 O&M Grade: **0**
 Clock Start/From:
 Clock To:
 1st Value:
 2nd Value:
 Value Percent: **15.000**
 Continuous Index: **S02**
 Within 8" of Joint: **NO**
 Remarks:

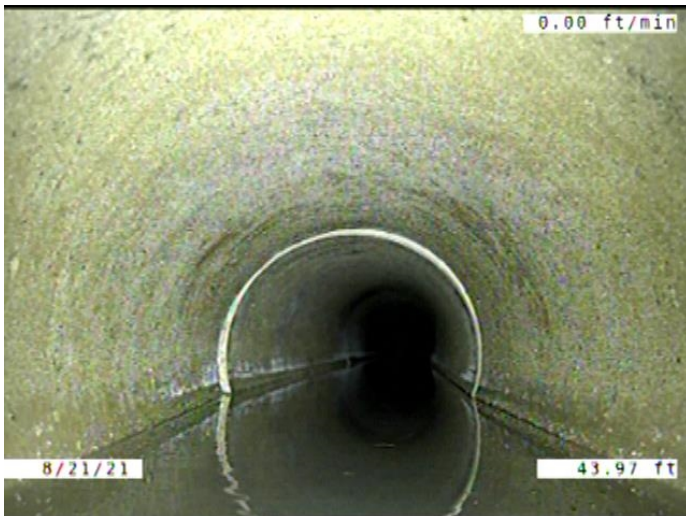
Code: **MWLS**
 Description: **Miscellaneous Water Level Sag**

Distance (ft): **44.0**
 Structural Grade: **2**
 O&M Grade: **0**
 Clock Start/From:
 Clock To:
 1st Value:
 2nd Value:
 Value Percent: **15.000**
 Continuous Index: **F02**
 Within 8" of Joint: **NO**
 Remarks:

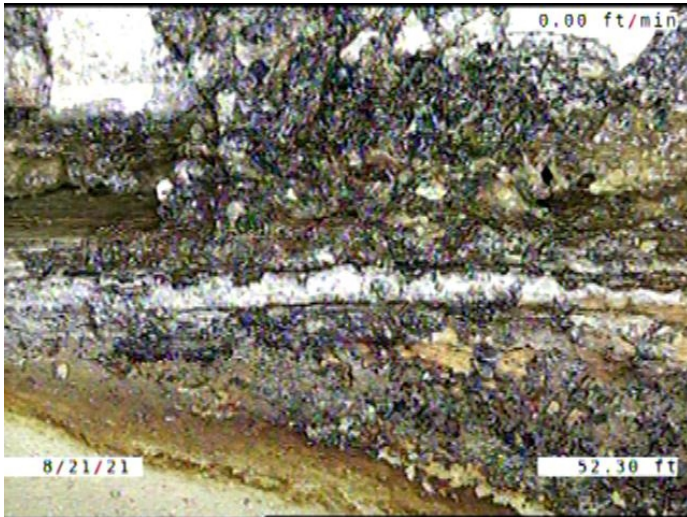
Code: **ISJ**
 Description: **Infiltration Stain Joint**

Distance (ft): **52.3**
 Structural Grade: **0**
 O&M Grade: **1**
 Clock Start/From: **9**
 Clock To: **4**
 1st Value:
 2nd Value:
 Value Percent:
 Continuous Index:
 Within 8" of Joint: **YES**
 Remarks:

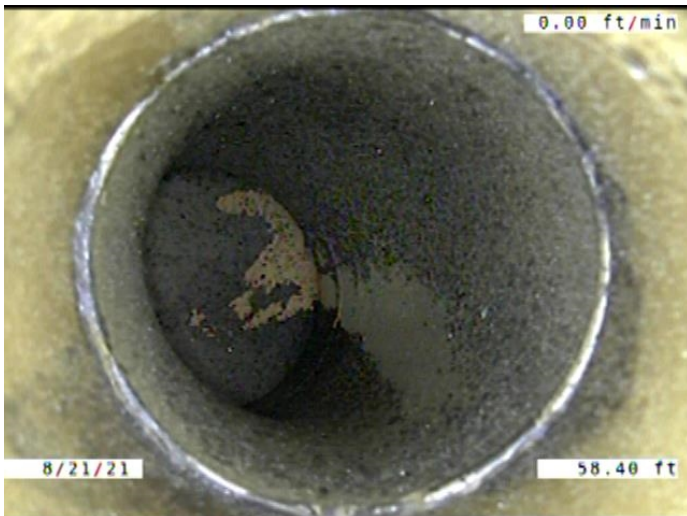
Code: **TFC**
 Description: **Tap Factory Capped**

Distance (ft): **58.4**
 Structural Grade: **0**
 O&M Grade: **0**
 Clock Start/From: **11**
 Clock To:
 1st Value: **4.000**
 2nd Value:
 Value Percent:
 Continuous Index:
 Within 8" of Joint: **YES**
 Remarks:

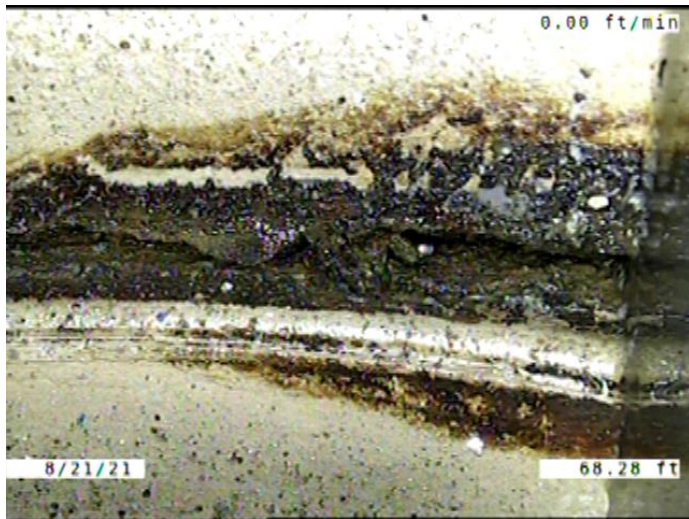
Code: **ISJ**
 Description: **Infiltration Stain Joint**

Distance (ft): **68.3**
 Structural Grade: **0**
 O&M Grade: **1**
 Clock Start/From: **9**
 Clock To: **3**
 1st Value:
 2nd Value:
 Value Percent:
 Continuous Index:
 Within 8" of Joint: **YES**
 Remarks:

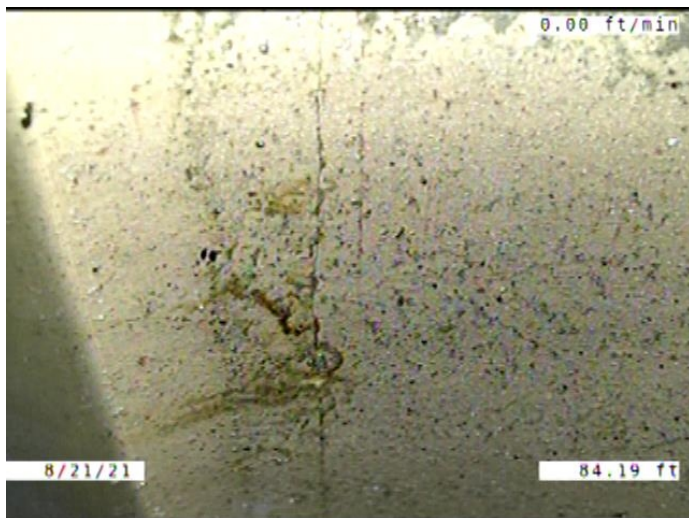
Code: **CM**
 Description: **Crack Multiple**

Distance (ft): **84.2**
 Structural Grade: **3**
 O&M Grade: **0**
 Clock Start/From: **8**
 Clock To: **4**
 1st Value:
 2nd Value:
 Value Percent:
 Continuous Index:
 Within 8" of Joint: **YES**
 Remarks:

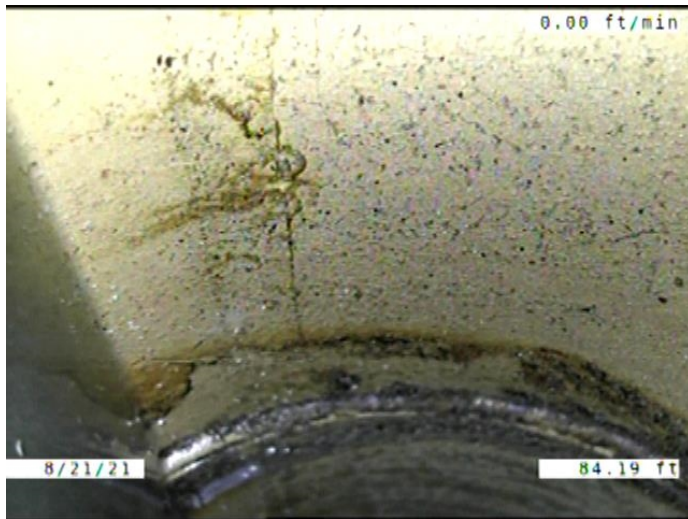
Code: **ISB**
 Description: **Infiltration Stain Barrel**

Distance (ft): **84.2**
 Structural Grade: **0**
 O&M Grade: **1**
 Clock Start/From: **8**
 Clock To: **4**
 1st Value:
 2nd Value:
 Value Percent:
 Continuous Index:
 Within 8" of Joint: **YES**
 Remarks:

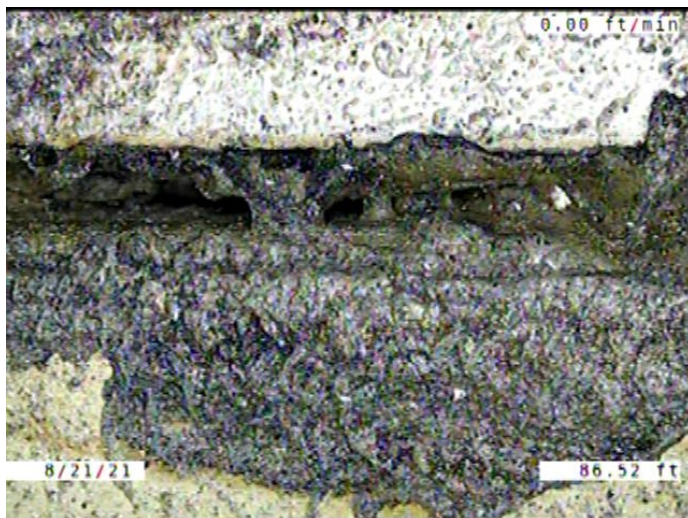
Code: **ISJ**
 Description: **Infiltration Stain Joint**

Distance (ft): **86.5**
 Structural Grade: **0**
 O&M Grade: **1**
 Clock Start/From: **8**
 Clock To: **4**
 1st Value:
 2nd Value:
 Value Percent:
 Continuous Index:
 Within 8" of Joint: **YES**
 Remarks:

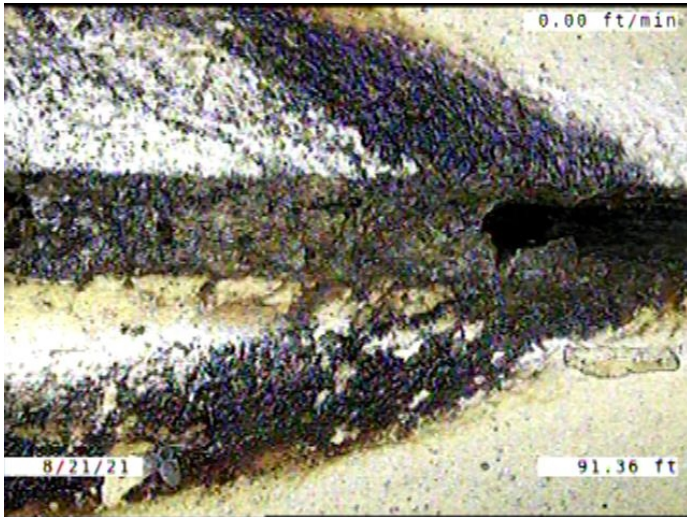
Code: **ISJ**
 Description: **Infiltration Stain Joint**

Distance (ft): **91.4**
 Structural Grade: **0**
 O&M Grade: **1**
 Clock Start/From: **8**
 Clock To: **11**
 1st Value:
 2nd Value:
 Value Percent:
 Continuous Index:
 Within 8" of Joint: **YES**
 Remarks:

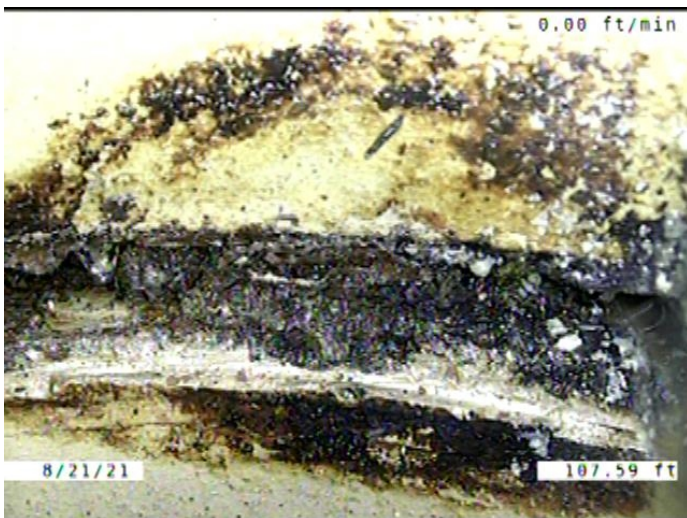
Code: **ISJ**
 Description: **Infiltration Stain Joint**

Distance (ft): **107.6**
 Structural Grade: **0**
 O&M Grade: **1**
 Clock Start/From: **8**
 Clock To: **4**
 1st Value:
 2nd Value:
 Value Percent:
 Continuous Index:
 Within 8" of Joint: **YES**
 Remarks:

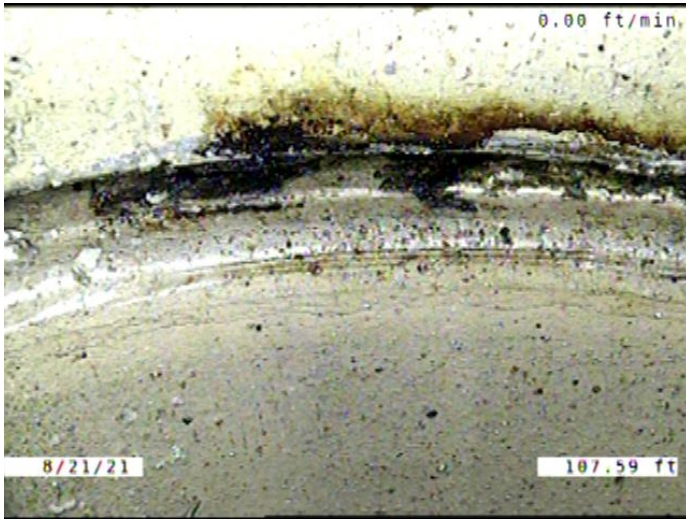
Code: **CS**
 Description: **Crack Spiral**

Distance (ft): **107.6**
 Structural Grade: **2**
 O&M Grade: **0**
 Clock Start/From: **8**
 Clock To: **4**
 1st Value:
 2nd Value:
 Value Percent:
 Continuous Index:
 Within 8" of Joint: **YES**
 Remarks:

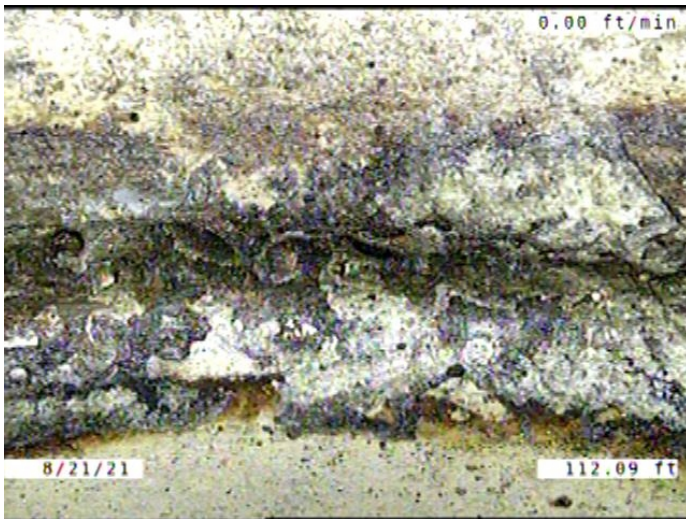
Code: **ISJ**
 Description: **Infiltration Stain Joint**

Distance (ft): **112.1**
 Structural Grade: **0**
 O&M Grade: **1**
 Clock Start/From: **8**
 Clock To: **4**
 1st Value:
 2nd Value:
 Value Percent:
 Continuous Index:
 Within 8" of Joint: **YES**
 Remarks:

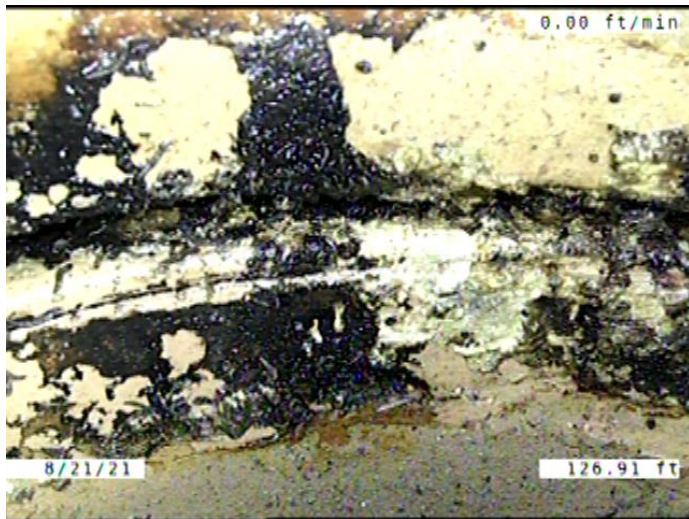
Code: **ISJ**
 Description: **Infiltration Stain Joint**

Distance (ft): **126.9**
 Structural Grade: **0**
 O&M Grade: **1**
 Clock Start/From: **9**
 Clock To: **3**
 1st Value:
 2nd Value:
 Value Percent:
 Continuous Index:
 Within 8" of Joint: **YES**
 Remarks:

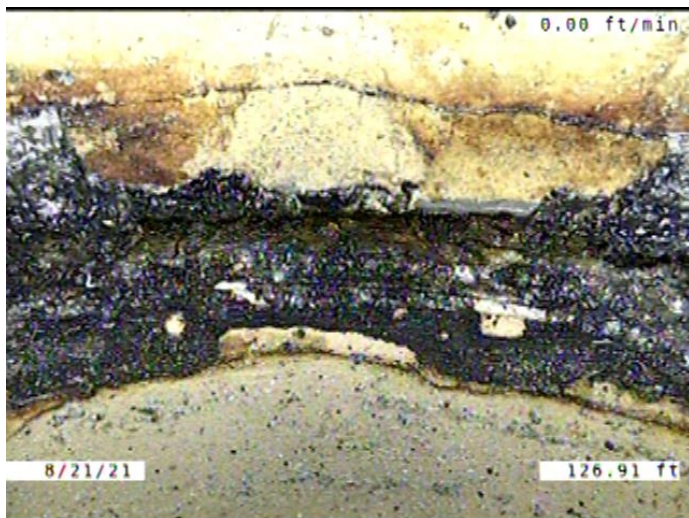
Code: **CM**
 Description: **Crack Multiple**

Distance (ft): **126.9**
 Structural Grade: **3**
 O&M Grade: **0**
 Clock Start/From: **9**
 Clock To: **3**
 1st Value:
 2nd Value:
 Value Percent:
 Continuous Index:
 Within 8" of Joint: **YES**
 Remarks:

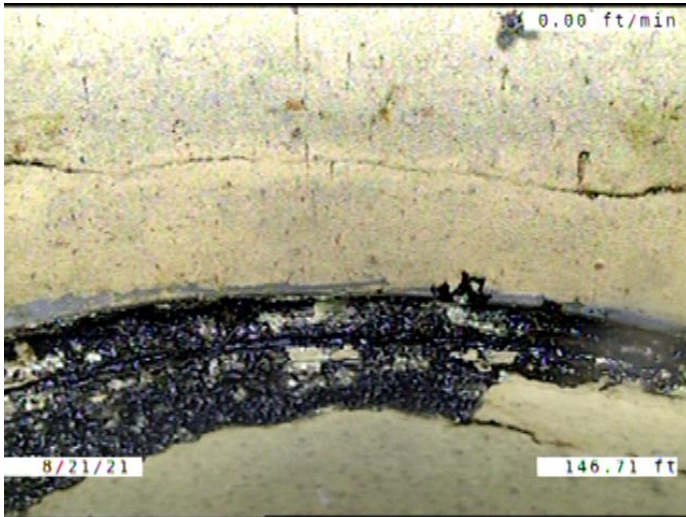
Code: **ISJ**
 Description: **Infiltration Stain Joint**

Distance (ft): **146.7**
 Structural Grade: **0**
 O&M Grade: **1**
 Clock Start/From: **9**
 Clock To: **3**
 1st Value:
 2nd Value:
 Value Percent:
 Continuous Index:
 Within 8" of Joint: **YES**
 Remarks:

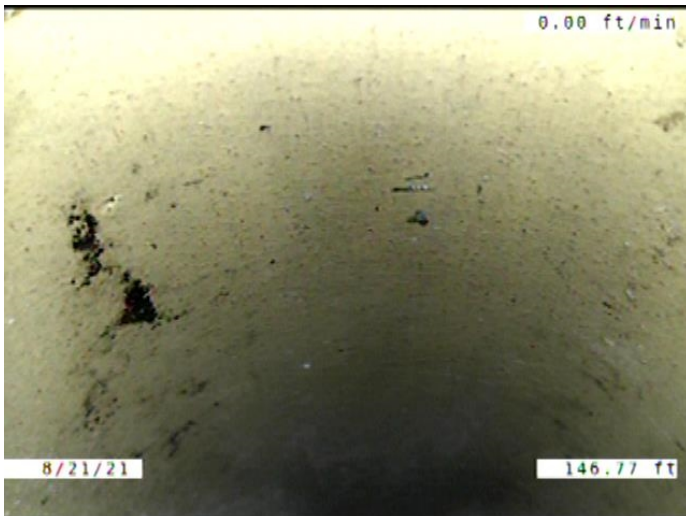
Code: **MWL**
 Description: **Miscellaneous Water Level**

Distance (ft): **146.8**
 Structural Grade: **0**
 O&M Grade: **0**
 Clock Start/From:
 Clock To:
 1st Value:
 2nd Value:
 Value Percent: **30.000**
 Continuous Index:
 Within 8" of Joint: **NO**
 Remarks:

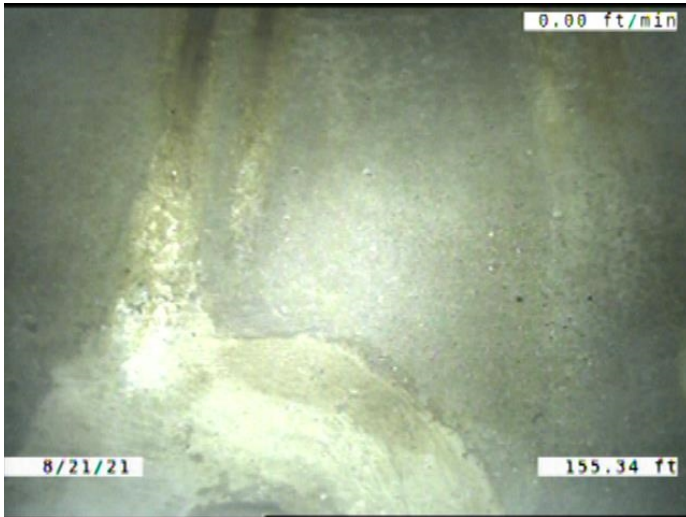
Code: **DSF**
 Description: **Deposits Settled Fine**

Distance (ft): **155.3**
 Structural Grade: **0**
 O&M Grade: **2**
 Clock Start/From: **5**
 Clock To: **7**
 1st Value:
 2nd Value:
 Value Percent: **5.000**
 Continuous Index: **F01**
 Within 8" of Joint: **YES**
 Remarks:

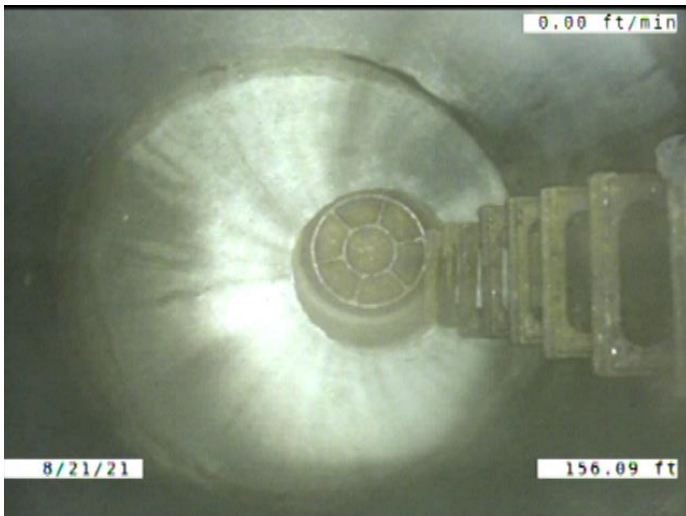
Code: **AMH**
 Description: **Manhole**

Distance (ft): **156.1**
 Structural Grade: **0**
 O&M Grade: **0**
 Clock Start/From:
 Clock To:
 1st Value:
 2nd Value:
 Value Percent:
 Continuous Index:
 Within 8" of Joint: **NO**
 Remarks: **M-503-075**
