Profile/Photo Observation Report

Street:	W 37TH PL & N COLORADO ST	Flow Control:	Not Controlled
City:	Hobart, IN	Year Renewed:	
Location:	Other	Tape/Media #:	
Purpose:	Not Known	Dia/Height:	10"
Use:	Sanitary	Material:	VCP
Drain Area:	NA	Lining:	
Category:	NA		
Comment:

Location Details:		Direction of Survey:	Downstream
US MH:	M-503-075	DS MH:	M-503-078
		Total Length Surveyed (ft):	192.1

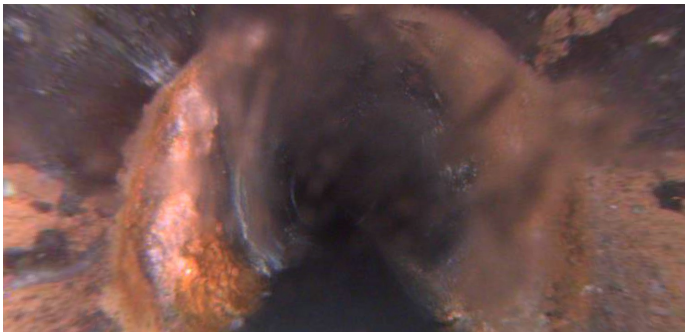
Code:	DAE
Description:	Deposits Attached Encrustation

Distance (ft):	3.3
Structural Grade:	0
O&M Grade:	2
Clock Start/From:	8
Clock To:	4
1st Value:	
2nd Value:	
Value Percent:	5.000
Continuous Index:	
Within 8" of Joint:	YES
Remarks:

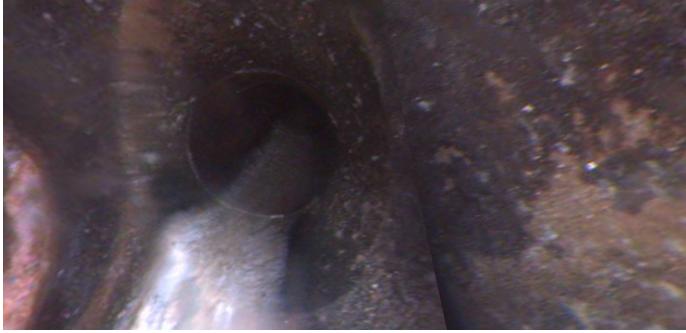
Code: **TFA**
Description: **Tap Factory Active**

Distance (ft): **4.9**
Structural Grade: **0**
O&M Grade: **0**
Clock Start/From: **10**
Clock To:
1st Value: **4.000**
2nd Value:
Value Percent:
Continuous Index:
Within 8" of Joint:
Remarks:

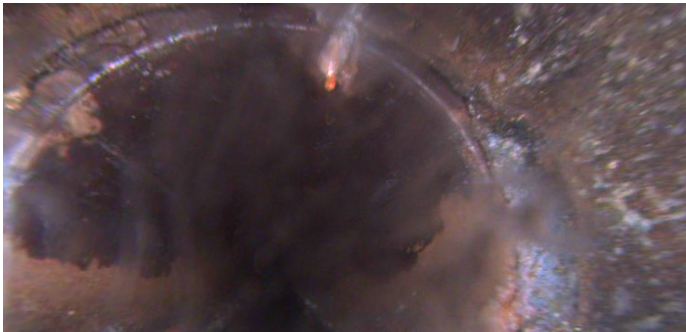
Code: **ID**
Description: **Infil Dripper**

Distance (ft): **5.6**
Structural Grade: **0**
O&M Grade: **3**
Clock Start/From: **12**
Clock To:
1st Value:
2nd Value:
Value Percent:
Continuous Index:
Within 8" of Joint: **YES**
Remarks:

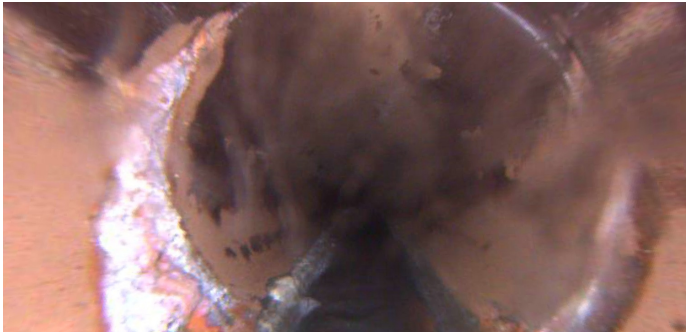
Code: **DAE**
Description: **Deposits Attached Encrustation**

Distance (ft): **10.4**
Structural Grade: **0**
O&M Grade: **2**
Clock Start/From: **8**
Clock To: **4**
1st Value:
2nd Value:
Value Percent: **5.000**
Continuous Index:
Within 8" of Joint: **YES**
Remarks:

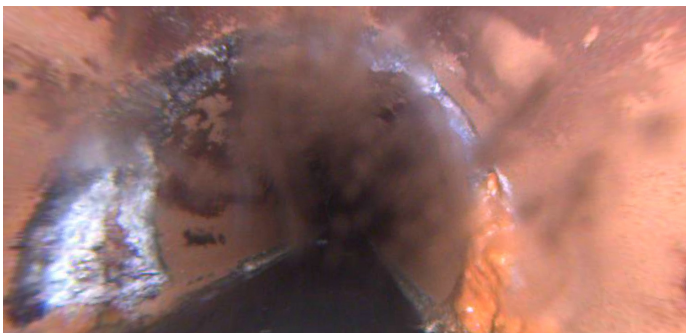
Code: **DAE**
Description: **Deposits Attached Encrustation**

Distance (ft): **20.2**
Structural Grade: **0**
O&M Grade: **2**
Clock Start/From: **8**
Clock To: **4**
1st Value:
2nd Value:
Value Percent: **5.000**
Continuous Index:
Within 8" of Joint: **YES**
Remarks:

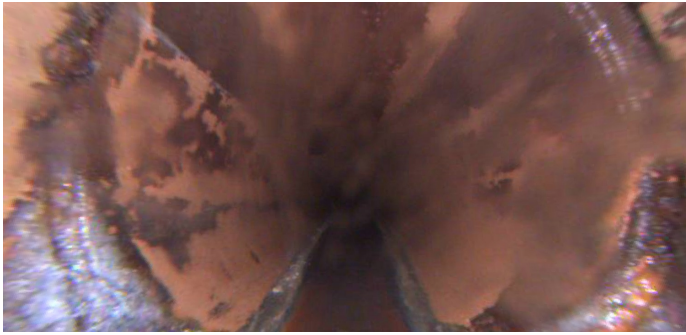
Code: **DAE**
Description: **Deposits Attached Encrustation**

Distance (ft): **35.2**
Structural Grade: **0**
O&M Grade: **2**
Clock Start/From: **8**
Clock To: **4**
1st Value:
2nd Value:
Value Percent: **5.000**
Continuous Index:
Within 8" of Joint: **YES**
Remarks:

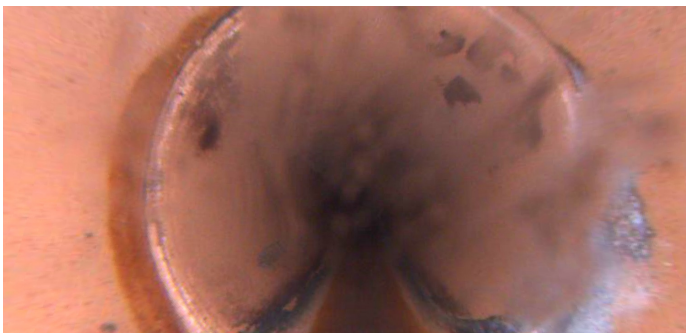
Code: **IW**
Description: **Infil Weeper**

Distance (ft): **79.7**
Structural Grade: **0**
O&M Grade: **2**
Clock Start/From: **8**
Clock To: **4**
1st Value:
2nd Value:
Value Percent:
Continuous Index:
Within 8" of Joint: **YES**
Remarks:

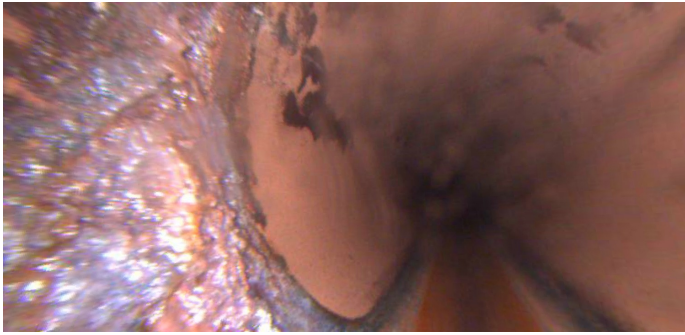
Code: **DAE**
Description: **Deposits Attached Encrustation**

Distance (ft): **89.9**
Structural Grade: **0**
O&M Grade: **2**
Clock Start/From: **7**
Clock To: **11**
1st Value:
2nd Value:
Value Percent: **10.000**
Continuous Index:
Within 8" of Joint: **YES**
Remarks:

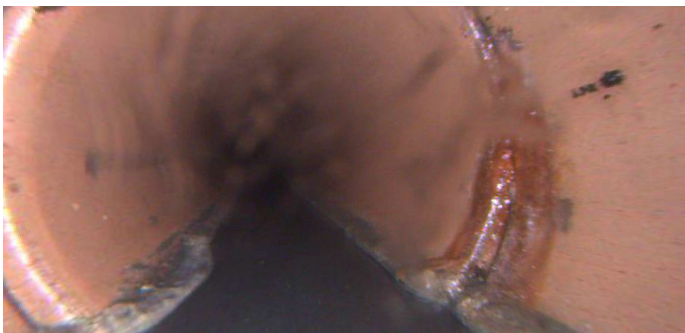
Code: **IW**
Description: **Infil Weeper**

Distance (ft): **104.7**
Structural Grade: **0**
O&M Grade: **2**
Clock Start/From: **2**
Clock To: **4**
1st Value:
2nd Value:
Value Percent:
Continuous Index:
Within 8" of Joint: **YES**
Remarks:

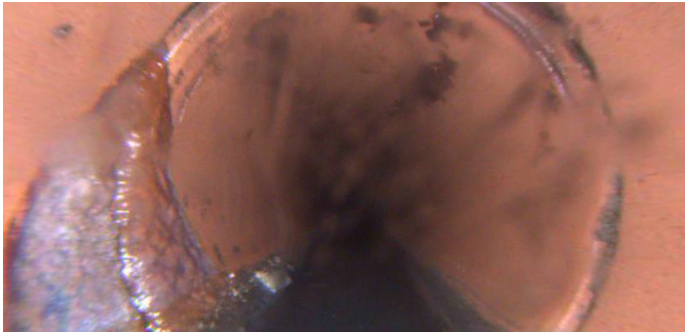
Code: **IW**
Description: **Infil Weeper**

Distance (ft): **109.7**
Structural Grade: **0**
O&M Grade: **2**
Clock Start/From: **7**
Clock To: **11**
1st Value:
2nd Value:
Value Percent:
Continuous Index:
Within 8" of Joint: **YES**
Remarks:

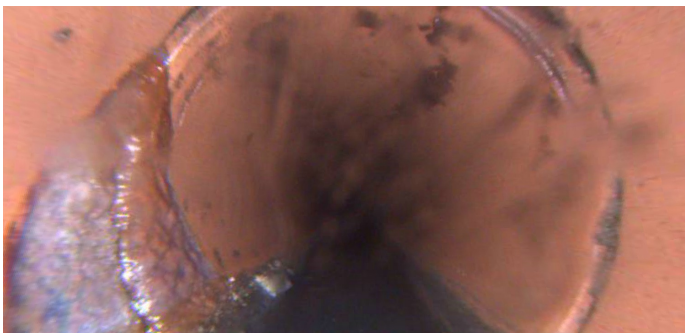
Code: **DAE**
Description: **Deposits Attached Encrustation**

Distance (ft): **109.7**
Structural Grade: **0**
O&M Grade: **2**
Clock Start/From: **7**
Clock To: **10**
1st Value:
2nd Value:
Value Percent: **5.000**
Continuous Index:
Within 8" of Joint: **YES**
Remarks:

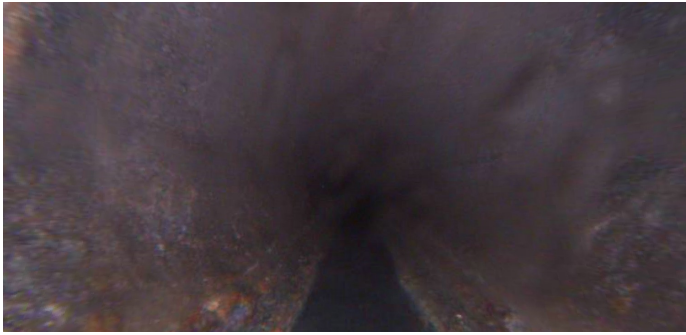
Code: **DAE**
Description: **Deposits Attached Encrustation**

Distance (ft): **170.1**
Structural Grade: **0**
O&M Grade: **2**
Clock Start/From: **7**
Clock To: **5**
1st Value:
2nd Value:
Value Percent: **5.000**
Continuous Index: **S01**
Within 8" of Joint: **NO**
Remarks:

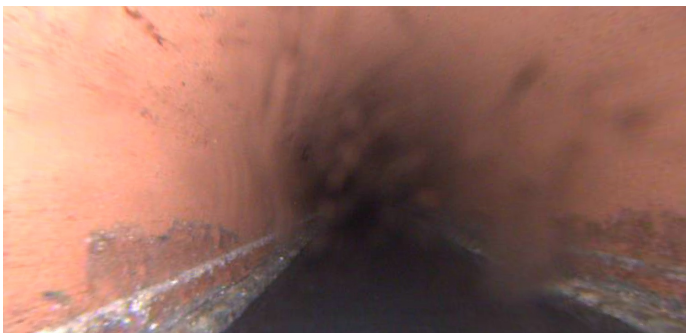
Code: **DAE**
Description: **Deposits Attached Encrustation**

Distance (ft): **189.3**
Structural Grade: **0**
O&M Grade: **2**
Clock Start/From: **7**
Clock To: **5**
1st Value:
2nd Value:
Value Percent: **5.000**
Continuous Index: **F01**
Within 8" of Joint: **NO**
Remarks:

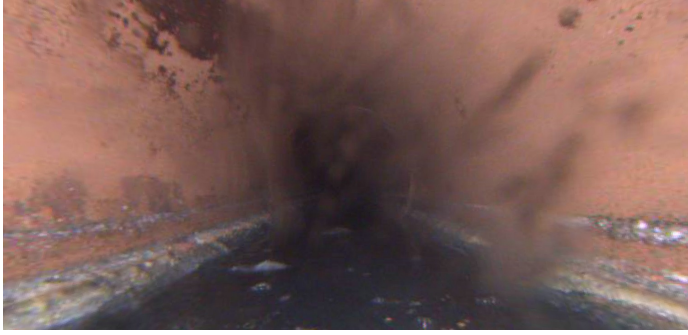
Code:	MSA
Description:	Abandoned Survey
Distance (ft):	192.1
Structural Grade:	0
O&M Grade:	0
Clock Start/From:	
Clock To:	
1st Value:	
2nd Value:	
Value Percent:	
Continuous Index:	
Within 8" of Joint:	NO
Remarks:	debris under water
