Profile/Photo Observation Report

Street:	W 40th ave	Flow Control:	Not Controlled
City:	Hobart, IN	Year Renewed:	
Location:	Other	Tape/Media #:	
Purpose:	Not Known	Dia/Height:	10"
Use:	Sanitary	Material:	VCP
Drain Area:	NA	Lining:	
Category:	NA		
Comment:

Location Details:		Direction of Survey:	Downstream
US MH:	M-503-075	DS MH:	M-503-078
		Total Length Surveyed (ft):	192.1

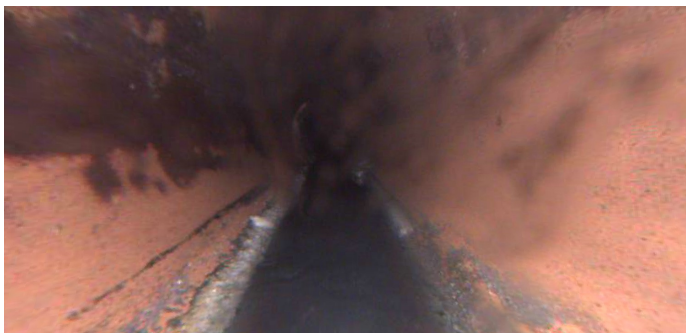
Code: **AMH**
Description: **Manhole**

Distance (ft): **.0**
Structural Grade: **0**
O&M Grade: **0**
Clock Start/From:
Clock To:
1st Value:
2nd Value:
Value Percent:
Continuous Index:
Within 8" of Joint: **NO**
Remarks: **M-503-075**

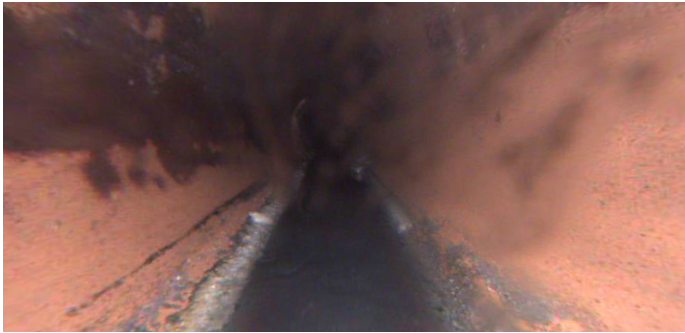
Code:	MWL
Description:	Water Level

Distance (ft):	.0
Structural Grade:	0
O&M Grade:	0
Clock Start/From:	
Clock To:	
1st Value:	
2nd Value:	
Value Percent:	5.000
Continuous Index:	
Within 8" of Joint:	NO
Remarks:

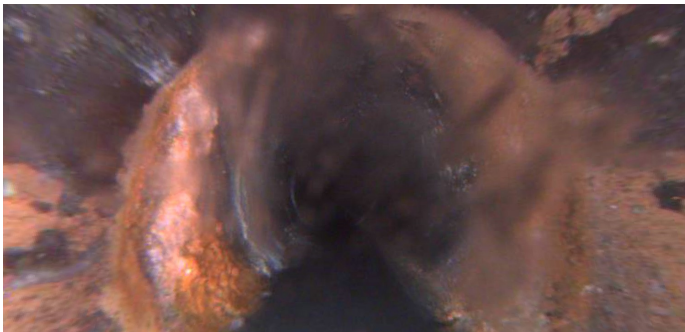
Code:	DAE
Description:	Deposits Attached Encrustation

Distance (ft):	3.3
Structural Grade:	0
O&M Grade:	2
Clock Start/From:	8
Clock To:	4
1st Value:	
2nd Value:	
Value Percent:	5.000
Continuous Index:	
Within 8" of Joint:	YES
Remarks:

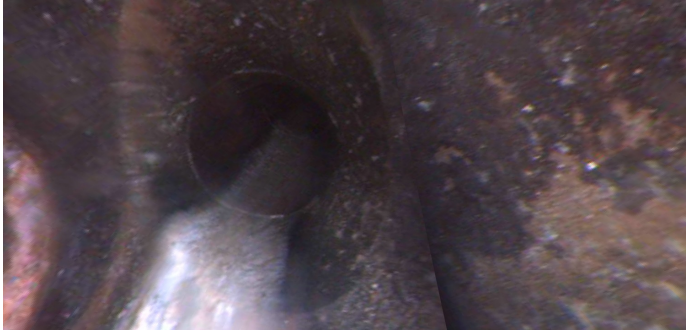
Code: **TFA**
Description: **Tap Factory Active**

Distance (ft): **4.9**
Structural Grade: **0**
O&M Grade: **0**
Clock Start/From: **10**
Clock To:
1st Value: **4.000**
2nd Value:
Value Percent:
Continuous Index:
Within 8" of Joint:
Remarks:

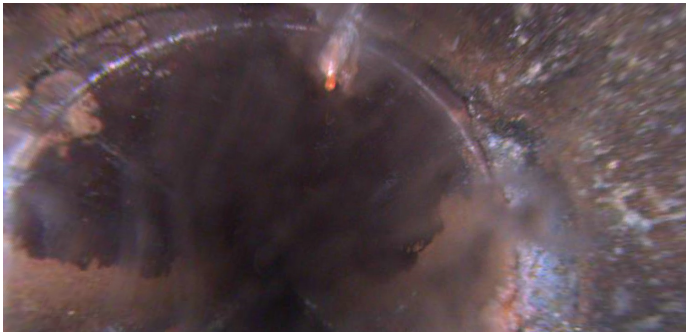
Code: **ID**
Description: **Infil Dripper**

Distance (ft): **5.6**
Structural Grade: **0**
O&M Grade: **3**
Clock Start/From: **12**
Clock To:
1st Value:
2nd Value:
Value Percent:
Continuous Index:
Within 8" of Joint: **YES**
Remarks:

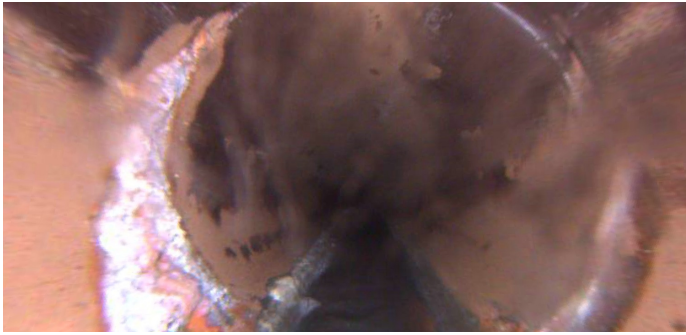
Code: **DAE**
Description: **Deposits Attached Encrustation**

Distance (ft): **10.4**
Structural Grade: **0**
O&M Grade: **2**
Clock Start/From: **8**
Clock To: **4**
1st Value:
2nd Value:
Value Percent: **5.000**
Continuous Index:
Within 8" of Joint: **YES**
Remarks:

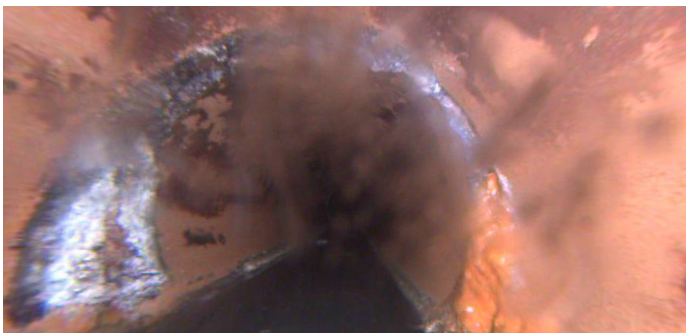
Code: **DAE**
Description: **Deposits Attached Encrustation**

Distance (ft): **20.2**
Structural Grade: **0**
O&M Grade: **2**
Clock Start/From: **8**
Clock To: **4**
1st Value:
2nd Value:
Value Percent: **5.000**
Continuous Index:
Within 8" of Joint: **YES**
Remarks:

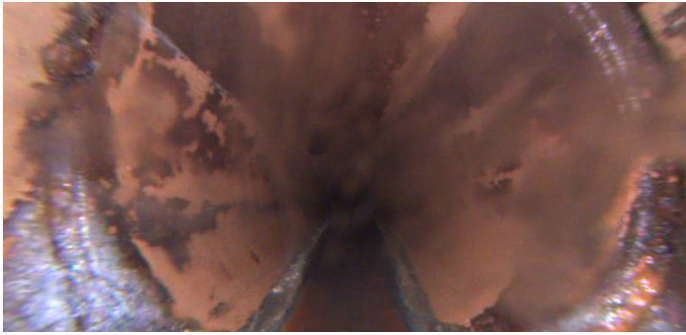
Code: **DAE**
Description: **Deposits Attached Encrustation**

Distance (ft): **35.2**
Structural Grade: **0**
O&M Grade: **2**
Clock Start/From: **8**
Clock To: **4**
1st Value:
2nd Value:
Value Percent: **5.000**
Continuous Index:
Within 8" of Joint: **YES**
Remarks:

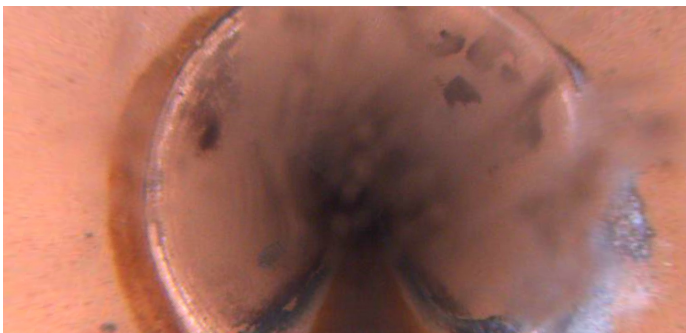
Code: **IW**
Description: **Infil Weeper**

Distance (ft): **79.7**
Structural Grade: **0**
O&M Grade: **2**
Clock Start/From: **8**
Clock To: **4**
1st Value:
2nd Value:
Value Percent:
Continuous Index:
Within 8" of Joint: **YES**
Remarks:

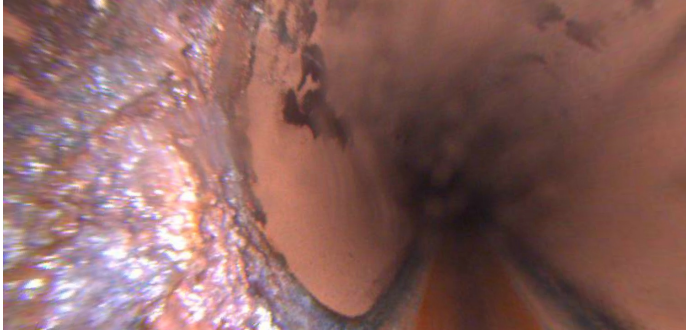
Code: **DAE**
Description: **Deposits Attached Encrustation**

Distance (ft): **89.9**
Structural Grade: **0**
O&M Grade: **2**
Clock Start/From: **7**
Clock To: **11**
1st Value:
2nd Value:
Value Percent: **10.000**
Continuous Index:
Within 8" of Joint: **YES**
Remarks:

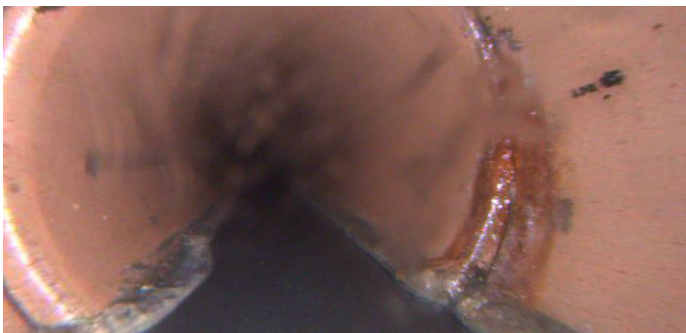
Code: **IW**
Description: **Infil Weeper**

Distance (ft): **104.7**
Structural Grade: **0**
O&M Grade: **2**
Clock Start/From: **2**
Clock To: **4**
1st Value:
2nd Value:
Value Percent:
Continuous Index:
Within 8" of Joint: **YES**
Remarks:

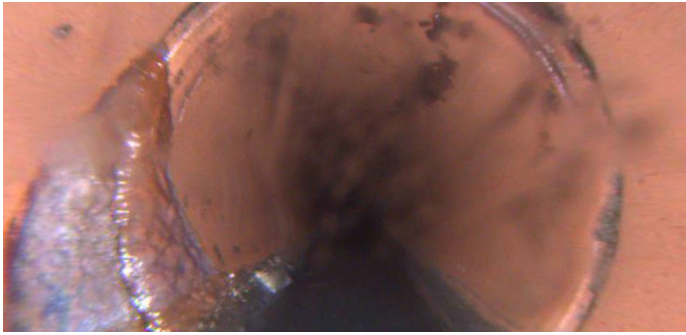
Code: **IW**
Description: **Infil Weeper**

Distance (ft): **109.7**
Structural Grade: **0**
O&M Grade: **2**
Clock Start/From: **7**
Clock To: **11**
1st Value:
2nd Value:
Value Percent:
Continuous Index:
Within 8" of Joint: **YES**
Remarks:

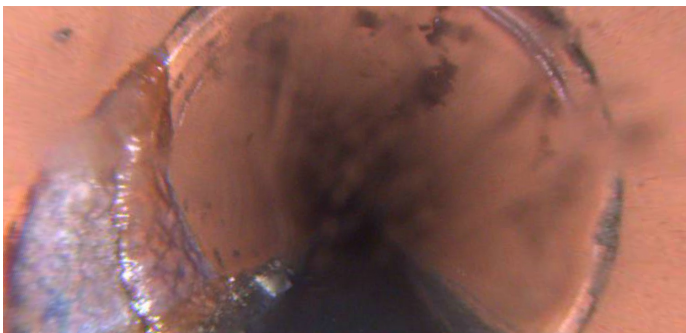
Code: **DAE**
Description: **Deposits Attached Encrustation**

Distance (ft): **109.7**
Structural Grade: **0**
O&M Grade: **2**
Clock Start/From: **7**
Clock To: **10**
1st Value:
2nd Value:
Value Percent: **5.000**
Continuous Index:
Within 8" of Joint: **YES**
Remarks:

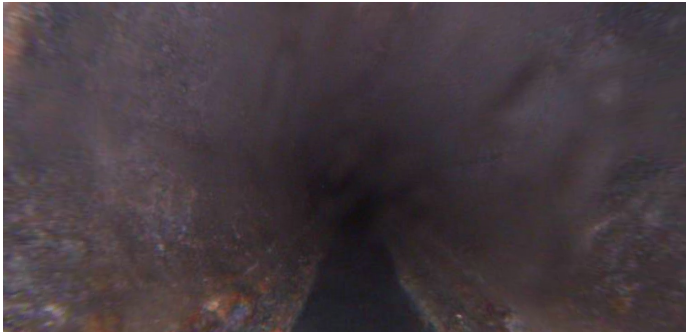
Code: **DAE**
Description: **Deposits Attached Encrustation**

Distance (ft): **170.1**
Structural Grade: **0**
O&M Grade: **2**
Clock Start/From: **7**
Clock To: **5**
1st Value:
2nd Value:
Value Percent: **5.000**
Continuous Index: **S01**
Within 8" of Joint: **NO**
Remarks:

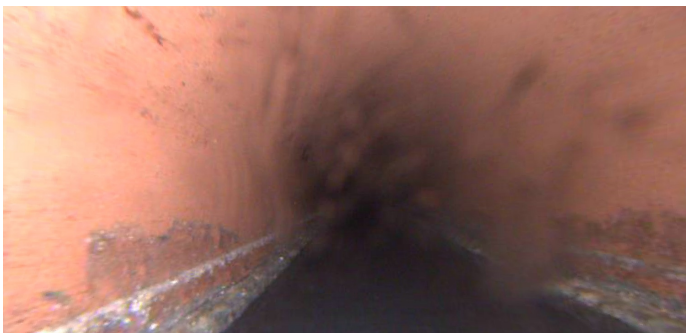
Code: **DAE**
Description: **Deposits Attached Encrustation**

Distance (ft): **189.3**
Structural Grade: **0**
O&M Grade: **2**
Clock Start/From: **7**
Clock To: **5**
1st Value:
2nd Value:
Value Percent: **5.000**
Continuous Index: **F01**
Within 8" of Joint: **NO**
Remarks:

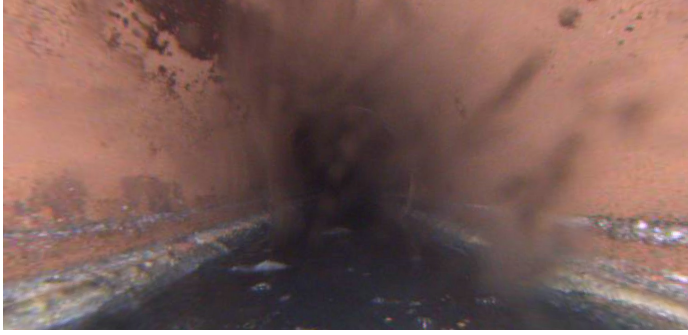
Code:	MSA
Description:	Abandoned Survey
Distance (ft):	192.1
Structural Grade:	0
O&M Grade:	0
Clock Start/From:	
Clock To:	
1st Value:	
2nd Value:	
Value Percent:	
Continuous Index:	
Within 8" of Joint:	NO
Remarks:	debris under water
