Profile/Photo Observation Report

Date:	08/21/2021	Weather:		Coding:	PACP 7.0
Pipe Length (ft):	329.6	Owner:	City of Hobart	Pre Clean:	Light Cleaning
P.O.#:	YES502259	Surveyor:	S. Bucklin	PSR:	P-503-078-075
Customer:	City of Hobart	Clean Date:	08/16/2021	Shape:	C

Street:	North Colorado Street	Flow Control:	Not Controlled
City:	Hobart, IN	Year Renewed:	
Location:	Local rural streets with light traffic, t	Tape/Media #:	
Purpose:	Routine Assessment	Dia/Height:	10"
Use:	Sanitary Sewage Pipe	Material:	VCP
Drain Area:		Lining:	
Category:	NA		
Comment:			
Location Details:		Direction of Survey:	Downstream
US MH:	M-503-075	DS MH:	M-503-078
		Total Length Surveyed (ft):	329.6

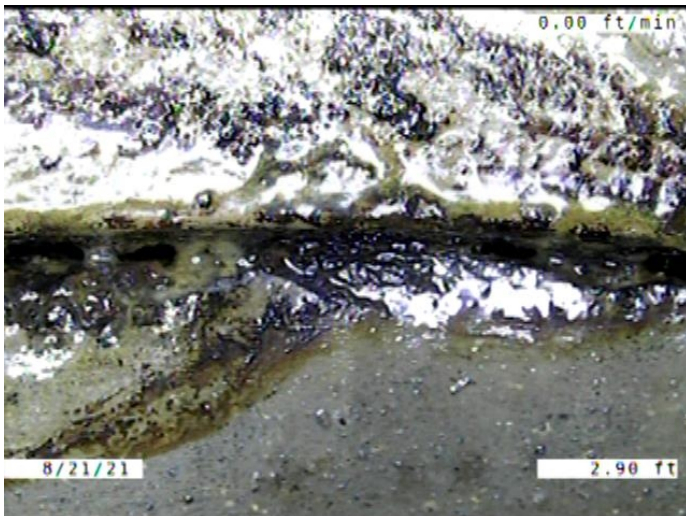
Code: **ISJ**
 Description: **Infiltration Stain Joint**

Distance (ft): **2.9**
 Structural Grade: **0**
 O&M Grade: **1**
 Clock Start/From: **8**
 Clock To: **4**
 1st Value:
 2nd Value:
 Value Percent:
 Continuous Index:
 Within 8" of Joint: **YES**
 Remarks:

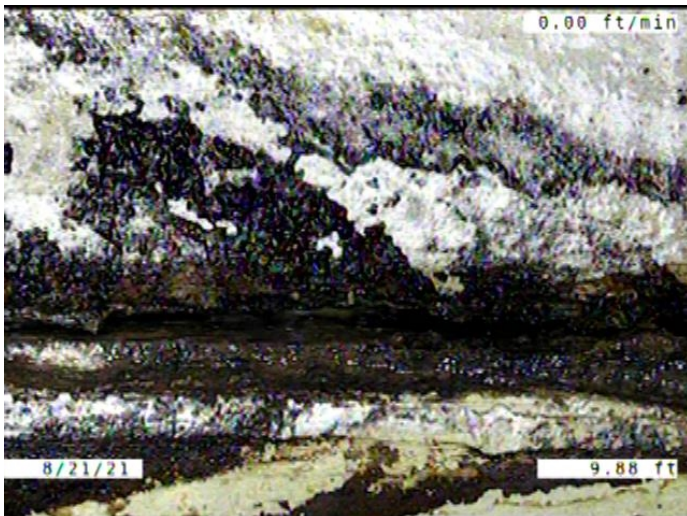
Code: **ISJ**
 Description: **Infiltration Stain Joint**

Distance (ft): **9.9**
 Structural Grade: **0**
 O&M Grade: **1**
 Clock Start/From: **7**
 Clock To: **10**
 1st Value:
 2nd Value:
 Value Percent:
 Continuous Index:
 Within 8" of Joint: **YES**
 Remarks:

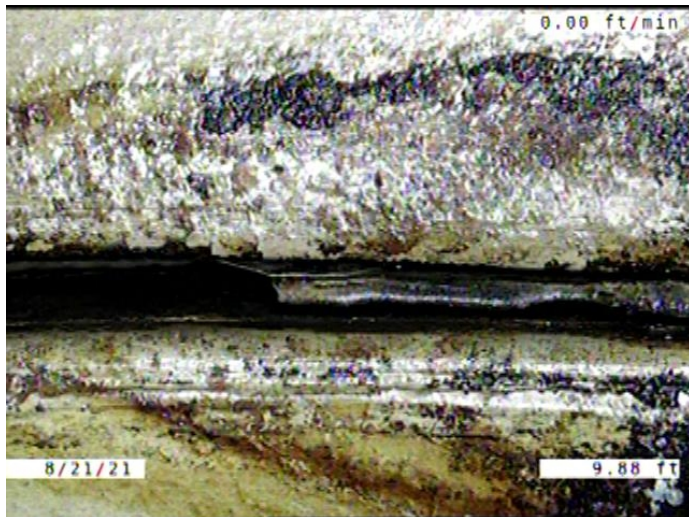
Code: **ISJ**
 Description: **Infiltration Stain Joint**

Distance (ft): **9.9**
 Structural Grade: **0**
 O&M Grade: **1**
 Clock Start/From: **2**
 Clock To: **4**
 1st Value:
 2nd Value:
 Value Percent:
 Continuous Index:
 Within 8" of Joint: **YES**
 Remarks:

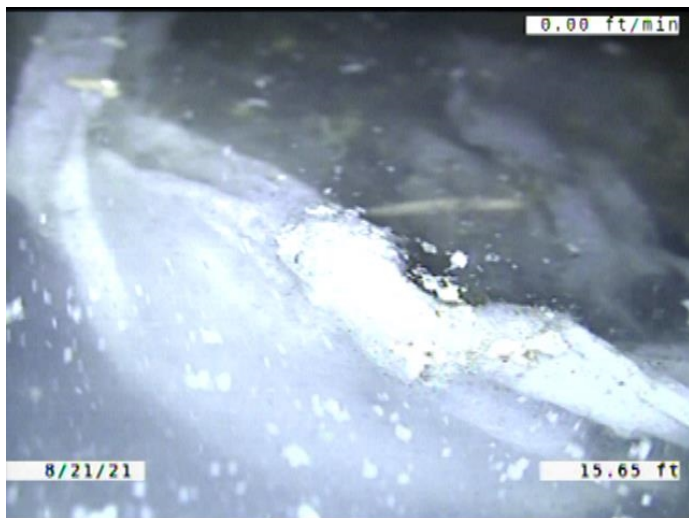
Code: **DSF**
 Description: **Deposits Settled Fine**

Distance (ft): **15.6**
 Structural Grade: **0**
 O&M Grade: **2**
 Clock Start/From: **5**
 Clock To: **7**
 1st Value:
 2nd Value:
 Value Percent: **5.000**
 Continuous Index:
 Within 8" of Joint: **YES**
 Remarks:

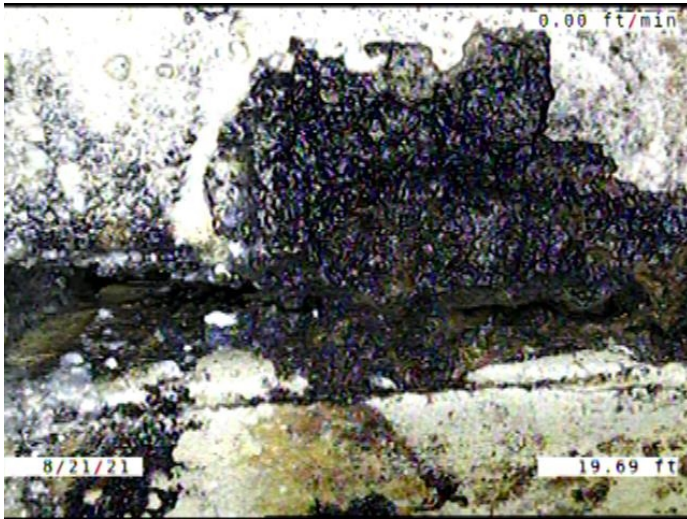
Code: **ISJ**
 Description: **Infiltration Stain Joint**

Distance (ft): **19.7**
 Structural Grade: **0**
 O&M Grade: **1**
 Clock Start/From: **8**
 Clock To: **4**
 1st Value:
 2nd Value:
 Value Percent:
 Continuous Index:
 Within 8" of Joint: **YES**
 Remarks:

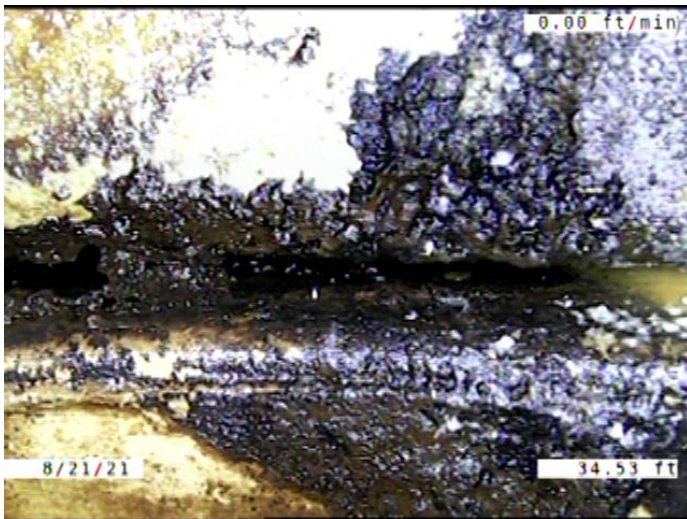
Code: **ISJ**
 Description: **Infiltration Stain Joint**

Distance (ft): **34.5**
 Structural Grade: **0**
 O&M Grade: **1**
 Clock Start/From: **2**
 Clock To: **5**
 1st Value:
 2nd Value:
 Value Percent:
 Continuous Index:
 Within 8" of Joint: **YES**
 Remarks:

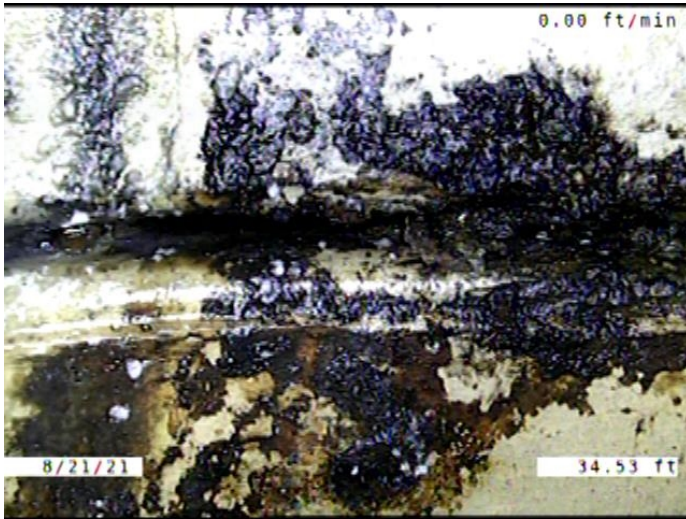
Code: **ISJ**
 Description: **Infiltration Stain Joint**

Distance (ft): **34.5**
 Structural Grade: **0**
 O&M Grade: **1**
 Clock Start/From: **8**
 Clock To: **11**
 1st Value:
 2nd Value:
 Value Percent:
 Continuous Index:
 Within 8" of Joint: **YES**
 Remarks:

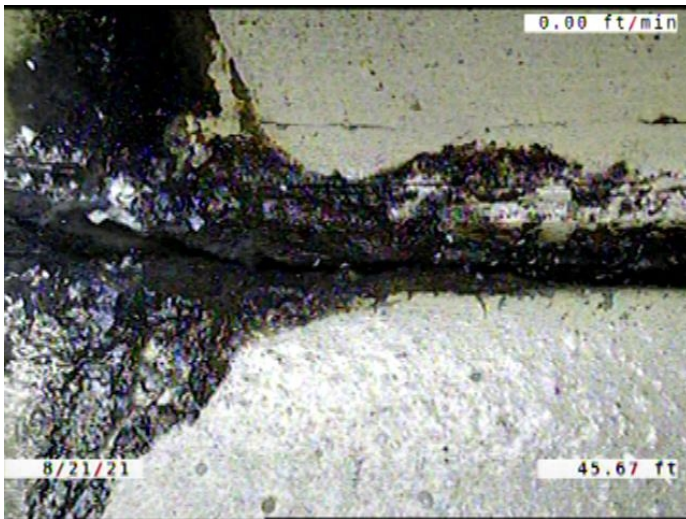
Code: **ISJ**
 Description: **Infiltration Stain Joint**

Distance (ft): **45.7**
 Structural Grade: **0**
 O&M Grade: **1**
 Clock Start/From: **3**
 Clock To: **5**
 1st Value:
 2nd Value:
 Value Percent:
 Continuous Index:
 Within 8" of Joint: **YES**
 Remarks:

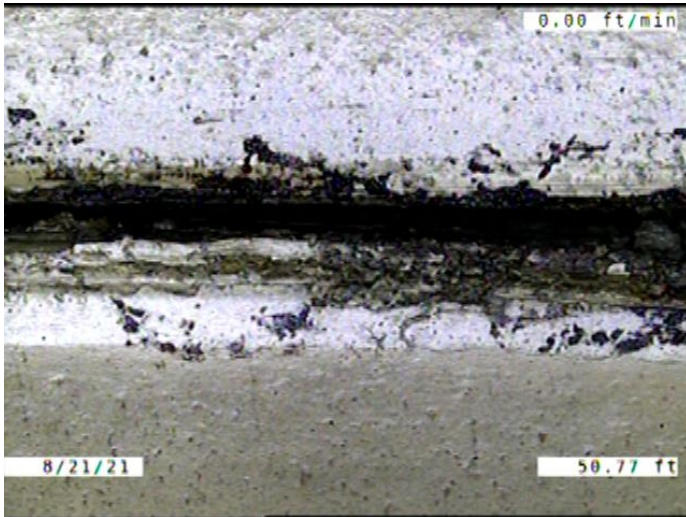
Code: **ISJ**
Description: **Infiltration Stain Joint**

Distance (ft): **50.8**
Structural Grade: **0**
O&M Grade: **1**
Clock Start/From: **9**
Clock To: **1**
1st Value:
2nd Value:
Value Percent:
Continuous Index:
Within 8" of Joint: **YES**
Remarks:

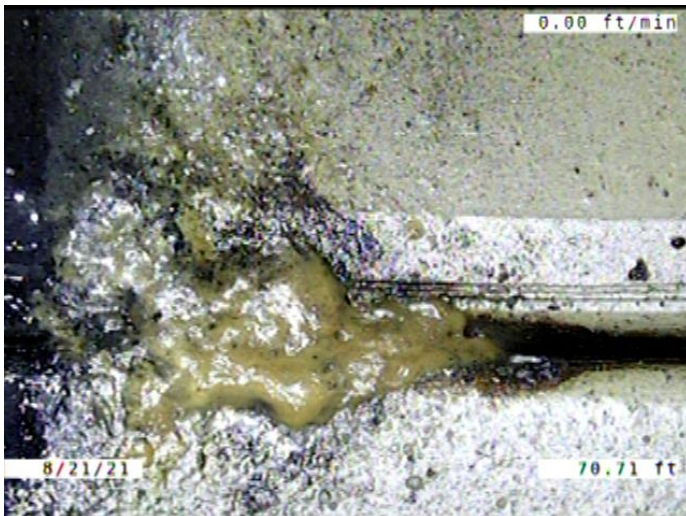
Code: **ISJ**
Description: **Infiltration Stain Joint**

Distance (ft): **70.7**
Structural Grade: **0**
O&M Grade: **1**
Clock Start/From: **4**
Clock To: **5**
1st Value:
2nd Value:
Value Percent:
Continuous Index:
Within 8" of Joint: **YES**
Remarks:

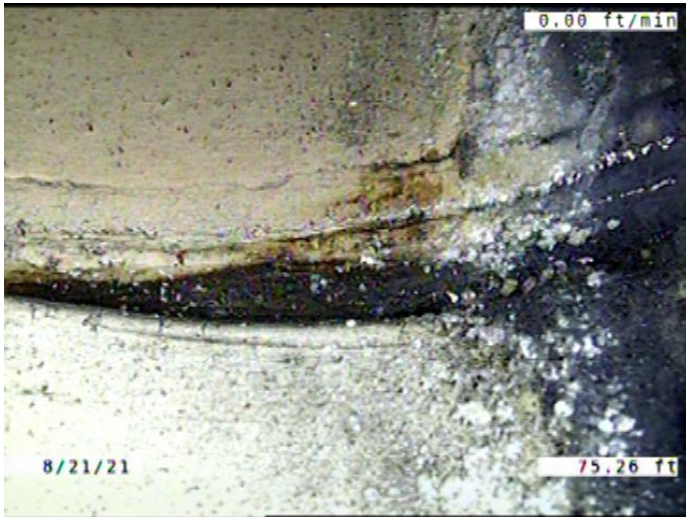
Code: **ISJ**
 Description: **Infiltration Stain Joint**

Distance (ft): **75.3**
 Structural Grade: **0**
 O&M Grade: **1**
 Clock Start/From: **8**
 Clock To: **9**
 1st Value:
 2nd Value:
 Value Percent:
 Continuous Index:
 Within 8" of Joint: **YES**
 Remarks:

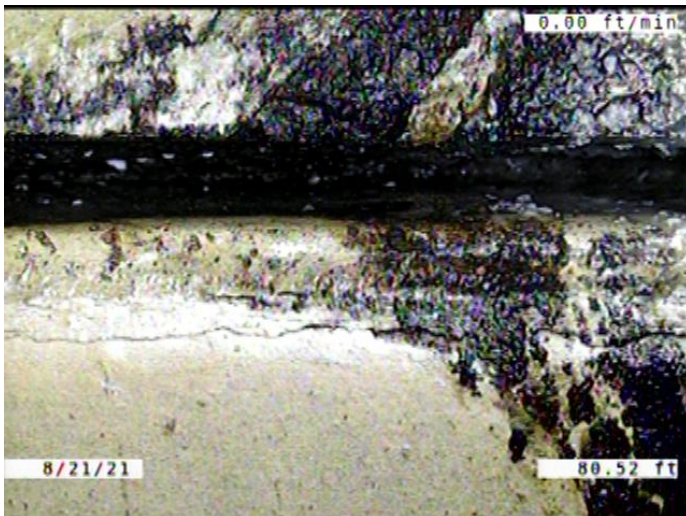
Code: **ISJ**
 Description: **Infiltration Stain Joint**

Distance (ft): **80.5**
 Structural Grade: **0**
 O&M Grade: **1**
 Clock Start/From: **2**
 Clock To: **5**
 1st Value:
 2nd Value:
 Value Percent:
 Continuous Index:
 Within 8" of Joint: **YES**
 Remarks:

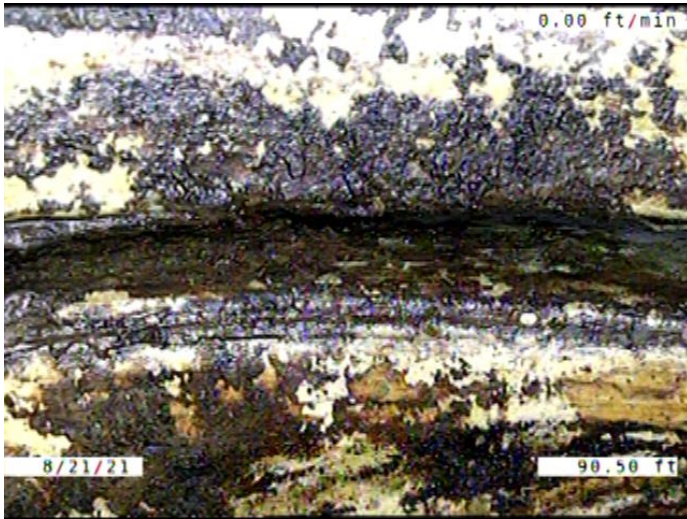
Code: **ISJ**
 Description: **Infiltration Stain Joint**

Distance (ft): **90.5**
 Structural Grade: **0**
 O&M Grade: **1**
 Clock Start/From: **7**
 Clock To: **11**
 1st Value:
 2nd Value:
 Value Percent:
 Continuous Index:
 Within 8" of Joint: **YES**
 Remarks:

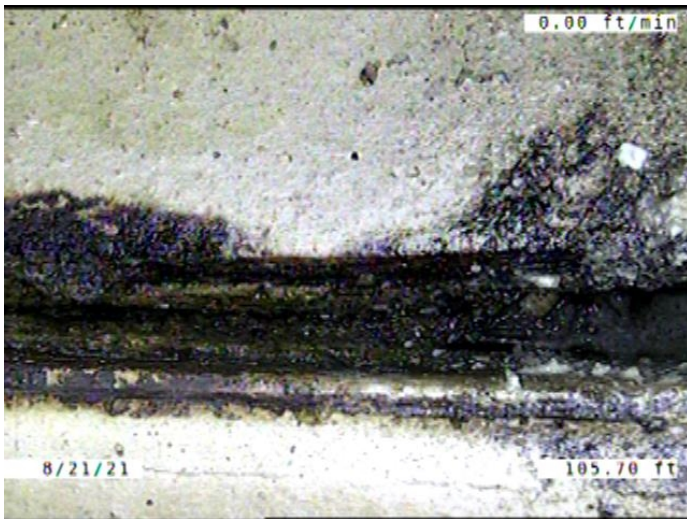
Code: **ISJ**
 Description: **Infiltration Stain Joint**

Distance (ft): **105.7**
 Structural Grade: **0**
 O&M Grade: **1**
 Clock Start/From: **1**
 Clock To: **5**
 1st Value:
 2nd Value:
 Value Percent:
 Continuous Index:
 Within 8" of Joint: **YES**
 Remarks:

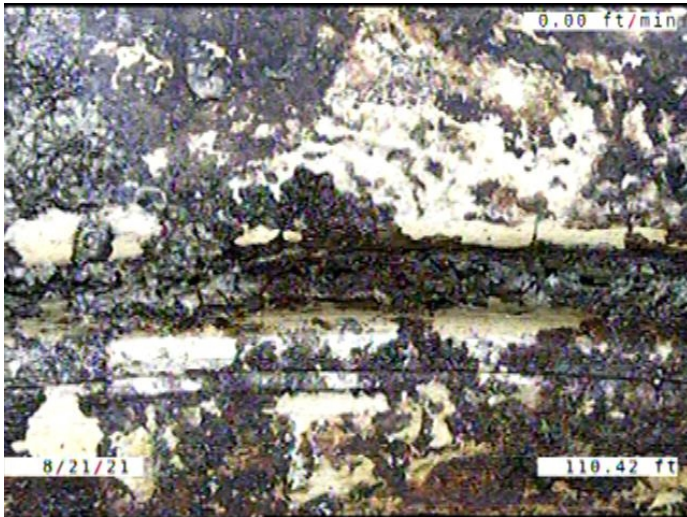
Code: **ISJ**
 Description: **Infiltration Stain Joint**

Distance (ft): **110.4**
 Structural Grade: **0**
 O&M Grade: **1**
 Clock Start/From: **8**
 Clock To: **10**
 1st Value:
 2nd Value:
 Value Percent:
 Continuous Index:
 Within 8" of Joint: **YES**
 Remarks:

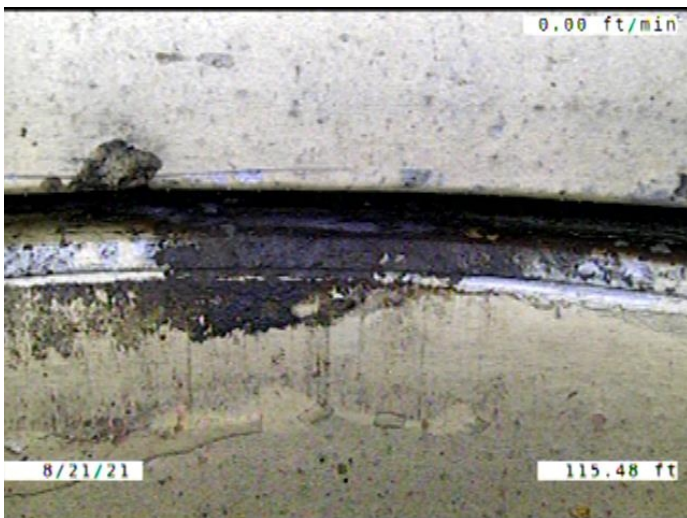
Code: **ISJ**
 Description: **Infiltration Stain Joint**

Distance (ft): **115.5**
 Structural Grade: **0**
 O&M Grade: **1**
 Clock Start/From: **11**
 Clock To: **12**
 1st Value:
 2nd Value:
 Value Percent:
 Continuous Index:
 Within 8" of Joint: **YES**
 Remarks:

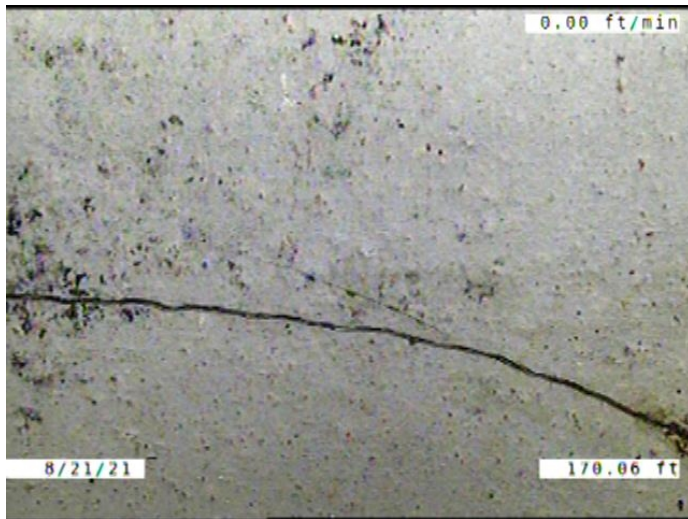
Code: **FM**
 Description: **Fracture Multiple**

Distance (ft): **170.1**
 Structural Grade: **4**
 O&M Grade: **0**
 Clock Start/From: **12**
 Clock To: **12**
 1st Value:
 2nd Value:
 Value Percent:
 Continuous Index:
 Within 8" of Joint: **NO**
 Remarks:

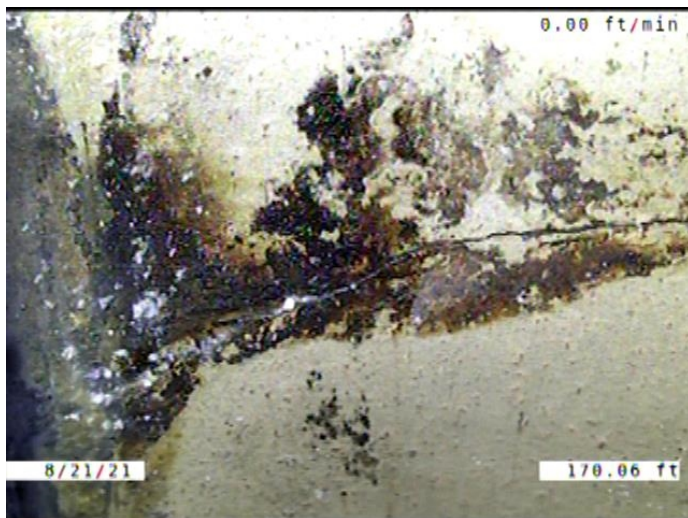
Code: **ISB**
 Description: **Infiltration Stain Barrel**

Distance (ft): **170.1**
 Structural Grade: **0**
 O&M Grade: **1**
 Clock Start/From: **3**
 Clock To: **9**
 1st Value:
 2nd Value:
 Value Percent:
 Continuous Index:
 Within 8" of Joint: **NO**
 Remarks:

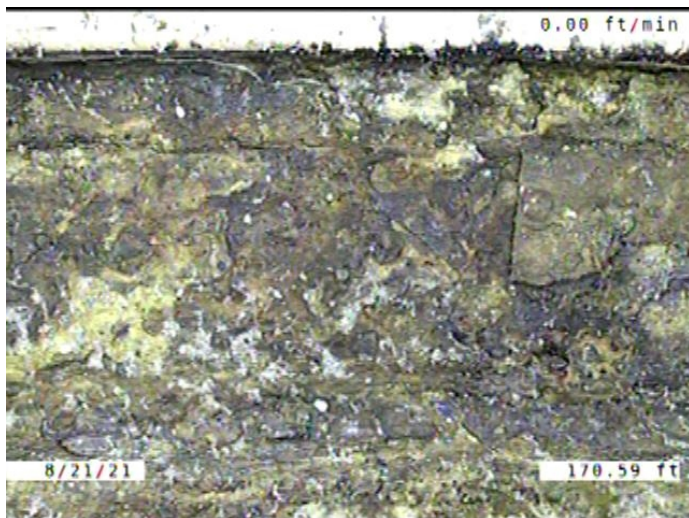
Code: **JSM**
 Description: **Joint Separated Medium**

Distance (ft): **170.6**
 Structural Grade: **3**
 O&M Grade: **0**
 Clock Start/From:
 Clock To:
 1st Value:
 2nd Value:
 Value Percent:
 Continuous Index:
 Within 8" of Joint: **NO**
 Remarks:

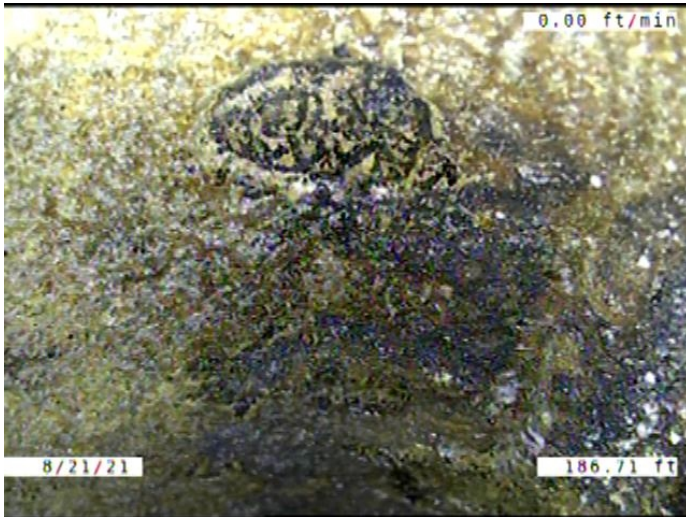
Code:	SSC
Description:	Surface Spalling of Damage Coating
Distance (ft):	186.7
Structural Grade:	1
O&M Grade:	0
Clock Start/From:	12
Clock To:	12
1st Value:	
2nd Value:	
Value Percent:	
Continuous Index:	S01
Within 8" of Joint:	YES
Remarks:

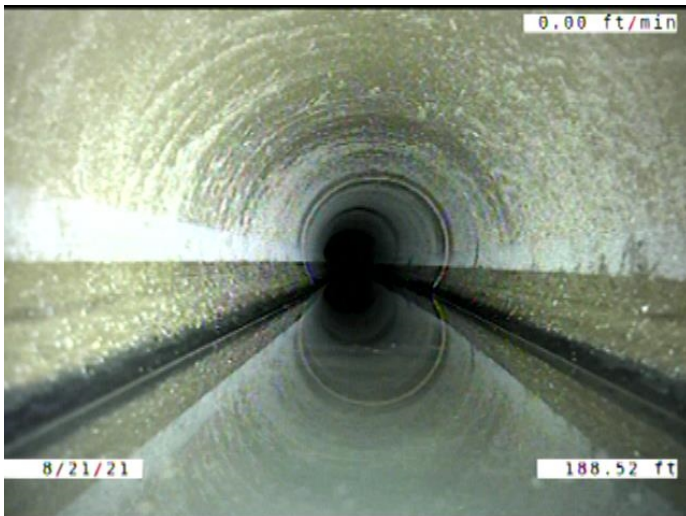
Code:	MWLS
Description:	Miscellaneous Water Level Sag
Distance (ft):	188.5
Structural Grade:	2
O&M Grade:	0
Clock Start/From:	
Clock To:	
1st Value:	
2nd Value:	
Value Percent:	10.000
Continuous Index:	
Within 8" of Joint:	NO
Remarks:

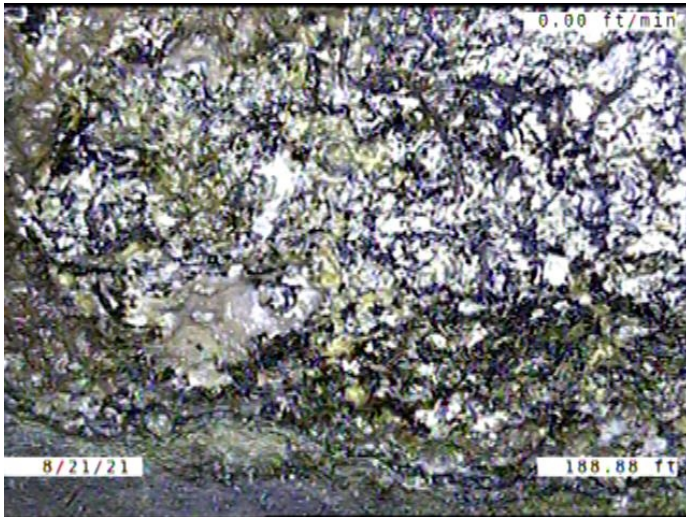
Code: **DAE**
Description: **Deposits Attached Encrustation**

Distance (ft): **188.9**
Structural Grade: **0**
O&M Grade: **2**
Clock Start/From: **12**
Clock To: **4**
1st Value:
2nd Value:
Value Percent: **5.000**
Continuous Index:
Within 8" of Joint: **YES**
Remarks:

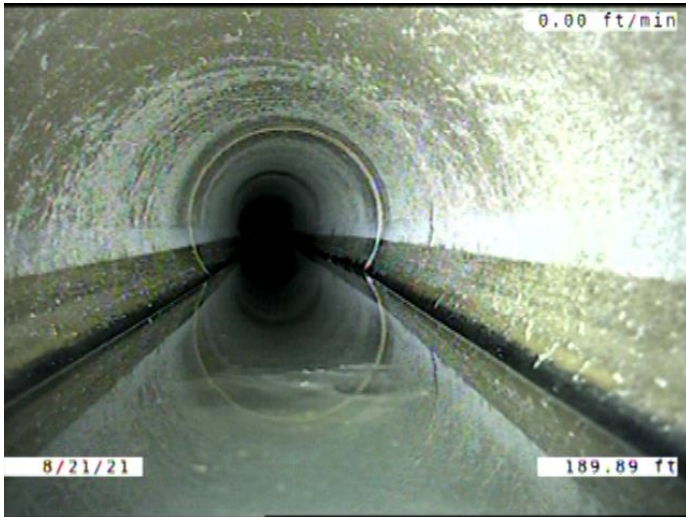
Code: **SSC**
 Description: **Surface Spalling of Damage Coating**

Distance (ft): **189.9**
 Structural Grade: **1**
 O&M Grade: **0**
 Clock Start/From: **12**
 Clock To: **12**
 1st Value:
 2nd Value:
 Value Percent:
 Continuous Index: **F01**
 Within 8" of Joint: **YES**
 Remarks:

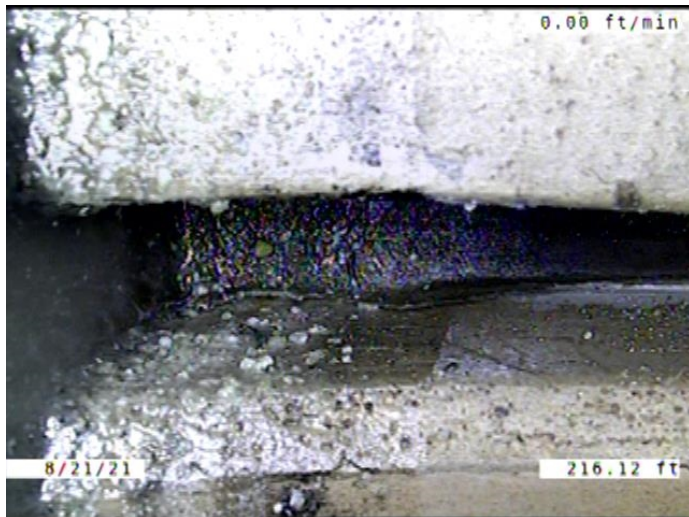
Code: **JAM**
 Description: **Joint Angular Medium**

Distance (ft): **216.1**
 Structural Grade: **3**
 O&M Grade: **0**
 Clock Start/From:
 Clock To:
 1st Value:
 2nd Value:
 Value Percent:
 Continuous Index:
 Within 8" of Joint: **NO**
 Remarks:

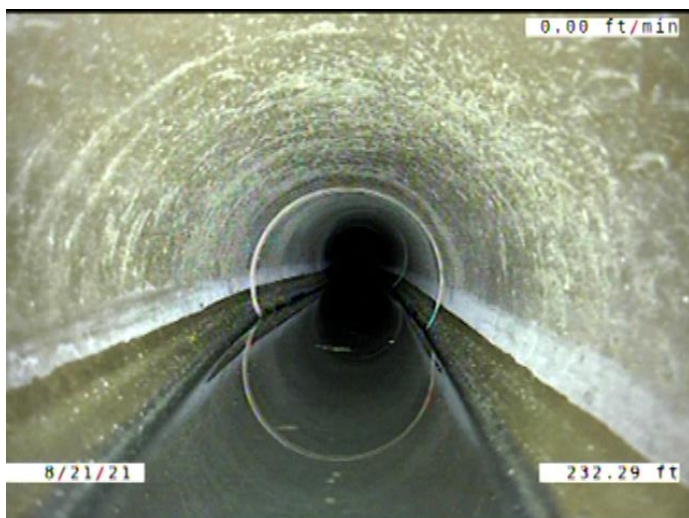
Code: **MWLS**
 Description: **Miscellaneous Water Level Sag**

Distance (ft): **232.3**
 Structural Grade: **2**
 O&M Grade: **0**
 Clock Start/From:
 Clock To:
 1st Value:
 2nd Value:
 Value Percent: **10.000**
 Continuous Index: **S02**
 Within 8" of Joint: **NO**
 Remarks:

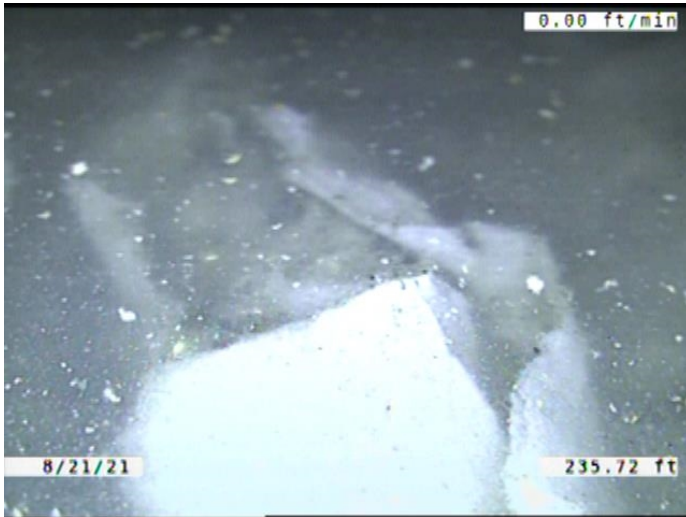
Code: **DSF**
 Description: **Deposits Settled Fine**

Distance (ft): **235.7**
 Structural Grade: **0**
 O&M Grade: **2**
 Clock Start/From: **5**
 Clock To: **7**
 1st Value:
 2nd Value:
 Value Percent: **5.000**
 Continuous Index:
 Within 8" of Joint: **YES**
 Remarks:

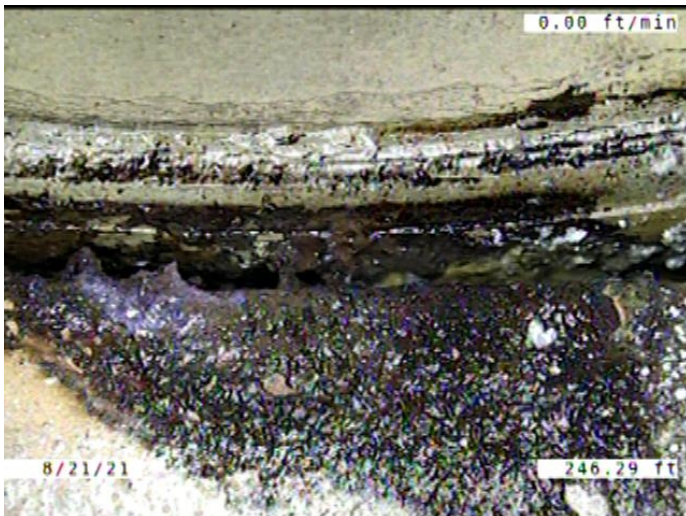
Code: **ISJ**
 Description: **Infiltration Stain Joint**

Distance (ft): **246.3**
 Structural Grade: **0**
 O&M Grade: **1**
 Clock Start/From: **7**
 Clock To: **9**
 1st Value:
 2nd Value:
 Value Percent:
 Continuous Index:
 Within 8" of Joint: **YES**
 Remarks:

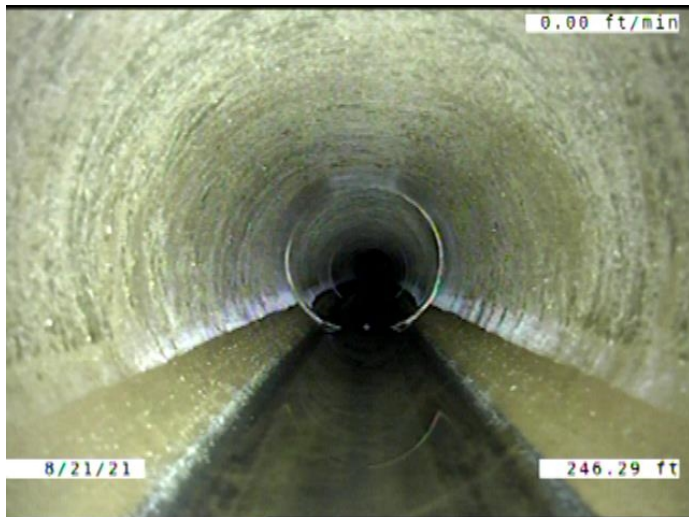
Code: **MWLS**
 Description: **Miscellaneous Water Level Sag**

Distance (ft): **246.3**
 Structural Grade: **2**
 O&M Grade: **0**
 Clock Start/From:
 Clock To:
 1st Value:
 2nd Value:
 Value Percent: **10.000**
 Continuous Index: **F02**
 Within 8" of Joint: **NO**
 Remarks:

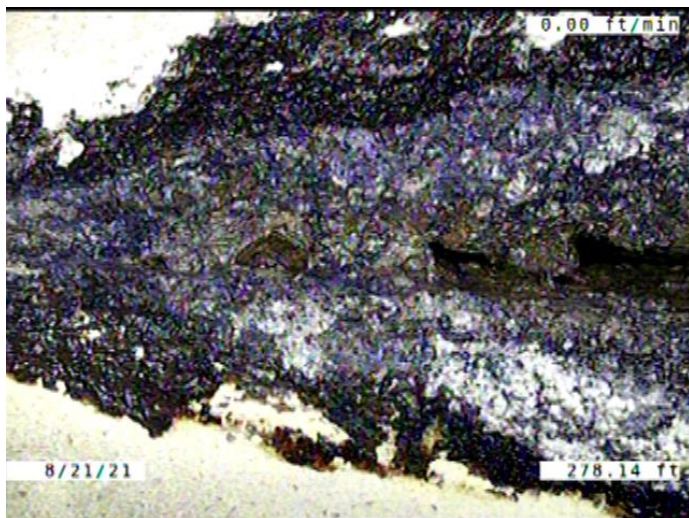
Code: **ISJ**
 Description: **Infiltration Stain Joint**

Distance (ft): **278.1**
 Structural Grade: **0**
 O&M Grade: **1**
 Clock Start/From: **1**
 Clock To: **4**
 1st Value:
 2nd Value:
 Value Percent:
 Continuous Index:
 Within 8" of Joint: **YES**
 Remarks:

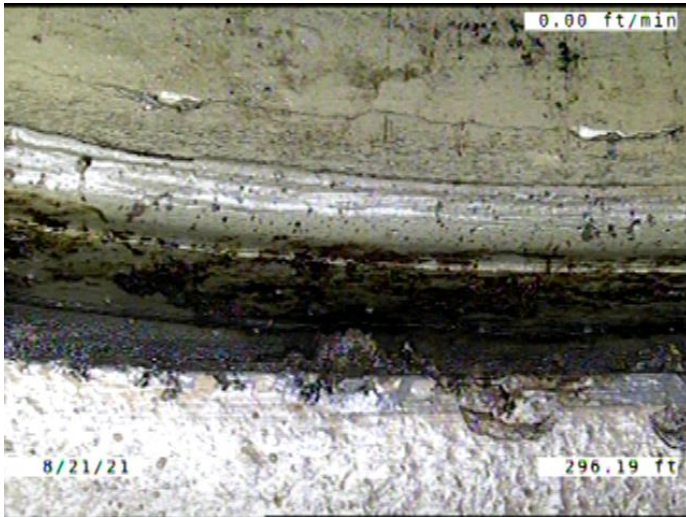
Code: **ISJ**
 Description: **Infiltration Stain Joint**

Distance (ft): **296.2**
 Structural Grade: **0**
 O&M Grade: **1**
 Clock Start/From: **7**
 Clock To: **5**
 1st Value:
 2nd Value:
 Value Percent:
 Continuous Index:
 Within 8" of Joint: **YES**
 Remarks:

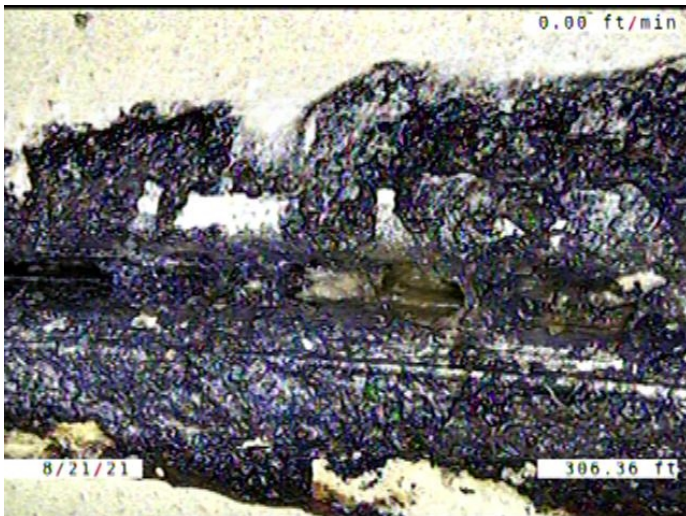
Code: **ISJ**
 Description: **Infiltration Stain Joint**

Distance (ft): **306.4**
 Structural Grade: **0**
 O&M Grade: **1**
 Clock Start/From: **9**
 Clock To: **3**
 1st Value:
 2nd Value:
 Value Percent:
 Continuous Index:
 Within 8" of Joint: **YES**
 Remarks:

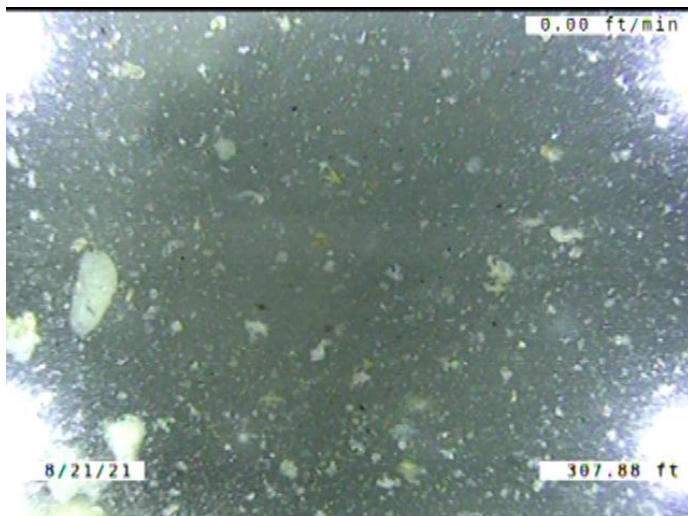
Code: **DSF**
 Description: **Deposits Settled Fine**

Distance (ft): **307.9**
 Structural Grade: **0**
 O&M Grade: **2**
 Clock Start/From: **5**
 Clock To: **7**
 1st Value:
 2nd Value:
 Value Percent: **5.000**
 Continuous Index: **S03**
 Within 8" of Joint: **YES**
 Remarks:

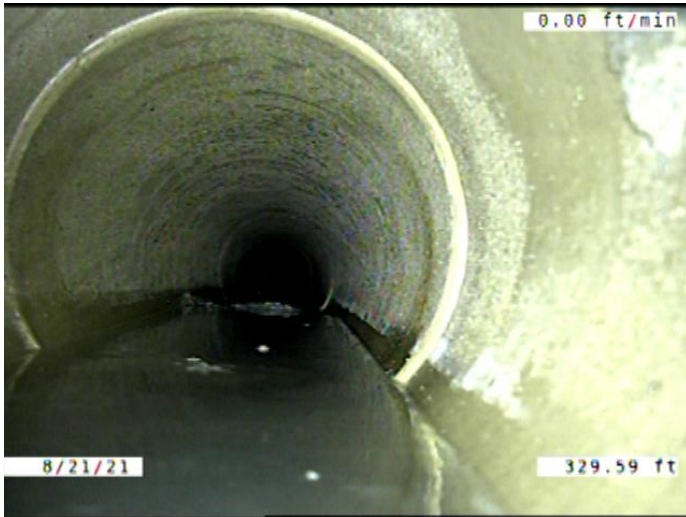
Code: **DSF**
 Description: **Deposits Settled Fine**

Distance (ft): **329.6**
 Structural Grade: **0**
 O&M Grade: **2**
 Clock Start/From: **5**
 Clock To: **7**
 1st Value:
 2nd Value:
 Value Percent: **5.000**
 Continuous Index: **F03**
 Within 8" of Joint: **YES**
 Remarks:
