RedZone  
ROBOTICS

Street:	North Guyer Street		Flow Control:	Not Controlled	
City:	Hobart, IN		Year Renewed:		
Location:	Alley		Tape/Media #:		
Purpose:	Routine Assessment		Dia/Height:	10"	
Use:	Sanitary Sewage Pipe		Material:	VCP	
Drain Area:			Lining:	None	
Category:	NA				
Comment:					
Location Details:			Direction of Survey:	Downstream	
US MH:	M-503-076	DS MH:	M-503-077	Total Length Surveyed (ft):	147.2

**Tuesday, April 25, 2023**

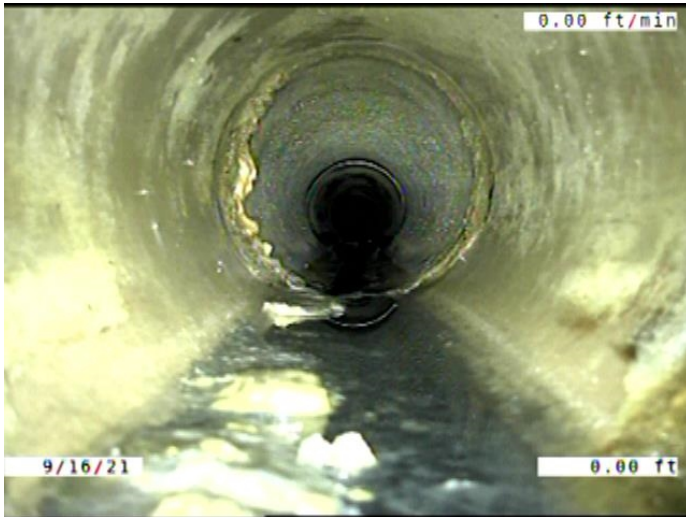
Code: **MWL**  
 Description: **Miscellaneous Water Level**

Distance (ft): **.0**  
 Structural Grade: **0**  
 O&M Grade: **0**  
 Clock Start/From:  
 Clock To:  
 1st Value:  
 2nd Value:  
 Value Percent: **5.000**  
 Continuous Index:  
 Within 8" of Joint: **NO**  
 Remarks:

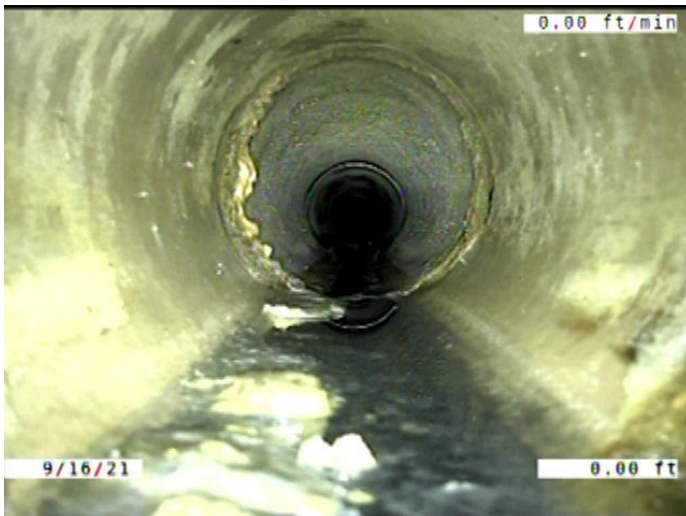
Code: **DSF**  
 Description: **Deposits Settled Fine**

Distance (ft): **.0**  
 Structural Grade: **0**  
 O&M Grade: **2**  
 Clock Start/From: **5**  
 Clock To: **7**  
 1st Value:  
 2nd Value:  
 Value Percent: **5.000**  
 Continuous Index: **S01**  
 Within 8" of Joint: **YES**  
 Remarks:

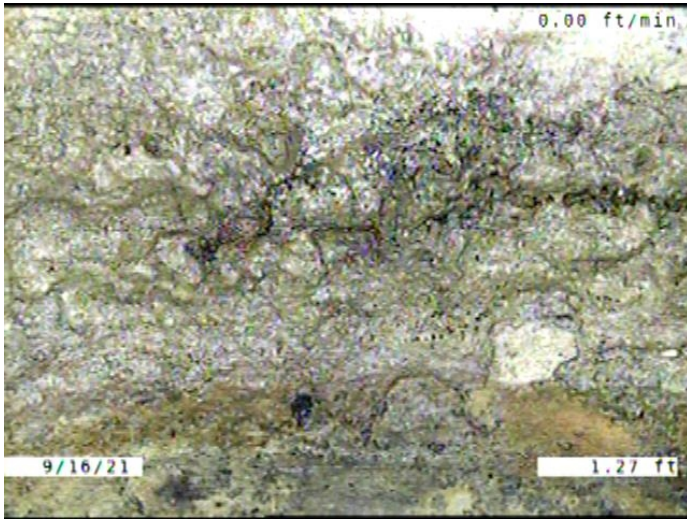
Code: **DAE**  
Description: **Deposits Attached Encrustation**

Distance (ft): **1.3**  
Structural Grade: **0**  
O&M Grade: **2**  
Clock Start/From: **12**  
Clock To: **12**  
1st Value:  
2nd Value:  
Value Percent: **5.000**  
Continuous Index:  
Within 8" of Joint: **YES**  
Remarks:

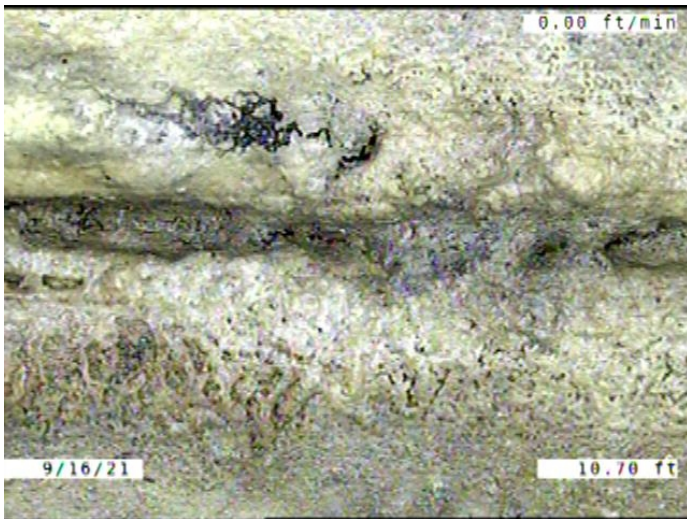
Code: **DAE**  
Description: **Deposits Attached Encrustation**

Distance (ft): **10.7**  
Structural Grade: **0**  
O&M Grade: **2**  
Clock Start/From: **8**  
Clock To: **5**  
1st Value:  
2nd Value:  
Value Percent: **5.000**  
Continuous Index:  
Within 8" of Joint: **YES**  
Remarks:

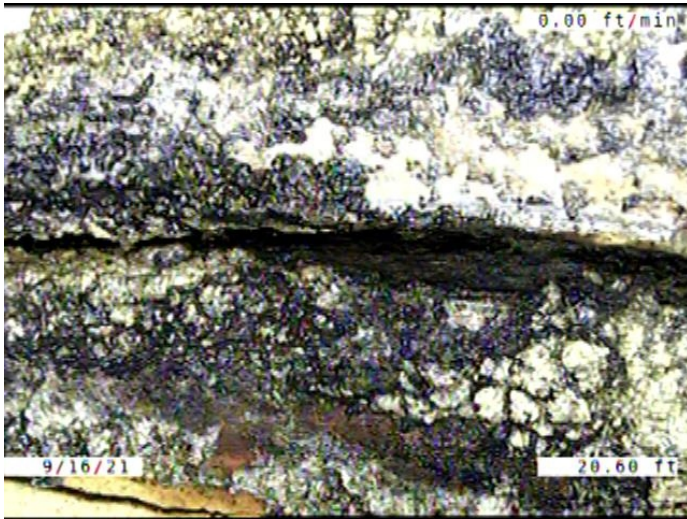
Code: **DAE**  
Description: **Deposits Attached Encrustation**

Distance (ft): **20.6**  
Structural Grade: **0**  
O&M Grade: **2**  
Clock Start/From: **8**  
Clock To: **5**  
1st Value:  
2nd Value:  
Value Percent: **5.000**  
Continuous Index:  
Within 8" of Joint: **YES**  
Remarks:

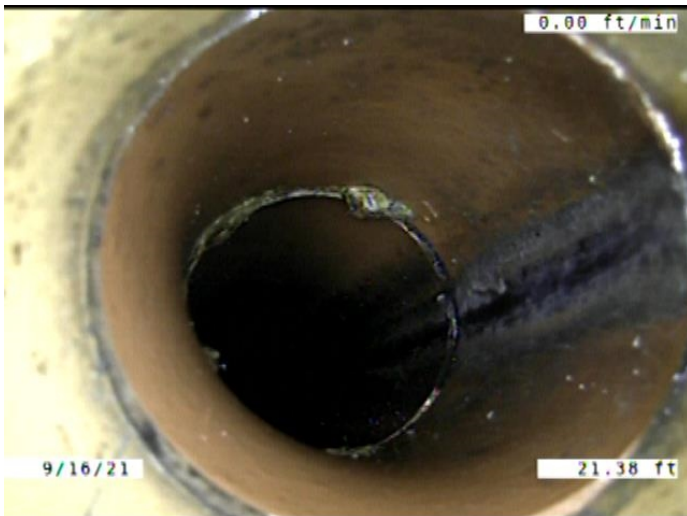
Code: **TF**  
Description: **Tap Factory**

Distance (ft): **21.4**  
Structural Grade: **0**  
O&M Grade: **0**  
Clock Start/From: **2**  
Clock To:  
1st Value: **4.000**  
2nd Value:  
Value Percent:  
Continuous Index:  
Within 8" of Joint: **YES**  
Remarks:

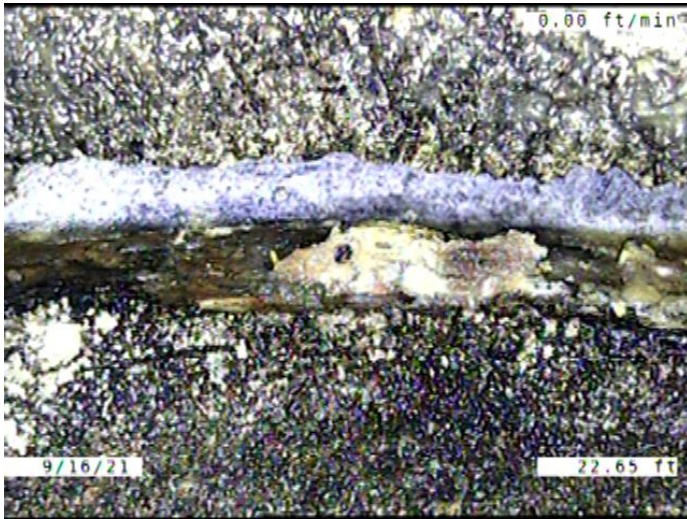
Code: **DAE**  
 Description: **Deposits Attached Encrustation**

Distance (ft): **22.6**  
 Structural Grade: **0**  
 O&M Grade: **2**  
 Clock Start/From: **7**  
 Clock To: **5**  
 1st Value:  
 2nd Value:  
 Value Percent: **5.000**  
 Continuous Index:  
 Within 8" of Joint: **YES**  
 Remarks:

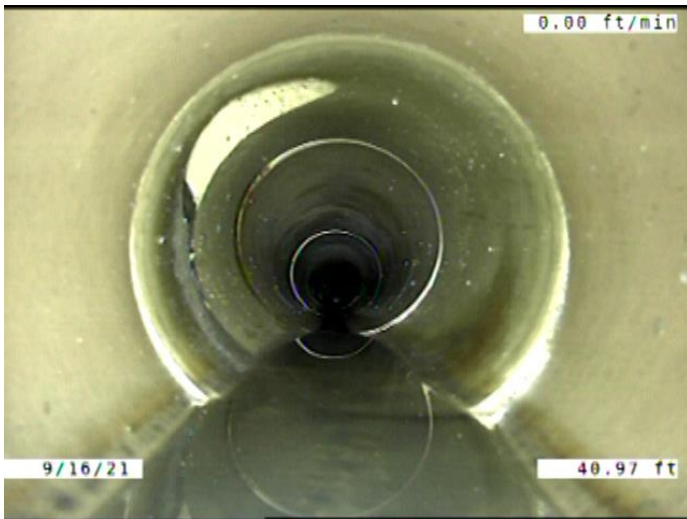
Code: **MWLS**  
 Description: **Miscellaneous Water Level Sag**

Distance (ft): **41.0**  
 Structural Grade: **2**  
 O&M Grade: **0**  
 Clock Start/From:  
 Clock To:  
 1st Value:  
 2nd Value:  
 Value Percent: **5.000**  
 Continuous Index:  
 Within 8" of Joint: **NO**  
 Remarks:

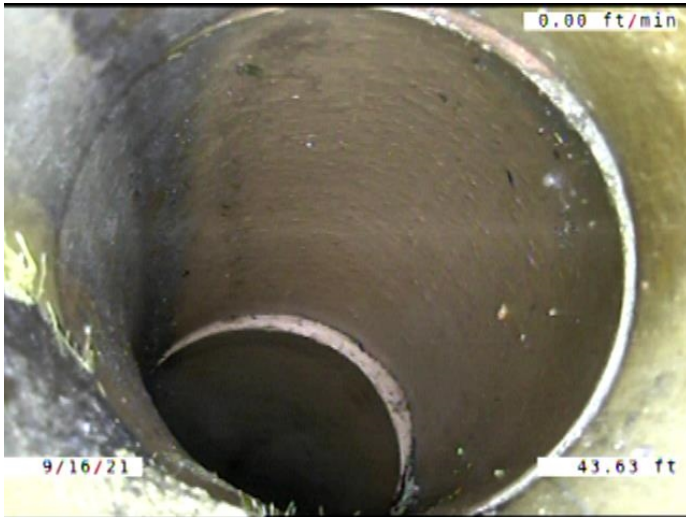
Code: **TF**  
 Description: **Tap Factory**

Distance (ft): **43.6**  
 Structural Grade: **0**  
 O&M Grade: **0**  
 Clock Start/From: **11**  
 Clock To:  
 1st Value: **4.000**  
 2nd Value:  
 Value Percent:  
 Continuous Index:  
 Within 8" of Joint: **YES**  
 Remarks:

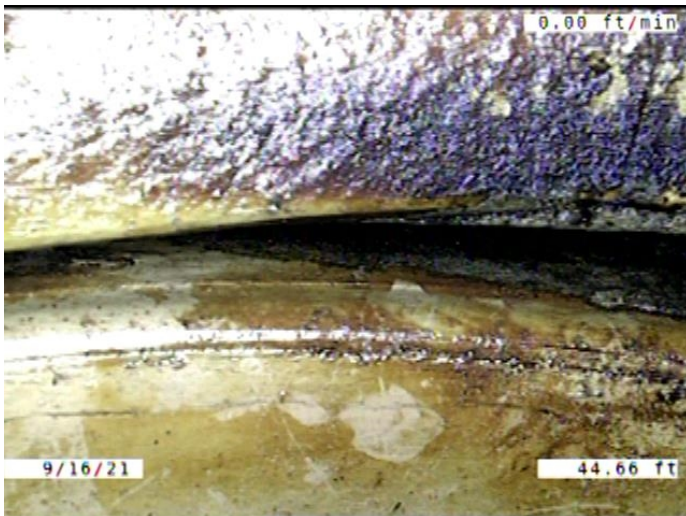
Code: **ISJ**  
 Description: **Infiltration Stain Joint**

Distance (ft): **44.7**  
 Structural Grade: **0**  
 O&M Grade: **1**  
 Clock Start/From: **7**  
 Clock To: **11**  
 1st Value:  
 2nd Value:  
 Value Percent:  
 Continuous Index:  
 Within 8" of Joint: **YES**  
 Remarks:

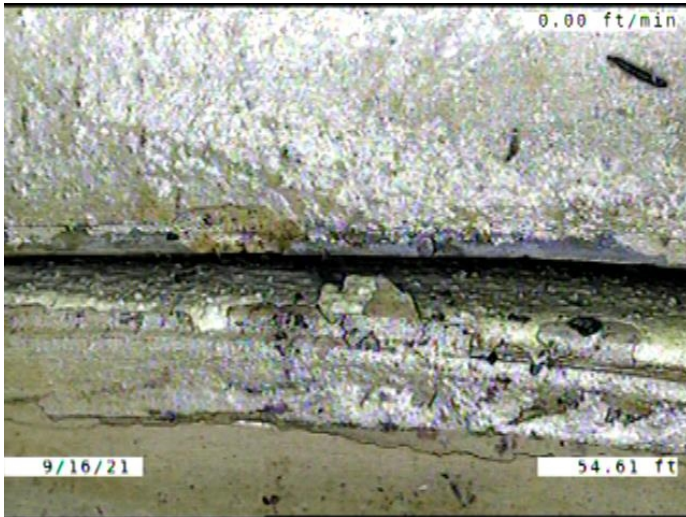
Code: **ISJ**  
 Description: **Infiltration Stain Joint**

Distance (ft): **54.6**  
 Structural Grade: **0**  
 O&M Grade: **1**  
 Clock Start/From: **2**  
 Clock To: **5**  
 1st Value:  
 2nd Value:  
 Value Percent:  
 Continuous Index:  
 Within 8" of Joint: **YES**  
 Remarks:

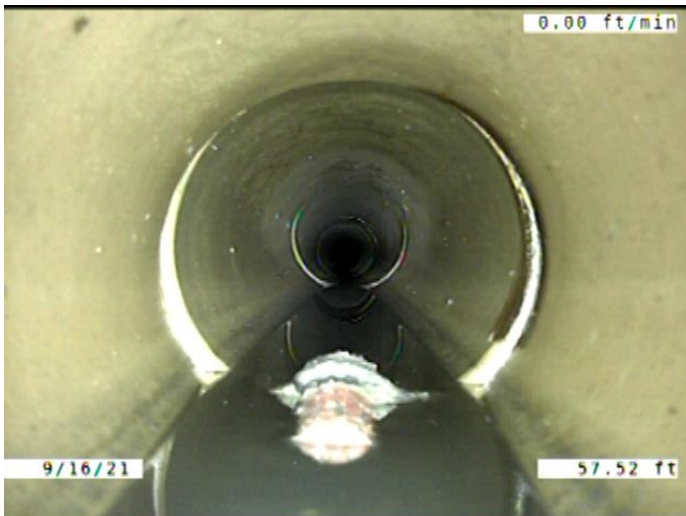
Code: **MWLS**  
 Description: **Miscellaneous Water Level Sag**

Distance (ft): **57.5**  
 Structural Grade: **2**  
 O&M Grade: **0**  
 Clock Start/From:  
 Clock To:  
 1st Value:  
 2nd Value:  
 Value Percent: **5.000**  
 Continuous Index:  
 Within 8" of Joint: **NO**  
 Remarks:

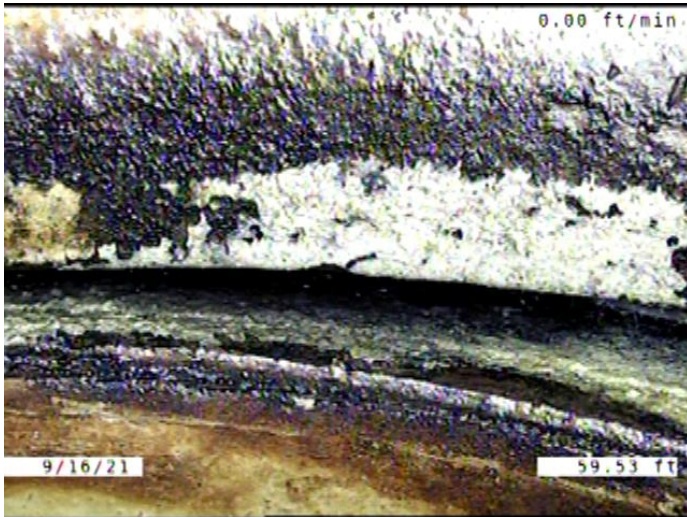
Code: **ISJ**  
 Description: **Infiltration Stain Joint**

Distance (ft): **59.5**  
 Structural Grade: **0**  
 O&M Grade: **1**  
 Clock Start/From: **1**  
 Clock To: **4**  
 1st Value:  
 2nd Value:  
 Value Percent:  
 Continuous Index:  
 Within 8" of Joint: **YES**  
 Remarks:

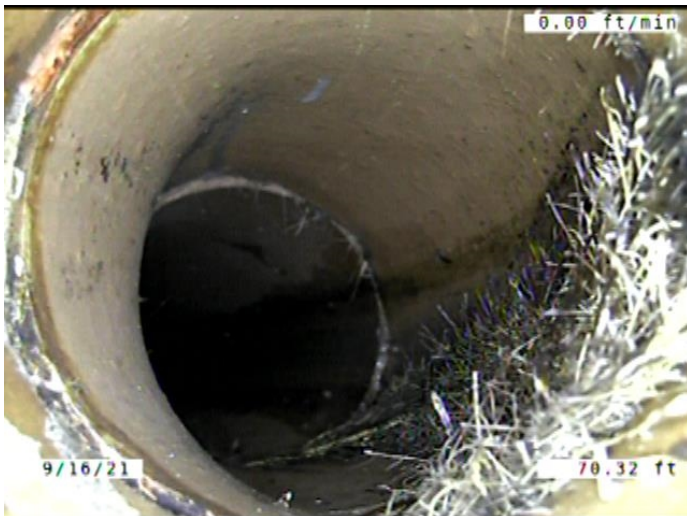
Code: **TF**  
 Description: **Tap Factory**

Distance (ft): **70.3**  
 Structural Grade: **0**  
 O&M Grade: **0**  
 Clock Start/From: **2**  
 Clock To:  
 1st Value: **4.000**  
 2nd Value:  
 Value Percent:  
 Continuous Index:  
 Within 8" of Joint: **YES**  
 Remarks: **ROOTS GROWING IN THE JOINTS OF THE TAP**

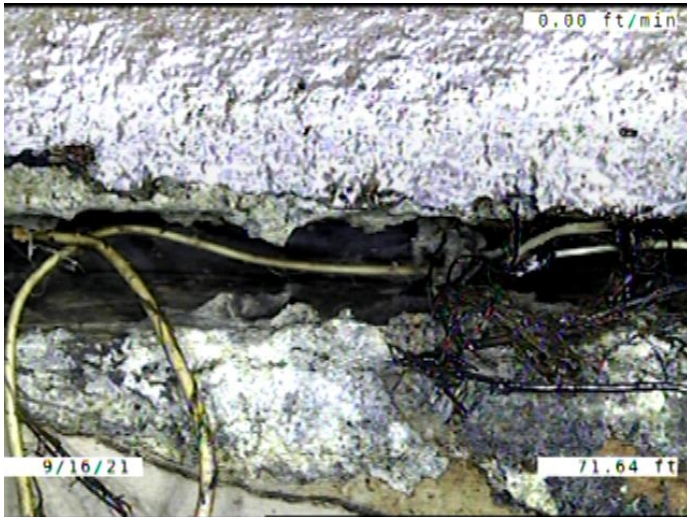
Code: **RFJ**  
 Description: **Roots Fine Joint**

Distance (ft): **71.6**  
 Structural Grade: **0**  
 O&M Grade: **1**  
 Clock Start/From: **9**  
 Clock To: **3**  
 1st Value:  
 2nd Value:  
 Value Percent:  
 Continuous Index:  
 Within 8" of Joint: **YES**  
 Remarks:

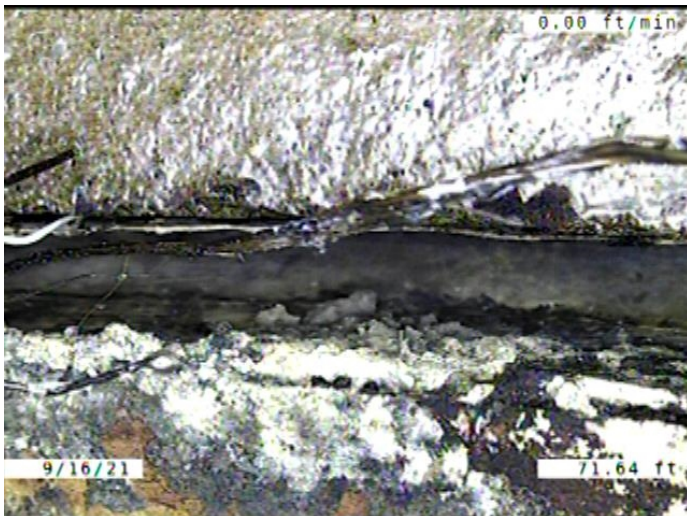
Code: **DAE**  
 Description: **Deposits Attached Encrustation**

Distance (ft): **71.6**  
 Structural Grade: **0**  
 O&M Grade: **2**  
 Clock Start/From: **8**  
 Clock To: **4**  
 1st Value:  
 2nd Value:  
 Value Percent: **5.000**  
 Continuous Index:  
 Within 8" of Joint: **YES**  
 Remarks:

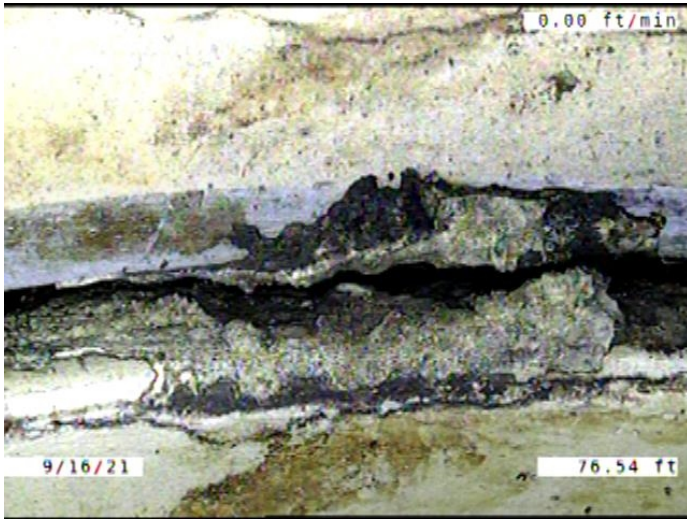
Code: **DAE**  
Description: **Deposits Attached Encrustation**

Distance (ft): **76.5**  
Structural Grade: **0**  
O&M Grade: **2**  
Clock Start/From: **7**  
Clock To: **5**  
1st Value:  
2nd Value:  
Value Percent: **5.000**  
Continuous Index:  
Within 8" of Joint: **YES**  
Remarks:

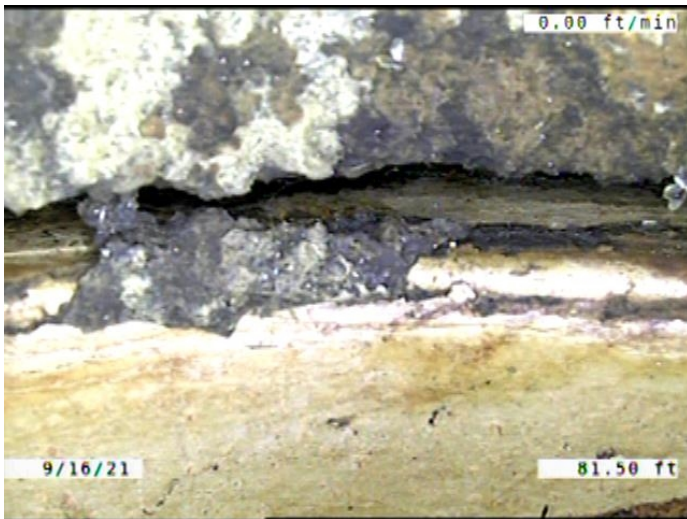
Code: **DAE**  
Description: **Deposits Attached Encrustation**

Distance (ft): **81.5**  
Structural Grade: **0**  
O&M Grade: **2**  
Clock Start/From: **7**  
Clock To: **11**  
1st Value:  
2nd Value:  
Value Percent: **5.000**  
Continuous Index:  
Within 8" of Joint: **YES**  
Remarks:

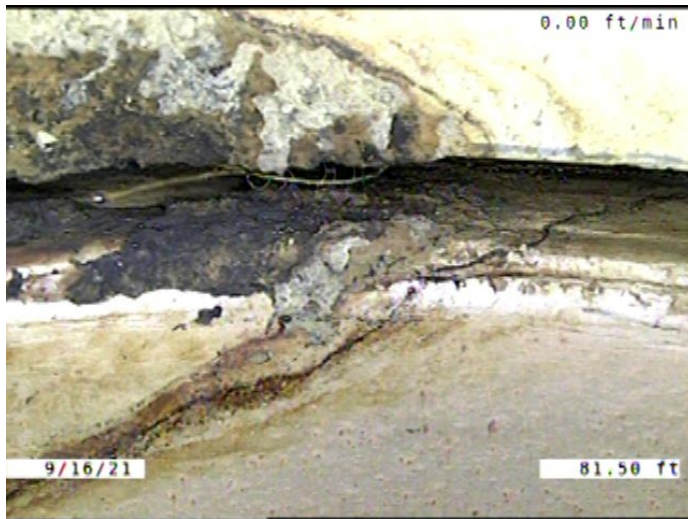
Code: **RFJ**  
Description: **Roots Fine Joint**

Distance (ft): **81.5**  
Structural Grade: **0**  
O&M Grade: **1**  
Clock Start/From: **11**  
Clock To:  
1st Value:  
2nd Value:  
Value Percent:  
Continuous Index:  
Within 8" of Joint: **YES**  
Remarks:

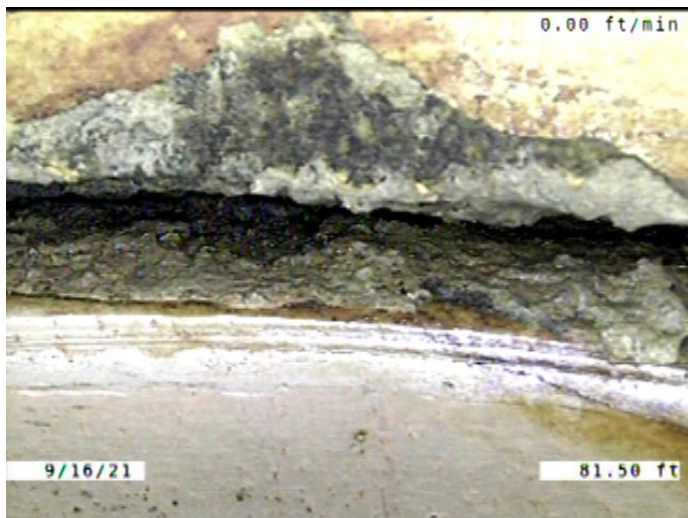
Code: **DAE**  
Description: **Deposits Attached Encrustation**

Distance (ft): **81.5**  
Structural Grade: **0**  
O&M Grade: **2**  
Clock Start/From: **2**  
Clock To: **5**  
1st Value:  
2nd Value:  
Value Percent: **5.000**  
Continuous Index:  
Within 8" of Joint: **YES**  
Remarks:

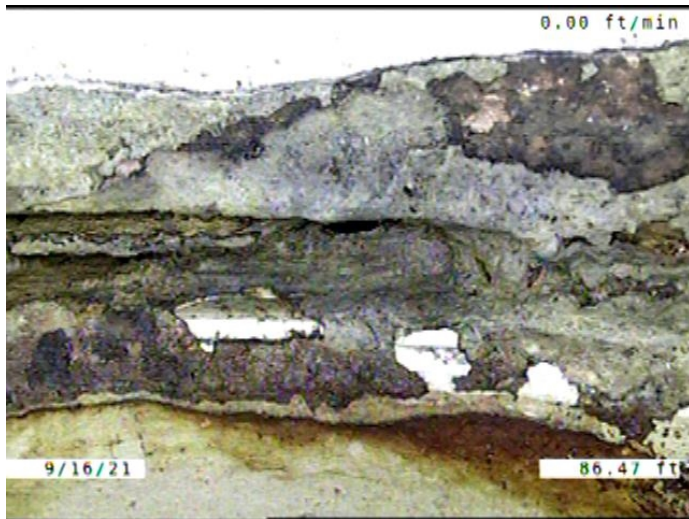
Code: **DAE**  
Description: **Deposits Attached Encrustation**

Distance (ft): **86.5**  
Structural Grade: **0**  
O&M Grade: **2**  
Clock Start/From: **8**  
Clock To: **5**  
1st Value:  
2nd Value:  
Value Percent: **5.000**  
Continuous Index:  
Within 8" of Joint: **YES**  
Remarks:

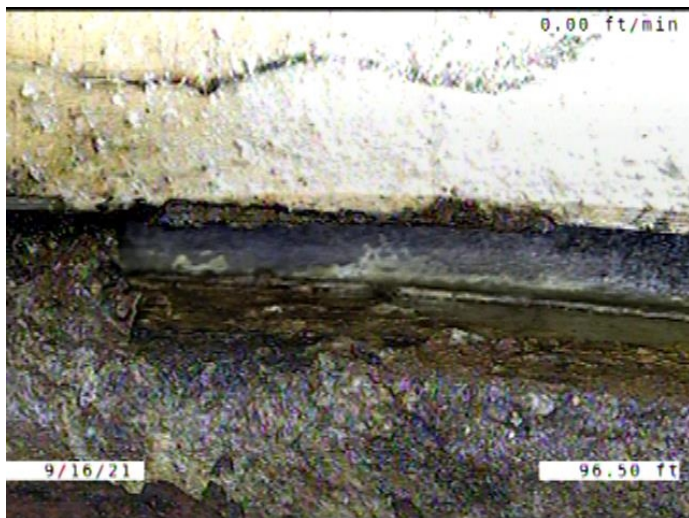
Code: **DAE**  
Description: **Deposits Attached Encrustation**

Distance (ft): **96.5**  
Structural Grade: **0**  
O&M Grade: **2**  
Clock Start/From: **7**  
Clock To: **5**  
1st Value:  
2nd Value:  
Value Percent: **5.000**  
Continuous Index:  
Within 8" of Joint: **YES**  
Remarks:

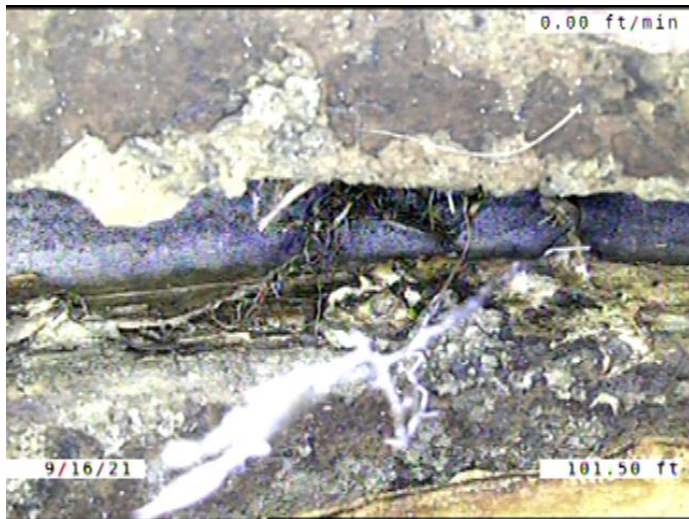
Code: **RFJ**  
 Description: **Roots Fine Joint**

Distance (ft): **101.5**  
 Structural Grade: **0**  
 O&M Grade: **1**  
 Clock Start/From: **9**  
 Clock To: **3**  
 1st Value:  
 2nd Value:  
 Value Percent:  
 Continuous Index:  
 Within 8" of Joint: **YES**  
 Remarks:

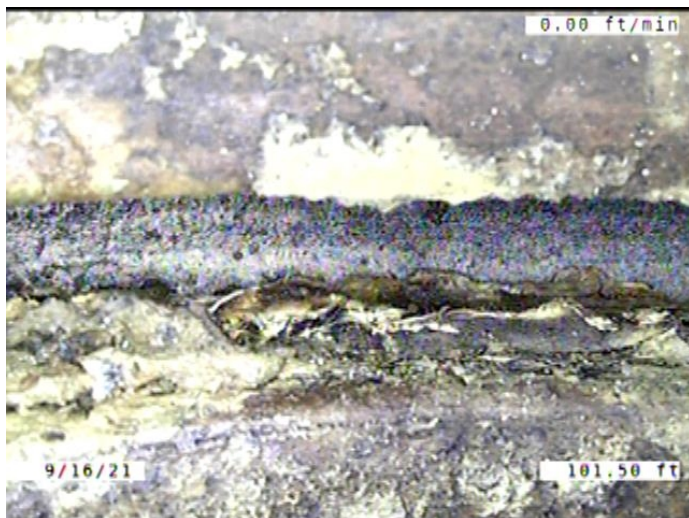
Code: **DAE**  
 Description: **Deposits Attached Encrustation**

Distance (ft): **101.5**  
 Structural Grade: **0**  
 O&M Grade: **2**  
 Clock Start/From: **8**  
 Clock To: **4**  
 1st Value:  
 2nd Value:  
 Value Percent: **5.000**  
 Continuous Index:  
 Within 8" of Joint: **YES**  
 Remarks:

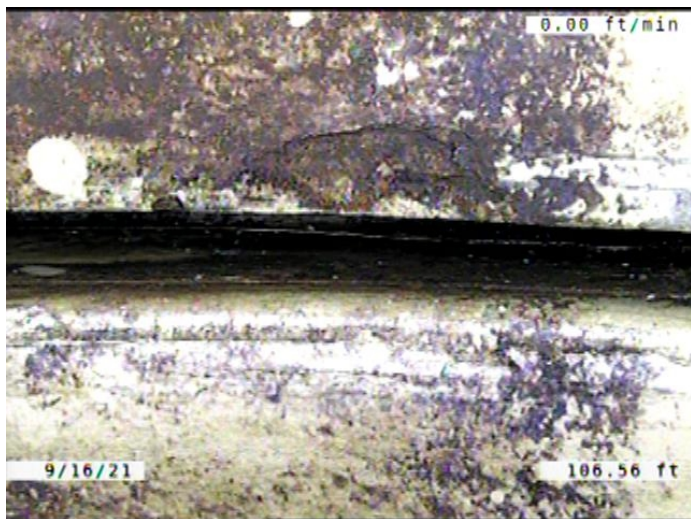
Code: **ISJ**  
 Description: **Infiltration Stain Joint**

Distance (ft): **106.6**  
 Structural Grade: **0**  
 O&M Grade: **1**  
 Clock Start/From: **12**  
 Clock To: **4**  
 1st Value:  
 2nd Value:  
 Value Percent:  
 Continuous Index:  
 Within 8" of Joint: **YES**  
 Remarks:

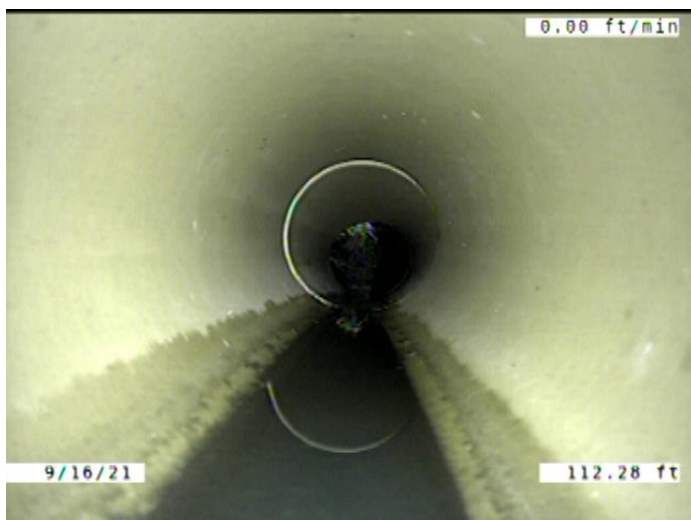
Code: **MWLS**  
 Description: **Miscellaneous Water Level Sag**

Distance (ft): **112.3**  
 Structural Grade: **2**  
 O&M Grade: **0**  
 Clock Start/From:  
 Clock To:  
 1st Value:  
 2nd Value:  
 Value Percent: **5.000**  
 Continuous Index:  
 Within 8" of Joint: **NO**  
 Remarks:

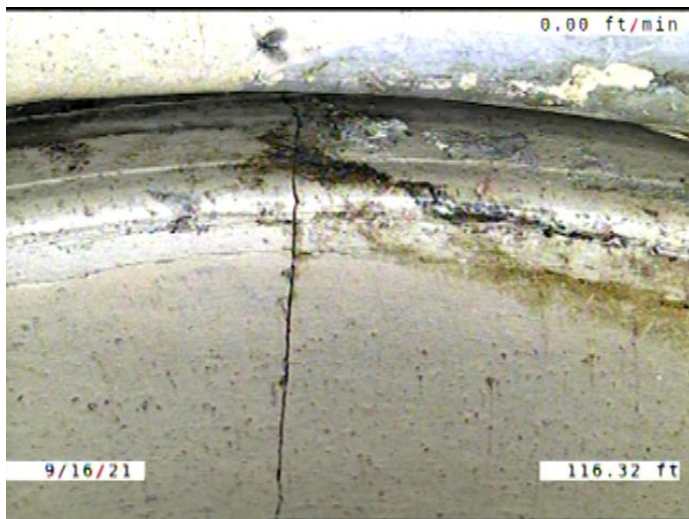
Code: **CL**  
 Description: **Crack Longitudinal**

Distance (ft): **116.3**  
 Structural Grade: **2**  
 O&M Grade: **0**  
 Clock Start/From: **2**  
 Clock To:  
 1st Value:  
 2nd Value:  
 Value Percent:  
 Continuous Index:  
 Within 8" of Joint: **YES**  
 Remarks:

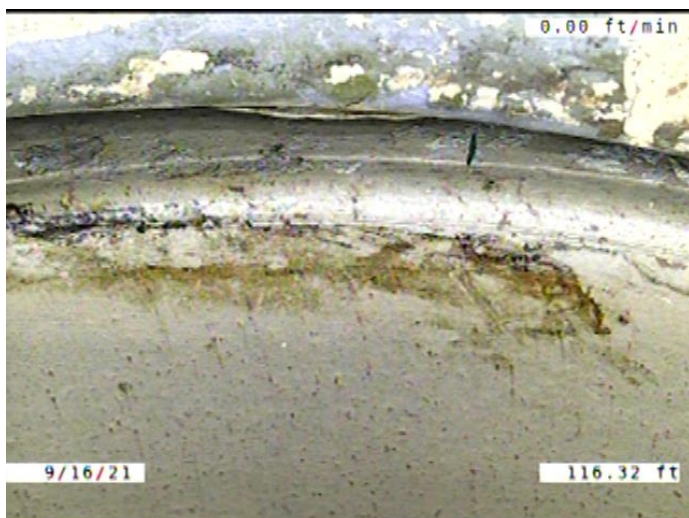
Code: **ISJ**  
 Description: **Infiltration Stain Joint**

Distance (ft): **116.3**  
 Structural Grade: **0**  
 O&M Grade: **1**  
 Clock Start/From: **2**  
 Clock To: **4**  
 1st Value:  
 2nd Value:  
 Value Percent:  
 Continuous Index:  
 Within 8" of Joint: **YES**  
 Remarks:

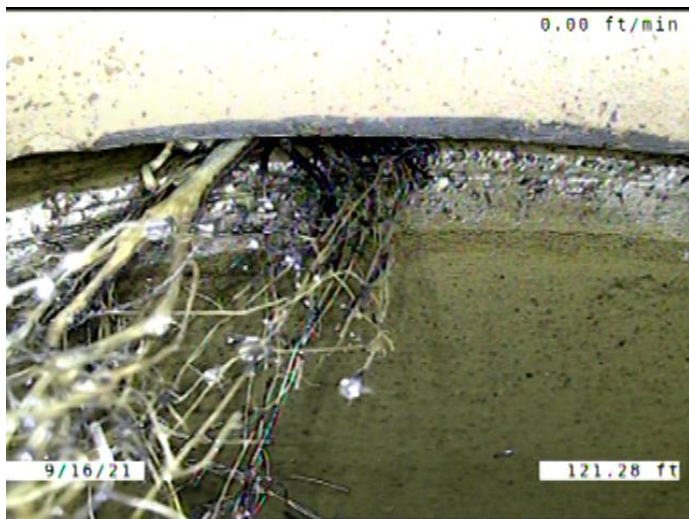
Code: **RFJ**  
 Description: **Roots Fine Joint**

Distance (ft): **121.3**  
 Structural Grade: **0**  
 O&M Grade: **1**  
 Clock Start/From: **9**  
 Clock To: **3**  
 1st Value:  
 2nd Value:  
 Value Percent:  
 Continuous Index:  
 Within 8" of Joint: **YES**  
 Remarks:

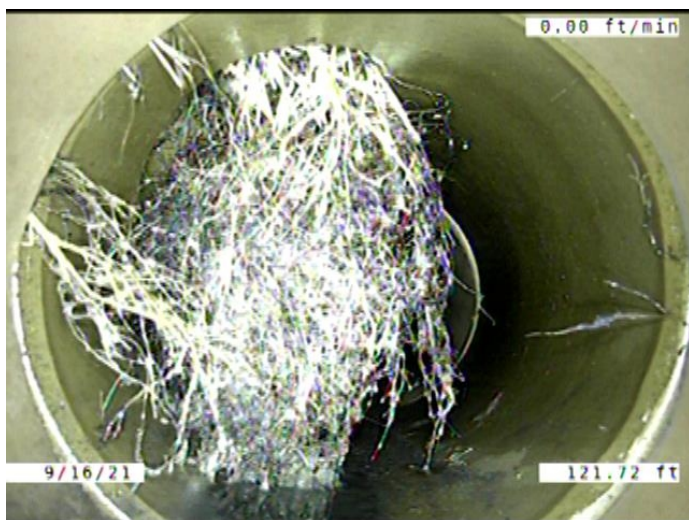
Code: **RML**  
 Description: **Roots Medium Lateral**

Distance (ft): **121.7**  
 Structural Grade: **0**  
 O&M Grade: **3**  
 Clock Start/From: **10**  
 Clock To: **12**  
 1st Value:  
 2nd Value:  
 Value Percent: **50.000**  
 Continuous Index:  
 Within 8" of Joint: **NO**  
 Remarks:

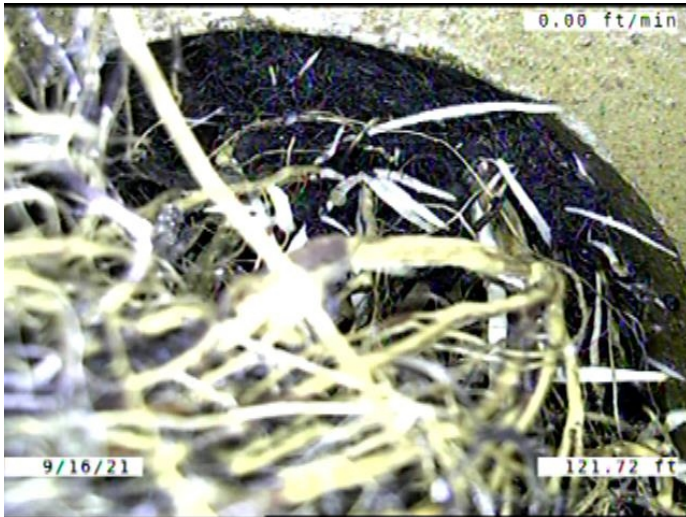
Code:	<b>TFD</b>
Description:	<b>Tap Factory Defective</b>
Distance (ft):	<b>121.7</b>
Structural Grade:	<b>0</b>
O&M Grade:	<b>3</b>
Clock Start/From:	<b>11</b>
Clock To:	
1st Value:	<b>4.000</b>
2nd Value:	
Value Percent:	
Continuous Index:	
Within 8" of Joint:	<b>YES</b>
Remarks:	<b>LOOKS TO BE 100% WITH ROOTS</b>

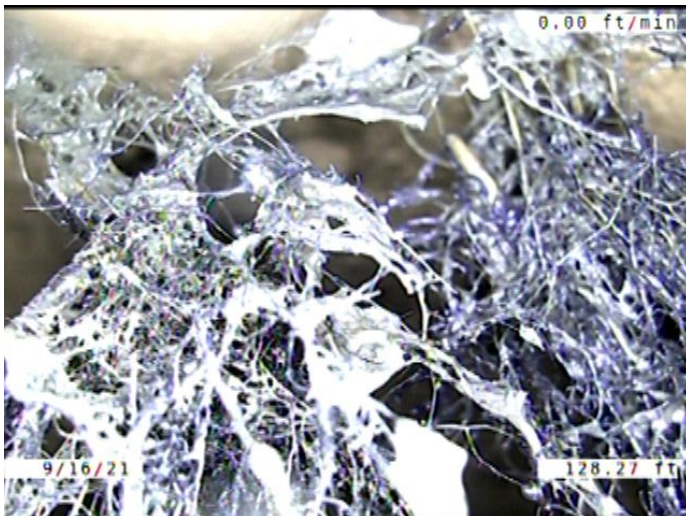
Code:	<b>RMJ</b>
Description:	<b>Roots Medium Joint</b>
Distance (ft):	<b>128.3</b>
Structural Grade:	<b>0</b>
O&M Grade:	<b>3</b>
Clock Start/From:	<b>9</b>
Clock To:	<b>3</b>
1st Value:	
2nd Value:	
Value Percent:	<b>5.000</b>
Continuous Index:	
Within 8" of Joint:	<b>YES</b>
Remarks:

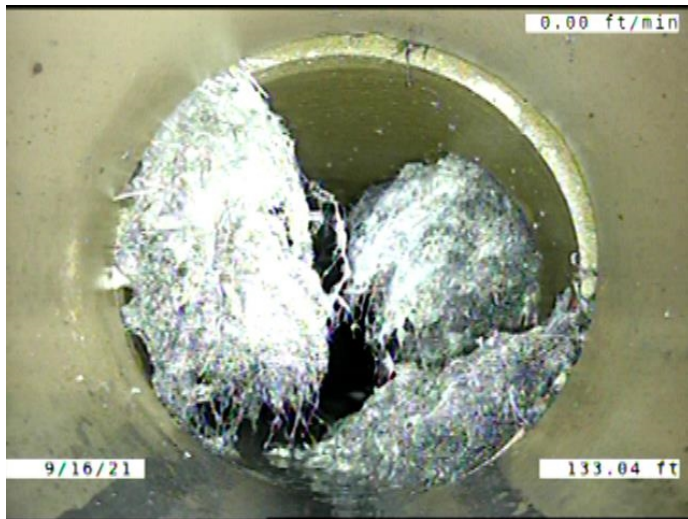
Code: **RMJ**  
 Description: **Roots Medium Joint**

Distance (ft): **133.0**  
 Structural Grade: **0**  
 O&M Grade: **3**  
 Clock Start/From: **7**  
 Clock To: **1**  
 1st Value:  
 2nd Value:  
 Value Percent: **20.000**  
 Continuous Index:  
 Within 8" of Joint: **YES**  
 Remarks:

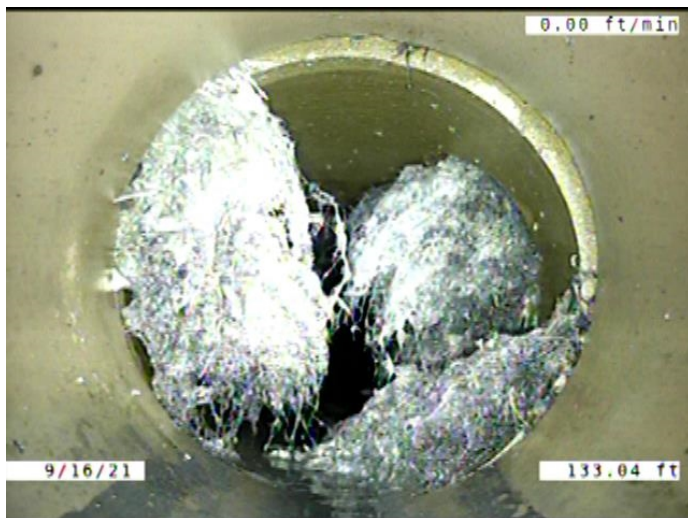
Code: **RMJ**  
 Description: **Roots Medium Joint**

Distance (ft): **133.0**  
 Structural Grade: **0**  
 O&M Grade: **3**  
 Clock Start/From: **3**  
 Clock To: **5**  
 1st Value:  
 2nd Value:  
 Value Percent: **5.000**  
 Continuous Index:  
 Within 8" of Joint: **YES**  
 Remarks:

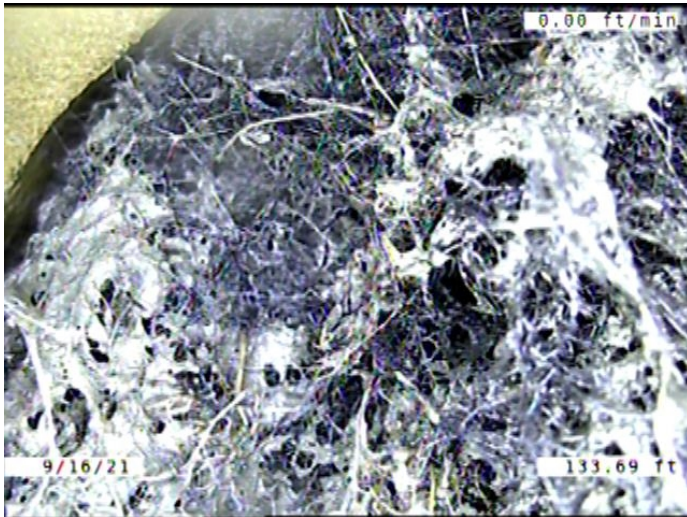
Code: **RML**  
 Description: **Roots Medium Lateral**

Distance (ft): **133.7**  
 Structural Grade: **0**  
 O&M Grade: **3**  
 Clock Start/From: **1**  
 Clock To: **3**  
 1st Value:  
 2nd Value:  
 Value Percent: **40.000**  
 Continuous Index:  
 Within 8" of Joint: **NO**  
 Remarks:

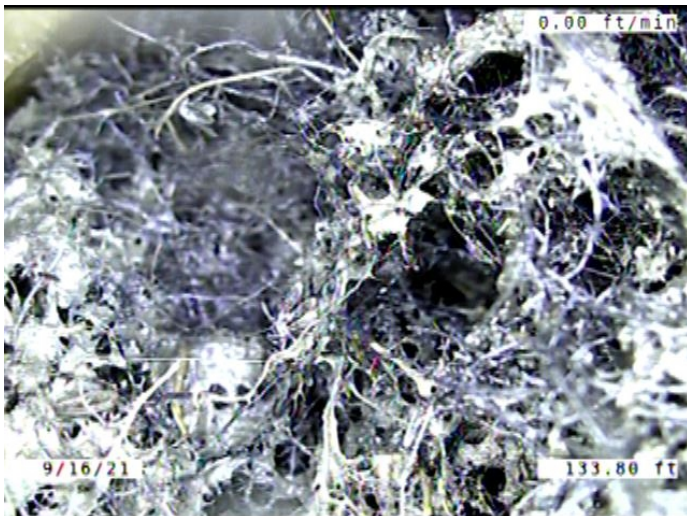
Code: **TFD**  
 Description: **Tap Factory Defective**

Distance (ft): **133.8**  
 Structural Grade: **0**  
 O&M Grade: **3**  
 Clock Start/From: **2**  
 Clock To:  
 1st Value: **4.000**  
 2nd Value:  
 Value Percent:  
 Continuous Index:  
 Within 8" of Joint: **YES**  
 Remarks: **LOOKS TO BE 100% PLUGGED WITH ROOTS**

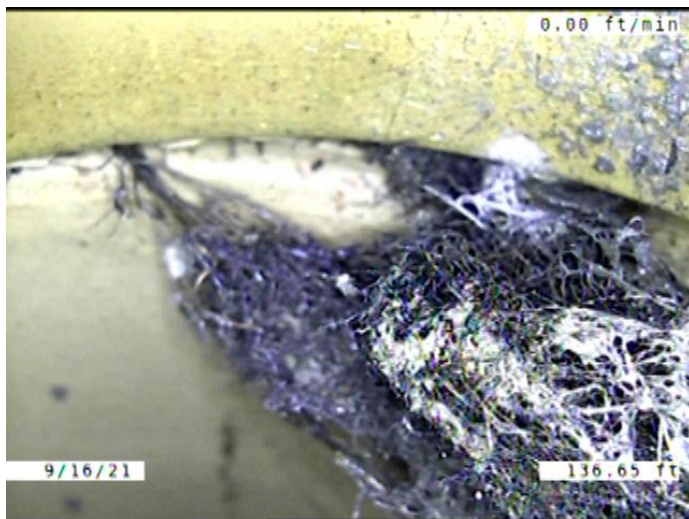
Code:	<b>RMJ</b>
Description:	<b>Roots Medium Joint</b>
Distance (ft):	<b>136.6</b>
Structural Grade:	<b>0</b>
O&M Grade:	<b>3</b>
Clock Start/From:	<b>9</b>
Clock To:	<b>5</b>
1st Value:	
2nd Value:	
Value Percent:	<b>5.000</b>
Continuous Index:	
Within 8" of Joint:	<b>YES</b>
Remarks:

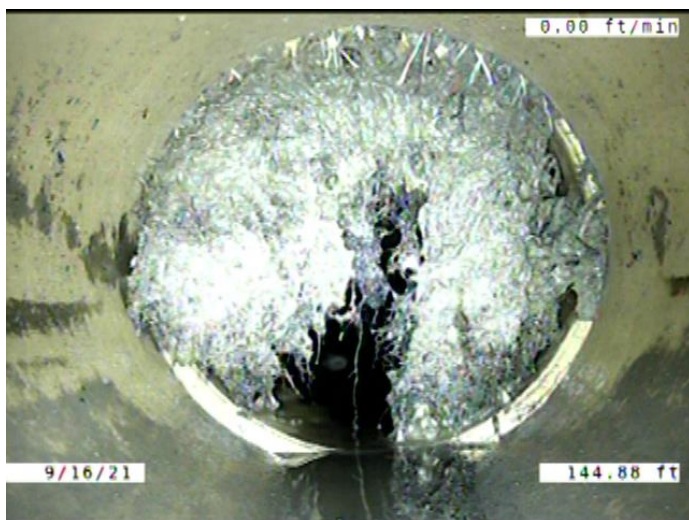
Code:	<b>RBJ</b>
Description:	<b>Roots Ball Joint</b>
Distance (ft):	<b>144.9</b>
Structural Grade:	<b>0</b>
O&M Grade:	<b>4</b>
Clock Start/From:	<b>9</b>
Clock To:	<b>5</b>
1st Value:	
2nd Value:	
Value Percent:	<b>80.000</b>
Continuous Index:	
Within 8" of Joint:	<b>YES</b>
Remarks:

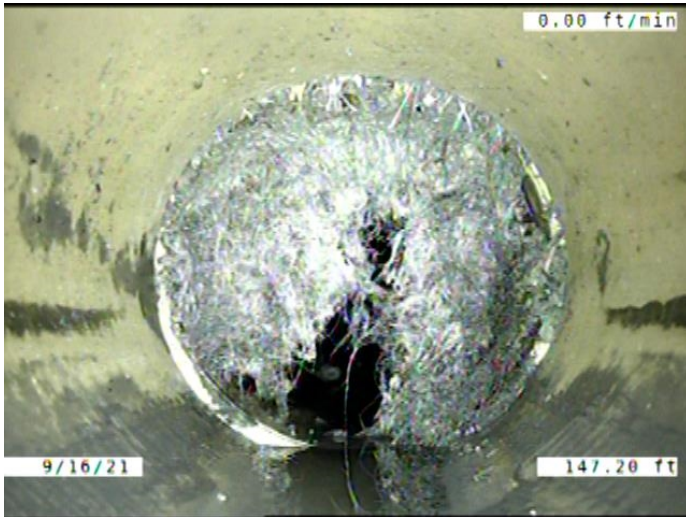
Code: **DSF**  
 Description: **Deposits Settled Fine**

Distance (ft): **147.2**  
 Structural Grade: **0**  
 O&M Grade: **2**  
 Clock Start/From: **5**  
 Clock To: **7**  
 1st Value:  
 2nd Value:  
 Value Percent: **5.000**  
 Continuous Index: **F01**  
 Within 8" of Joint: **YES**  
 Remarks:

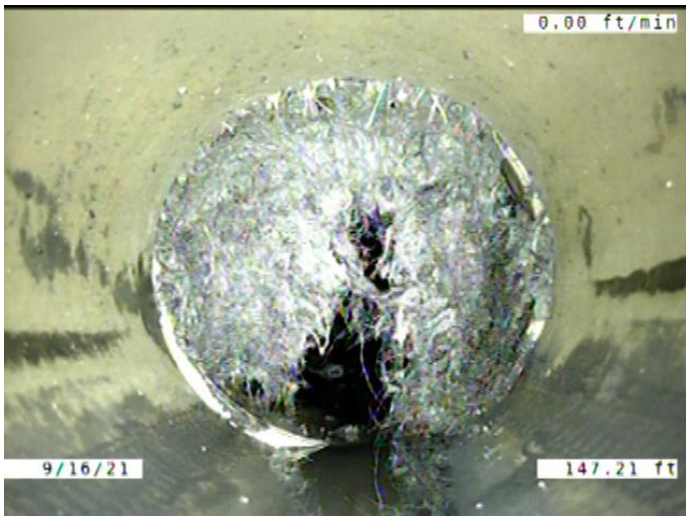
Code: **MSA**  
 Description: **Miscellaneous Survey Abandoned**

Distance (ft): **147.2**  
 Structural Grade: **0**  
 O&M Grade: **0**  
 Clock Start/From:  
 Clock To:  
 1st Value:  
 2nd Value:  
 Value Percent:  
 Continuous Index:  
 Within 8" of Joint: **NO**  
 Remarks: **CAMERA CANT MAKE IT PAST ROOTS**
