Profile/Photo Observation Report

Date:	10/21/2021	Weather:		Coding:	PACP 7.0
Pipe Length (ft):	319.0	Owner:	City of Hobart	Pre Clean:	Heavy Cleaning
P.O.#:	YES502259	Surveyor:	S. Bucklin	PSR:	P-503-077-076
Customer:	City of Hobart	Clean Date:	08/23/2021	Shape:	C

Street:	North Guyer Street	Flow Control:	Not Controlled
City:	Hobart, IN	Year Renewed:	
Location:	Alley	Tape/Media #:	
Purpose:	Routine Assessment	Dia/Height:	10"
Use:	Sanitary Sewage Pipe	Material:	VCP
Drain Area:		Lining:	None
Category:	NA		
Comment:

Location Details:		Direction of Survey:	Upstream
US MH:	M-503-076	DS MH:	M-503-077
		Total Length Surveyed (ft):	157.2

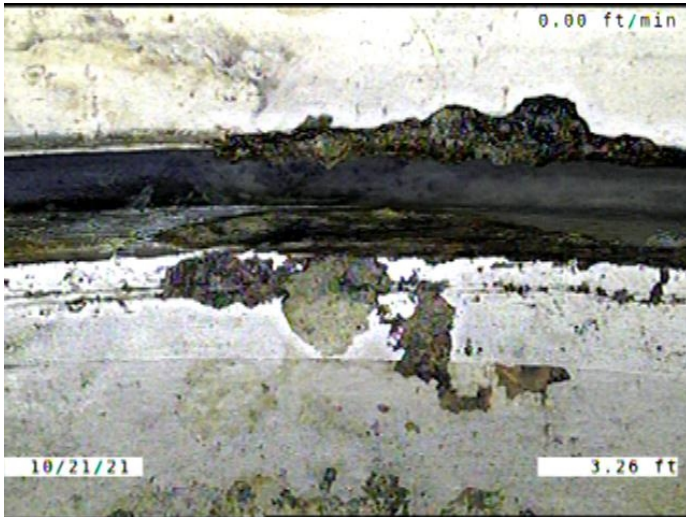
Code: **DAE**
 Description: **Deposits Attached Encrustation**

Distance (ft): **3.3**
 Structural Grade: **0**
 O&M Grade: **2**
 Clock Start/From: **7**
 Clock To: **5**
 1st Value:
 2nd Value:
 Value Percent: **5.000**
 Continuous Index: **S01**
 Within 8" of Joint: **YES**
 Remarks:

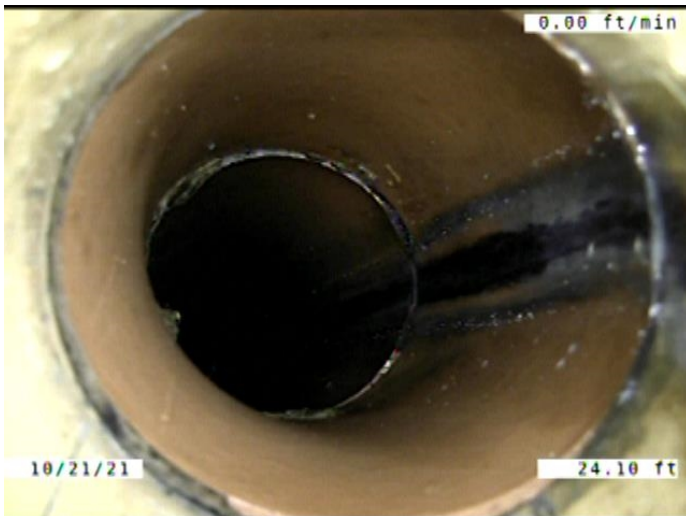
Code: **TF**
 Description: **Tap Factory**

Distance (ft): **24.1**
 Structural Grade: **0**
 O&M Grade: **0**
 Clock Start/From: **2**
 Clock To:
 1st Value: **4.000**
 2nd Value:
 Value Percent:
 Continuous Index:
 Within 8" of Joint: **YES**
 Remarks:

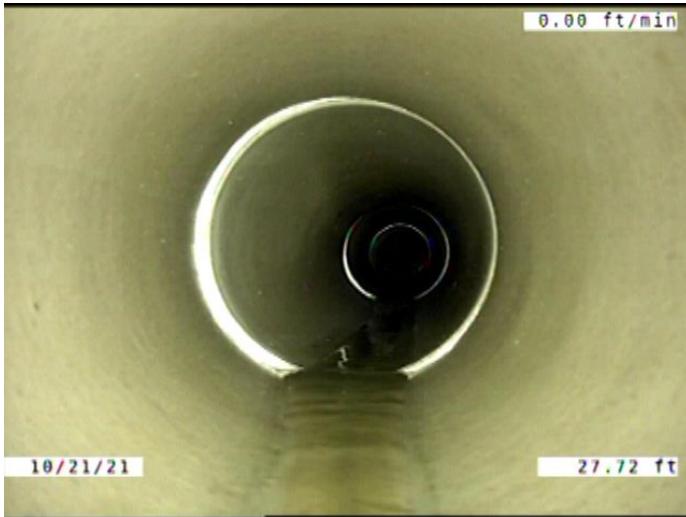
Code: **DAE**
Description: **Deposits Attached Encrustation**

Distance (ft): **27.7**
Structural Grade: **0**
O&M Grade: **2**
Clock Start/From: **7**
Clock To: **5**
1st Value:
2nd Value:
Value Percent: **5.000**
Continuous Index: **F01**
Within 8" of Joint: **YES**
Remarks:

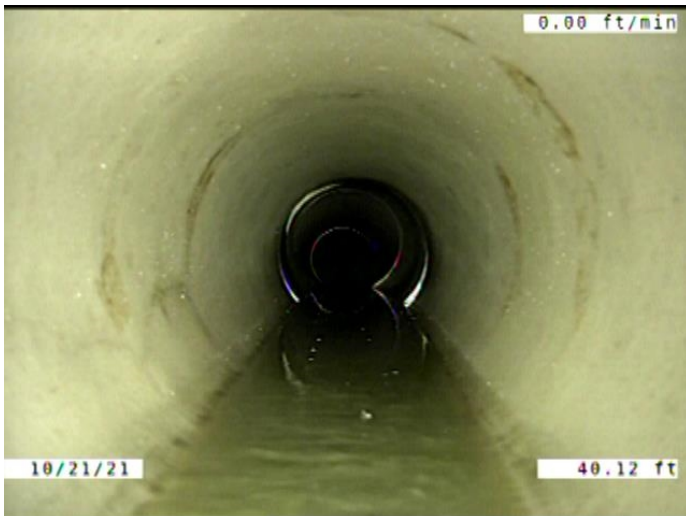
Code: **MWLS**
Description: **Miscellaneous Water Level Sag**

Distance (ft): **40.1**
Structural Grade: **2**
O&M Grade: **0**
Clock Start/From:
Clock To:
1st Value:
2nd Value:
Value Percent: **5.000**
Continuous Index: **S02**
Within 8" of Joint: **NO**
Remarks:

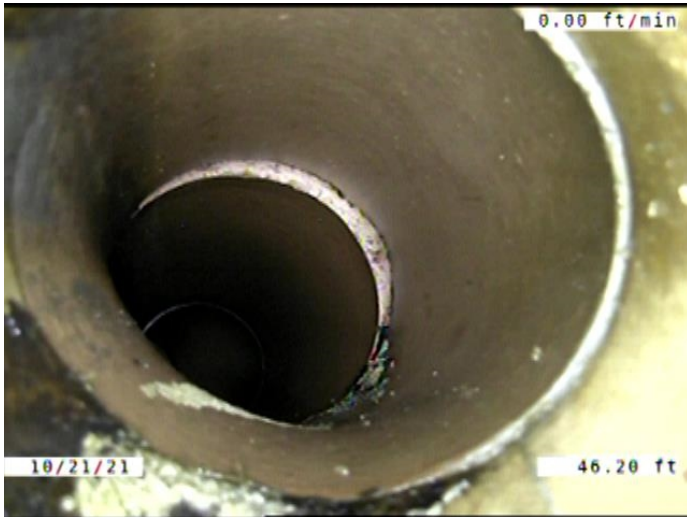
Code: **TF**
Description: **Tap Factory**

Distance (ft): **46.2**
Structural Grade: **0**
O&M Grade: **0**
Clock Start/From: **11**
Clock To:
1st Value: **4.000**
2nd Value:
Value Percent:
Continuous Index:
Within 8" of Joint: **YES**
Remarks: **ENCRUSTATION AROUND THE JOINTS**

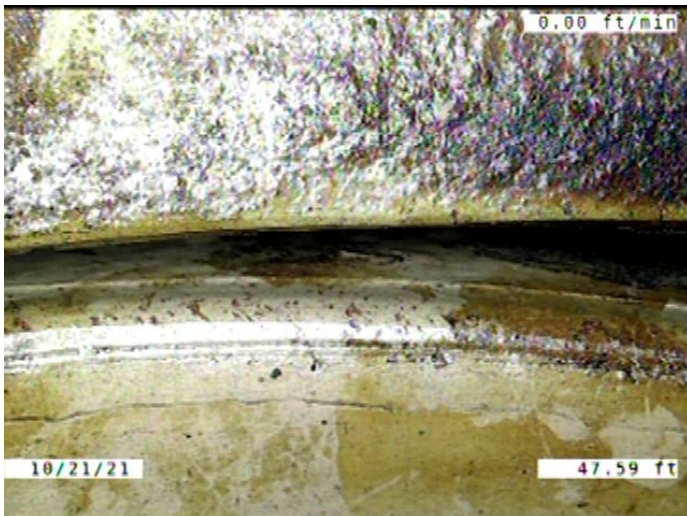
Code: **ISJ**
Description: **Infiltration Stain Joint**

Distance (ft): **47.6**
Structural Grade: **0**
O&M Grade: **1**
Clock Start/From: **7**
Clock To: **11**
1st Value:
2nd Value:
Value Percent:
Continuous Index:
Within 8" of Joint: **YES**
Remarks:

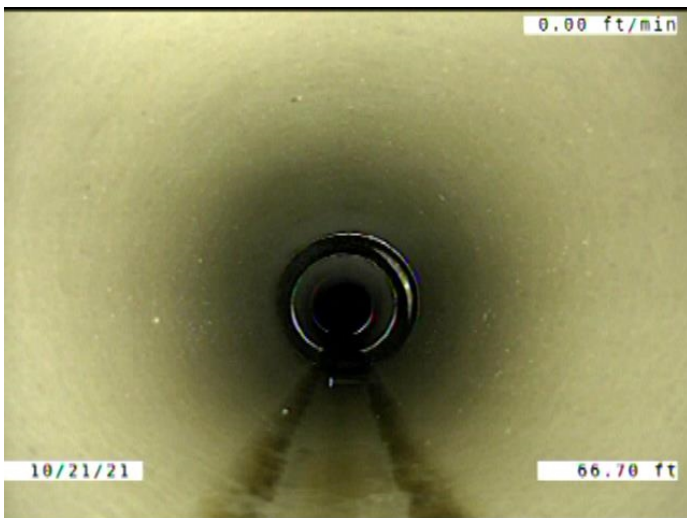
Code: **MWLS**
Description: **Miscellaneous Water Level Sag**

Distance (ft): **66.7**
Structural Grade: **2**
O&M Grade: **0**
Clock Start/From:
Clock To:
1st Value:
2nd Value:
Value Percent: **5.000**
Continuous Index: **F03**
Within 8" of Joint: **NO**
Remarks:

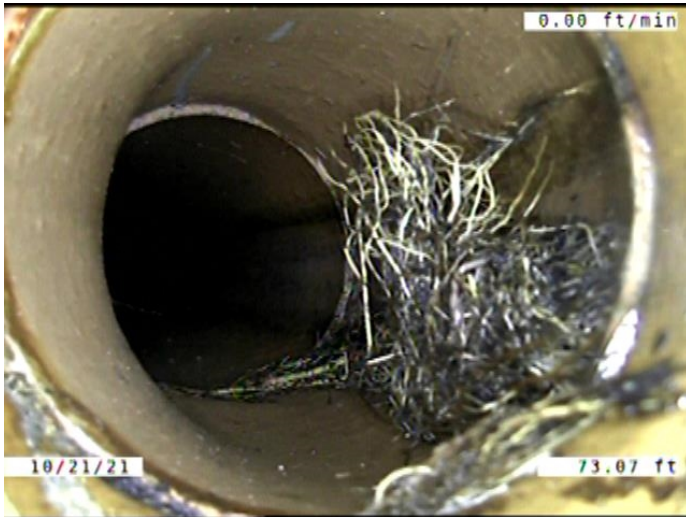
Code:	TF
Description:	Tap Factory
Distance (ft):	73.1
Structural Grade:	0
O&M Grade:	0
Clock Start/From:	2
Clock To:	
1st Value:	4.000
2nd Value:	
Value Percent:	
Continuous Index:	
Within 8" of Joint:	YES
Remarks:	ENCRRUSTATION AND ROOTS IN THE JOINTS

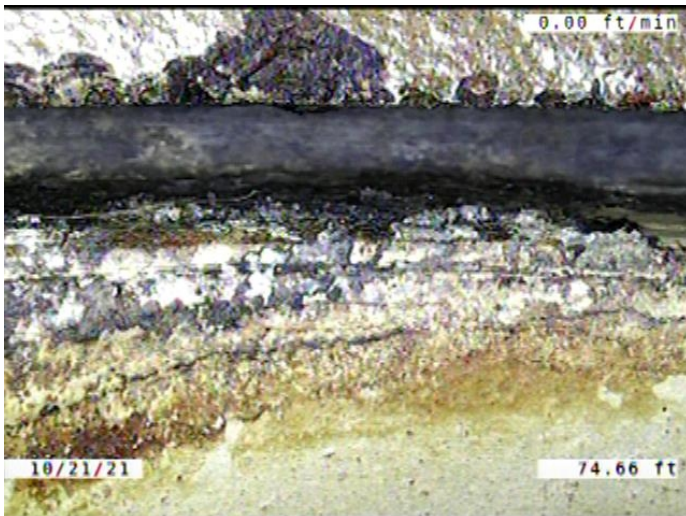
Code:	DAE
Description:	Deposits Attached Encrustation
Distance (ft):	74.7
Structural Grade:	0
O&M Grade:	2
Clock Start/From:	8
Clock To:	4
1st Value:	
2nd Value:	
Value Percent:	5.000
Continuous Index:	S04
Within 8" of Joint:	YES
Remarks:

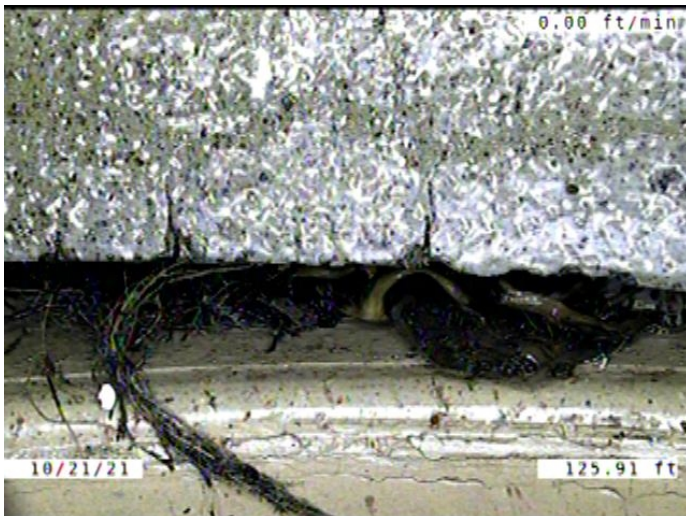
Code:	RFJ
Description:	Roots Fine Joint
Distance (ft):	125.9
Structural Grade:	0
O&M Grade:	1
Clock Start/From:	1
Clock To:	3
1st Value:	
2nd Value:	
Value Percent:	
Continuous Index:	
Within 8" of Joint:	YES
Remarks:

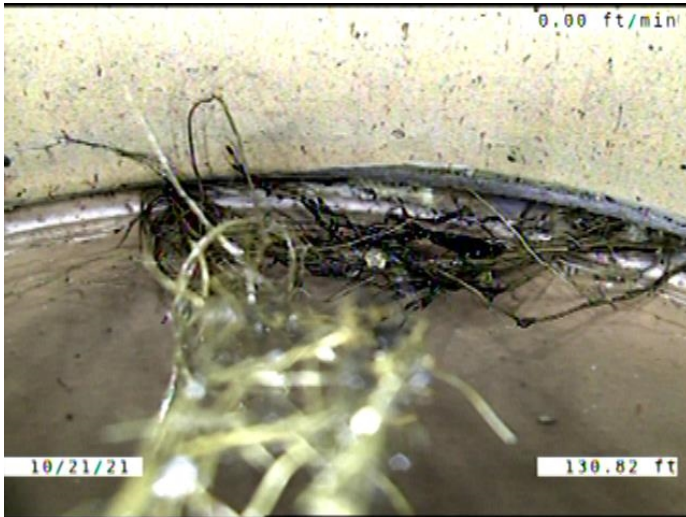
Code: **RFJ**
 Description: **Roots Fine Joint**

Distance (ft): **130.8**
 Structural Grade: **0**
 O&M Grade: **1**
 Clock Start/From: **11**
 Clock To: **2**
 1st Value:
 2nd Value:
 Value Percent:
 Continuous Index:
 Within 8" of Joint: **YES**
 Remarks:

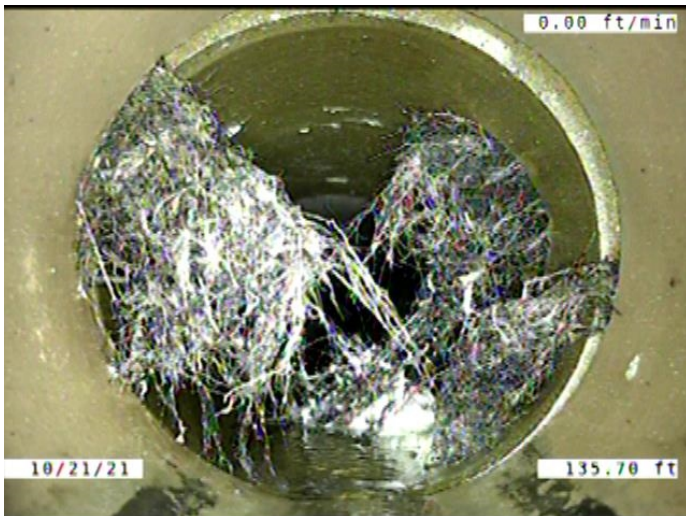
Code: **RMJ**
 Description: **Roots Medium Joint**

Distance (ft): **135.7**
 Structural Grade: **0**
 O&M Grade: **3**
 Clock Start/From: **7**
 Clock To: **4**
 1st Value:
 2nd Value:
 Value Percent: **15.000**
 Continuous Index:
 Within 8" of Joint: **YES**
 Remarks:

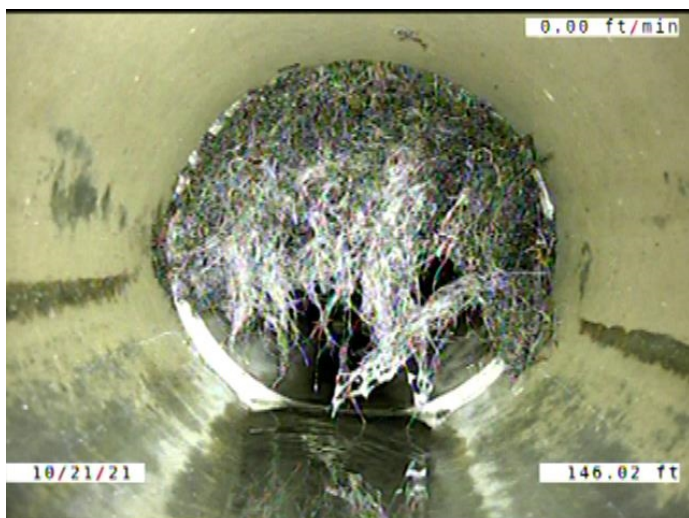
Code: **RBJ**
 Description: **Roots Ball Joint**

Distance (ft): **146.0**
 Structural Grade: **0**
 O&M Grade: **4**
 Clock Start/From: **8**
 Clock To: **4**
 1st Value:
 2nd Value:
 Value Percent: **70.000**
 Continuous Index:
 Within 8" of Joint: **YES**
 Remarks:

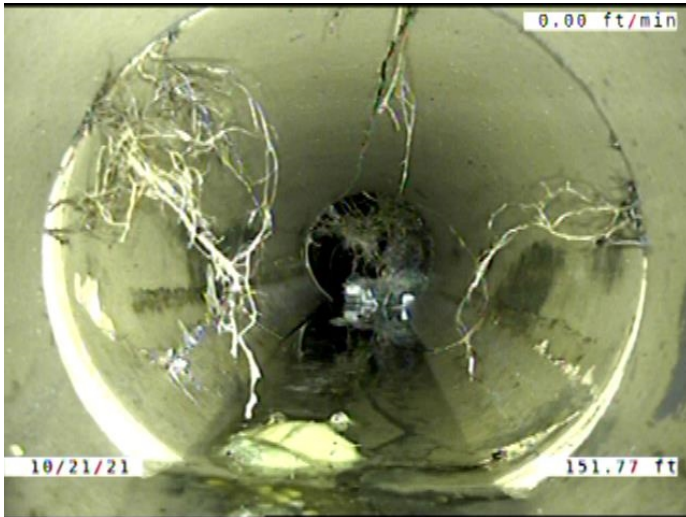
Code: **RFJ**
Description: **Roots Fine Joint**

Distance (ft): **151.8**
Structural Grade: **0**
O&M Grade: **1**
Clock Start/From: **9**
Clock To: **3**
1st Value:
2nd Value:
Value Percent:
Continuous Index:
Within 8" of Joint: **YES**
Remarks:

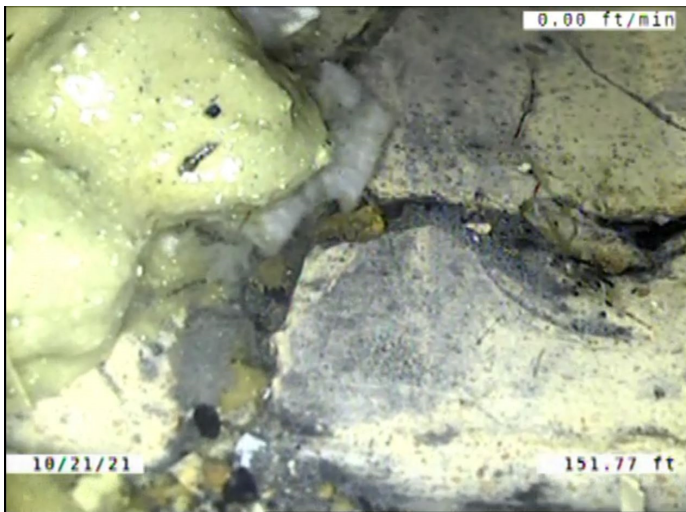
Code: **B**
Description: **Broken**

Distance (ft): **151.8**
Structural Grade: **4**
O&M Grade: **0**
Clock Start/From: **4**
Clock To: **7**
1st Value:
2nd Value:
Value Percent:
Continuous Index:
Within 8" of Joint: **YES**
Remarks:

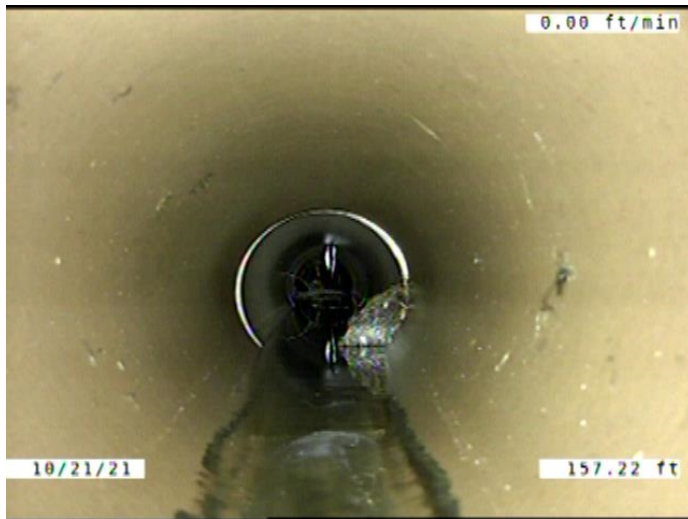
Code: **DAE**
 Description: **Deposits Attached Encrustation**

Distance (ft): **157.2**
 Structural Grade: **0**
 O&M Grade: **2**
 Clock Start/From: **8**
 Clock To: **4**
 1st Value:
 2nd Value:
 Value Percent: **5.000**
 Continuous Index: **F04**
 Within 8" of Joint: **YES**
 Remarks:

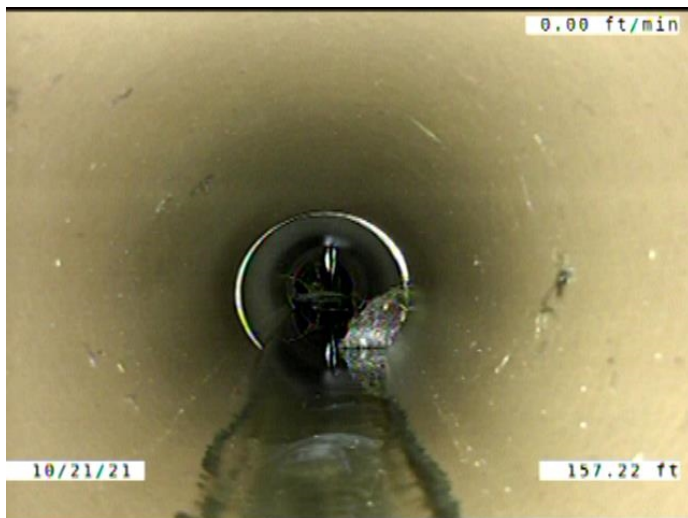
Code: **DSF**
 Description: **Deposits Settled Fine**

Distance (ft): **157.2**
 Structural Grade: **0**
 O&M Grade: **2**
 Clock Start/From: **5**
 Clock To: **7**
 1st Value:
 2nd Value:
 Value Percent: **5.000**
 Continuous Index: **F06**
 Within 8" of Joint: **YES**
 Remarks:
