Profile/Photo Observation Report

Date:	10/21/2021	Weather:		Coding:	PACP 7.0
Pipe Length (ft):	319.0	Owner:	City of Hobart	Pre Clean:	Heavy Cleaning
P.O.#:	YES502259	Surveyor:	S. Bucklin	PSR:	P-503-077-076
Customer:	City of Hobart	Clean Date:	08/23/2021	Shape:	C

Street:	North Guyer Street	Flow Control:	Not Controlled
City:	Hobart, IN	Year Renewed:	
Location:	Alley	Tape/Media #:	
Purpose:	Routine Assessment	Dia/Height:	10"
Use:	Sanitary Sewage Pipe	Material:	VCP
Drain Area:		Lining:	None
Category:	NA		
Comment:

Location Details:		Direction of Survey:	Upstream
US MH:	M-503-076	DS MH:	M-503-077
		Total Length Surveyed (ft):	157.2

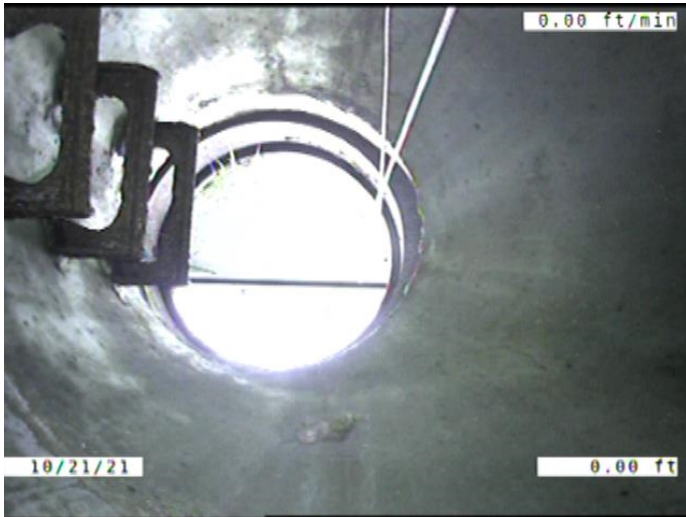
Code: **AMH**
 Description: **Manhole**

Distance (ft): **.0**
 Structural Grade: **0**
 O&M Grade: **0**
 Clock Start/From:
 Clock To:
 1st Value:
 2nd Value:
 Value Percent:
 Continuous Index:
 Within 8" of Joint: **NO**
 Remarks: **M-503-077**

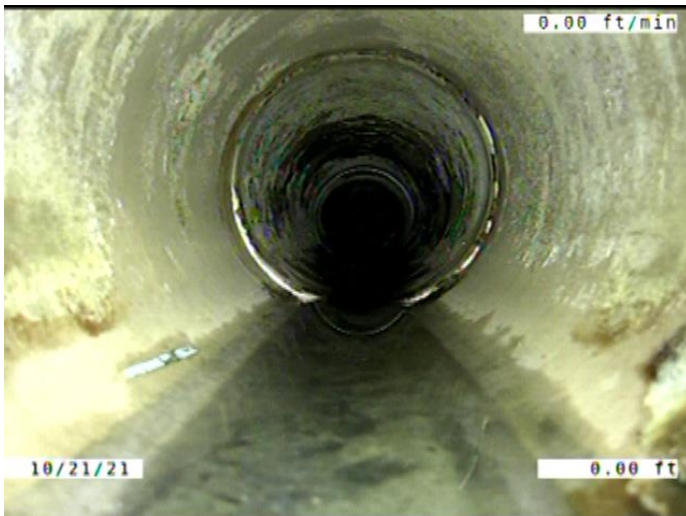
Code: **MWL**
 Description: **Miscellaneous Water Level**

Distance (ft): **.0**
 Structural Grade: **0**
 O&M Grade: **0**
 Clock Start/From:
 Clock To:
 1st Value:
 2nd Value:
 Value Percent: **5.000**
 Continuous Index:
 Within 8" of Joint: **NO**
 Remarks:

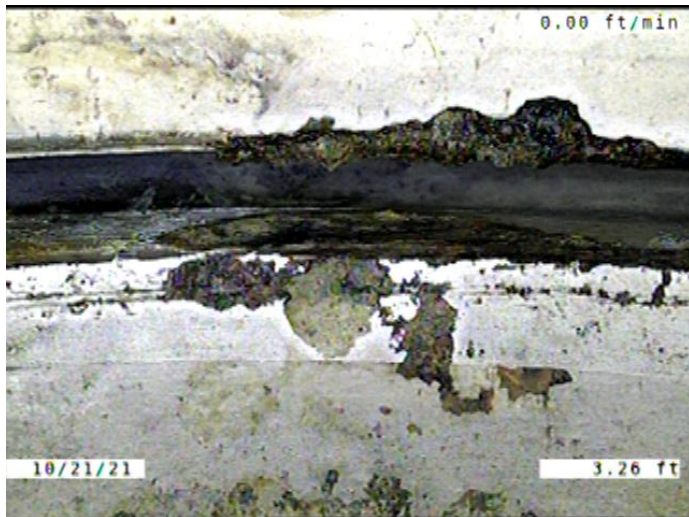
Code: **DAE**
 Description: **Deposits Attached Encrustation**

Distance (ft): **3.3**
 Structural Grade: **0**
 O&M Grade: **2**
 Clock Start/From: **7**
 Clock To: **5**
 1st Value:
 2nd Value:
 Value Percent: **5.000**
 Continuous Index: **S01**
 Within 8" of Joint: **YES**
 Remarks:

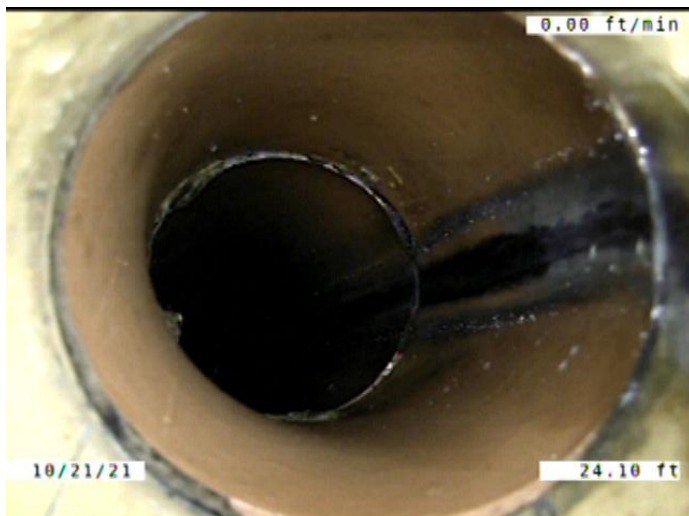
Code: **TF**
 Description: **Tap Factory**

Distance (ft): **24.1**
 Structural Grade: **0**
 O&M Grade: **0**
 Clock Start/From: **2**
 Clock To:
 1st Value: **4.000**
 2nd Value:
 Value Percent:
 Continuous Index:
 Within 8" of Joint: **YES**
 Remarks:

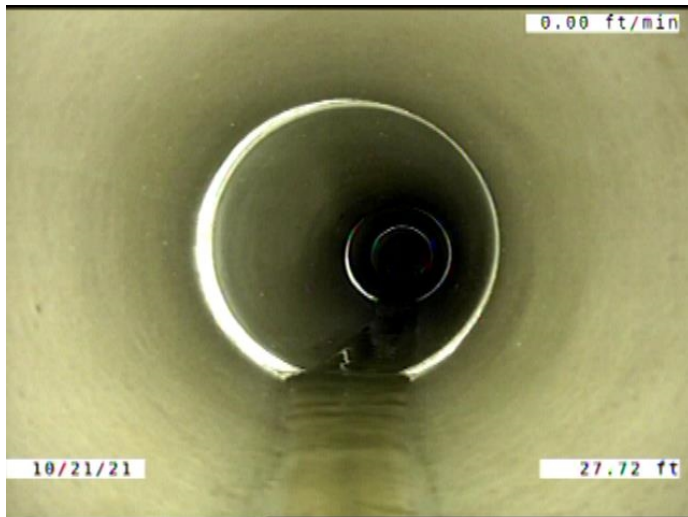
Code: **DAE**
Description: **Deposits Attached Encrustation**

Distance (ft): **27.7**
Structural Grade: **0**
O&M Grade: **2**
Clock Start/From: **7**
Clock To: **5**
1st Value:
2nd Value:
Value Percent: **5.000**
Continuous Index: **F01**
Within 8" of Joint: **YES**
Remarks:

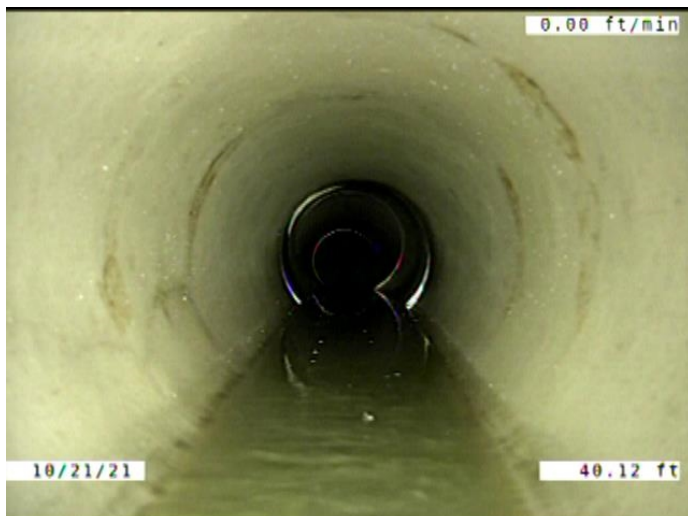
Code: **MWLS**
Description: **Miscellaneous Water Level Sag**

Distance (ft): **40.1**
Structural Grade: **2**
O&M Grade: **0**
Clock Start/From:
Clock To:
1st Value:
2nd Value:
Value Percent: **5.000**
Continuous Index: **S02**
Within 8" of Joint: **NO**
Remarks:

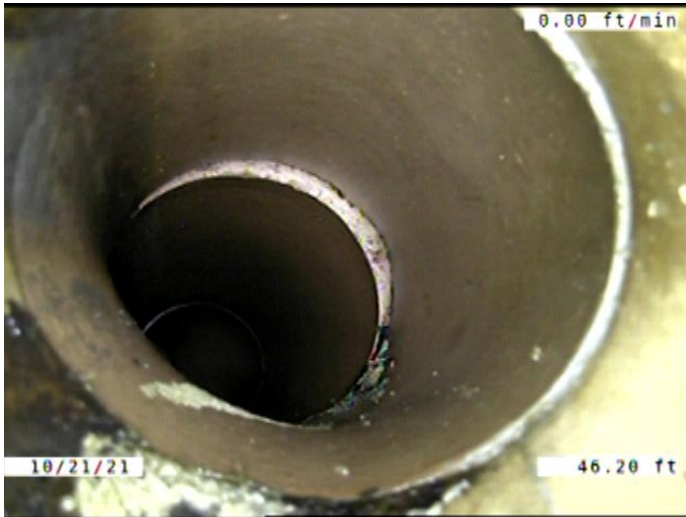
Code: **TF**
Description: **Tap Factory**

Distance (ft): **46.2**
Structural Grade: **0**
O&M Grade: **0**
Clock Start/From: **11**
Clock To:
1st Value: **4.000**

2nd Value:
Value Percent:
Continuous Index:
Within 8" of Joint: **YES**
Remarks: **ENCRUSTATION AROUND THE JOINTS**

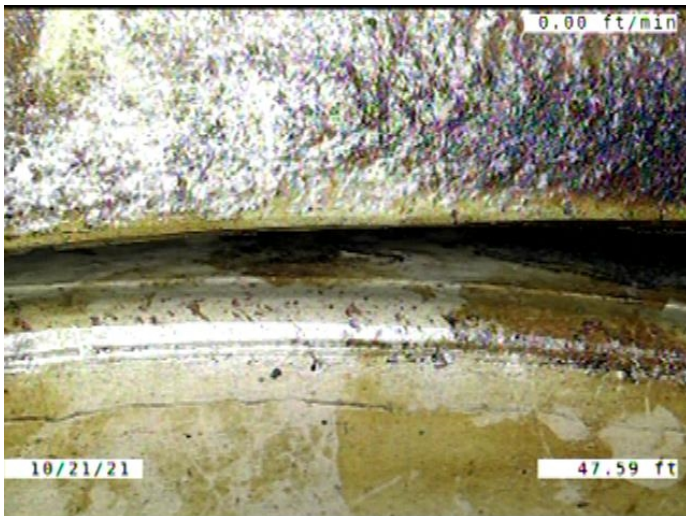
Code: **ISJ**
Description: **Infiltration Stain Joint**

Distance (ft): **47.6**
Structural Grade: **0**
O&M Grade: **1**
Clock Start/From: **7**
Clock To: **11**

1st Value:
2nd Value:
Value Percent:
Continuous Index:
Within 8" of Joint: **YES**
Remarks:

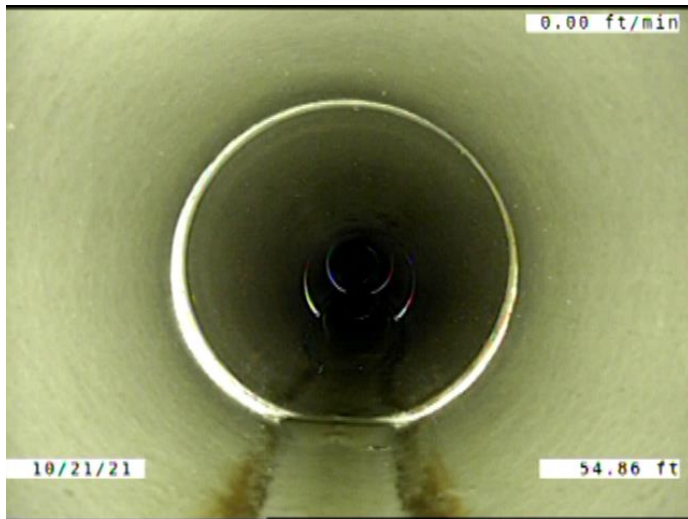
Code: **MWLS**
 Description: **Miscellaneous Water Level Sag**

Distance (ft): **54.9**
 Structural Grade: **2**
 O&M Grade: **0**
 Clock Start/From:
 Clock To:
 1st Value:
 2nd Value:
 Value Percent: **5.000**
 Continuous Index: **F02**
 Within 8" of Joint: **NO**
 Remarks:

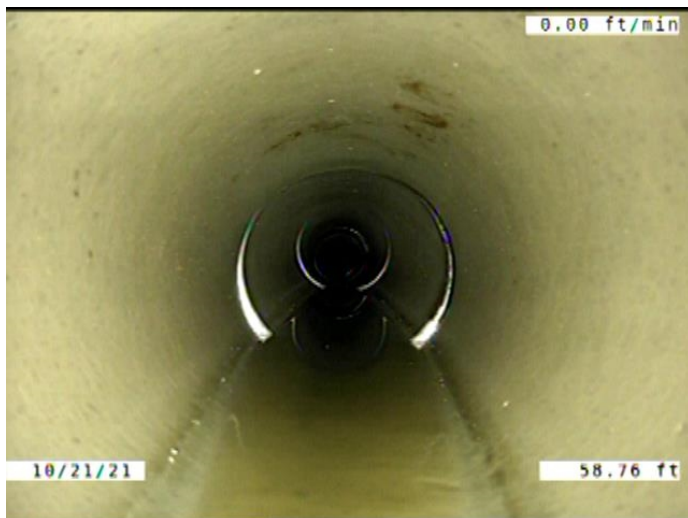
Code: **MWLS**
 Description: **Miscellaneous Water Level Sag**

Distance (ft): **58.8**
 Structural Grade: **2**
 O&M Grade: **0**
 Clock Start/From:
 Clock To:
 1st Value:
 2nd Value:
 Value Percent: **5.000**
 Continuous Index: **S03**
 Within 8" of Joint: **NO**
 Remarks:

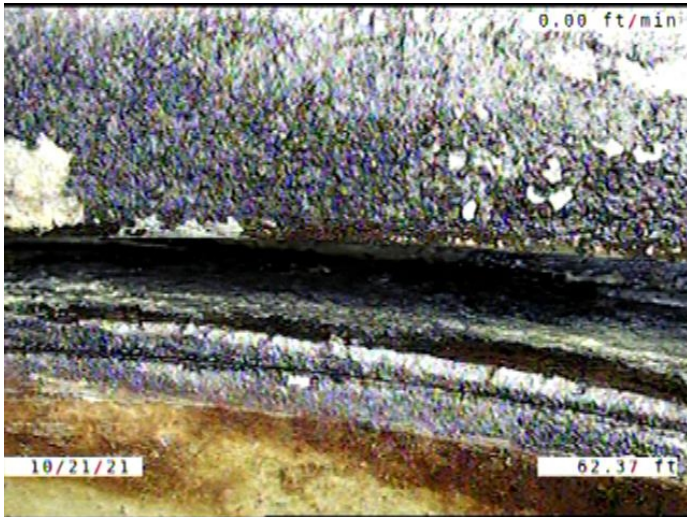
Code: **ISJ**
 Description: **Infiltration Stain Joint**

Distance (ft): **62.4**
 Structural Grade: **0**
 O&M Grade: **1**
 Clock Start/From: **1**
 Clock To: **4**
 1st Value:
 2nd Value:
 Value Percent:
 Continuous Index:
 Within 8" of Joint: **YES**
 Remarks:

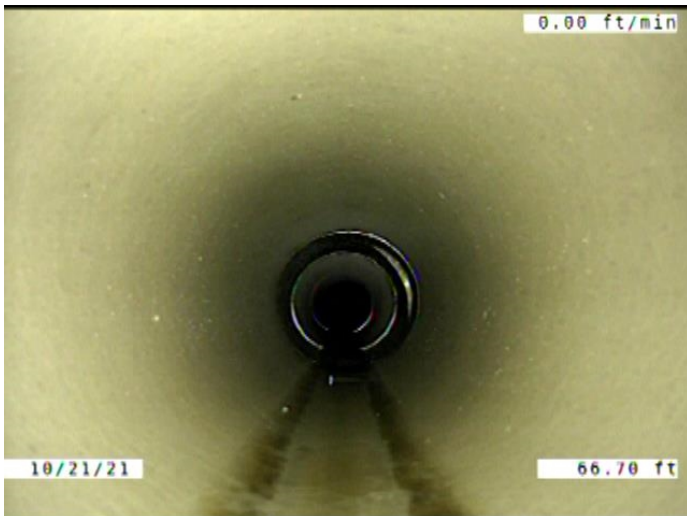
Code: **MWLS**
 Description: **Miscellaneous Water Level Sag**

Distance (ft): **66.7**
 Structural Grade: **2**
 O&M Grade: **0**
 Clock Start/From:
 Clock To:
 1st Value:
 2nd Value:
 Value Percent: **5.000**
 Continuous Index: **F03**
 Within 8" of Joint: **NO**
 Remarks:

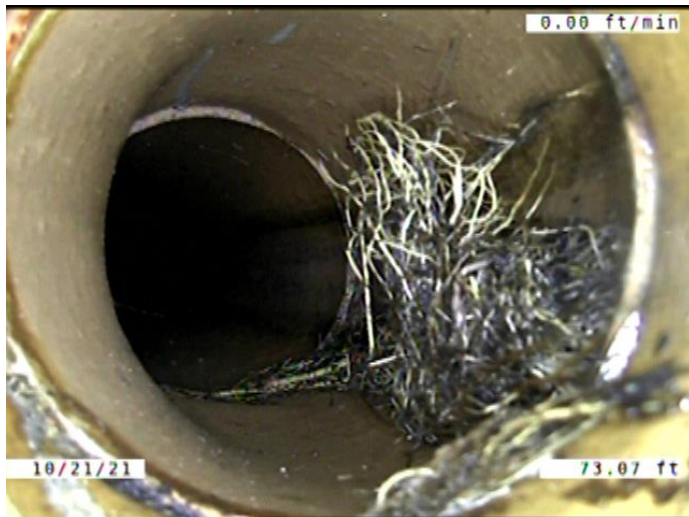
Code: **TF**
 Description: **Tap Factory**

Distance (ft): **73.1**
 Structural Grade: **0**
 O&M Grade: **0**
 Clock Start/From: **2**
 Clock To:
 1st Value: **4.000**
 2nd Value:
 Value Percent:
 Continuous Index:
 Within 8" of Joint: **YES**
 Remarks: **ENCRRUSTATION AND ROOTS IN THE JOINTS**

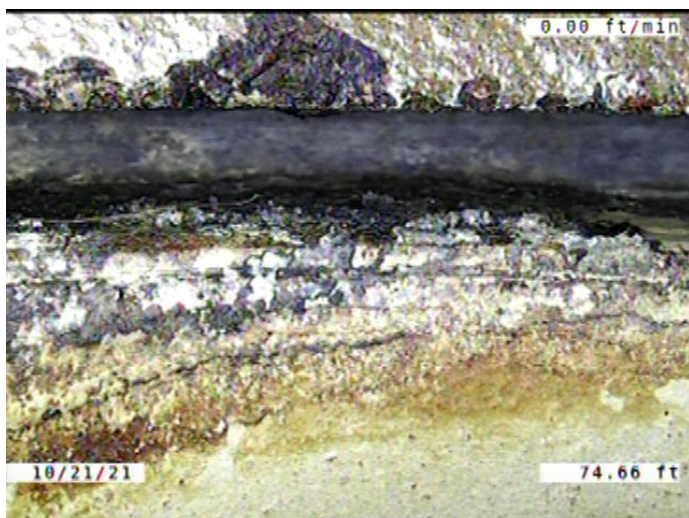
Code: **DAE**
 Description: **Deposits Attached Encrustation**

Distance (ft): **74.7**
 Structural Grade: **0**
 O&M Grade: **2**
 Clock Start/From: **8**
 Clock To: **4**
 1st Value:
 2nd Value:
 Value Percent: **5.000**
 Continuous Index: **S04**
 Within 8" of Joint: **YES**
 Remarks:

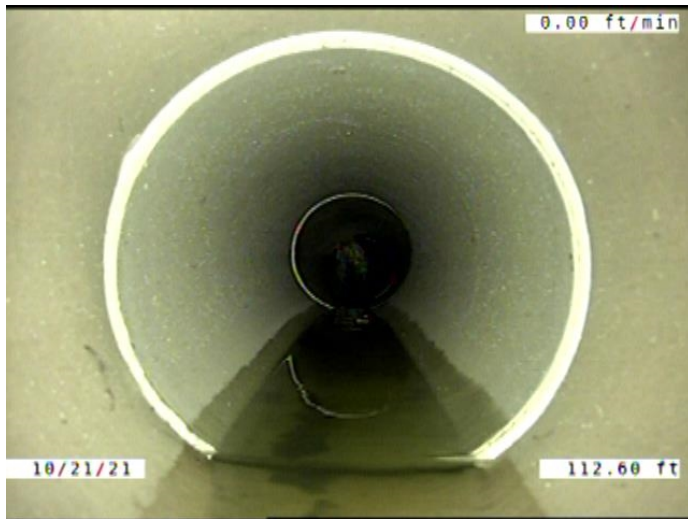
Code: **MWLS**
Description: **Miscellaneous Water Level Sag**

Distance (ft): **112.6**
Structural Grade: **2**
O&M Grade: **0**
Clock Start/From:
Clock To:
1st Value:
2nd Value:
Value Percent: **5.000**
Continuous Index: **S05**
Within 8" of Joint: **NO**
Remarks:

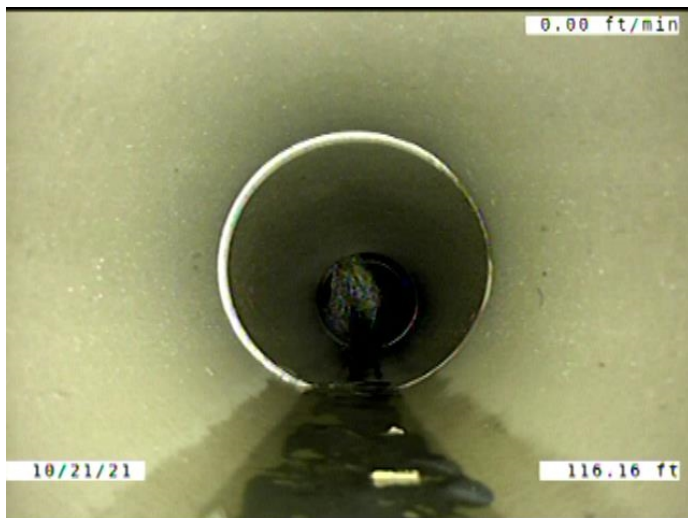
Code: **DSF**
Description: **Deposits Settled Fine**

Distance (ft): **116.2**
Structural Grade: **0**
O&M Grade: **2**
Clock Start/From: **5**
Clock To: **7**
1st Value:
2nd Value:
Value Percent: **5.000**
Continuous Index: **S06**
Within 8" of Joint: **YES**
Remarks:

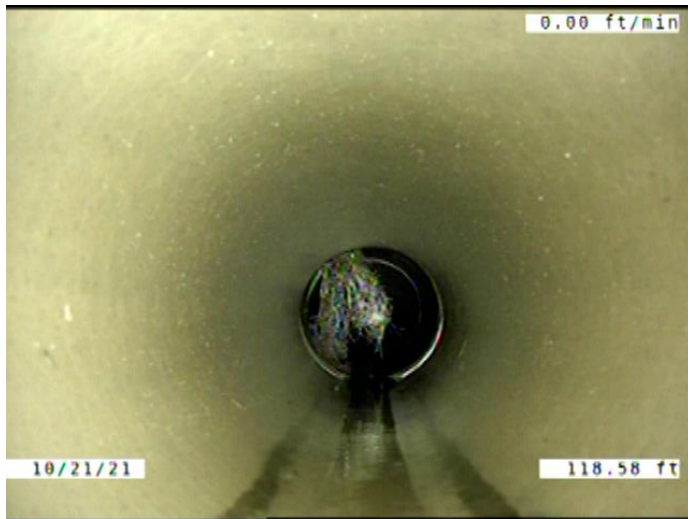
Code: **MWLS**
 Description: **Miscellaneous Water Level Sag**

Distance (ft): **118.6**
 Structural Grade: **2**
 O&M Grade: **0**
 Clock Start/From:
 Clock To:
 1st Value:
 2nd Value:
 Value Percent: **5.000**
 Continuous Index: **F05**
 Within 8" of Joint: **NO**
 Remarks:

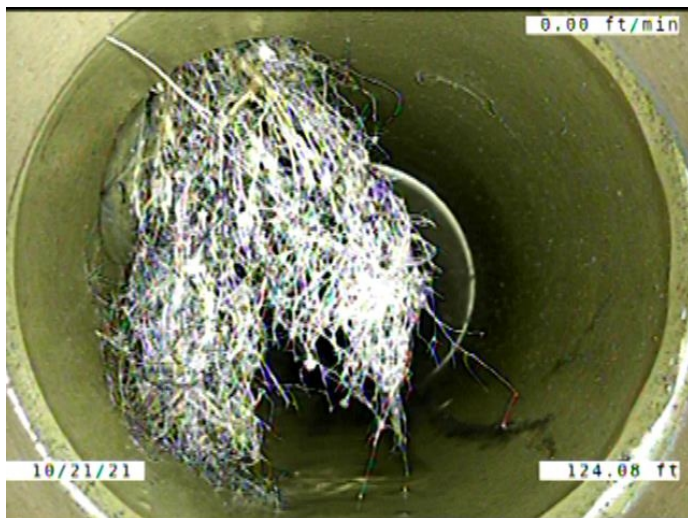
Code: **RMC**
 Description: **Roots Medium Connection**

Distance (ft): **124.1**
 Structural Grade: **0**
 O&M Grade: **3**
 Clock Start/From: **9**
 Clock To: **11**
 1st Value:
 2nd Value:
 Value Percent: **30.000**
 Continuous Index:
 Within 8" of Joint: **NO**
 Remarks:

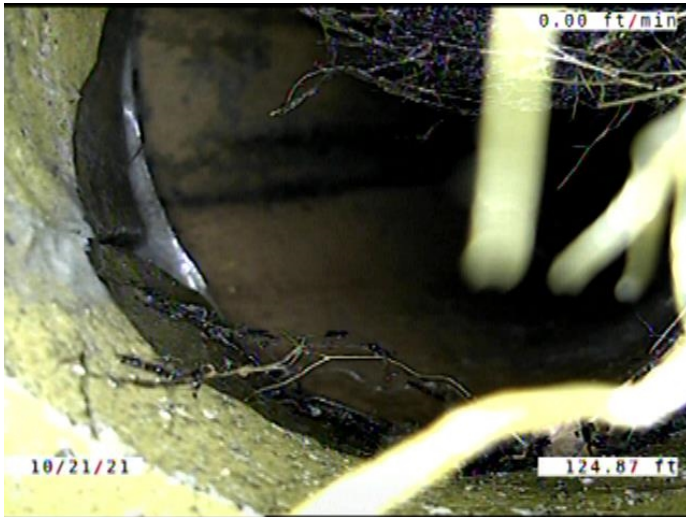
Code:	TFD
Description:	Tap Factory Defective
Distance (ft):	124.9
Structural Grade:	0
O&M Grade:	3
Clock Start/From:	10
Clock To:	
1st Value:	4.000
2nd Value:	
Value Percent:	
Continuous Index:	
Within 8" of Joint:	YES
Remarks:	CONSTANTLY RUNNING WATER. ROOTS IN THE JOINTS. BROKEN CON

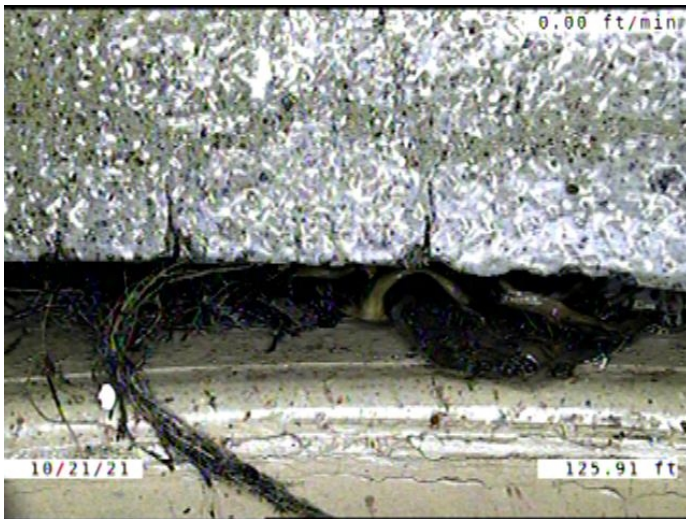
Code:	RFJ
Description:	Roots Fine Joint
Distance (ft):	125.9
Structural Grade:	0
O&M Grade:	1
Clock Start/From:	1
Clock To:	3
1st Value:	
2nd Value:	
Value Percent:	
Continuous Index:	
Within 8" of Joint:	YES
Remarks:

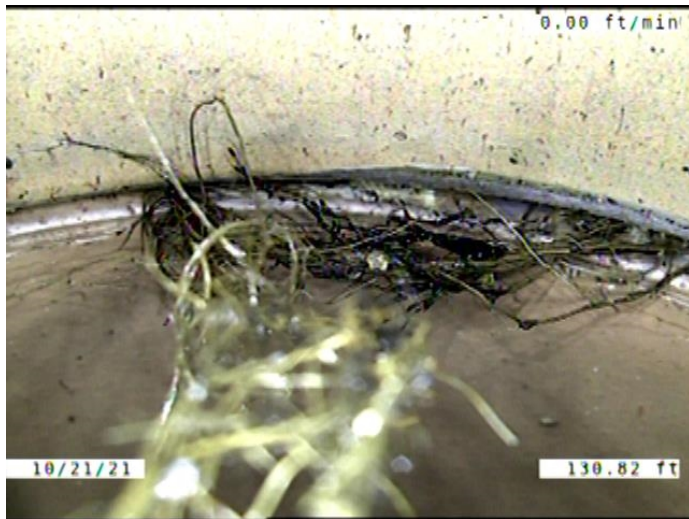
Code: **RFJ**
 Description: **Roots Fine Joint**

Distance (ft): **130.8**
 Structural Grade: **0**
 O&M Grade: **1**
 Clock Start/From: **11**
 Clock To: **2**
 1st Value:
 2nd Value:
 Value Percent:
 Continuous Index:
 Within 8" of Joint: **YES**
 Remarks:

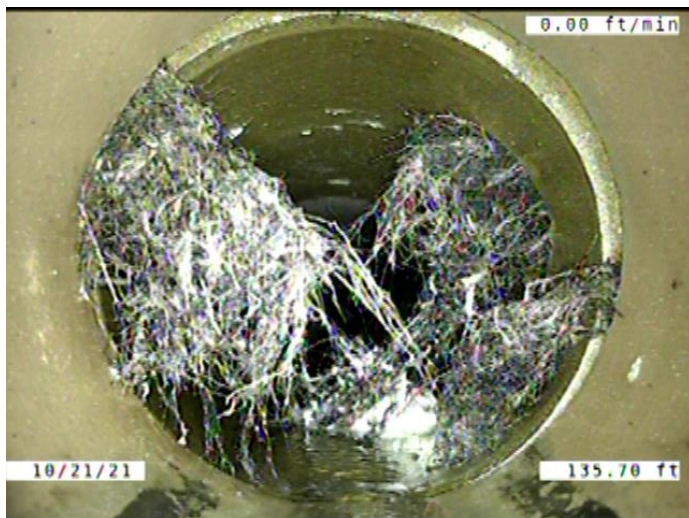
Code: **RMJ**
 Description: **Roots Medium Joint**

Distance (ft): **135.7**
 Structural Grade: **0**
 O&M Grade: **3**
 Clock Start/From: **7**
 Clock To: **4**
 1st Value:
 2nd Value:
 Value Percent: **15.000**
 Continuous Index:
 Within 8" of Joint: **YES**
 Remarks:

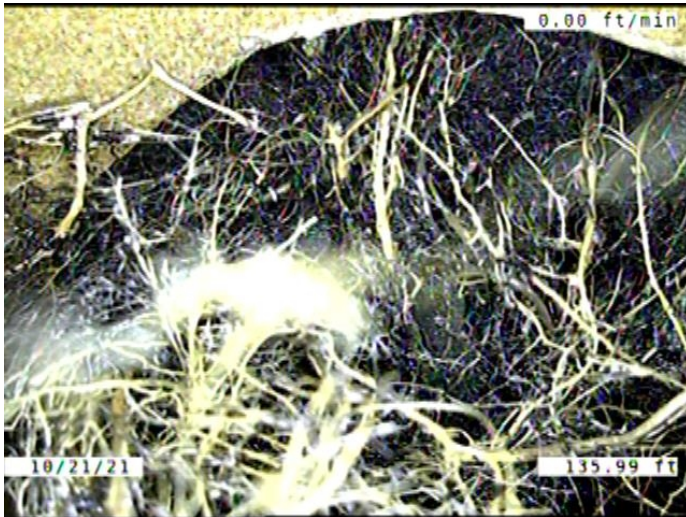
Code: **RMC**
 Description: **Roots Medium Connection**

Distance (ft): **136.0**
 Structural Grade: **0**
 O&M Grade: **3**
 Clock Start/From: **1**
 Clock To: **3**
 1st Value:
 2nd Value:
 Value Percent: **30.000**
 Continuous Index:
 Within 8" of Joint: **NO**
 Remarks:

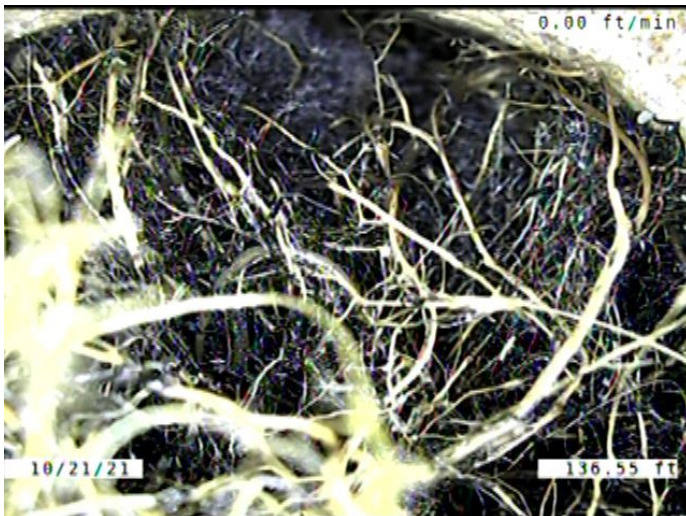
Code: **TFD**
 Description: **Tap Factory Defective**

Distance (ft): **136.5**
 Structural Grade: **0**
 O&M Grade: **3**
 Clock Start/From: **2**
 Clock To:
 1st Value: **4.000**
 2nd Value:
 Value Percent:
 Continuous Index:
 Within 8" of Joint: **YES**
 Remarks: **LOOKS TO BE 100% PLUGGED WITH ROOTS**

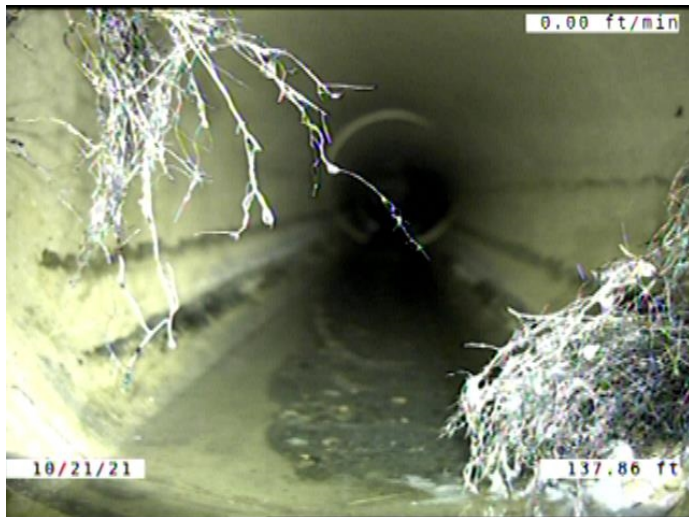
Code: **RMJ**
 Description: **Roots Medium Joint**

Distance (ft): **137.9**
 Structural Grade: **0**
 O&M Grade: **3**
 Clock Start/From: **9**
 Clock To: **5**
 1st Value:
 2nd Value:
 Value Percent: **5.000**
 Continuous Index:
 Within 8" of Joint: **YES**
 Remarks:

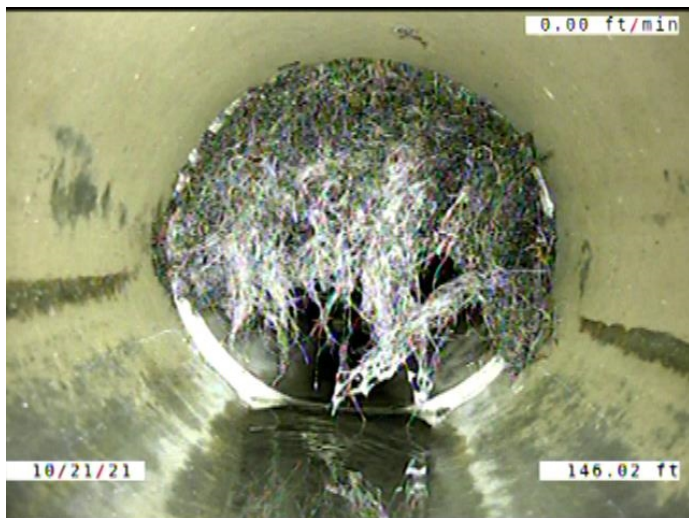
Code: **RBJ**
 Description: **Roots Ball Joint**

Distance (ft): **146.0**
 Structural Grade: **0**
 O&M Grade: **4**
 Clock Start/From: **8**
 Clock To: **4**
 1st Value:
 2nd Value:
 Value Percent: **70.000**
 Continuous Index:
 Within 8" of Joint: **YES**
 Remarks:

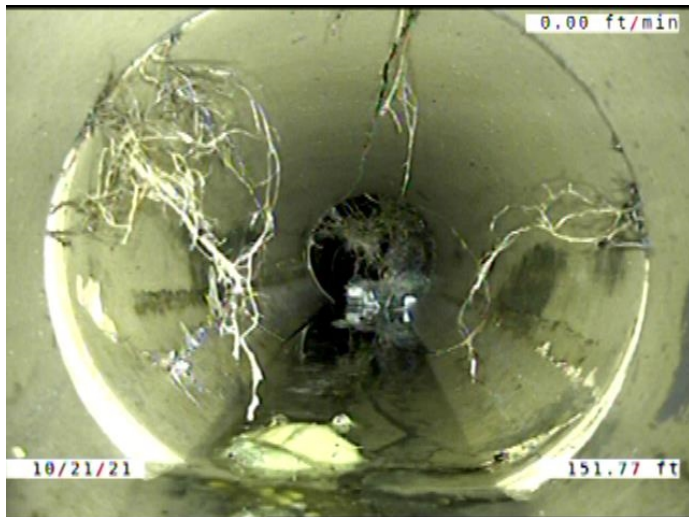
Code: **RFJ**
 Description: **Roots Fine Joint**

Distance (ft): **151.8**
 Structural Grade: **0**
 O&M Grade: **1**
 Clock Start/From: **9**
 Clock To: **3**
 1st Value:
 2nd Value:
 Value Percent:
 Continuous Index:
 Within 8" of Joint: **YES**
 Remarks:

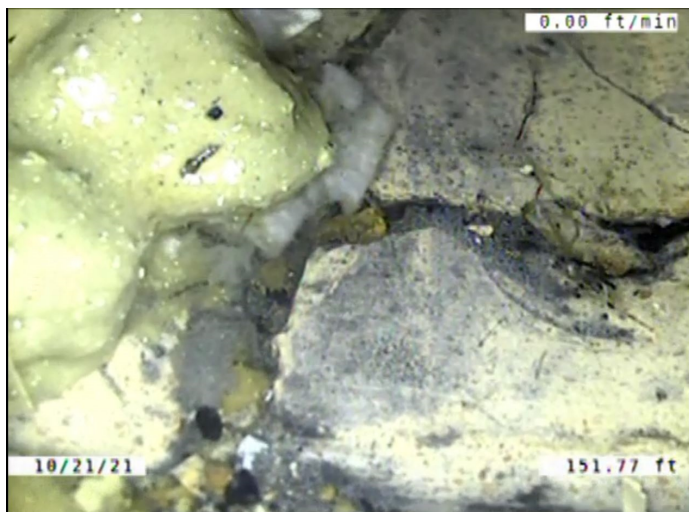
Code: **B**
 Description: **Broken**

Distance (ft): **151.8**
 Structural Grade: **4**
 O&M Grade: **0**
 Clock Start/From: **4**
 Clock To: **7**
 1st Value:
 2nd Value:
 Value Percent:
 Continuous Index:
 Within 8" of Joint: **YES**
 Remarks:

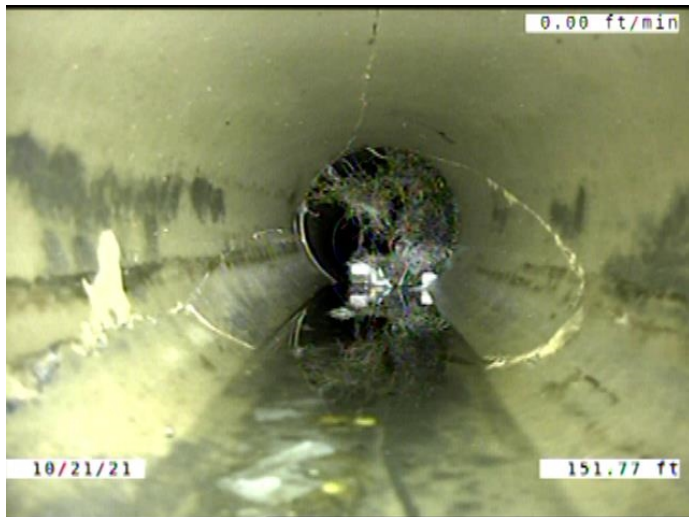
Code: **FM**
 Description: **Fracture Multiple**

Distance (ft): **151.8**
 Structural Grade: **4**
 O&M Grade: **0**
 Clock Start/From: **9**
 Clock To: **3**
 1st Value:
 2nd Value:
 Value Percent:
 Continuous Index:
 Within 8" of Joint: **YES**
 Remarks:

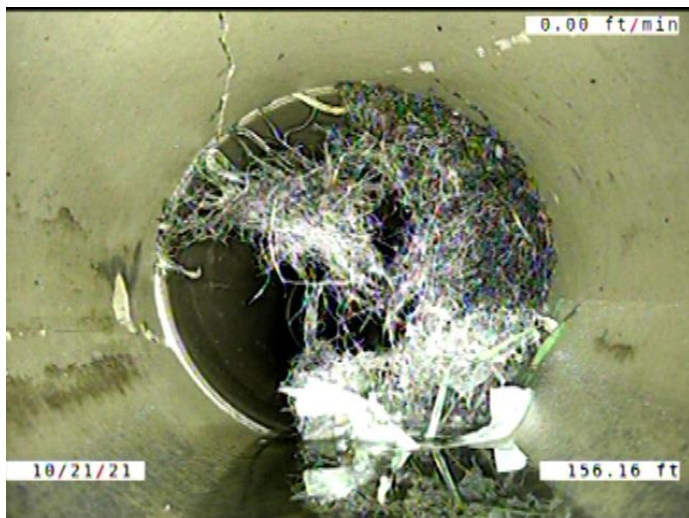
Code: **RBJ**
 Description: **Roots Ball Joint**

Distance (ft): **156.2**
 Structural Grade: **0**
 O&M Grade: **4**
 Clock Start/From: **10**
 Clock To: **6**
 1st Value:
 2nd Value:
 Value Percent: **55.000**
 Continuous Index:
 Within 8" of Joint: **YES**
 Remarks:

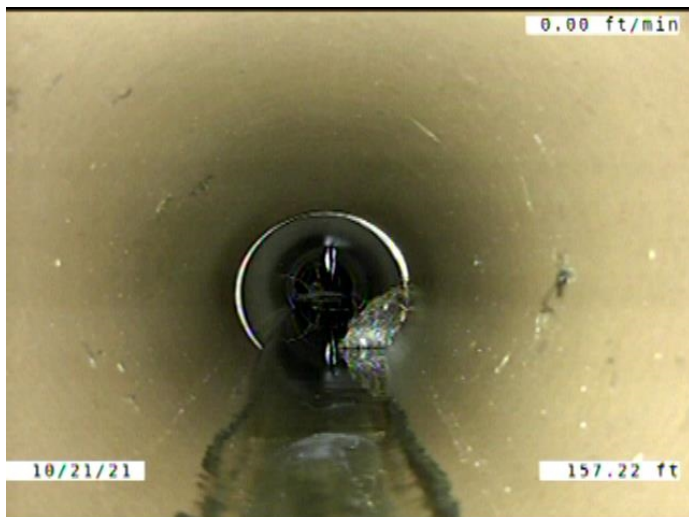
Code: **DAE**
 Description: **Deposits Attached Encrustation**

Distance (ft): **157.2**
 Structural Grade: **0**
 O&M Grade: **2**
 Clock Start/From: **8**
 Clock To: **4**
 1st Value:
 2nd Value:
 Value Percent: **5.000**
 Continuous Index: **F04**
 Within 8" of Joint: **YES**
 Remarks:

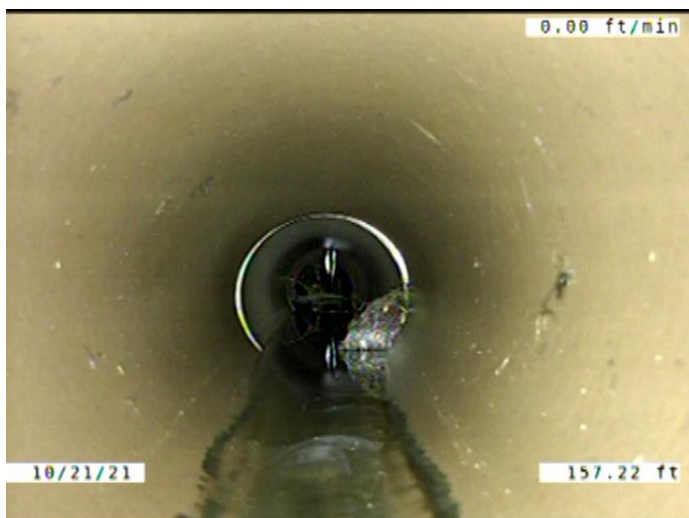
Code: **DSF**
 Description: **Deposits Settled Fine**

Distance (ft): **157.2**
 Structural Grade: **0**
 O&M Grade: **2**
 Clock Start/From: **5**
 Clock To: **7**
 1st Value:
 2nd Value:
 Value Percent: **5.000**
 Continuous Index: **F06**
 Within 8" of Joint: **YES**
 Remarks:

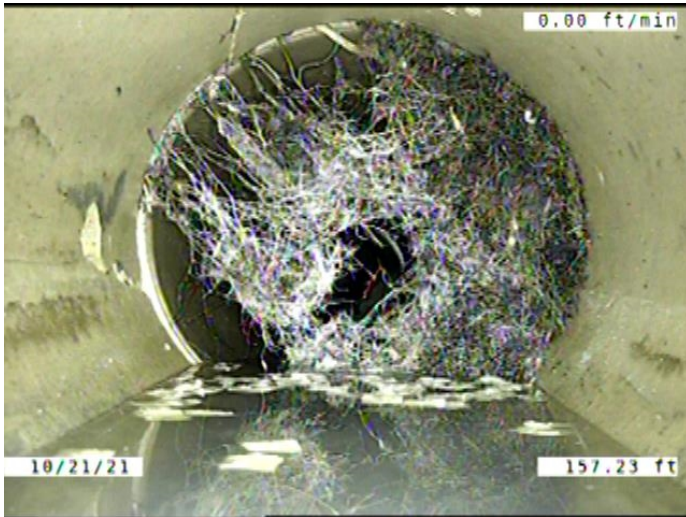
Code:	MSA
Description:	Miscellaneous Survey Abandoned
Distance (ft):	157.2
Structural Grade:	0
O&M Grade:	0
Clock Start/From:	
Clock To:	
1st Value:	
2nd Value:	
Value Percent:	
Continuous Index:	
Within 8" of Joint:	NO
Remarks:	CAMERA CANT MAKE IT PAST ROOTS
