Profile/Photo Observation Report

Date:	10/21/2021	Weather:		Coding:	PACP 7.0
Pipe Length (ft):	319.0	Owner:	City of Hobart	Pre Clean:	Heavy Cleaning
P.O.#:	YES502259	Surveyor:	S. Bucklin	PSR:	P-503-077-076
Customer:	City of Hobart	Clean Date:	08/23/2021	Shape:	C

Street:	North Guyer Street	Flow Control:	Not Controlled
City:	Hobart, IN	Year Renewed:	
Location:	Alley	Tape/Media #:	
Purpose:	Routine Assessment	Dia/Height:	10"
Use:	Sanitary Sewage Pipe	Material:	VCP
Drain Area:		Lining:	None
Category:	NA		
Comment:			
Location Details:		Direction of Survey:	Upstream
US MH:	M-503-076	DS MH:	M-503-077
		Total Length Surveyed (ft):	138.1

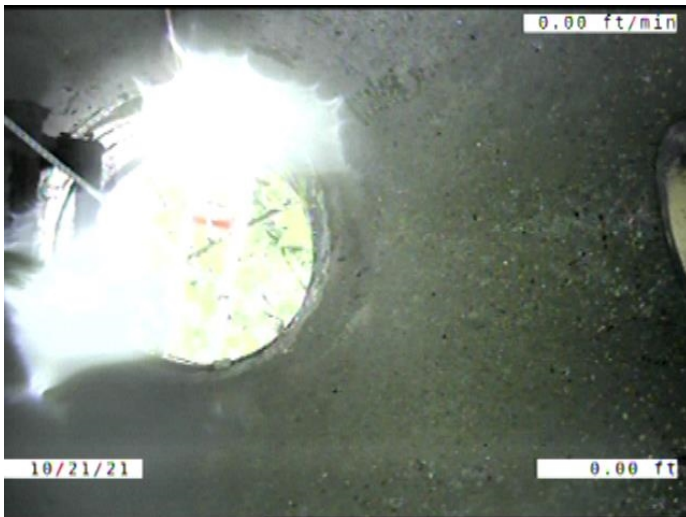
Code: **AMH**
Description: **Manhole**

Distance (ft): **.0**
Structural Grade: **0**
O&M Grade: **0**
Clock Start/From:
Clock To:
1st Value:
2nd Value:
Value Percent:
Continuous Index:
Within 8" of Joint: **NO**
Remarks: **M-503-077**

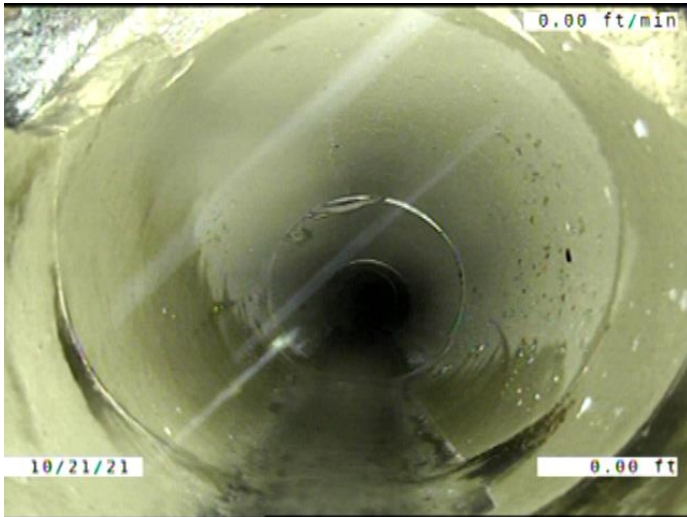
Code: **MWL**
 Description: **Miscellaneous Water Level**

Distance (ft): **.0**
 Structural Grade: **0**
 O&M Grade: **0**
 Clock Start/From:
 Clock To:
 1st Value:
 2nd Value:
 Value Percent: **5.000**
 Continuous Index:
 Within 8" of Joint: **NO**
 Remarks:

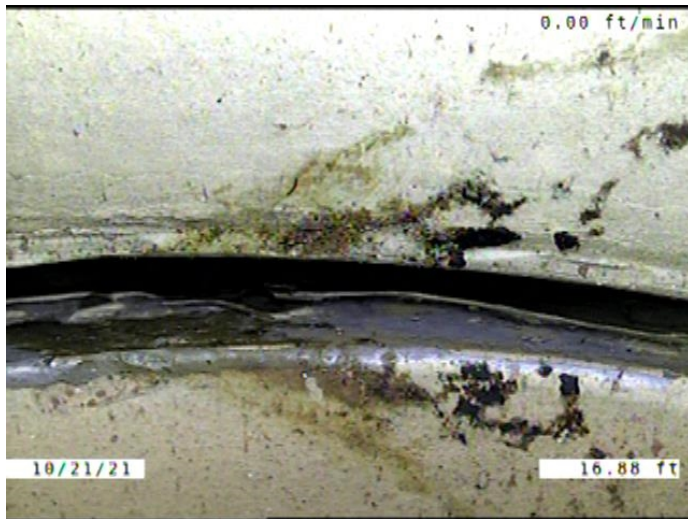
Code: **ISJ**
 Description: **Infiltration Stain Joint**

Distance (ft): **16.9**
 Structural Grade: **0**
 O&M Grade: **1**
 Clock Start/From: **2**
 Clock To: **5**
 1st Value:
 2nd Value:
 Value Percent:
 Continuous Index:
 Within 8" of Joint: **YES**
 Remarks:

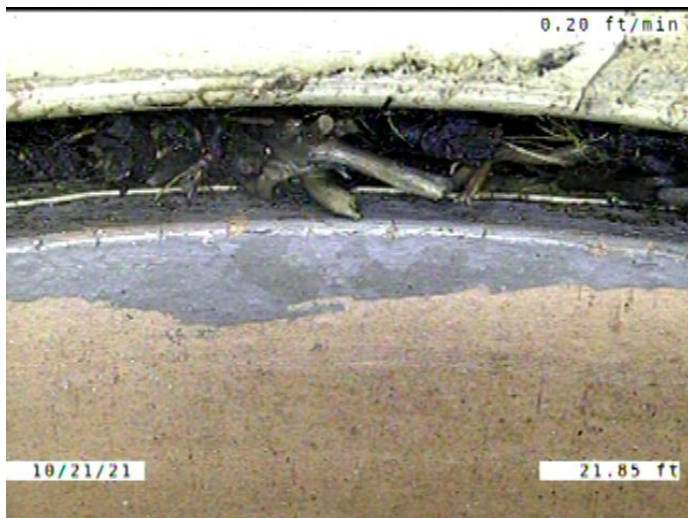
Code: **RFJ**
 Description: **Roots Fine Joint**

Distance (ft): **21.8**
 Structural Grade: **0**
 O&M Grade: **1**
 Clock Start/From: **10**
 Clock To: **4**
 1st Value:
 2nd Value:
 Value Percent:
 Continuous Index:
 Within 8" of Joint: **YES**
 Remarks:

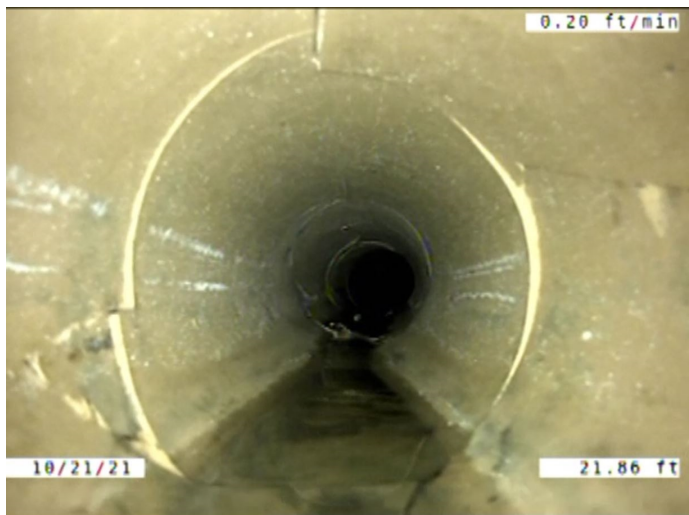
Code: **DR**
Description: **Deformed Rigid**

Distance (ft): **21.9**
Structural Grade: **5**
O&M Grade: **0**
Clock Start/From:
Clock To:
1st Value:
2nd Value:
Value Percent: **10.000**
Continuous Index:
Within 8" of Joint: **NO**
Remarks:

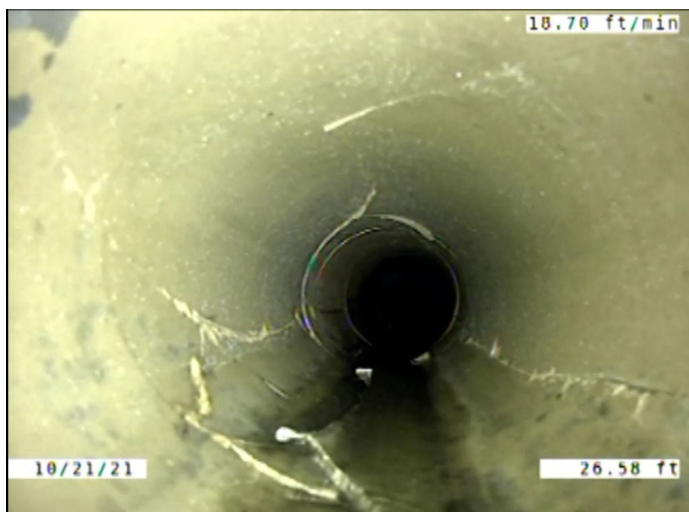
Code: **B**
Description: **Broken**

Distance (ft): **26.6**
Structural Grade: **4**
O&M Grade: **0**
Clock Start/From: **6**
Clock To: **8**
1st Value:
2nd Value:
Value Percent:
Continuous Index:
Within 8" of Joint: **NO**
Remarks:

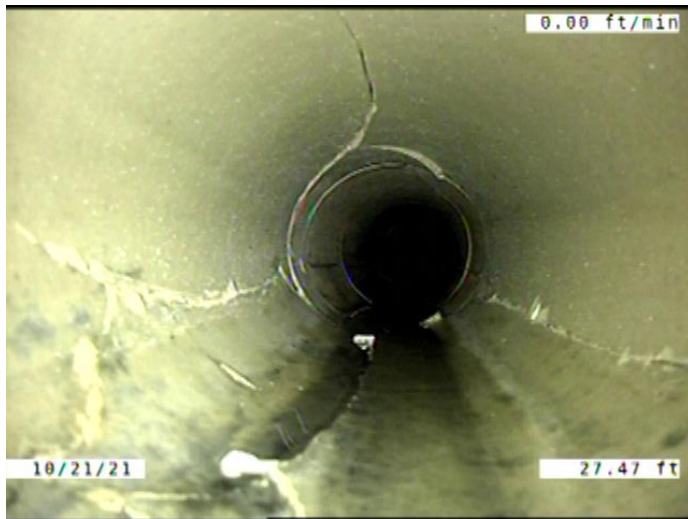
Code: **DR**
 Description: **Deformed Rigid**

Distance (ft): **27.5**
 Structural Grade: **4**
 O&M Grade: **0**
 Clock Start/From:
 Clock To:
 1st Value:
 2nd Value:
 Value Percent: **5.000**
 Continuous Index:
 Within 8" of Joint: **NO**
 Remarks:

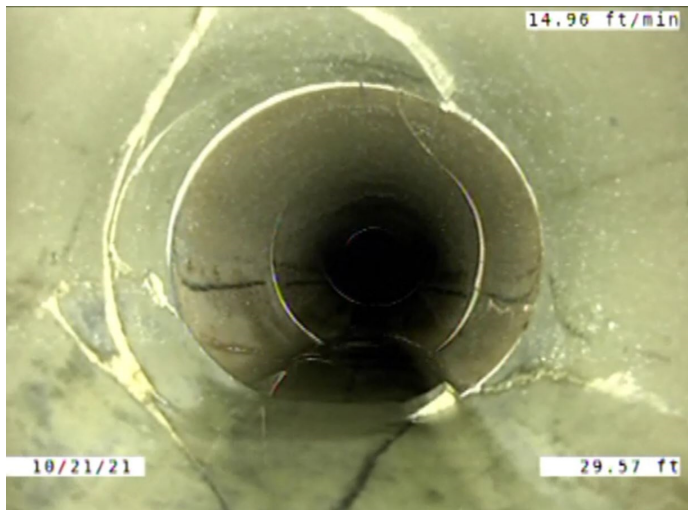
Code: **B**
 Description: **Broken**

Distance (ft): **29.6**
 Structural Grade: **4**
 O&M Grade: **0**
 Clock Start/From: **12**
 Clock To: **12**
 1st Value:
 2nd Value:
 Value Percent:
 Continuous Index:
 Within 8" of Joint: **YES**
 Remarks:

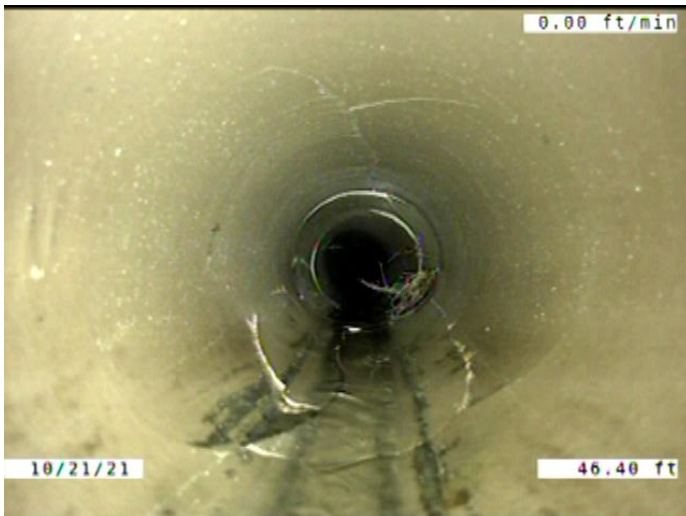
Code: **B**
Description: **Broken**

Distance (ft): **46.4**
Structural Grade: **4**
O&M Grade: **0**
Clock Start/From: **12**
Clock To: **12**
1st Value:
2nd Value:
Value Percent:
Continuous Index: **S02**
Within 8" of Joint: **YES**
Remarks:

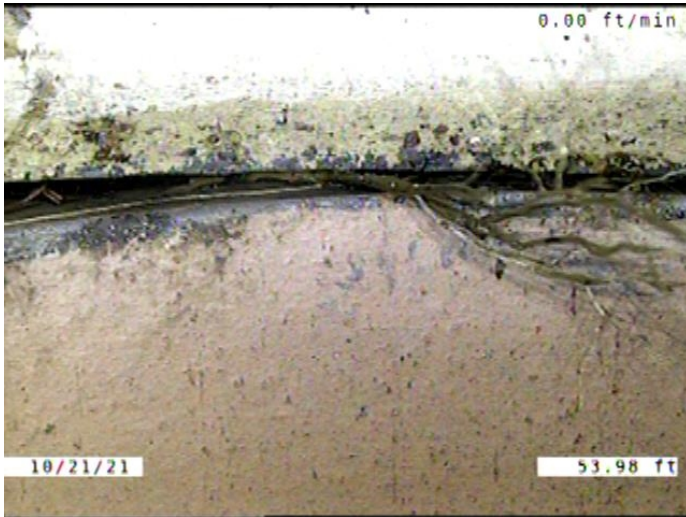
Code: **RFJ**
 Description: **Roots Fine Joint**

Distance (ft): **54.0**
 Structural Grade: **0**
 O&M Grade: **1**
 Clock Start/From: **8**
 Clock To: **10**
 1st Value:
 2nd Value:
 Value Percent:
 Continuous Index:
 Within 8" of Joint: **YES**
 Remarks:

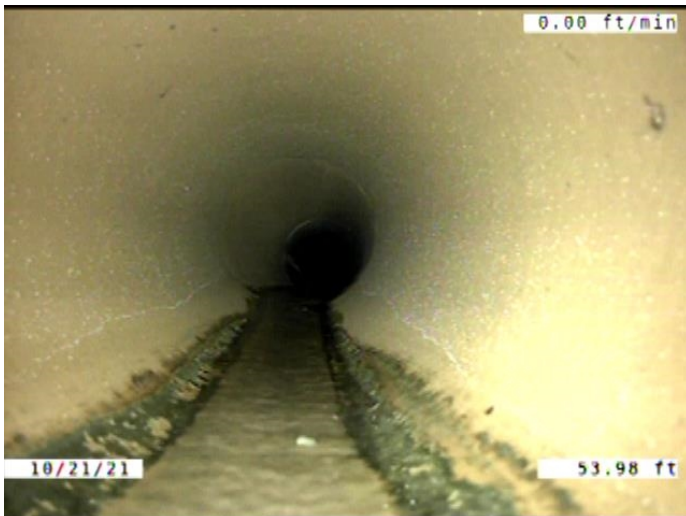
Code: **B**
 Description: **Broken**

Distance (ft): **54.0**
 Structural Grade: **4**
 O&M Grade: **0**
 Clock Start/From: **12**
 Clock To: **12**
 1st Value:
 2nd Value:
 Value Percent:
 Continuous Index: **F02**
 Within 8" of Joint: **YES**
 Remarks:

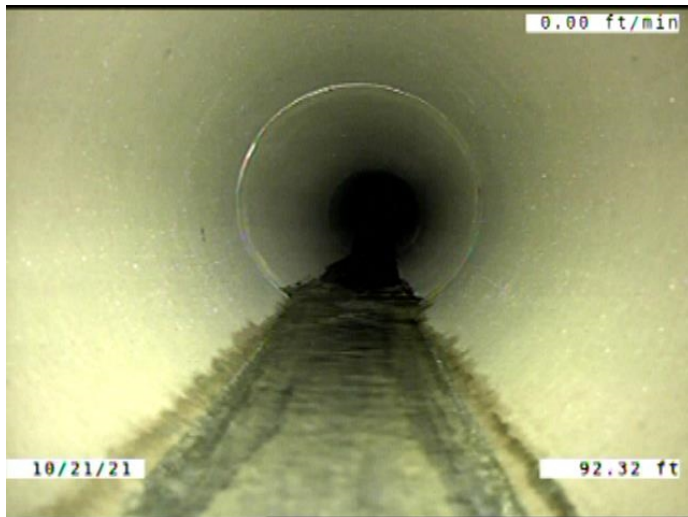
Code: **FM**
 Description: **Fracture Multiple**

Distance (ft): **92.3**
 Structural Grade: **4**
 O&M Grade: **0**
 Clock Start/From: **12**
 Clock To: **12**
 1st Value:
 2nd Value:
 Value Percent:
 Continuous Index: **F03**
 Within 8" of Joint: **YES**
 Remarks:

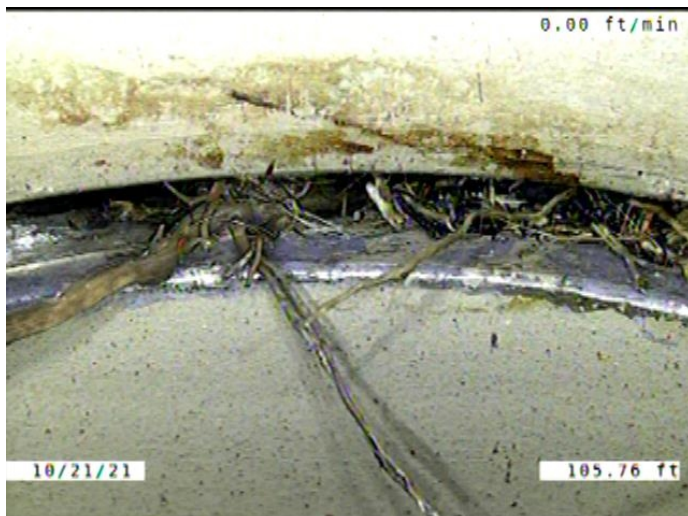
Code: **RFJ**
 Description: **Roots Fine Joint**

Distance (ft): **105.8**
 Structural Grade: **0**
 O&M Grade: **1**
 Clock Start/From: **10**
 Clock To: **3**
 1st Value:
 2nd Value:
 Value Percent:
 Continuous Index:
 Within 8" of Joint: **YES**
 Remarks:

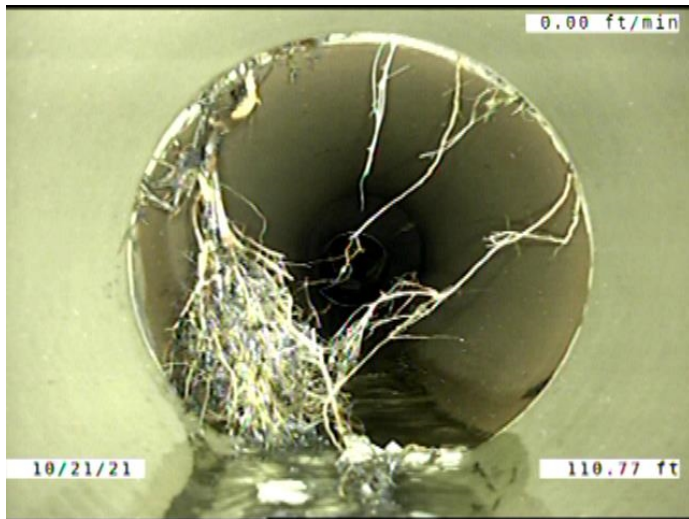
Code: **RMJ**
 Description: **Roots Medium Joint**

Distance (ft): **110.8**
 Structural Grade: **0**
 O&M Grade: **3**
 Clock Start/From: **7**
 Clock To: **3**
 1st Value:
 2nd Value:
 Value Percent: **10.000**
 Continuous Index: **S04**
 Within 8" of Joint: **YES**
 Remarks:

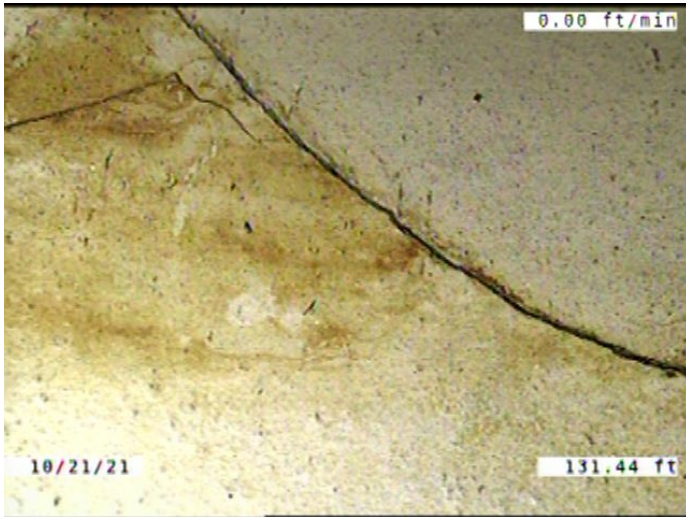
Code: **ISB**
 Description: **Infiltration Stain Barrel**

Distance (ft): **131.4**
 Structural Grade: **0**
 O&M Grade: **1**
 Clock Start/From: **3**
 Clock To: **5**
 1st Value:
 2nd Value:
 Value Percent:
 Continuous Index:
 Within 8" of Joint: **NO**
 Remarks:

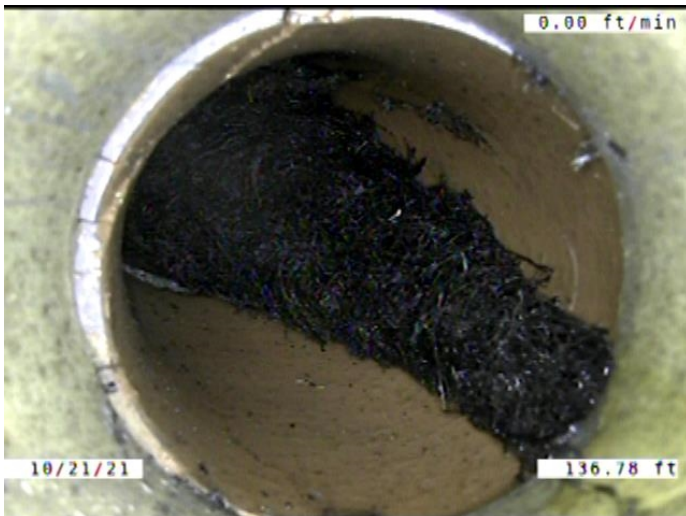
Code: **TFD**
 Description: **Tap Factory Defective**

Distance (ft): **136.8**
 Structural Grade: **0**
 O&M Grade: **3**
 Clock Start/From: **2**
 Clock To:
 1st Value: **4.000**
 2nd Value:
 Value Percent:
 Continuous Index:
 Within 8" of Joint: **YES**
 Remarks: **Defective**

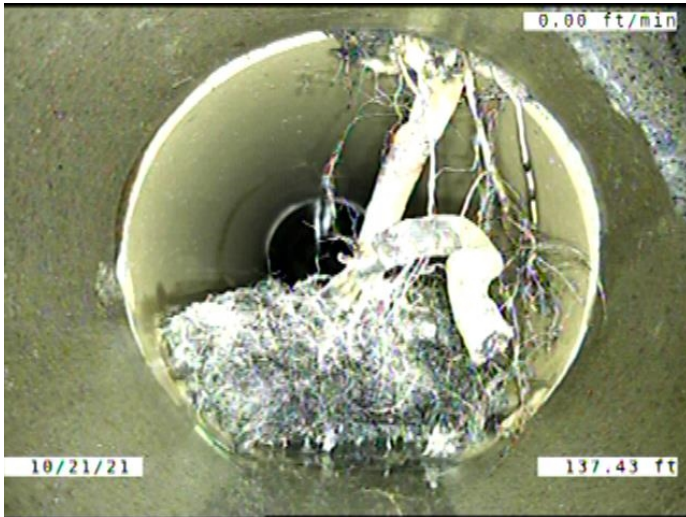
Code: **RTJ**
 Description: **Roots Tap Joint**

Distance (ft): **137.4**
 Structural Grade: **0**
 O&M Grade: **2**
 Clock Start/From: **12**
 Clock To: **8**
 1st Value:
 2nd Value:
 Value Percent: **35.000**
 Continuous Index:
 Within 8" of Joint: **YES**
 Remarks:

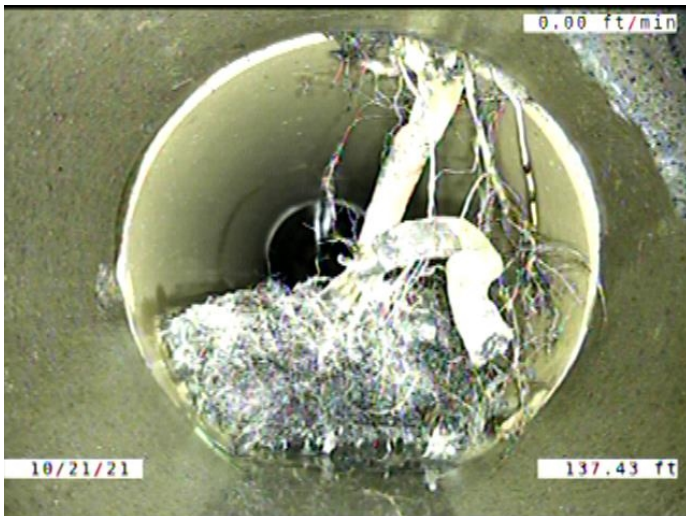
Code: **RMJ**
 Description: **Roots Medium Joint**

Distance (ft): **137.4**
 Structural Grade: **0**
 O&M Grade: **3**
 Clock Start/From: **7**
 Clock To: **3**
 1st Value:
 2nd Value:
 Value Percent: **10.000**
 Continuous Index: **F04**
 Within 8" of Joint: **YES**
 Remarks:

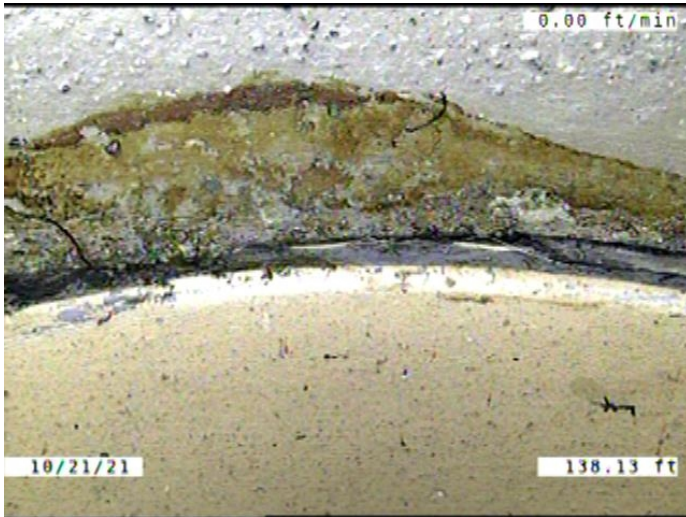
Code: **ISJ**
 Description: **Infiltration Stain Joint**

Distance (ft): **138.1**
 Structural Grade: **0**
 O&M Grade: **1**
 Clock Start/From: **9**
 Clock To: **11**
 1st Value:
 2nd Value:
 Value Percent:
 Continuous Index:
 Within 8" of Joint: **YES**
 Remarks:

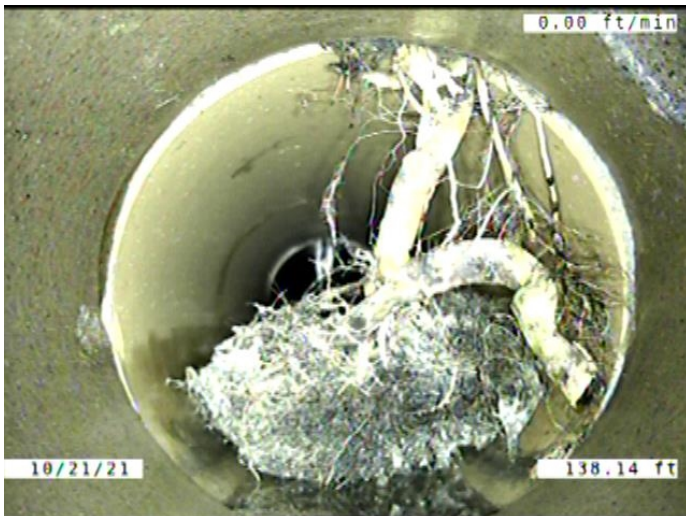
Code: **MSA**
 Description: **Miscellaneous Survey Abandoned**

Distance (ft): **138.1**
 Structural Grade: **0**
 O&M Grade: **0**
 Clock Start/From:
 Clock To:
 1st Value:
 2nd Value:
 Value Percent:
 Continuous Index:
 Within 8" of Joint: **NO**
 Remarks: **CAMERA CANT MAKE IT PAST TAP ROOT**
