Profile/Photo Observation Report

Street:	North Guyer Street	Flow Control:	Not Controlled
City:	Hobart, IN	Year Renewed:	
Location:	Alley	Tape/Media #:	
Purpose:	Routine Assessment	Dia/Height:	10"
Use:	Sanitary Sewage Pipe	Material:	VCP
Drain Area:		Lining:	None
Category:	NA		
Comment:			
Location Details:		Direction of Survey:	Upstream
US MH:	M-503-076	DS MH:	M-503-077
		Total Length Surveyed (ft):	138.1

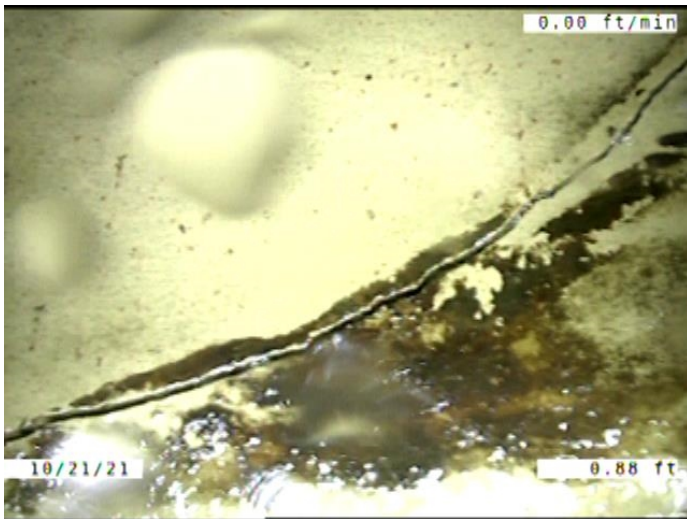
Code: **B**
 Description: **Broken**

Distance (ft): **.9**
 Structural Grade: **4**
 O&M Grade: **0**
 Clock Start/From: **12**
 Clock To: **12**
 1st Value:
 2nd Value:
 Value Percent:
 Continuous Index:
 Within 8" of Joint: **YES**
 Remarks:

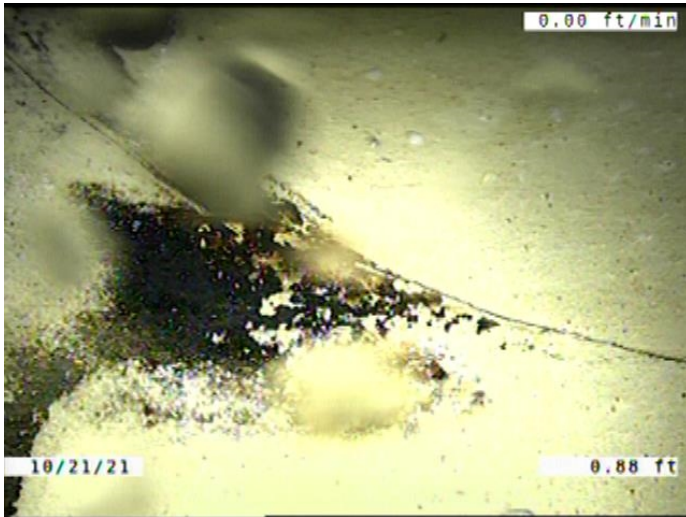
Code: **ISB**
 Description: **Infiltration Stain Barrel**

Distance (ft): **.9**
 Structural Grade: **0**
 O&M Grade: **1**
 Clock Start/From: **3**
 Clock To: **9**
 1st Value:
 2nd Value:
 Value Percent:
 Continuous Index:
 Within 8" of Joint: **YES**
 Remarks:

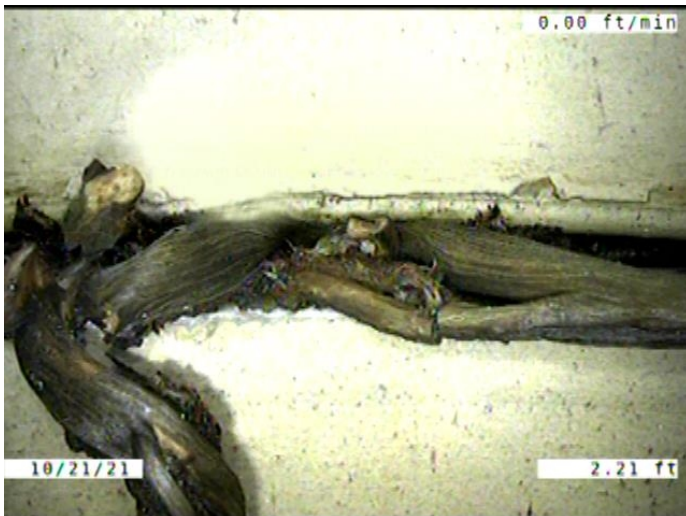
Code: **RTJ**
 Description: **Roots Tap Joint**

Distance (ft): **2.2**
 Structural Grade: **0**
 O&M Grade: **2**
 Clock Start/From: **10**
 Clock To: **1**
 1st Value:
 2nd Value:
 Value Percent: **5.000**
 Continuous Index:
 Within 8" of Joint: **YES**
 Remarks:

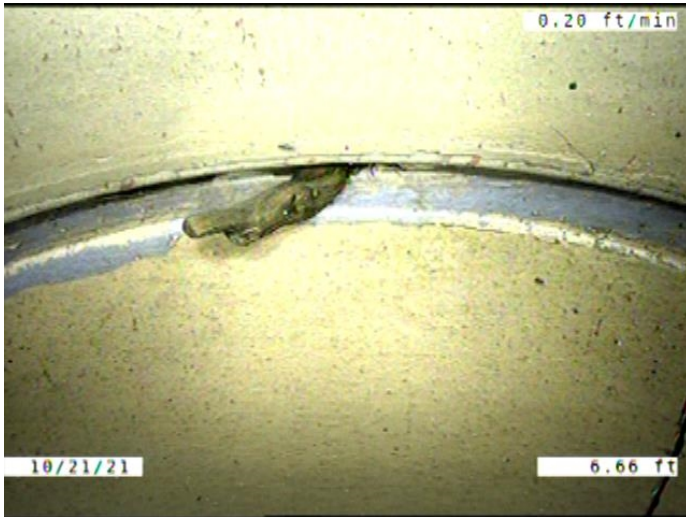
Code: **RTJ**
 Description: **Roots Tap Joint**

Distance (ft): **6.7**
 Structural Grade: **0**
 O&M Grade: **2**
 Clock Start/From: **11**
 Clock To:
 1st Value:
 2nd Value:
 Value Percent: **5.000**
 Continuous Index:
 Within 8" of Joint: **YES**
 Remarks:

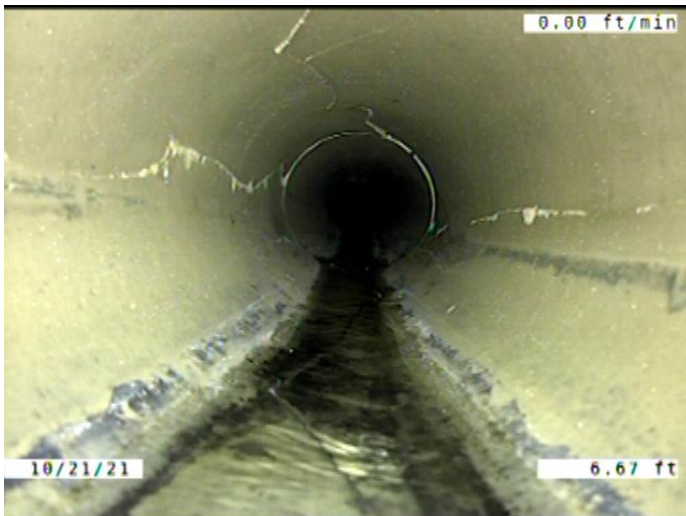
Code: **FH4**
 Description: **Fracture Longitudinal Hinge, 4**

Distance (ft): **6.7**
 Structural Grade: **4**
 O&M Grade: **0**
 Clock Start/From: **12**
 Clock To: **12**
 1st Value:
 2nd Value:
 Value Percent:
 Continuous Index: **S01**
 Within 8" of Joint: **YES**
 Remarks:

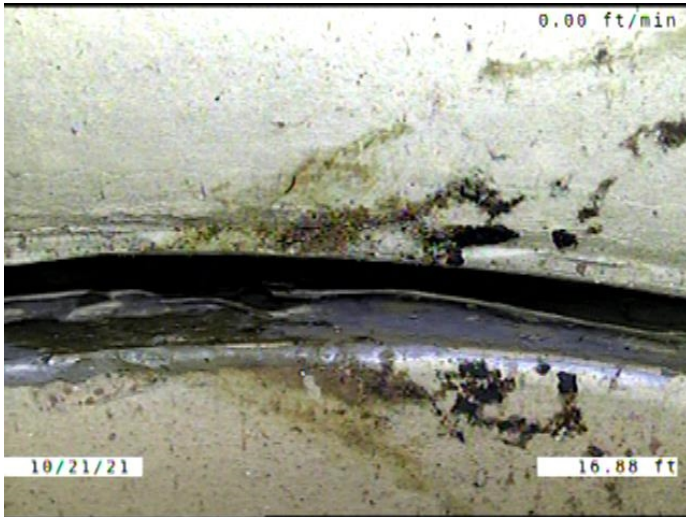
Code: **ISJ**
 Description: **Infiltration Stain Joint**

Distance (ft): **16.9**
 Structural Grade: **0**
 O&M Grade: **1**
 Clock Start/From: **2**
 Clock To: **5**
 1st Value:
 2nd Value:
 Value Percent:
 Continuous Index:
 Within 8" of Joint: **YES**
 Remarks:

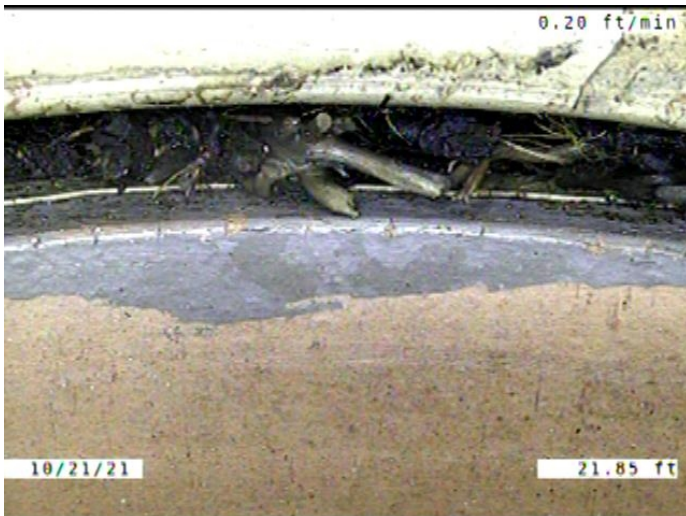
Code: **RFJ**
 Description: **Roots Fine Joint**

Distance (ft): **21.8**
 Structural Grade: **0**
 O&M Grade: **1**
 Clock Start/From: **10**
 Clock To: **4**
 1st Value:
 2nd Value:
 Value Percent:
 Continuous Index:
 Within 8" of Joint: **YES**
 Remarks:

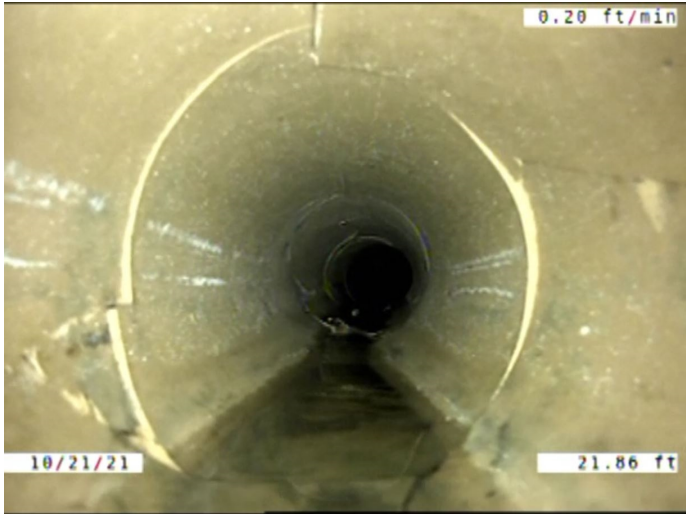
Code: **DR**
Description: **Deformed Rigid**

Distance (ft): **21.9**
Structural Grade: **5**
O&M Grade: **0**
Clock Start/From:
Clock To:
1st Value:
2nd Value:
Value Percent: **10.000**
Continuous Index:
Within 8" of Joint: **NO**
Remarks:

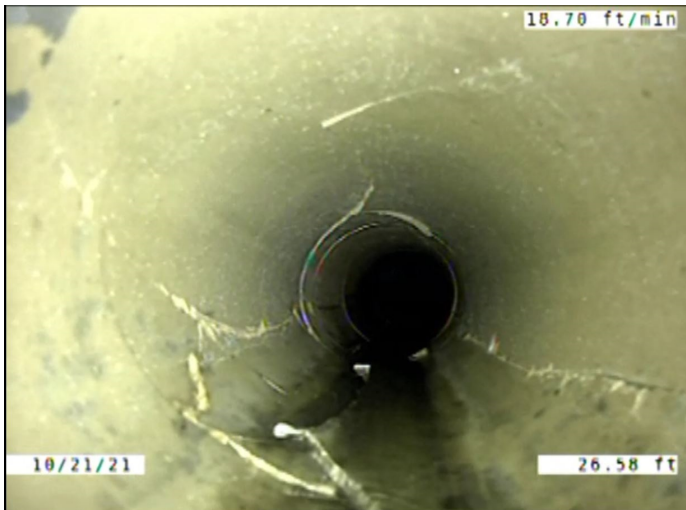
Code: **B**
Description: **Broken**

Distance (ft): **26.6**
Structural Grade: **4**
O&M Grade: **0**
Clock Start/From: **6**
Clock To: **8**
1st Value:
2nd Value:
Value Percent:
Continuous Index:
Within 8" of Joint: **NO**
Remarks:

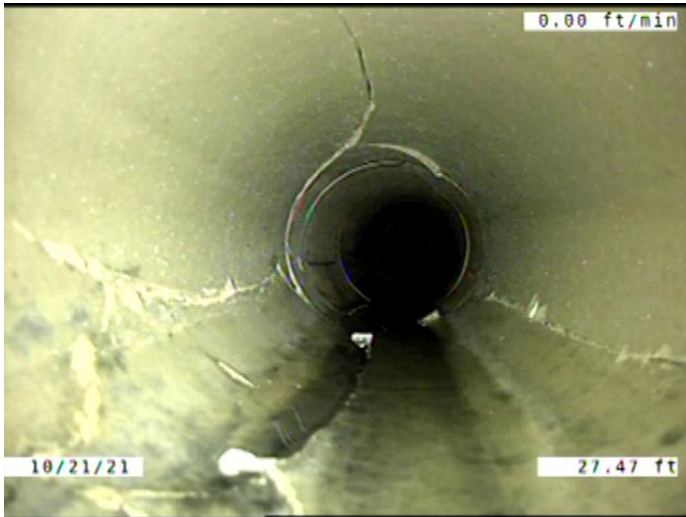
Code: **DR**
 Description: **Deformed Rigid**

Distance (ft): **27.5**
 Structural Grade: **4**
 O&M Grade: **0**
 Clock Start/From:
 Clock To:
 1st Value:
 2nd Value:
 Value Percent: **5.000**
 Continuous Index:
 Within 8" of Joint: **NO**
 Remarks:

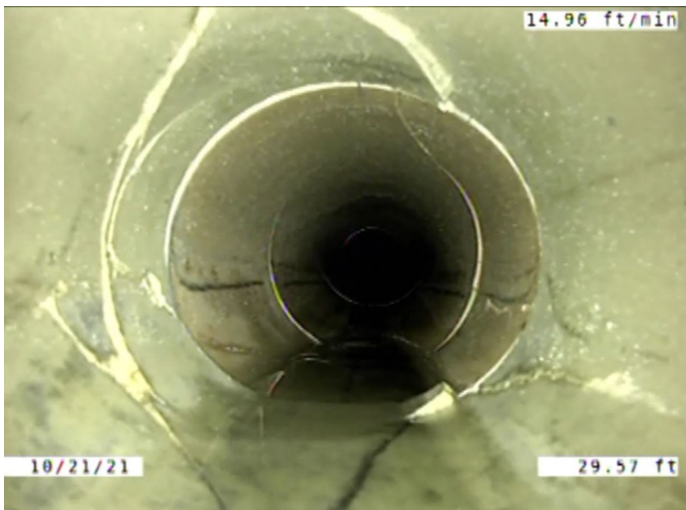
Code: **B**
 Description: **Broken**

Distance (ft): **29.6**
 Structural Grade: **4**
 O&M Grade: **0**
 Clock Start/From: **12**
 Clock To: **12**
 1st Value:
 2nd Value:
 Value Percent:
 Continuous Index:
 Within 8" of Joint: **YES**
 Remarks:

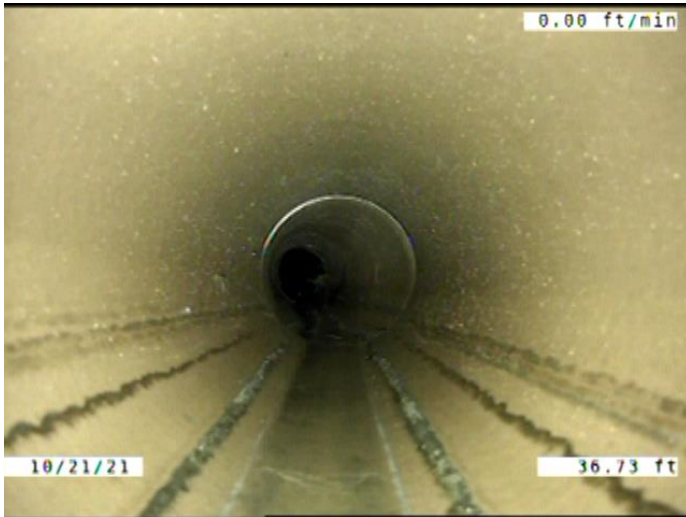
Code: **FH4**
Description: **Fracture Longitudinal Hinge, 4**

Distance (ft): **36.7**
Structural Grade: **4**
O&M Grade: **0**
Clock Start/From: **12**
Clock To: **12**
1st Value:
2nd Value:
Value Percent:
Continuous Index: **F01**
Within 8" of Joint: **YES**
Remarks:

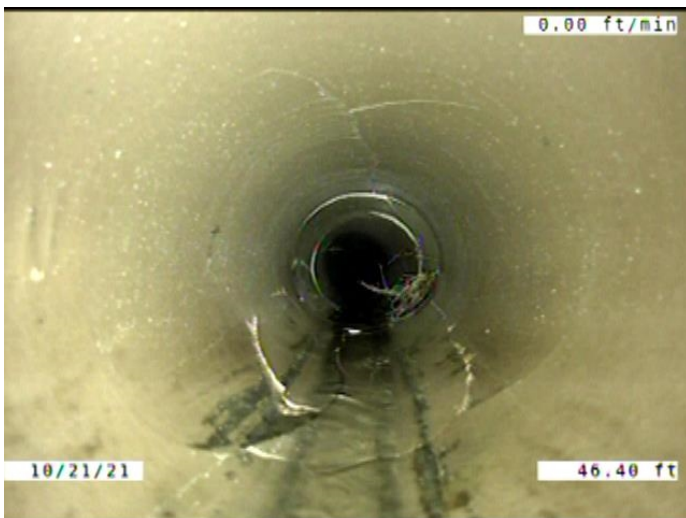
Code: **B**
Description: **Broken**

Distance (ft): **46.4**
Structural Grade: **4**
O&M Grade: **0**
Clock Start/From: **12**
Clock To: **12**
1st Value:
2nd Value:
Value Percent:
Continuous Index: **S02**
Within 8" of Joint: **YES**
Remarks:

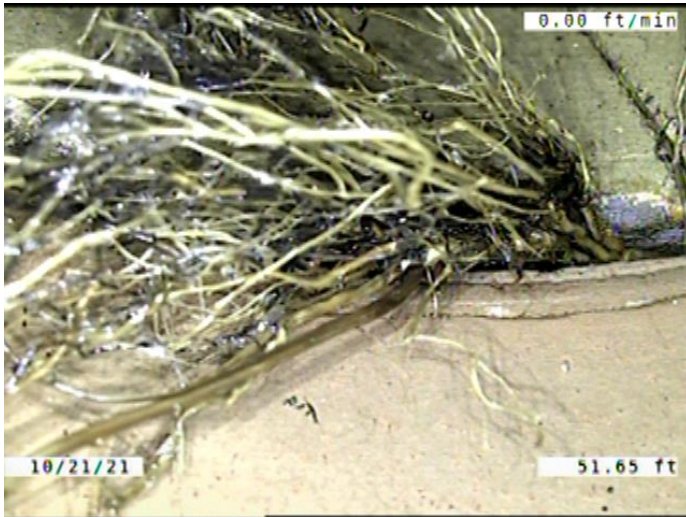
Code: **RMJ**
 Description: **Roots Medium Joint**

Distance (ft): **51.7**
 Structural Grade: **0**
 O&M Grade: **3**
 Clock Start/From: **2**
 Clock To: **5**
 1st Value:
 2nd Value:
 Value Percent: **5.000**
 Continuous Index:
 Within 8" of Joint: **YES**
 Remarks:

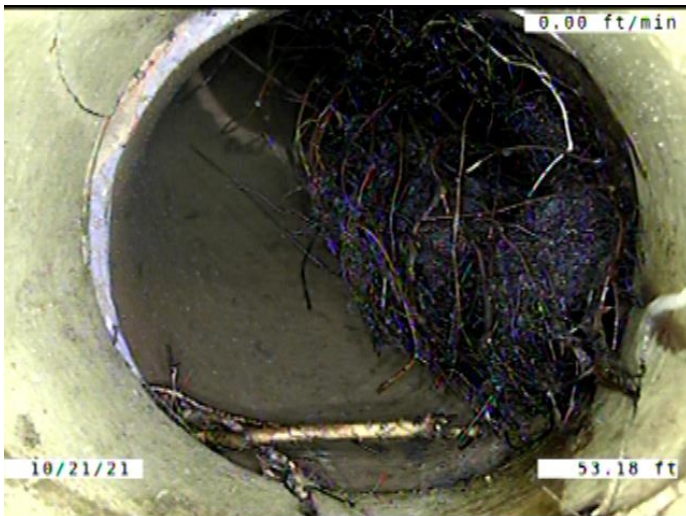
Code: **TFD**
 Description: **Tap Factory Defective**

Distance (ft): **53.2**
 Structural Grade: **0**
 O&M Grade: **3**
 Clock Start/From: **1**
 Clock To:
 1st Value: **4.000**
 2nd Value:
 Value Percent:
 Continuous Index:
 Within 8" of Joint: **YES**
 Remarks: **Defective**

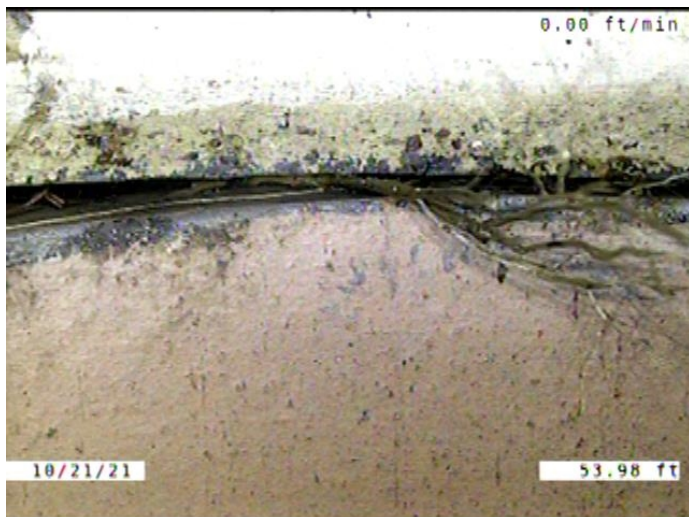
Code: **RFJ**
 Description: **Roots Fine Joint**

Distance (ft): **54.0**
 Structural Grade: **0**
 O&M Grade: **1**
 Clock Start/From: **8**
 Clock To: **10**
 1st Value:
 2nd Value:
 Value Percent:
 Continuous Index:
 Within 8" of Joint: **YES**
 Remarks:

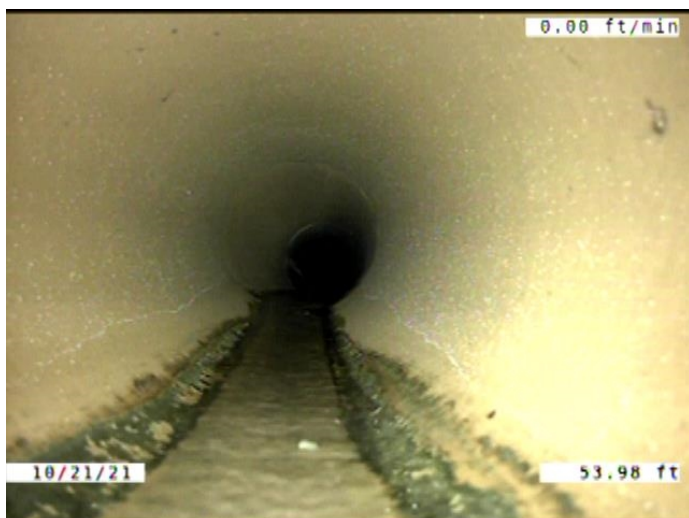
Code: **B**
 Description: **Broken**

Distance (ft): **54.0**
 Structural Grade: **4**
 O&M Grade: **0**
 Clock Start/From: **12**
 Clock To: **12**
 1st Value:
 2nd Value:
 Value Percent:
 Continuous Index: **F02**
 Within 8" of Joint: **YES**
 Remarks:

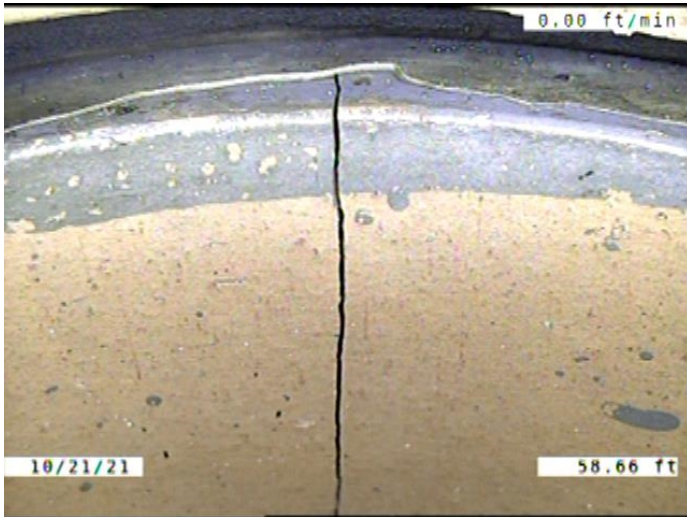
Code: **FS**
 Description: **Fracture Spiral**

Distance (ft): **58.7**
 Structural Grade: **3**
 O&M Grade: **0**
 Clock Start/From: **12**
 Clock To: **1**
 1st Value:
 2nd Value:
 Value Percent:
 Continuous Index:
 Within 8" of Joint: **YES**
 Remarks:

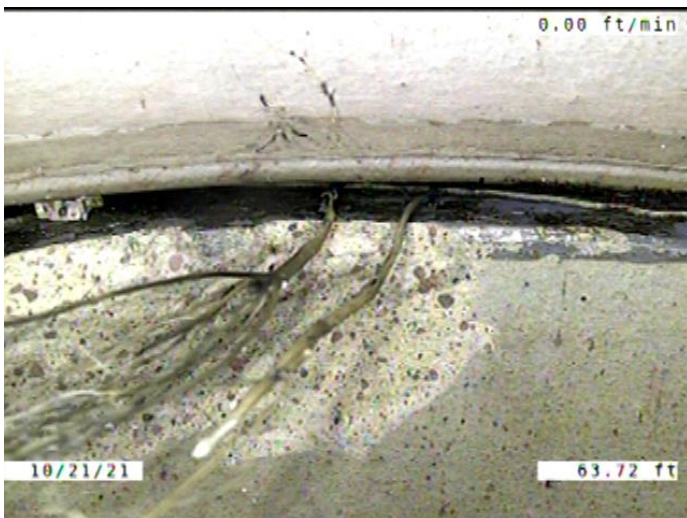
Code: **RFJ**
 Description: **Roots Fine Joint**

Distance (ft): **63.7**
 Structural Grade: **0**
 O&M Grade: **1**
 Clock Start/From: **8**
 Clock To: **4**
 1st Value:
 2nd Value:
 Value Percent:
 Continuous Index:
 Within 8" of Joint: **YES**
 Remarks:

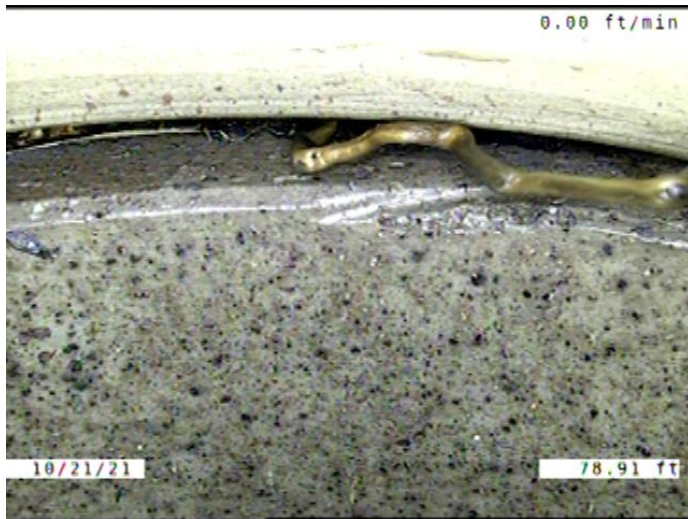
Code: **RFJ**
Description: **Roots Fine Joint**

Distance (ft): **78.9**
Structural Grade: **0**
O&M Grade: **1**
Clock Start/From: **10**
Clock To: **2**
1st Value:
2nd Value:
Value Percent:
Continuous Index:
Within 8" of Joint: **YES**
Remarks:

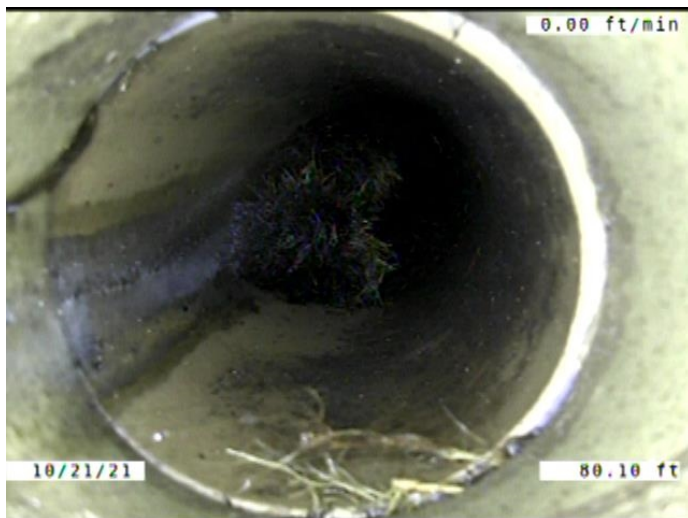
Code: **TFD**
Description: **Tap Factory Defective**

Distance (ft): **80.1**
Structural Grade: **0**
O&M Grade: **3**
Clock Start/From: **10**
Clock To:
1st Value: **4.000**
2nd Value:
Value Percent:
Continuous Index:
Within 8" of Joint: **YES**
Remarks: **Defective**

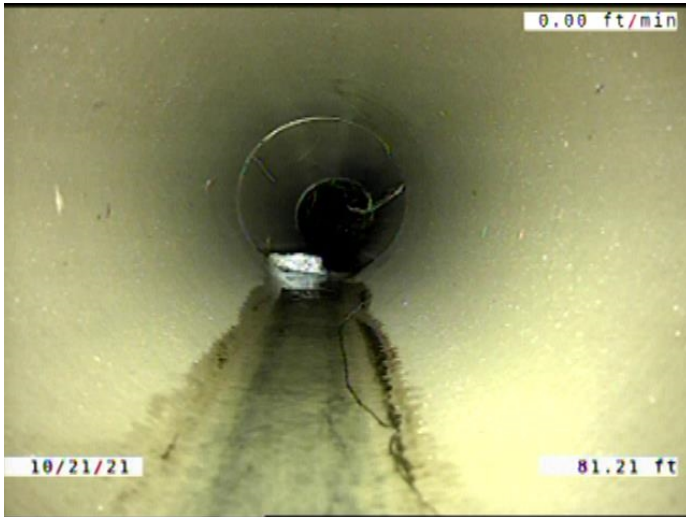
Code: **FM**
 Description: **Fracture Multiple**

Distance (ft): **81.2**
 Structural Grade: **4**
 O&M Grade: **0**
 Clock Start/From: **12**
 Clock To: **12**
 1st Value:
 2nd Value:
 Value Percent:
 Continuous Index: **S03**
 Within 8" of Joint: **YES**
 Remarks:

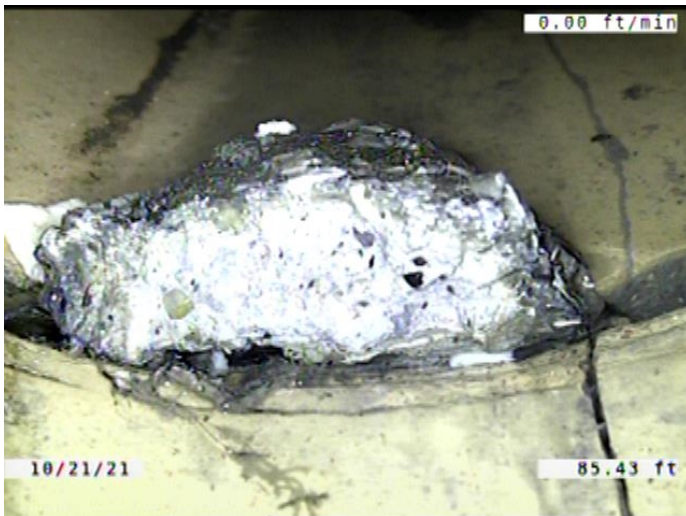
Code: **OBN**
 Description: **Obstruction Construction Debris**

Distance (ft): **85.4**
 Structural Grade: **0**
 O&M Grade: **2**
 Clock Start/From: **6**
 Clock To: **7**
 1st Value:
 2nd Value:
 Value Percent: **5.000**
 Continuous Index:
 Within 8" of Joint: **YES**
 Remarks:

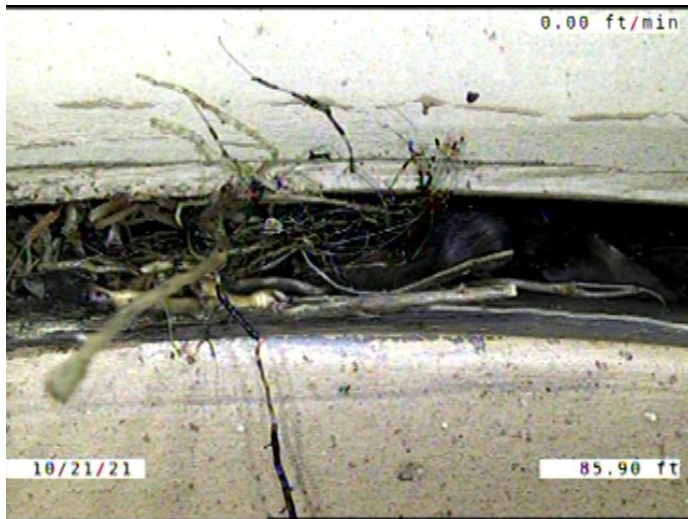
Code: **RFJ**
 Description: **Roots Fine Joint**

Distance (ft): **85.9**
 Structural Grade: **0**
 O&M Grade: **1**
 Clock Start/From: **10**
 Clock To: **2**
 1st Value:
 2nd Value:
 Value Percent:
 Continuous Index:
 Within 8" of Joint: **YES**
 Remarks:

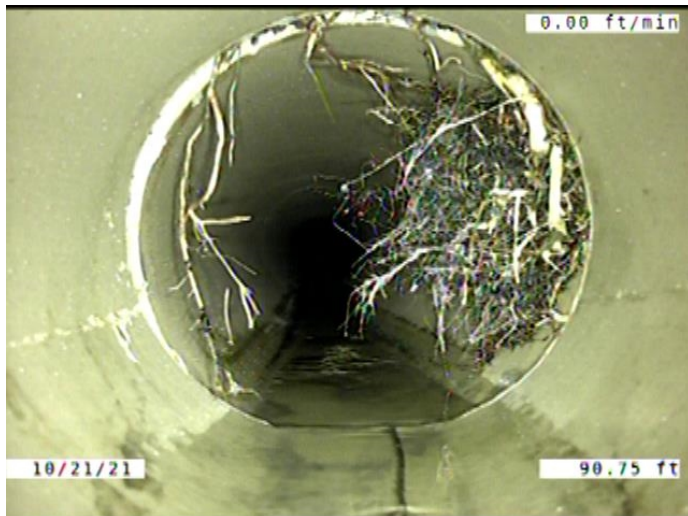
Code: **RMJ**
 Description: **Roots Medium Joint**

Distance (ft): **90.7**
 Structural Grade: **0**
 O&M Grade: **3**
 Clock Start/From: **10**
 Clock To: **4**
 1st Value:
 2nd Value:
 Value Percent: **15.000**
 Continuous Index:
 Within 8" of Joint: **YES**
 Remarks:

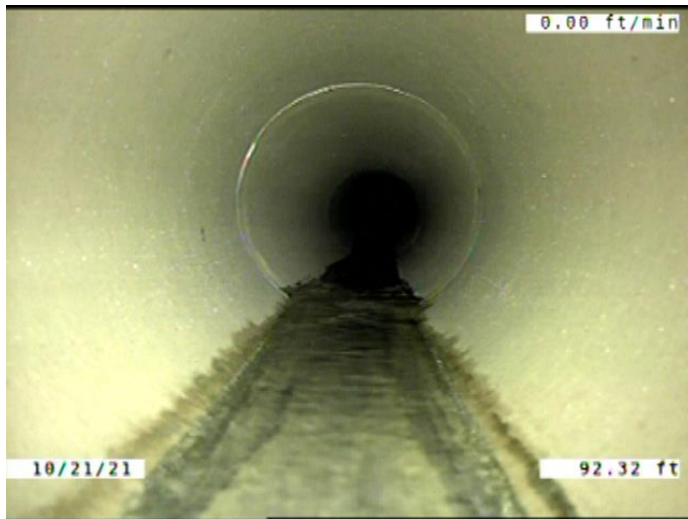
Code: **FM**
 Description: **Fracture Multiple**

Distance (ft): **92.3**
 Structural Grade: **4**
 O&M Grade: **0**
 Clock Start/From: **12**
 Clock To: **12**
 1st Value:
 2nd Value:
 Value Percent:
 Continuous Index: **F03**
 Within 8" of Joint: **YES**
 Remarks:

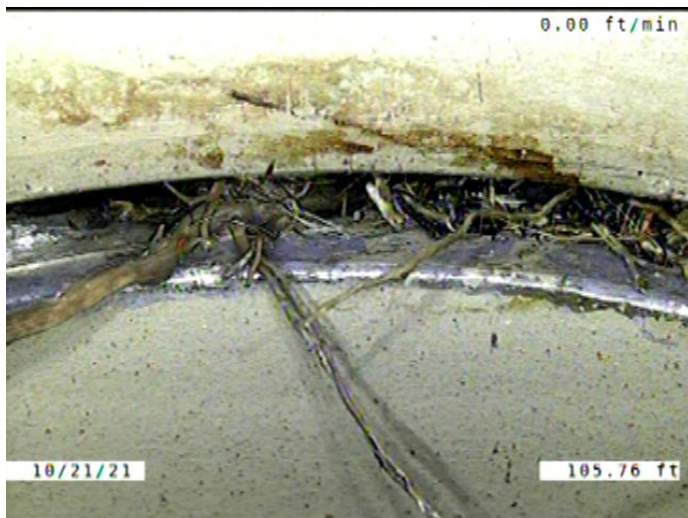
Code: **RFJ**
 Description: **Roots Fine Joint**

Distance (ft): **105.8**
 Structural Grade: **0**
 O&M Grade: **1**
 Clock Start/From: **10**
 Clock To: **3**
 1st Value:
 2nd Value:
 Value Percent:
 Continuous Index:
 Within 8" of Joint: **YES**
 Remarks:

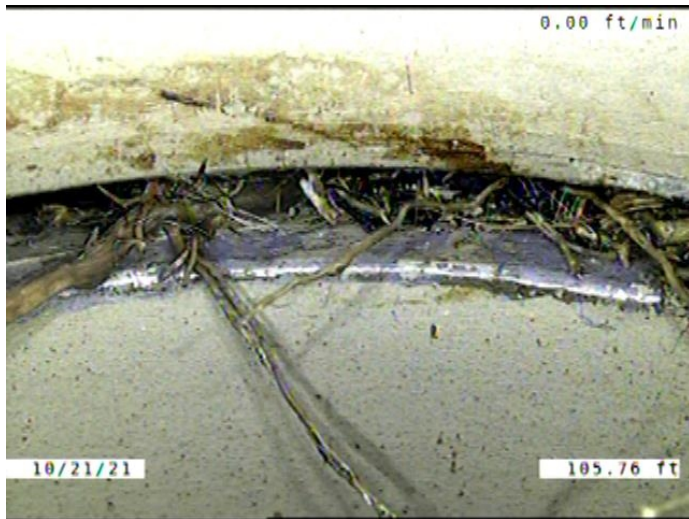
Code: **ISJ**
 Description: **Infiltration Stain Joint**

Distance (ft): **105.8**
 Structural Grade: **0**
 O&M Grade: **1**
 Clock Start/From: **8**
 Clock To: **1**
 1st Value:
 2nd Value:
 Value Percent:
 Continuous Index:
 Within 8" of Joint: **YES**
 Remarks:

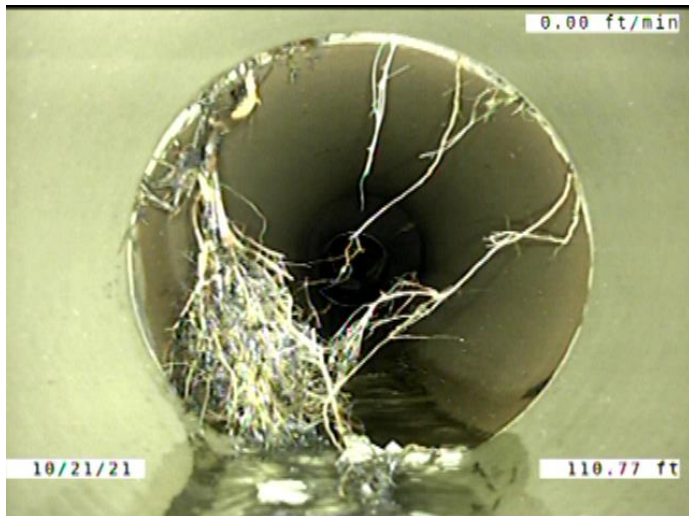
Code: **RMJ**
 Description: **Roots Medium Joint**

Distance (ft): **110.8**
 Structural Grade: **0**
 O&M Grade: **3**
 Clock Start/From: **7**
 Clock To: **3**
 1st Value:
 2nd Value:
 Value Percent: **10.000**
 Continuous Index: **S04**
 Within 8" of Joint: **YES**
 Remarks:

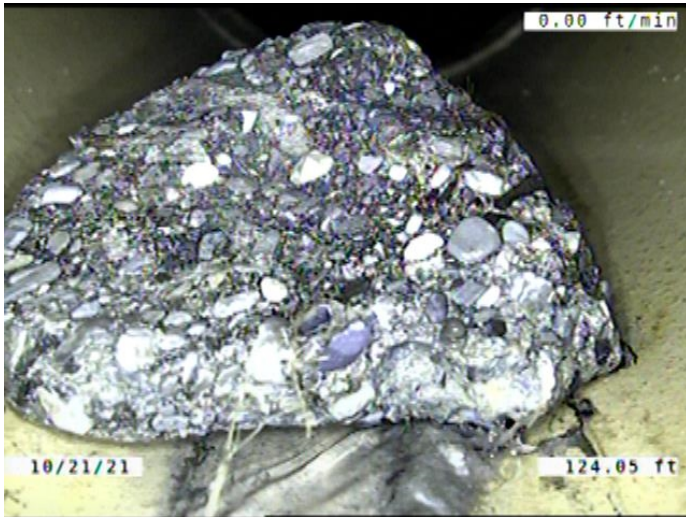
Code:	OBN
Description:	Obstruction Construction Debris
Distance (ft):	124.0
Structural Grade:	0
O&M Grade:	3
Clock Start/From:	5
Clock To:	7
1st Value:	
2nd Value:	
Value Percent:	15.000
Continuous Index:	
Within 8" of Joint:	YES
Remarks:

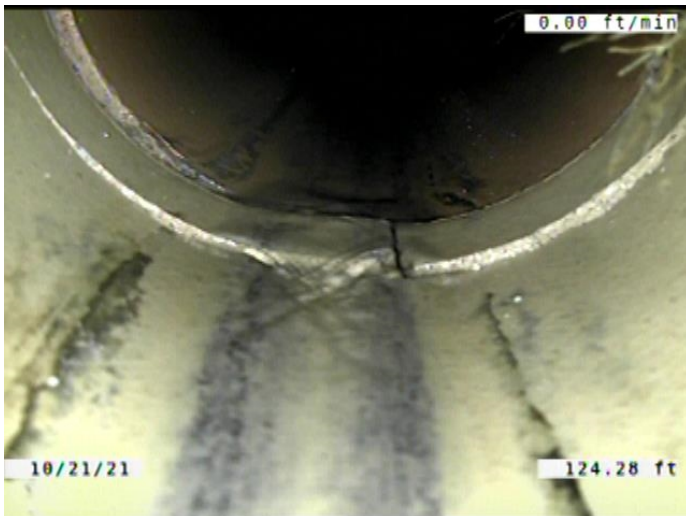
Code:	B
Description:	Broken
Distance (ft):	124.3
Structural Grade:	4
O&M Grade:	0
Clock Start/From:	2
Clock To:	9
1st Value:	
2nd Value:	
Value Percent:	
Continuous Index:	
Within 8" of Joint:	YES
Remarks:

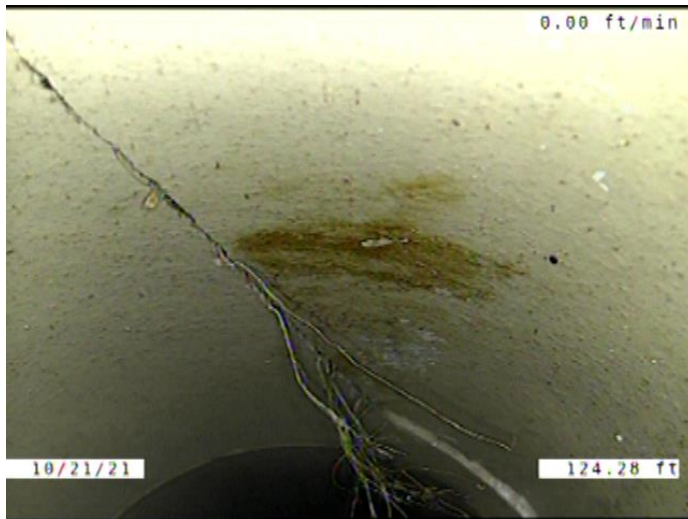
Code: **ISB**
 Description: **Infiltration Stain Barrel**

Distance (ft): **124.3**
 Structural Grade: **0**
 O&M Grade: **1**
 Clock Start/From: **3**
 Clock To: **4**
 1st Value:
 2nd Value:
 Value Percent:
 Continuous Index:
 Within 8" of Joint: **YES**
 Remarks:

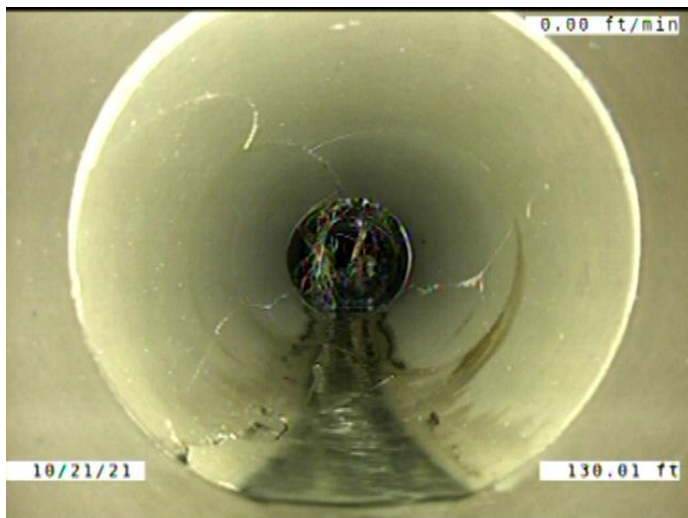
Code: **B**
 Description: **Broken**

Distance (ft): **130.0**
 Structural Grade: **4**
 O&M Grade: **0**
 Clock Start/From: **12**
 Clock To: **12**
 1st Value:
 2nd Value:
 Value Percent:
 Continuous Index:
 Within 8" of Joint: **YES**
 Remarks:

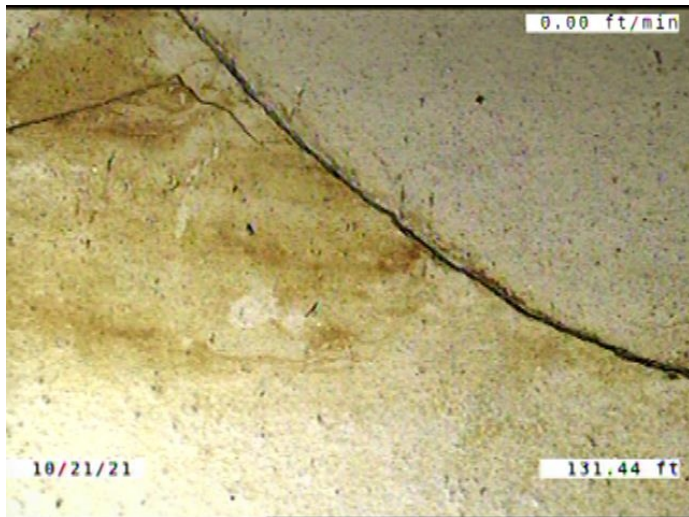
Code: **ISB**
 Description: **Infiltration Stain Barrel**

Distance (ft): **131.4**
 Structural Grade: **0**
 O&M Grade: **1**
 Clock Start/From: **3**
 Clock To: **5**
 1st Value:
 2nd Value:
 Value Percent:
 Continuous Index:
 Within 8" of Joint: **NO**
 Remarks:

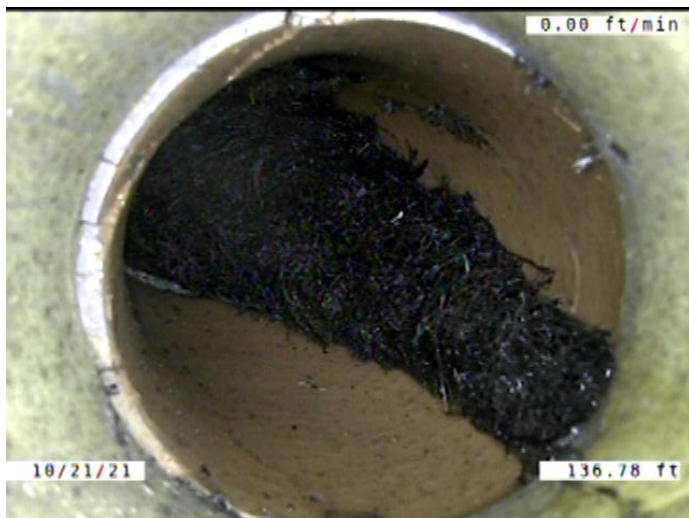
Code: **TFD**
 Description: **Tap Factory Defective**

Distance (ft): **136.8**
 Structural Grade: **0**
 O&M Grade: **3**
 Clock Start/From: **2**
 Clock To:
 1st Value: **4.000**
 2nd Value:
 Value Percent:
 Continuous Index:
 Within 8" of Joint: **YES**
 Remarks: **Defective**

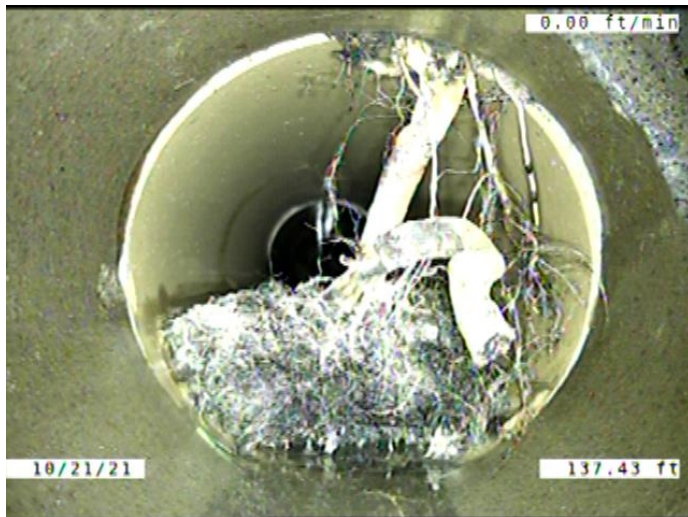
Code: **RTJ**
 Description: **Roots Tap Joint**

Distance (ft): **137.4**
 Structural Grade: **0**
 O&M Grade: **2**
 Clock Start/From: **12**
 Clock To: **8**
 1st Value:
 2nd Value:
 Value Percent: **35.000**
 Continuous Index:
 Within 8" of Joint: **YES**
 Remarks:

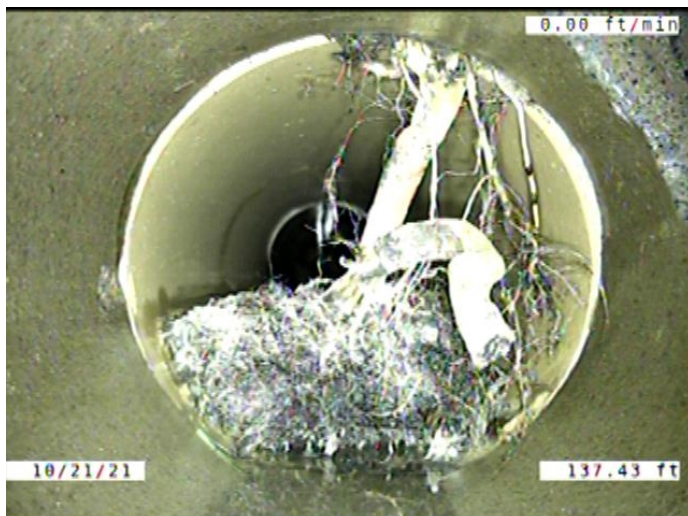
Code: **RMJ**
 Description: **Roots Medium Joint**

Distance (ft): **137.4**
 Structural Grade: **0**
 O&M Grade: **3**
 Clock Start/From: **7**
 Clock To: **3**
 1st Value:
 2nd Value:
 Value Percent: **10.000**
 Continuous Index: **F04**
 Within 8" of Joint: **YES**
 Remarks:

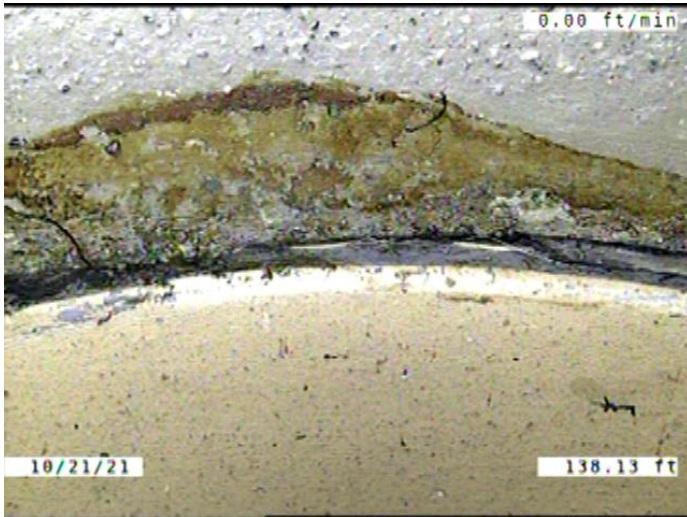
Code: **ISJ**
 Description: **Infiltration Stain Joint**

Distance (ft): **138.1**
 Structural Grade: **0**
 O&M Grade: **1**
 Clock Start/From: **9**
 Clock To: **11**
 1st Value:
 2nd Value:
 Value Percent:
 Continuous Index:
 Within 8" of Joint: **YES**
 Remarks:

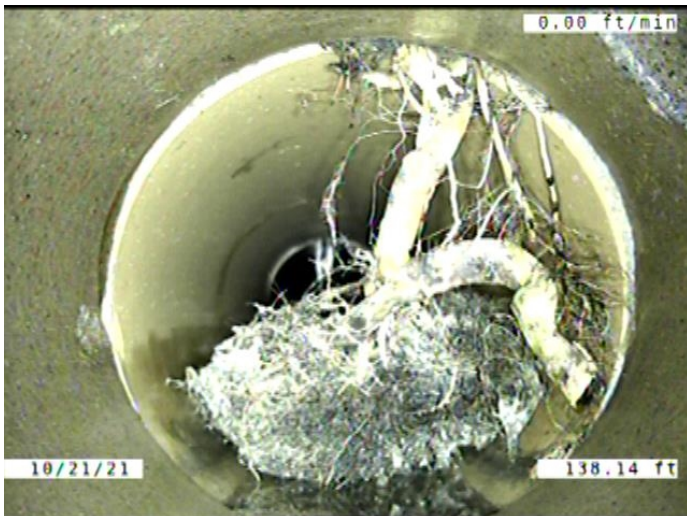
Code: **MSA**
 Description: **Miscellaneous Survey Abandoned**

Distance (ft): **138.1**
 Structural Grade: **0**
 O&M Grade: **0**
 Clock Start/From:
 Clock To:
 1st Value:
 2nd Value:
 Value Percent:
 Continuous Index:
 Within 8" of Joint: **NO**
 Remarks: **CAMERA CANT MAKE IT PAST TAP ROOT**
