## Profile/Photo Observation Report

Street:	<b>N COLORADO ST</b>	Flow Control:	<b>Not Controlled</b>
City:	<b>Hobart, IN</b>	Year Renewed:	
Location:	<b>Other</b>	Tape/Media #:	
Purpose:	<b>Not Known</b>	Dia/Height:	<b>10"</b>
Use:	<b>Sanitary</b>	Material:	<b>VCP</b>
Drain Area:	<b>NA</b>	Lining:	
Category:	<b>NA</b>		
Comment:

Location Details:		Direction of Survey:	<b>Upstream</b>
US MH:	<b>M-503-078</b>	DS MH:	<b>M-503-079</b>
		Total Length Surveyed (ft):	<b>27.2</b>

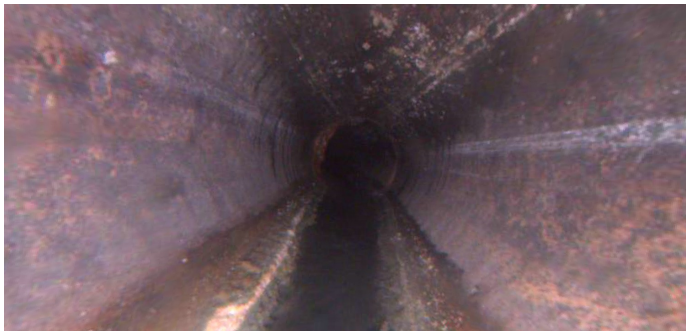
Code: **AMH**  
Description: **Manhole**

Distance (ft): **.0**  
Structural Grade: **0**  
O&M Grade: **0**  
Clock Start/From:  
Clock To:  
1st Value:  
2nd Value:  
Value Percent:  
Continuous Index:  
Within 8" of Joint: **NO**  
Remarks: **M-503-078**

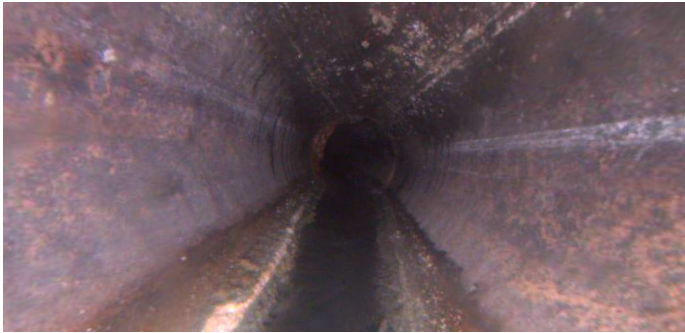
Code:	<b>MWL</b>
Description:	<b>Water Level</b>

Distance (ft):	<b>.0</b>
Structural Grade:	<b>0</b>
O&M Grade:	<b>0</b>
Clock Start/From:	
Clock To:	
1st Value:	
2nd Value:	
Value Percent:	<b>5.000</b>
Continuous Index:	
Within 8" of Joint:	<b>NO</b>
Remarks:

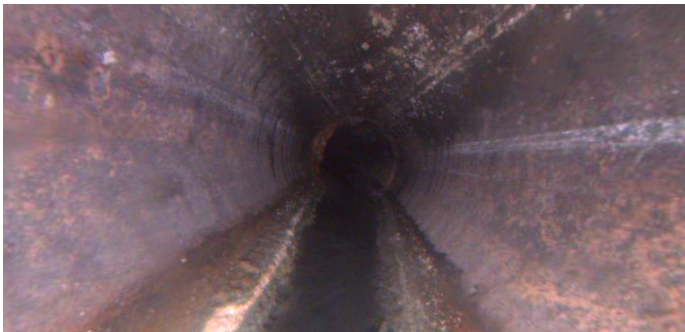
Code:	<b>DAGS</b>
Description:	<b>Deposits Attached Grease</b>

Distance (ft):	<b>.0</b>
Structural Grade:	<b>0</b>
O&M Grade:	<b>2</b>
Clock Start/From:	<b>7</b>
Clock To:	<b>5</b>
1st Value:	
2nd Value:	
Value Percent:	<b>10.000</b>
Continuous Index:	<b>S01</b>
Within 8" of Joint:	<b>NO</b>
Remarks:

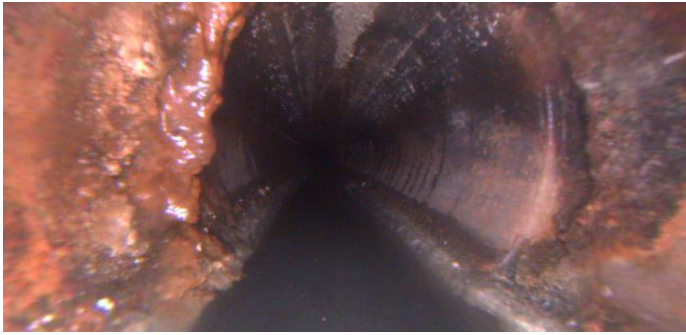
Code: **LL**  
Description: **Alignment Left**

Distance (ft): **3.2**  
Structural Grade: **0**  
O&M Grade: **1**  
Clock Start/From:  
Clock To:  
1st Value:  
2nd Value:  
Value Percent: **5.000**  
Continuous Index:  
Within 8" of Joint: **NO**  
Remarks:

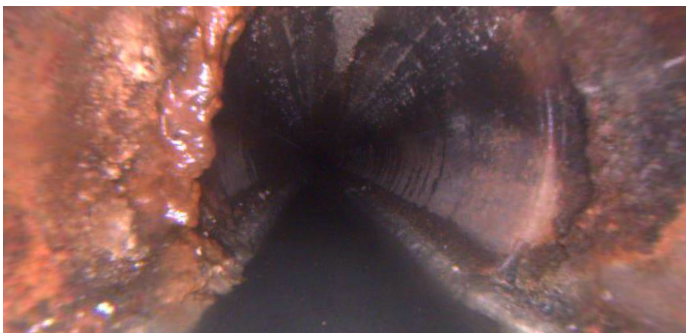
Code: **DAE**  
Description: **Deposits Attached Encrustation**

Distance (ft): **3.2**  
Structural Grade: **0**  
O&M Grade: **3**  
Clock Start/From: **8**  
Clock To: **4**  
1st Value:  
2nd Value:  
Value Percent: **20.000**  
Continuous Index:  
Within 8" of Joint: **YES**  
Remarks:

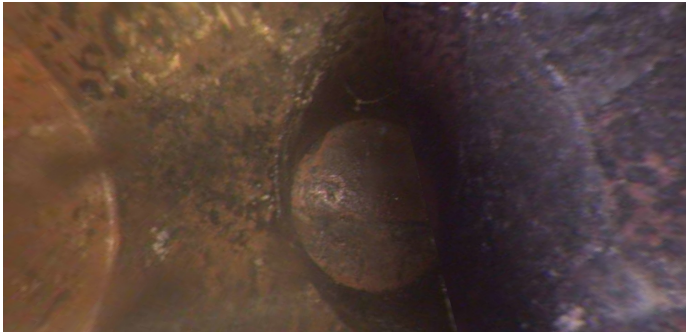
Code: **TFC**  
Description: **Tap Factory Capped**

Distance (ft): **19.5**  
Structural Grade: **0**  
O&M Grade: **0**  
Clock Start/From: **10**  
Clock To:  
1st Value: **4.000**  
2nd Value:  
Value Percent:  
Continuous Index:  
Within 8" of Joint:  
Remarks:

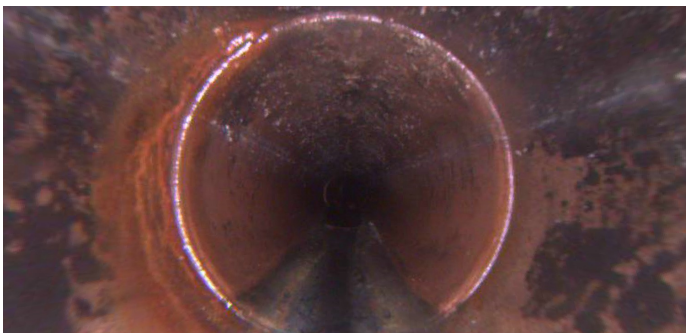
Code: **IW**  
Description: **Infil Weeper**

Distance (ft): **20.2**  
Structural Grade: **0**  
O&M Grade: **2**  
Clock Start/From: **7**  
Clock To: **11**  
1st Value:  
2nd Value:  
Value Percent:  
Continuous Index:  
Within 8" of Joint: **YES**  
Remarks:

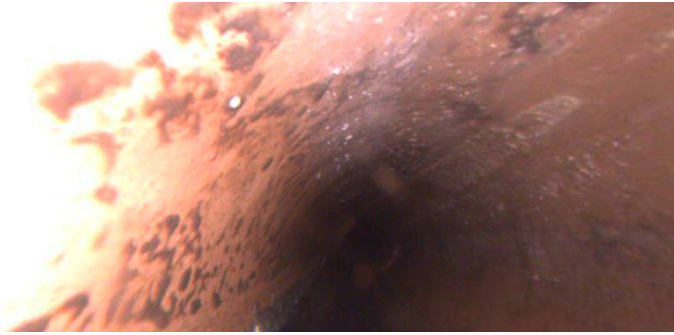
Code: **MSA**  
Description: **Abandoned Survey**

Distance (ft): **27.2**  
Structural Grade: **0**  
O&M Grade: **0**  
Clock Start/From:  
Clock To:  
1st Value:  
2nd Value:  
Value Percent:  
Continuous Index:  
Within 8" of Joint: **NO**  
Remarks: **debris under water**

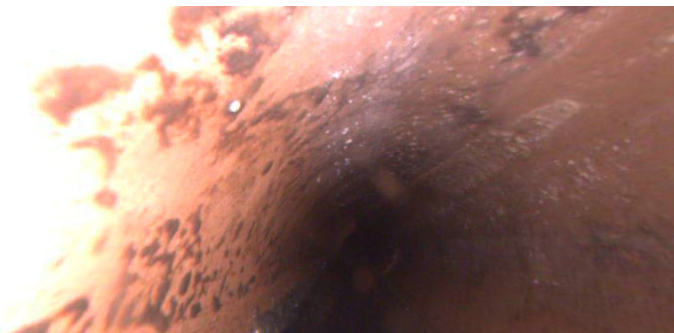
Code: **DAGS**  
Description: **Deposits Attached Grease**

Distance (ft): **27.2**  
Structural Grade: **0**  
O&M Grade: **2**  
Clock Start/From: **7**  
Clock To: **5**  
1st Value:  
2nd Value:  
Value Percent: **10.000**  
Continuous Index: **F01**  
Within 8" of Joint: **NO**  
Remarks:
