# Profile/Photo Observation Report

| Pipe Length (ft): | 231.8 | Owner: | City of Hobart | Pre Clean: | Heavy Cleaning |

| Street: | North Colorado Street | Flow Control: | Not Controlled |
| US MH: | M-503-078 | DS MH: | M-503-079 |

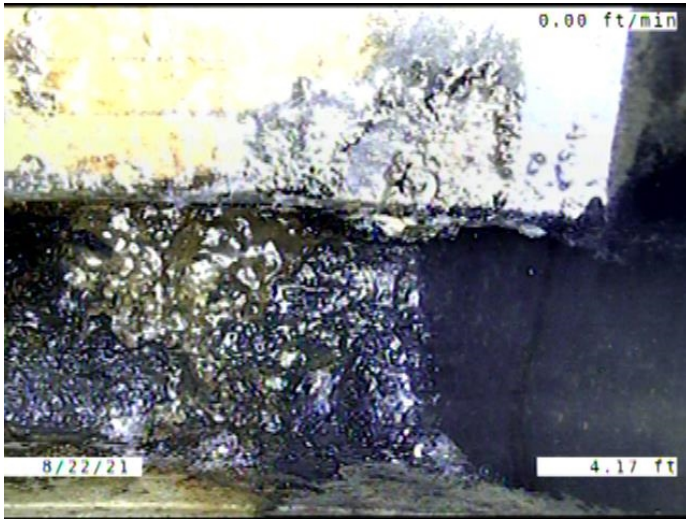
Code: **JAM**  
 Description: **Joint Angular Medium**

Distance (ft): **4.2**  
 Structural Grade: **3**  
 O&M Grade: **0**  
 Clock Start/From:  
 Clock To:  
 1st Value:  
 2nd Value:  
 Value Percent:  
 Continuous Index:  
 Within 8" of Joint: **NO**  
 Remarks:

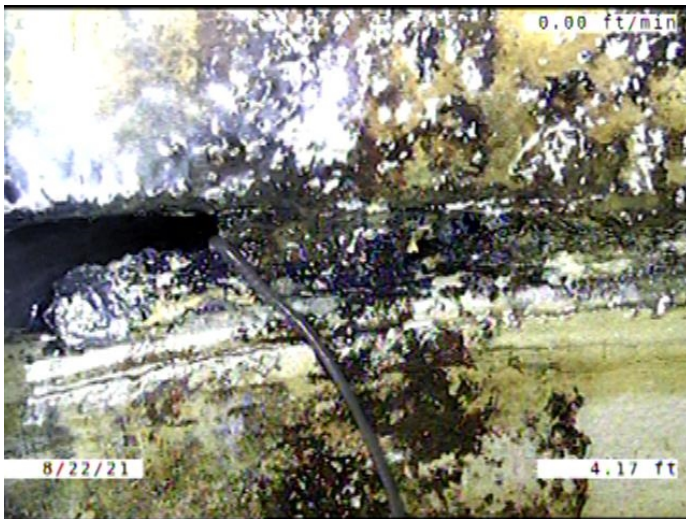
Code: **ISJ**  
 Description: **Infiltration Stain Joint**

Distance (ft): **4.2**  
 Structural Grade: **0**  
 O&M Grade: **1**  
 Clock Start/From: **8**  
 Clock To: **4**  
 1st Value:  
 2nd Value:  
 Value Percent:  
 Continuous Index:  
 Within 8" of Joint: **YES**  
 Remarks:

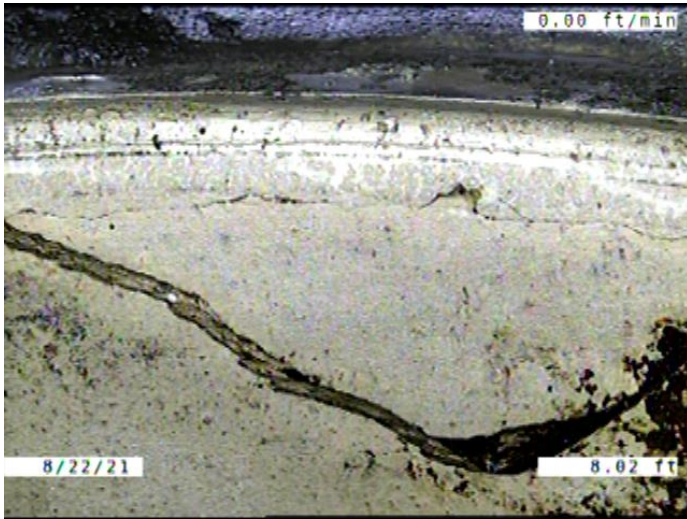
Code: **B**  
 Description: **Broken**

Distance (ft): **8.0**  
 Structural Grade: **4**  
 O&M Grade: **0**  
 Clock Start/From: **1**  
 Clock To: **3**  
 1st Value:  
 2nd Value:  
 Value Percent:  
 Continuous Index:  
 Within 8" of Joint: **YES**  
 Remarks:

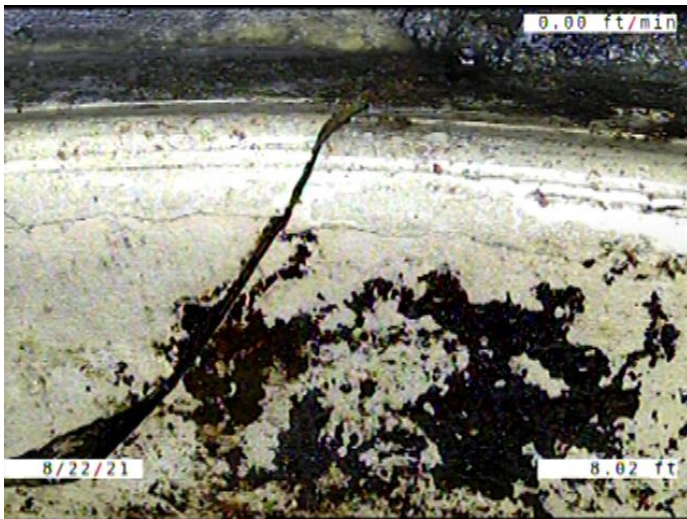
Code: **ISB**  
 Description: **Infiltration Stain Barrel**

Distance (ft): **8.0**  
 Structural Grade: **0**  
 O&M Grade: **1**  
 Clock Start/From: **2**  
 Clock To: **5**  
 1st Value:  
 2nd Value:  
 Value Percent:  
 Continuous Index:  
 Within 8" of Joint: **YES**  
 Remarks:

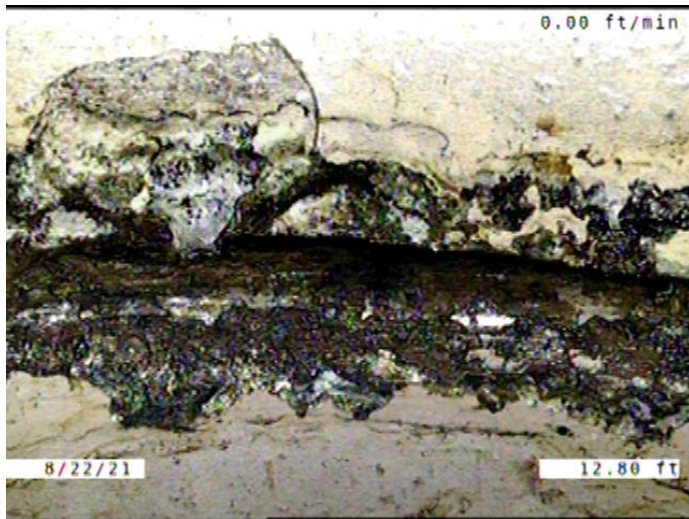
Code: **ISJ**  
 Description: **Infiltration Stain Joint**

Distance (ft): **12.8**  
 Structural Grade: **0**  
 O&M Grade: **1**  
 Clock Start/From: **8**  
 Clock To: **4**  
 1st Value:  
 2nd Value:  
 Value Percent:  
 Continuous Index:  
 Within 8" of Joint: **YES**  
 Remarks:

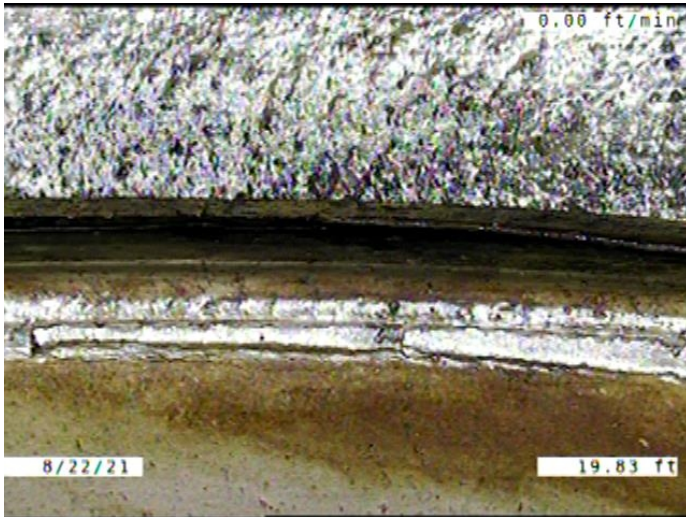
Code: **ISJ**  
 Description: **Infiltration Stain Joint**

Distance (ft): **19.8**  
 Structural Grade: **0**  
 O&M Grade: **1**  
 Clock Start/From: **7**  
 Clock To: **5**  
 1st Value:  
 2nd Value:  
 Value Percent:  
 Continuous Index:  
 Within 8" of Joint: **YES**  
 Remarks:

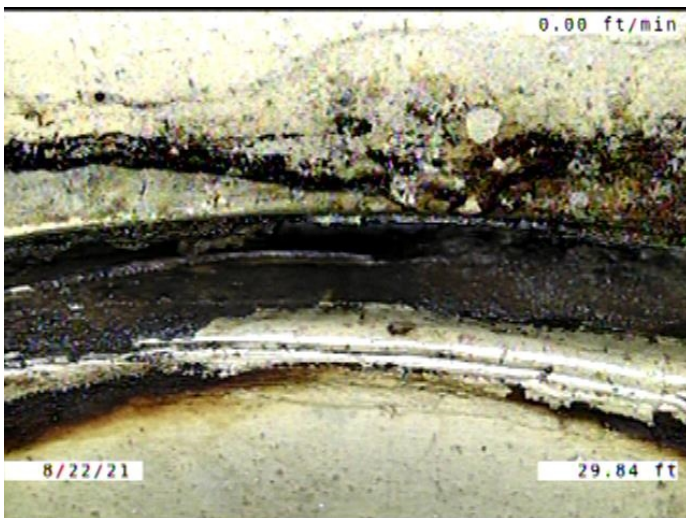
Code: **ISJ**  
 Description: **Infiltration Stain Joint**

Distance (ft): **29.8**  
 Structural Grade: **0**  
 O&M Grade: **1**  
 Clock Start/From: **7**  
 Clock To: **5**  
 1st Value:  
 2nd Value:  
 Value Percent:  
 Continuous Index:  
 Within 8" of Joint: **YES**  
 Remarks:

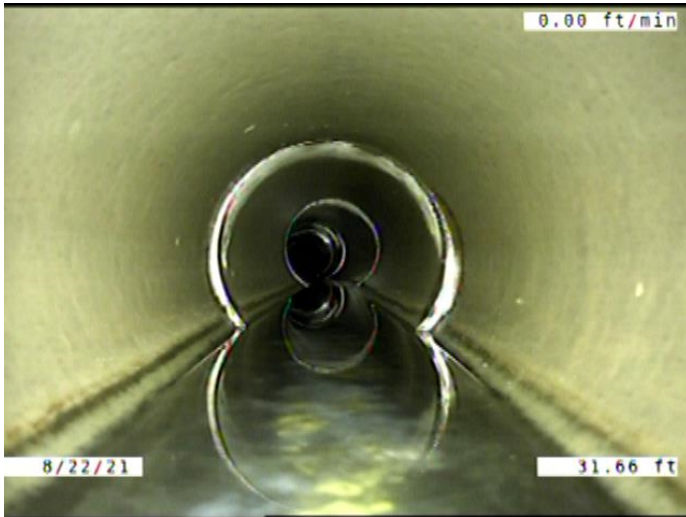
Code: **DSF**  
 Description: **Deposits Settled Fine**

Distance (ft): **31.7**  
 Structural Grade: **0**  
 O&M Grade: **2**  
 Clock Start/From: **5**  
 Clock To: **7**  
 1st Value:  
 2nd Value:  
 Value Percent: **5.000**  
 Continuous Index: **S01**  
 Within 8" of Joint: **YES**  
 Remarks:

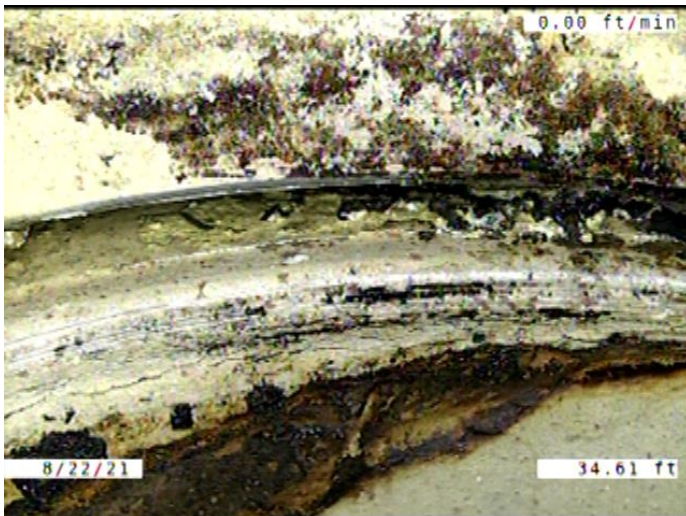
Code: **ISJ**  
 Description: **Infiltration Stain Joint**

Distance (ft): **34.6**  
 Structural Grade: **0**  
 O&M Grade: **1**  
 Clock Start/From: **8**  
 Clock To: **4**  
 1st Value:  
 2nd Value:  
 Value Percent:  
 Continuous Index:  
 Within 8" of Joint: **YES**  
 Remarks:

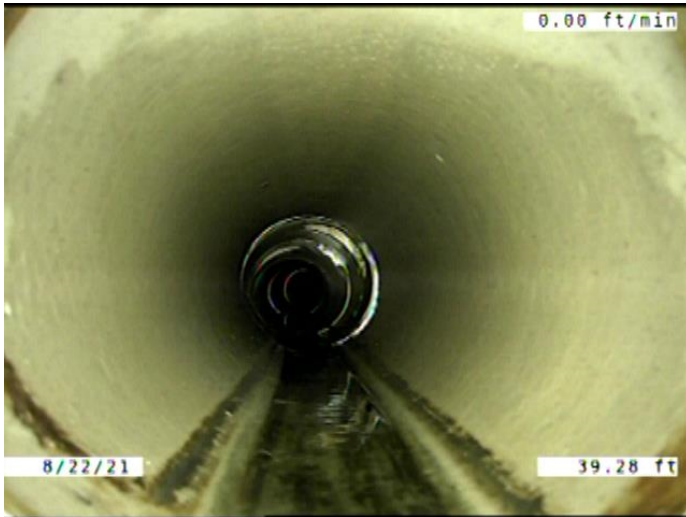
Code: **DSF**  
 Description: **Deposits Settled Fine**

Distance (ft): **39.3**  
 Structural Grade: **0**  
 O&M Grade: **2**  
 Clock Start/From: **5**  
 Clock To: **7**  
 1st Value:  
 2nd Value:  
 Value Percent: **5.000**  
 Continuous Index: **F01**  
 Within 8" of Joint: **YES**  
 Remarks:

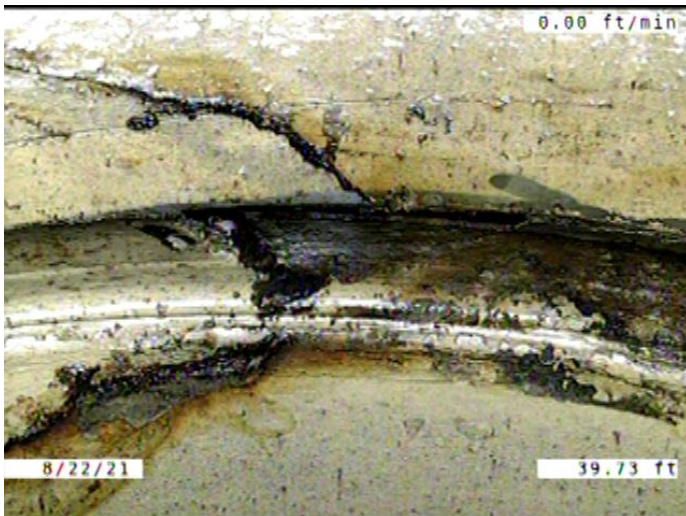
Code: **ISJ**  
 Description: **Infiltration Stain Joint**

Distance (ft): **39.7**  
 Structural Grade: **0**  
 O&M Grade: **1**  
 Clock Start/From: **7**  
 Clock To: **5**  
 1st Value:  
 2nd Value:  
 Value Percent:  
 Continuous Index:  
 Within 8" of Joint: **YES**  
 Remarks:

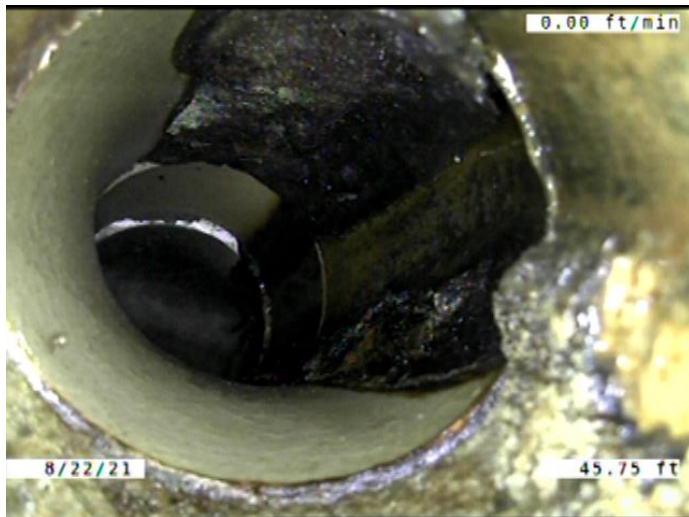
Code: **TF**  
 Description: **Tap Factory**

Distance (ft): **45.8**  
 Structural Grade: **0**  
 O&M Grade: **0**  
 Clock Start/From: **1**  
 Clock To:  
 1st Value: **4.000**  
 2nd Value:  
 Value Percent:  
 Continuous Index:  
 Within 8" of Joint: **YES**  
 Remarks: **CONSTANTLY RUNING WATER**

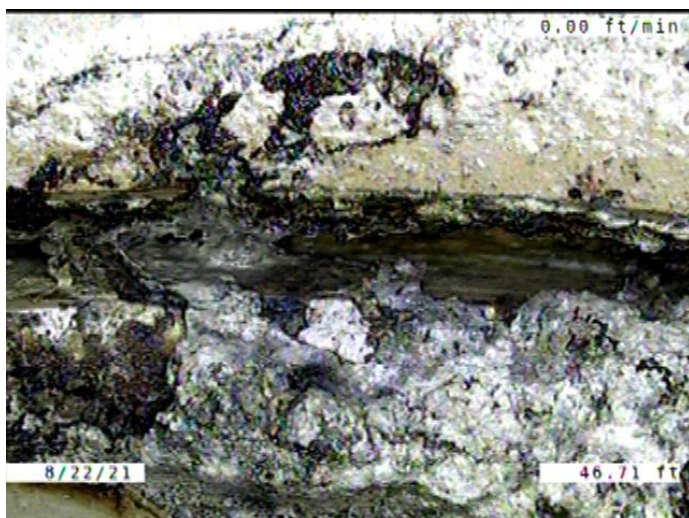
Code: **DAE**  
 Description: **Deposits Attached Encrustation**

Distance (ft): **46.7**  
 Structural Grade: **0**  
 O&M Grade: **2**  
 Clock Start/From: **7**  
 Clock To: **5**  
 1st Value:  
 2nd Value:  
 Value Percent: **5.000**  
 Continuous Index:  
 Within 8" of Joint: **YES**  
 Remarks:

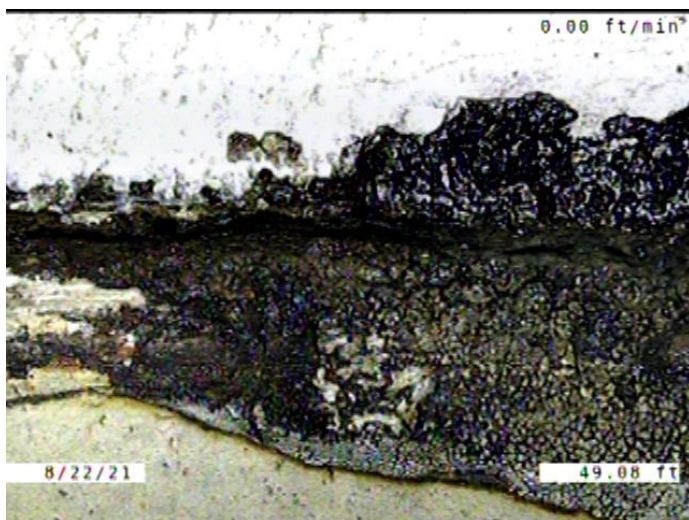
Code: **ISJ**  
 Description: **Infiltration Stain Joint**

Distance (ft): **49.1**  
 Structural Grade: **0**  
 O&M Grade: **1**  
 Clock Start/From: **8**  
 Clock To: **5**  
 1st Value:  
 2nd Value:  
 Value Percent:  
 Continuous Index:  
 Within 8" of Joint: **YES**  
 Remarks:

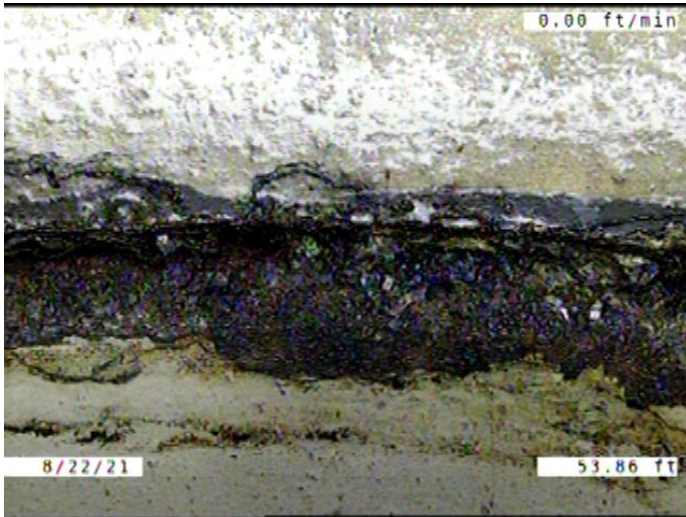
Code: **ISJ**  
Description: **Infiltration Stain Joint**

Distance (ft): **53.9**  
Structural Grade: **0**  
O&M Grade: **1**  
Clock Start/From: **7**  
Clock To: **5**  
1st Value:  
2nd Value:  
Value Percent:  
Continuous Index:  
Within 8" of Joint: **YES**  
Remarks:

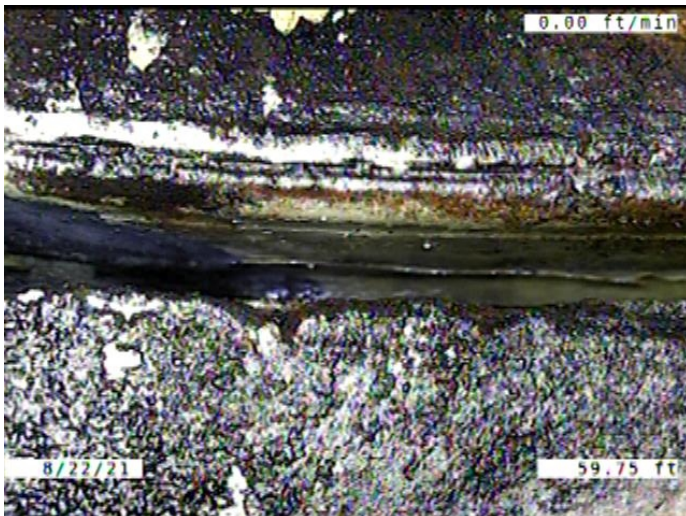
Code: **ISJ**  
Description: **Infiltration Stain Joint**

Distance (ft): **59.7**  
Structural Grade: **0**  
O&M Grade: **1**  
Clock Start/From: **3**  
Clock To: **5**  
1st Value:  
2nd Value:  
Value Percent:  
Continuous Index:  
Within 8" of Joint: **YES**  
Remarks:

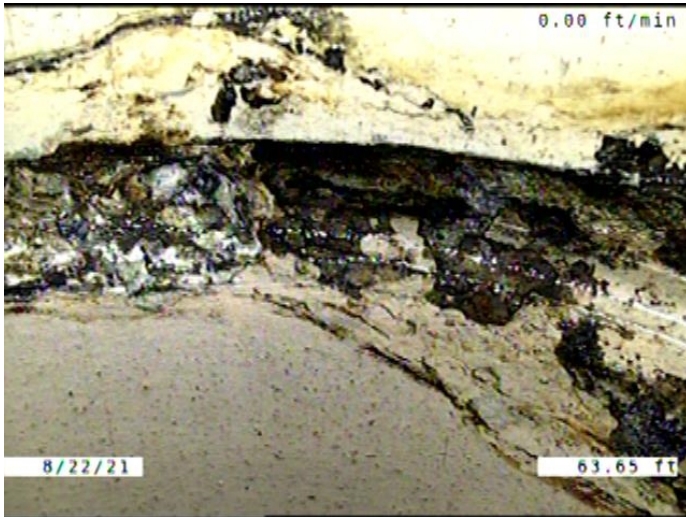
Code: **ISJ**  
 Description: **Infiltration Stain Joint**

Distance (ft): **63.7**  
 Structural Grade: **0**  
 O&M Grade: **1**  
 Clock Start/From: **11**  
 Clock To: **4**  
 1st Value:  
 2nd Value:  
 Value Percent:  
 Continuous Index:  
 Within 8" of Joint: **YES**  
 Remarks:

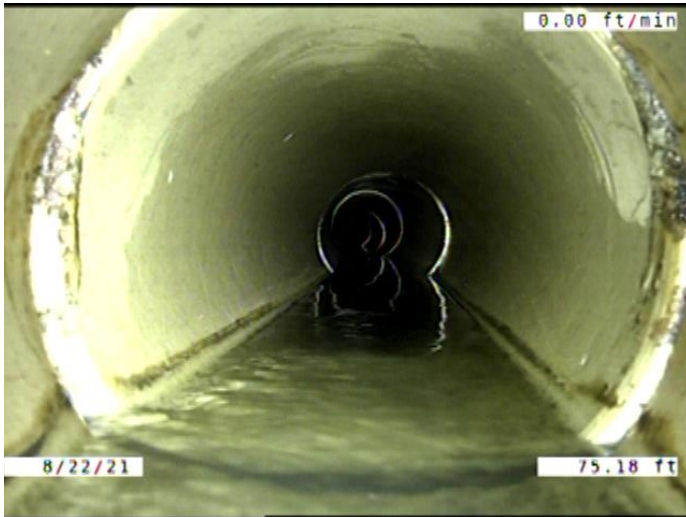
Code: **MWLS**  
 Description: **Miscellaneous Water Level Sag**

Distance (ft): **75.2**  
 Structural Grade: **2**  
 O&M Grade: **0**  
 Clock Start/From:  
 Clock To:  
 1st Value:  
 2nd Value:  
 Value Percent: **5.000**  
 Continuous Index: **S02**  
 Within 8" of Joint: **NO**  
 Remarks:

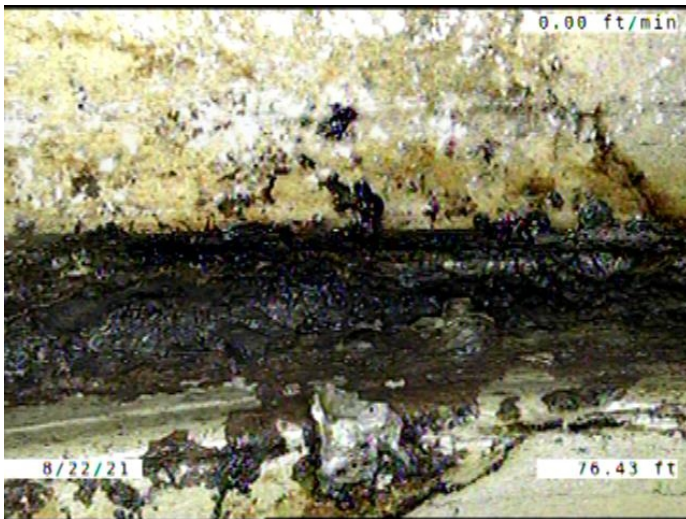
Code: **ISJ**  
 Description: **Infiltration Stain Joint**

Distance (ft): **76.4**  
 Structural Grade: **0**  
 O&M Grade: **1**  
 Clock Start/From: **8**  
 Clock To: **4**  
 1st Value:  
 2nd Value:  
 Value Percent:  
 Continuous Index:  
 Within 8" of Joint: **YES**  
 Remarks:

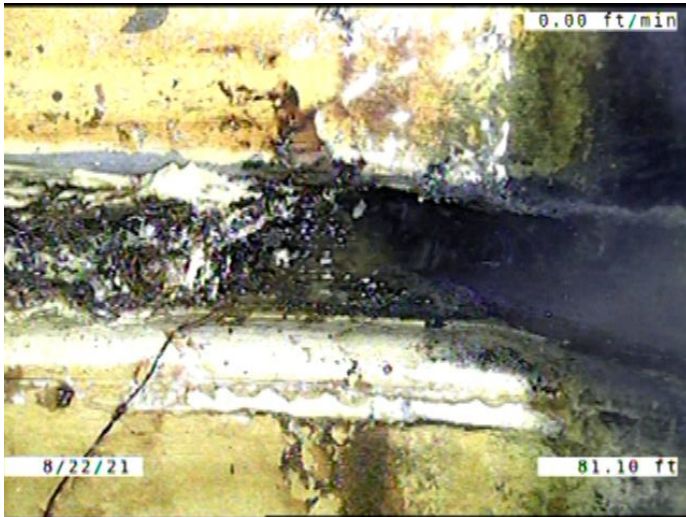
Code: **ISJ**  
 Description: **Infiltration Stain Joint**

Distance (ft): **81.1**  
 Structural Grade: **0**  
 O&M Grade: **1**  
 Clock Start/From: **1**  
 Clock To: **4**  
 1st Value:  
 2nd Value:  
 Value Percent:  
 Continuous Index:  
 Within 8" of Joint: **YES**  
 Remarks:

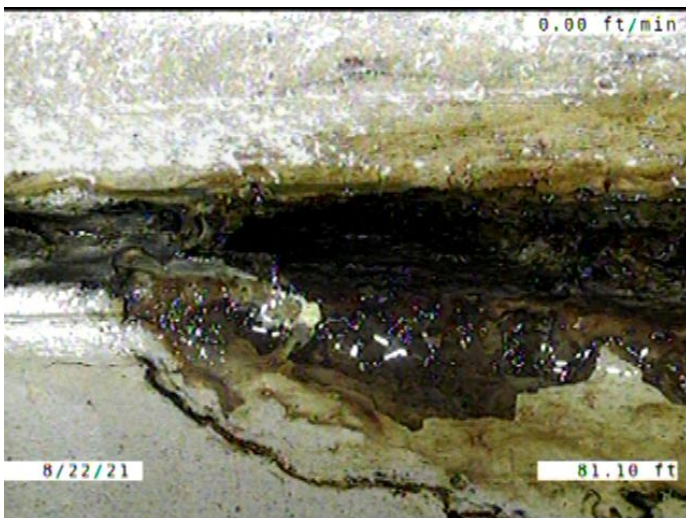
Code: **IDJ**  
 Description: **Infiltration Dripper Joint**

Distance (ft): **81.1**  
 Structural Grade: **0**  
 O&M Grade: **3**  
 Clock Start/From: **1**  
 Clock To: **5**  
 1st Value:  
 2nd Value:  
 Value Percent:  
 Continuous Index:  
 Within 8" of Joint: **YES**  
 Remarks:

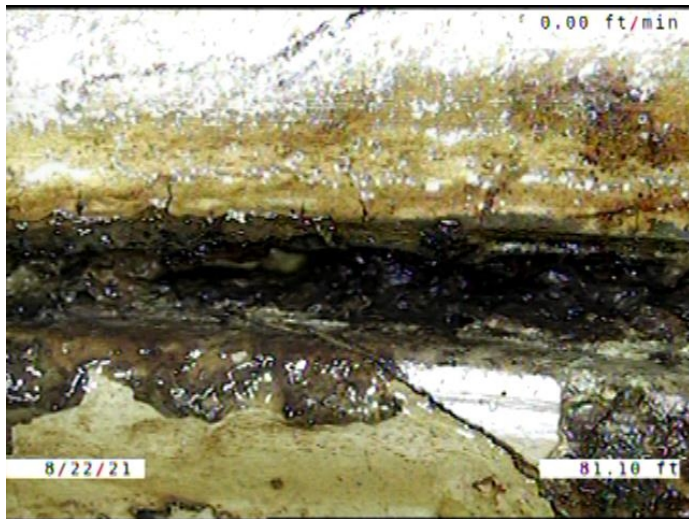
Code: **FM**  
 Description: **Fracture Multiple**

Distance (ft): **81.1**  
 Structural Grade: **4**  
 O&M Grade: **0**  
 Clock Start/From: **12**  
 Clock To: **4**  
 1st Value:  
 2nd Value:  
 Value Percent:  
 Continuous Index:  
 Within 8" of Joint: **NO**  
 Remarks:

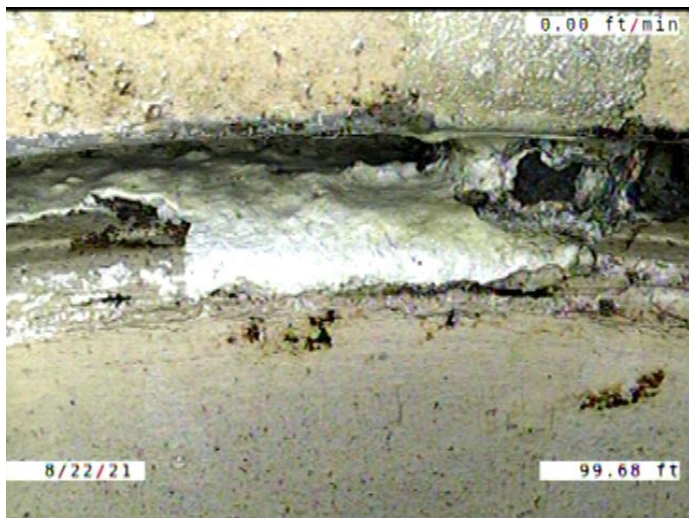
Code: **DAE**  
 Description: **Deposits Attached Encrustation**

Distance (ft): **99.7**  
 Structural Grade: **0**  
 O&M Grade: **2**  
 Clock Start/From: **7**  
 Clock To: **5**  
 1st Value:  
 2nd Value:  
 Value Percent: **5.000**  
 Continuous Index:  
 Within 8" of Joint: **YES**  
 Remarks:

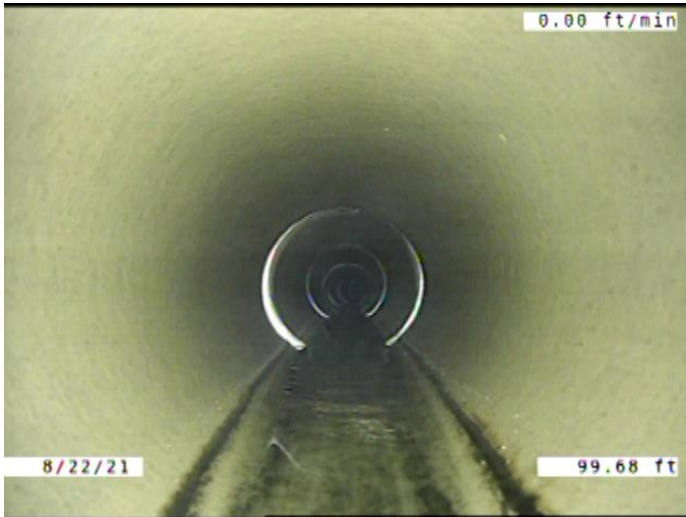
Code: **MWLS**  
 Description: **Miscellaneous Water Level Sag**

Distance (ft): **99.7**  
 Structural Grade: **2**  
 O&M Grade: **0**  
 Clock Start/From:  
 Clock To:  
 1st Value:  
 2nd Value:  
 Value Percent: **5.000**  
 Continuous Index: **F02**  
 Within 8" of Joint: **NO**  
 Remarks:

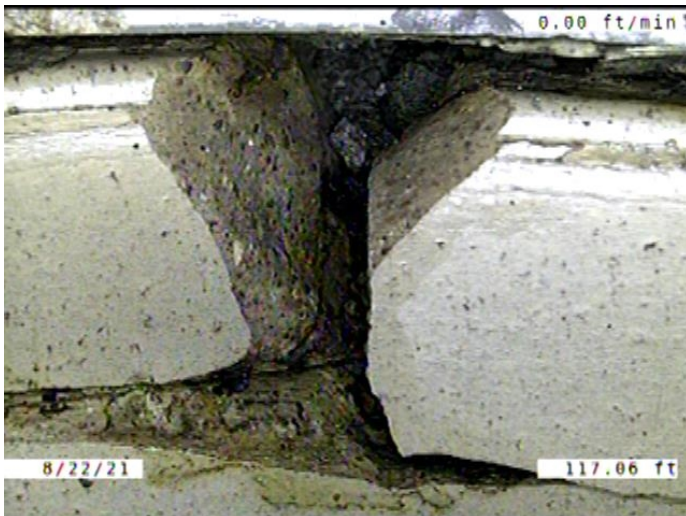
Code: **BSV**  
 Description: **Broken Soil Visible**

Distance (ft): **117.1**  
 Structural Grade: **5**  
 O&M Grade: **0**  
 Clock Start/From: **12**  
 Clock To: **12**  
 1st Value:  
 2nd Value:  
 Value Percent:  
 Continuous Index:  
 Within 8" of Joint: **YES**  
 Remarks:

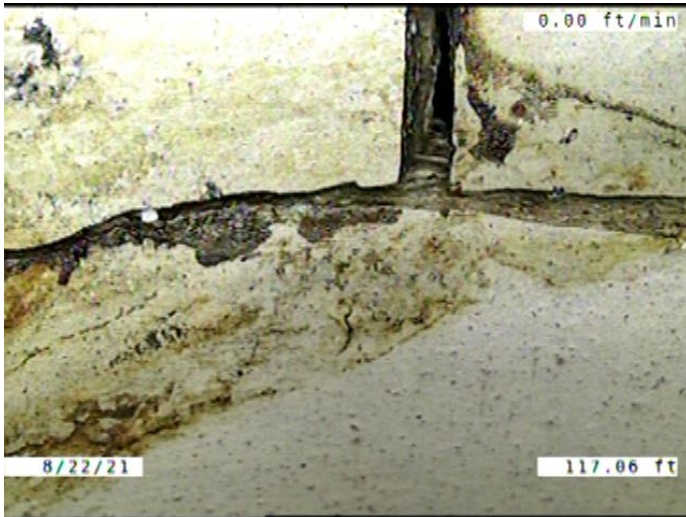
Code: **ISB**  
 Description: **Infiltration Stain Barrel**

Distance (ft): **117.1**  
 Structural Grade: **0**  
 O&M Grade: **1**  
 Clock Start/From: **7**  
 Clock To: **5**  
 1st Value:  
 2nd Value:  
 Value Percent:  
 Continuous Index:  
 Within 8" of Joint: **NO**  
 Remarks:

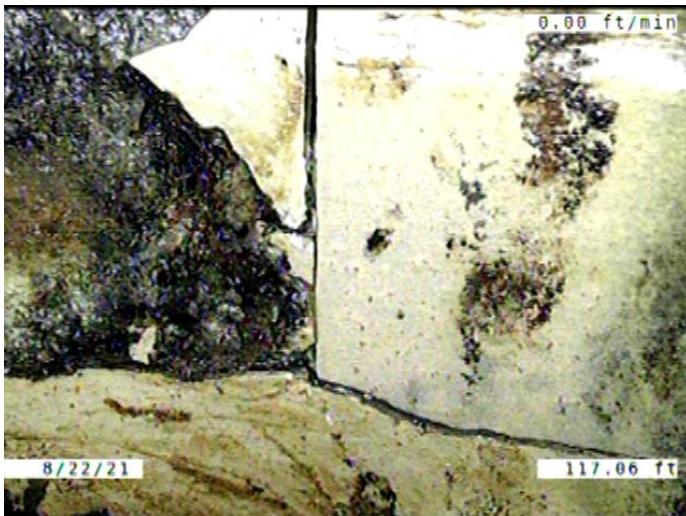
Code: **IRB**  
 Description: **Infiltration Runner Barrel**

Distance (ft): **117.1**  
 Structural Grade: **0**  
 O&M Grade: **4**  
 Clock Start/From: **4**  
 Clock To:  
 1st Value:  
 2nd Value:  
 Value Percent:  
 Continuous Index:  
 Within 8" of Joint: **YES**  
 Remarks:

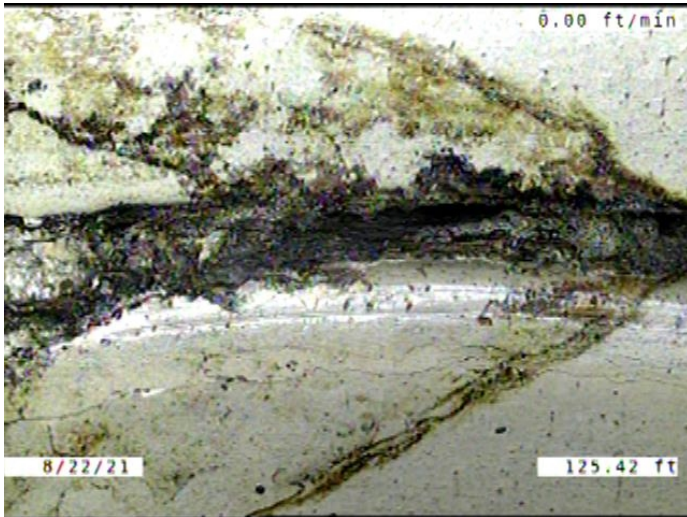
Code: **ISJ**  
 Description: **Infiltration Stain Joint**

Distance (ft): **125.4**  
 Structural Grade: **0**  
 O&M Grade: **1**  
 Clock Start/From: **8**  
 Clock To: **11**  
 1st Value:  
 2nd Value:  
 Value Percent:  
 Continuous Index:  
 Within 8" of Joint: **YES**  
 Remarks:

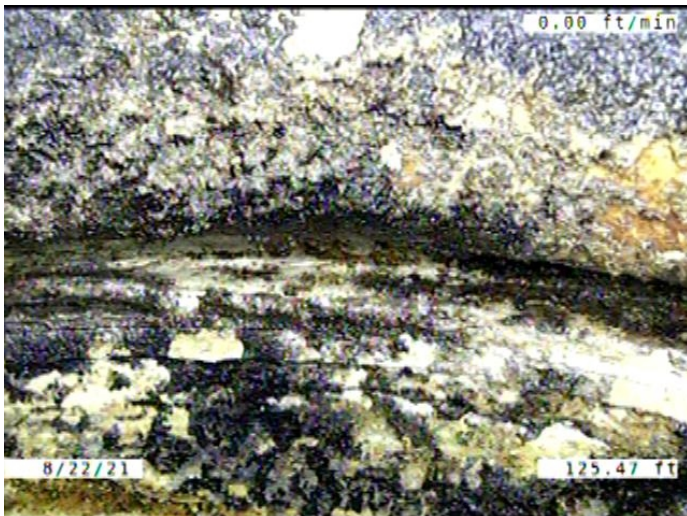
Code: **ISJ**  
 Description: **Infiltration Stain Joint**

Distance (ft): **125.5**  
 Structural Grade: **0**  
 O&M Grade: **1**  
 Clock Start/From: **1**  
 Clock To: **5**  
 1st Value:  
 2nd Value:  
 Value Percent:  
 Continuous Index:  
 Within 8" of Joint: **YES**  
 Remarks:

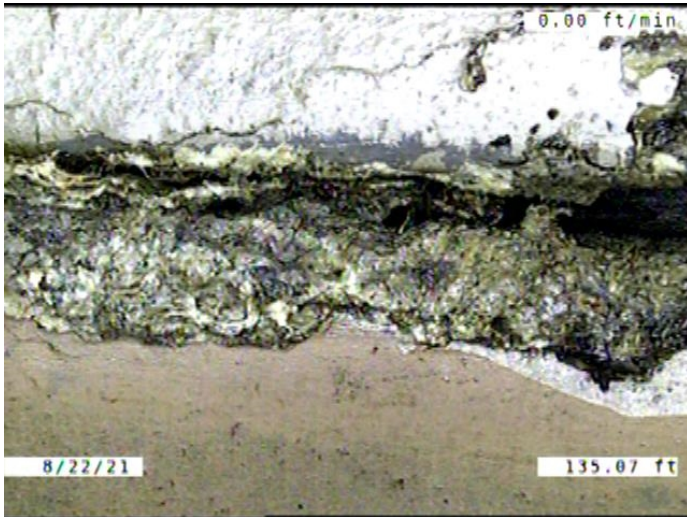
| Code: | <b>DAE</b> |
| Description: | <b>Deposits Attached Encrustation</b> |
| Distance (ft): | <b>135.1</b> |
| O&M Grade: | <b>2</b> |

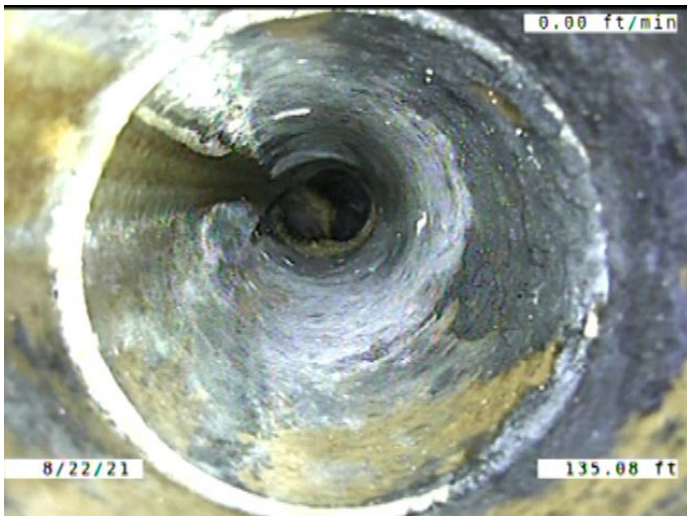
| Code: | <b>TF</b> |
| Description: | <b>Tap Factory</b> |
| Remarks: | <b>CONSTANTLY RUNNING WATER</b> |

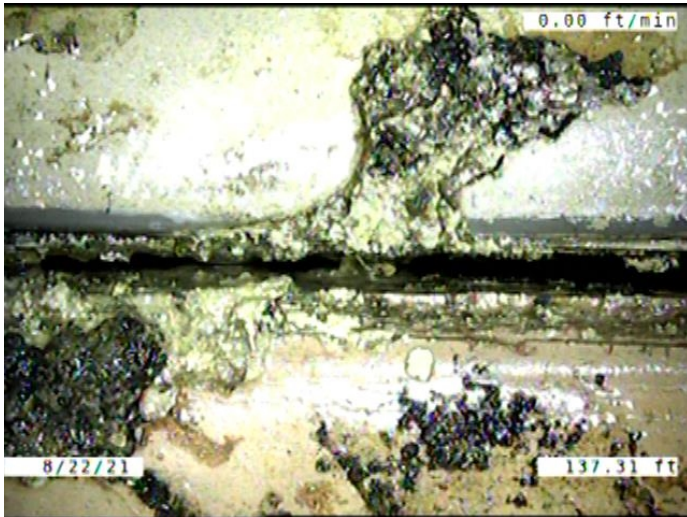
Code: **DAE**  
 Description: **Deposits Attached Encrustation**

Distance (ft): **137.3**  
 Structural Grade: **0**  
 O&M Grade: **2**  
 Clock Start/From: **1**  
 Clock To: **5**  
 1st Value:  
 2nd Value:  
 Value Percent: **5.000**  
 Continuous Index:  
 Within 8" of Joint: **YES**  
 Remarks:

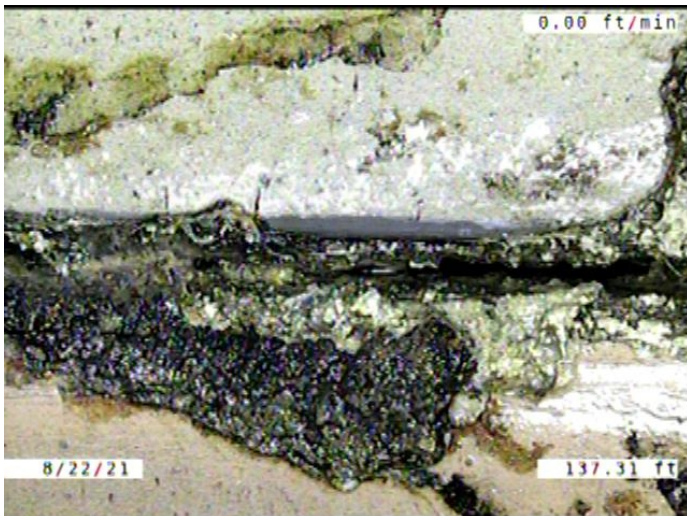
Code: **IDJ**  
 Description: **Infiltration Dripper Joint**

Distance (ft): **137.3**  
 Structural Grade: **0**  
 O&M Grade: **3**  
 Clock Start/From: **3**  
 Clock To:  
 1st Value:  
 2nd Value:  
 Value Percent:  
 Continuous Index:  
 Within 8" of Joint: **YES**  
 Remarks:

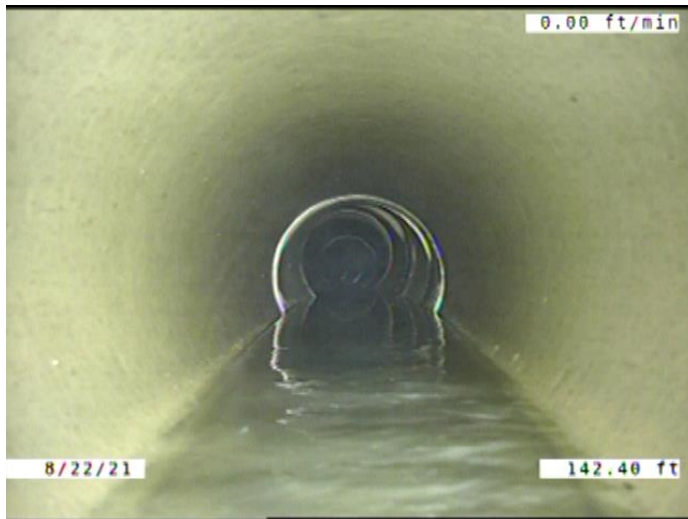
Code: **MWLS**  
Description: **Miscellaneous Water Level Sag**

Distance (ft): **142.4**  
Structural Grade: **2**  
O&M Grade: **0**  
Clock Start/From:  
Clock To:  
1st Value:  
2nd Value:  
Value Percent: **10.000**  
Continuous Index: **S03**  
Within 8" of Joint: **NO**  
Remarks:

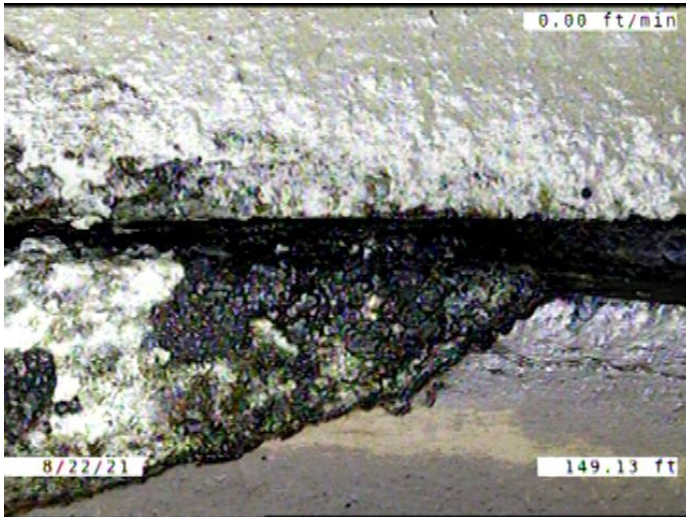
Code: **DAE**  
 Description: **Deposits Attached Encrustation**

Distance (ft): **149.1**  
 Structural Grade: **0**  
 O&M Grade: **2**  
 Clock Start/From: **7**  
 Clock To: **11**  
 1st Value:  
 2nd Value:  
 Value Percent: **5.000**  
 Continuous Index:  
 Within 8" of Joint: **YES**  
 Remarks:

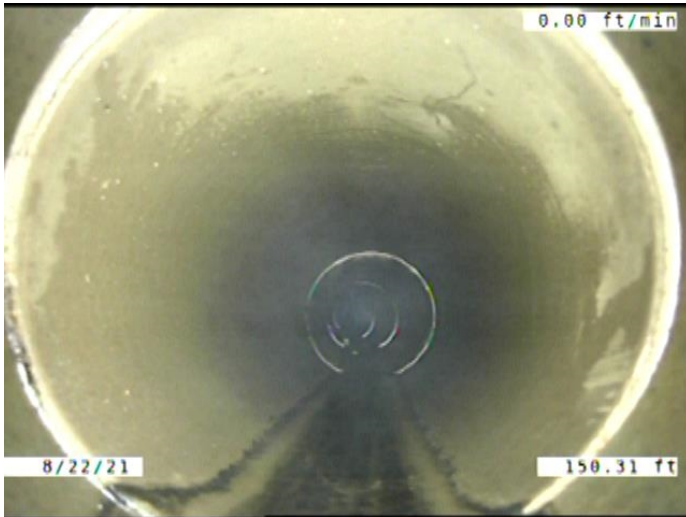
Code: **MWLS**  
 Description: **Miscellaneous Water Level Sag**

Distance (ft): **150.3**  
 Structural Grade: **2**  
 O&M Grade: **0**  
 Clock Start/From:  
 Clock To:  
 1st Value:  
 2nd Value:  
 Value Percent: **10.000**  
 Continuous Index: **F03**  
 Within 8" of Joint: **NO**  
 Remarks:

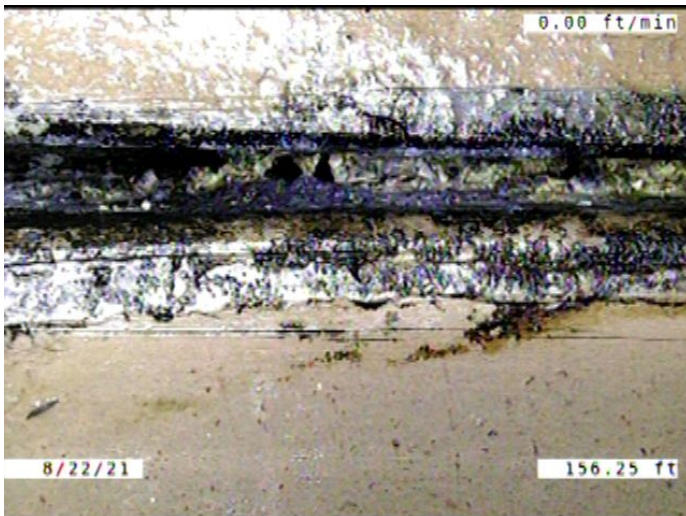
Code: **ISJ**  
 Description: **Infiltration Stain Joint**

Distance (ft): **156.2**  
 Structural Grade: **0**  
 O&M Grade: **1**  
 Clock Start/From: **7**  
 Clock To: **5**  
 1st Value:  
 2nd Value:  
 Value Percent:  
 Continuous Index:  
 Within 8" of Joint: **YES**  
 Remarks:

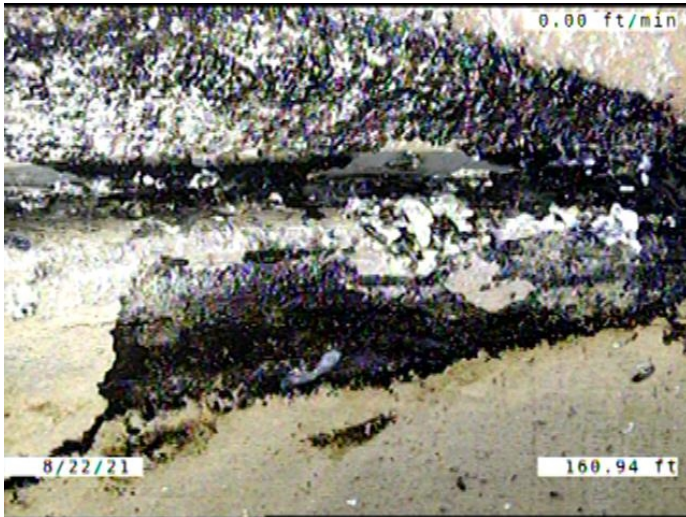
Code: **ISJ**  
 Description: **Infiltration Stain Joint**

Distance (ft): **160.9**  
 Structural Grade: **0**  
 O&M Grade: **1**  
 Clock Start/From: **7**  
 Clock To: **11**  
 1st Value:  
 2nd Value:  
 Value Percent:  
 Continuous Index:  
 Within 8" of Joint: **YES**  
 Remarks:

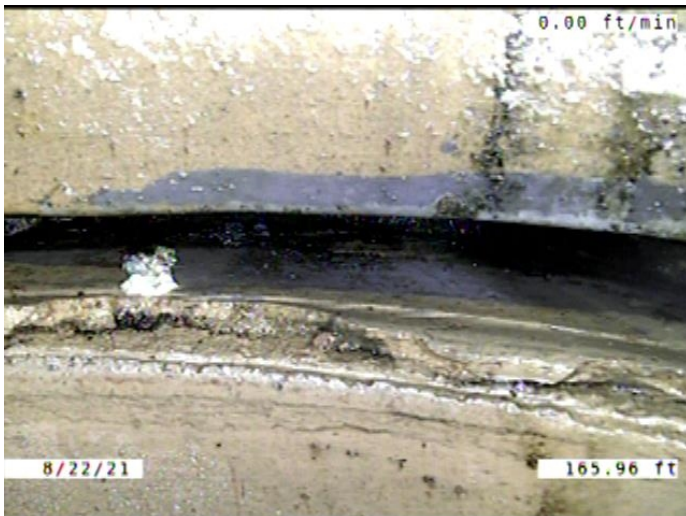
Code: **SSS**  
 Description: **Surface Damage Surface Spalling**

Distance (ft): **166.0**  
 Structural Grade: **2**  
 O&M Grade: **0**  
 Clock Start/From: **12**  
 Clock To: **5**  
 1st Value:  
 2nd Value:  
 Value Percent:  
 Continuous Index:  
 Within 8" of Joint: **YES**  
 Remarks:

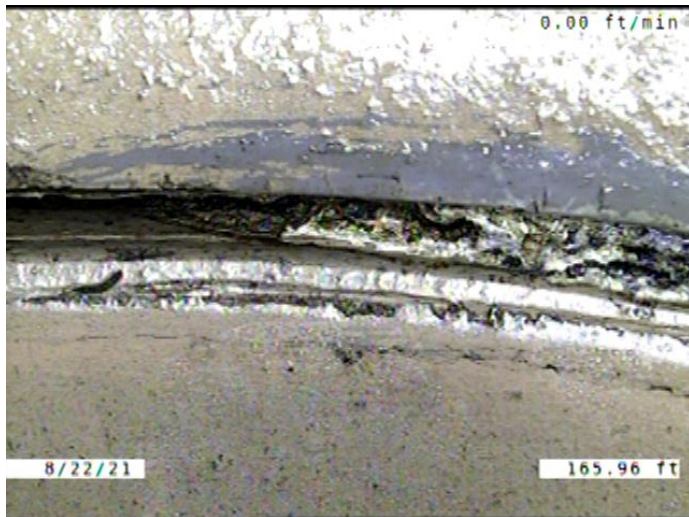
Code: **ISJ**  
 Description: **Infiltration Stain Joint**

Distance (ft): **166.0**  
 Structural Grade: **0**  
 O&M Grade: **1**  
 Clock Start/From: **7**  
 Clock To: **5**  
 1st Value:  
 2nd Value:  
 Value Percent:  
 Continuous Index:  
 Within 8" of Joint: **YES**  
 Remarks:

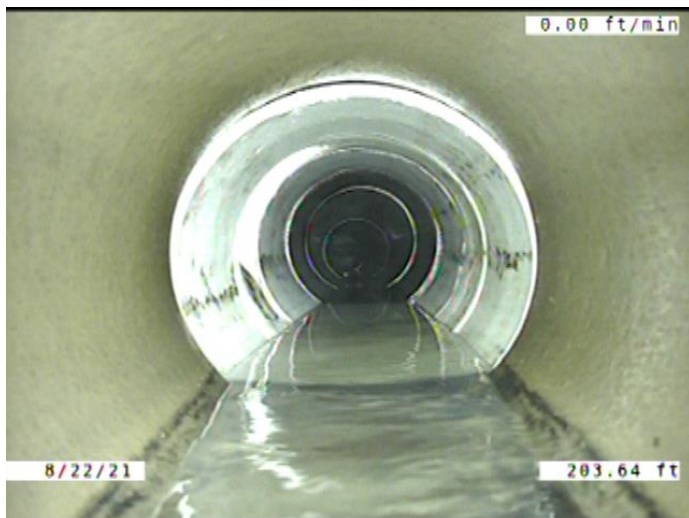
Code: **MWLS**  
 Description: **Miscellaneous Water Level Sag**

Distance (ft): **203.6**  
 Structural Grade: **2**  
 O&M Grade: **0**  
 Clock Start/From:  
 Clock To:  
 1st Value:  
 2nd Value:  
 Value Percent: **5.000**  
 Continuous Index: **S04**  
 Within 8" of Joint: **NO**  
 Remarks:

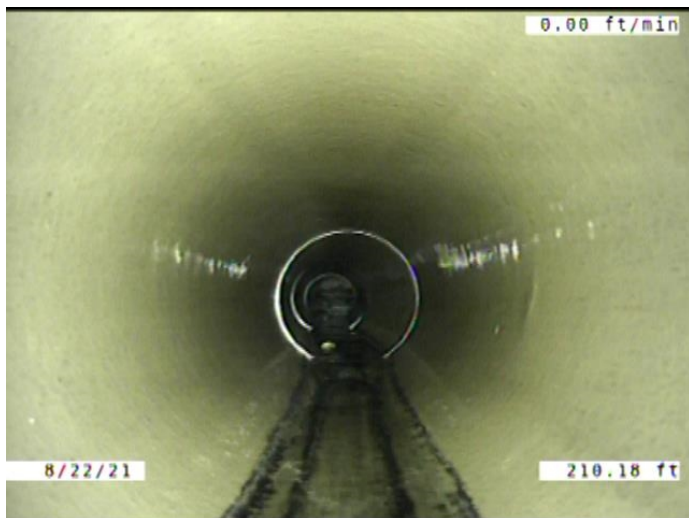
Code: **MWLS**  
Description: **Miscellaneous Water Level Sag**

Distance (ft): **210.2**  
Structural Grade: **2**  
O&M Grade: **0**  
Clock Start/From:  
Clock To:  
1st Value:  
2nd Value:  
Value Percent: **5.000**  
Continuous Index: **F04**  
Within 8" of Joint: **NO**  
Remarks:

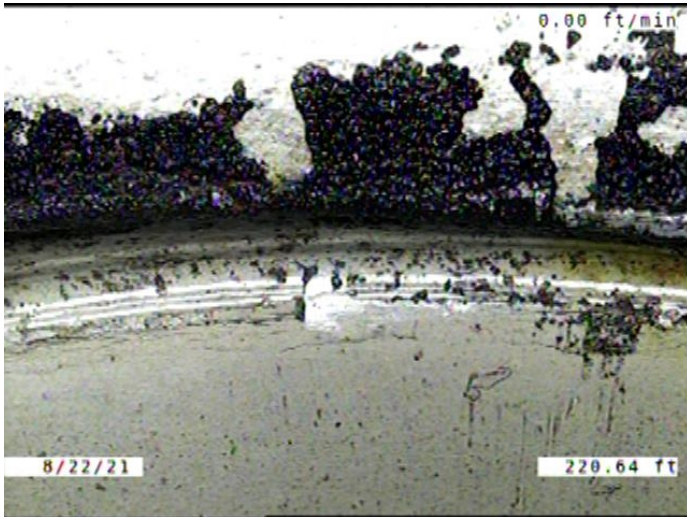
Code: **DAE**  
 Description: **Deposits Attached Encrustation**

Distance (ft): **220.6**  
 Structural Grade: **0**  
 O&M Grade: **2**  
 Clock Start/From: **7**  
 Clock To: **5**  
 1st Value:  
 2nd Value:  
 Value Percent: **5.000**  
 Continuous Index:  
 Within 8" of Joint: **YES**  
 Remarks:
