Profile/Photo Observation Report

Date:	10/18/2021	Weather:		Coding:	PACP 6.0
Pipe Length (ft):		Owner:	Hobart, IN	Pre Clean:	Not Known
P.O.#:	878_1	Surveyor:	M. Pielacha	PSR:	P-503-082-053
Customer:	Hobart, IN	Clean Date:		Shape:	C

Street:	Off 38th Place	Flow Control:	
City:	Hobart, IN	Year Renewed:	
Location:	Easement/Right of Way	Tape/Media #:	878
Purpose:	Routine Assessment	Dia/Height:	10"
Use:	Sanitary	Material:	VCP
Drain Area:		Lining:	
Category:	NA		
Comment:			
Location Details:		Direction of Survey:	Upstream
US MH:	M-503-82	DS MH:	M-503-53
		Total Length Surveyed (ft):	9.0

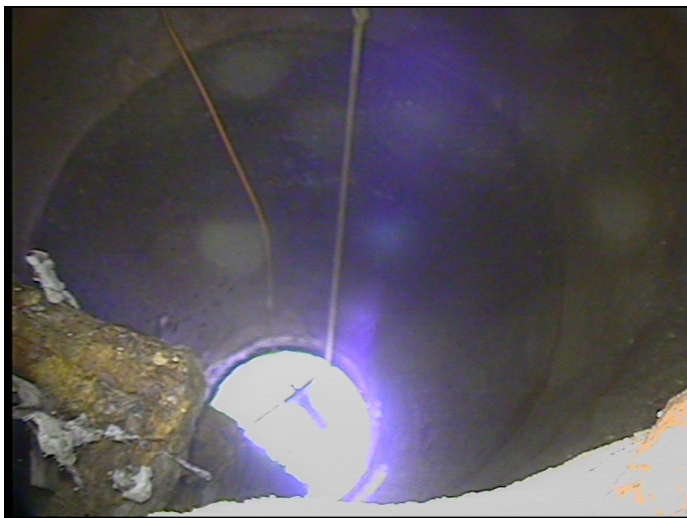
Code:	AMH
Description:	Manhole
Distance (ft):	.0
Structural Grade:	0
O&M Grade:	0
Clock Start/From:	
Clock To:	
1st Value:	
2nd Value:	
Value Percent:	
Continuous Index:	
Within 8" of Joint:	NO
Remarks:	M-503-53

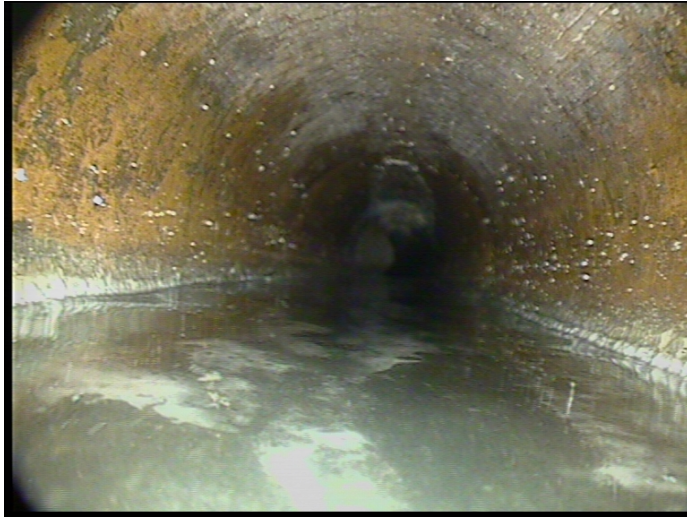
Code: **MWL**
Description: **Water Level**

Distance (ft): **.0**
Structural Grade: **0**
O&M Grade: **0**
Clock Start/From:
Clock To:
1st Value:
2nd Value:
Value Percent: **15.000**
Continuous Index:
Within 8" of Joint: **NO**
Remarks:

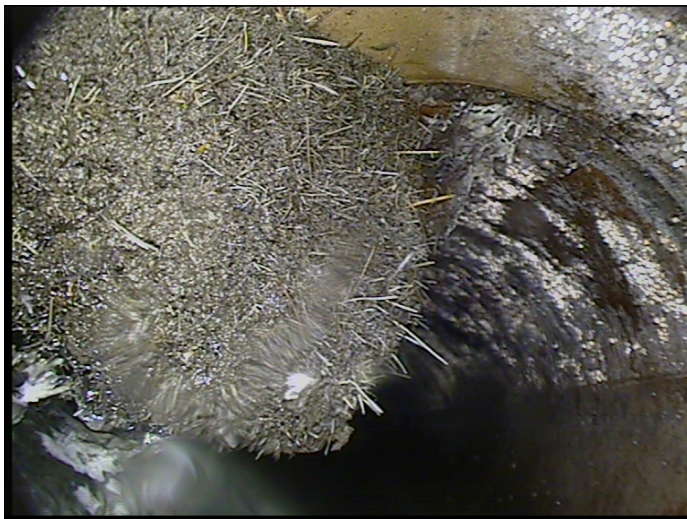
Code: **RMJ**
Description: **Roots Medium Joint**

Distance (ft): **8.6**
Structural Grade: **0**
O&M Grade: **3**
Clock Start/From: **7**
Clock To: **10**
1st Value:
2nd Value:
Value Percent: **25.000**
Continuous Index:
Within 8" of Joint: **YES**
Remarks:

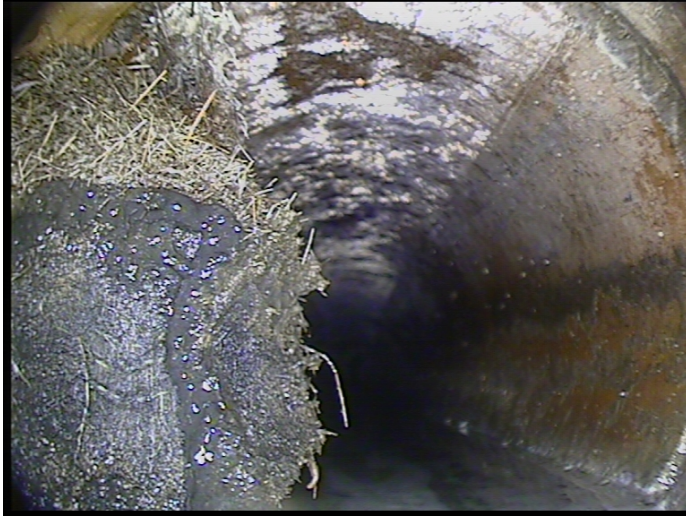
Code:	MSA
Description:	Abandoned Survey
Distance (ft):	9.0
Structural Grade:	0
O&M Grade:	0
Clock Start/From:	
Clock To:	
1st Value:	
2nd Value:	
Value Percent:	
Continuous Index:	
Within 8" of Joint:	NO
Remarks:	Large Roots
