Date: Pipe Length (ft)	10/18/2021	Weather: Owner:	Hobart, IN		Coding: Pre Clean:	PACP 6.0 Not Known
P.O.#:		Surveyor:	M. Pielacha		PSR:	P-503-082-053
Customer:	Hobart, IN	Clean Date:			Shape:	C
Street:	Off Guyer Street		Flow Control:			
City:	Hobart, IN		Year Renewed:			
Location:	Yard		Tape/Media #:		880	
Purpose:	Routine Assessment		Dia/Height:		10"	
Use:	Sanitary		Material:		VCP	
Drain Area:			Lining:			
Category:	NA					
Comment:						
Location Detail	s:		Direction of Surv	/ey:	Downstream	
US MH:	M-503-82	DS MH:	M-503-53	Total Leng	th Surveyed (ft):	168.9
0&M Index:	1.20	O&M Quick:	281	E O8	M Rating:	49.00
Structural Index:	0.00	 Structural Qu	uick: 000	0	uctural Rating:	0.00
Overall Index:	1.20	Overall Quick		-	erall Rating:	49.00

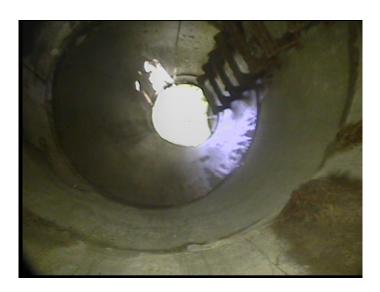
Code: Description:	AMH Manhole
Distance (ft):	.0
Structural Grade:	0
O&M Grade:	0
Clock Start/From:	
Clock To:	
1st Value:	
2nd Value:	
Value Percent:	
Continuous Index:	
Within 8" of Joint:	NO
Remarks:	M-503-82

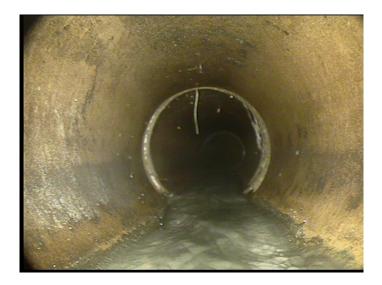
Code:	MWL
Description:	Water Level
Distance (ft):	0
Distance (ft):	.0
Structural Grade:	0
O&M Grade:	0
Clock Start/From:	
Clock To:	
1st Value:	
2nd Value:	
Value Percent:	5.000
Continuous Index:	
Within 8" of Joint:	NO
Remarks:

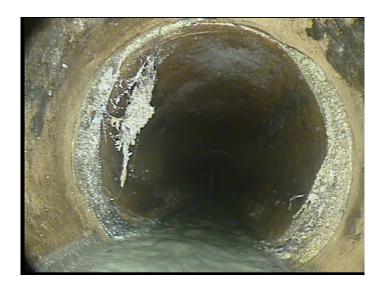
Code: Description:	RFJ Roots Fine Joint
Distance (ft):	.0
Structural Grade:	0
O&M Grade:	1
Clock Start/From:	7
Clock To:	5
1st Value:	
2nd Value:	
Value Percent:	
Continuous Index:	S01
Within 8" of Joint:	YES
Remarks:

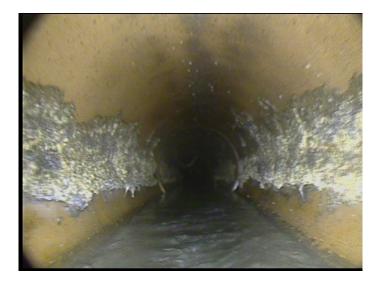
Code: Description:	DAGS Deposits Attached Grease
Distance (ft):	72.1
Structural Grade:	0
O&M Grade:	2
Clock Start/From:	8
Clock To:	4
1st Value:	
2nd Value:	
Value Percent:	5.000
Continuous Index:	S02
Within 8" of Joint:	YES
Remarks:

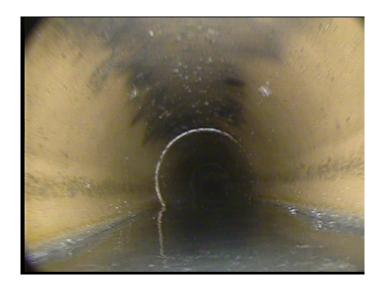
Code: Description:	DAGS Deposits Attached Grease
Distance (ft): Structural Grade: O&M Grade: Clock Start/From: Clock To: 1st Value: 2nd Value: Value Percent: Continuous Index:	109.8 0 2 8 4 5.000 F02
Within 8" of Joint: Remarks:	NO

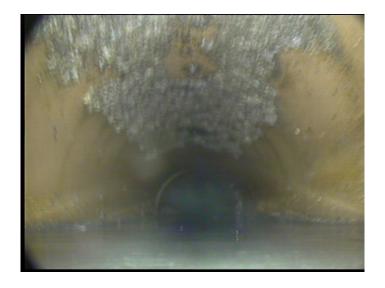
Code:	MWL
Description:	Water Level
Distance (ft):	124.7
Structural Grade:	0
O&M Grade:	0
Clock Start/From:	
Clock To:	
1st Value:	
2nd Value:	
Value Percent:	20.000
Continuous Index:	
Within 8" of Joint:	NO
Remarks:

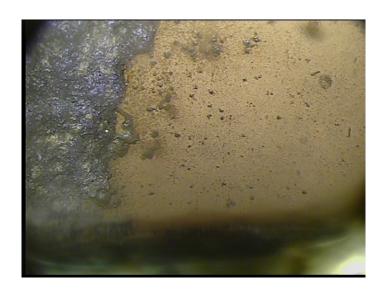
Code: Description:	RFJ Roots Fine Joint
Distance (ft): Structural Grade: O&M Grade: Clock Start/From: Clock To: 1st Value: 2nd Value: Value Percent:	162.7 0 1 7 5
Continuous Index: Within 8" of Joint: Remarks:	F01 YES

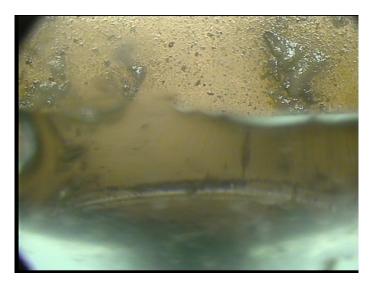
Code: MSA Description: Abandoned Survey Distance (ft): 168.9 Structural Grade: 0 O&M Grade: 0 Clock Start/From: Clock To: 1st Value: 2nd Value: Value Percent: Continuous Index: Within 8" of Joint: NO Remarks: Under water debris
