## Profile/Photo Observation Report

Date:	<b>10/18/2021</b>	Weather:		Coding:	<b>PACP 6.0</b>
Pipe Length (ft):		Owner:	<b>Hobart, IN</b>	Pre Clean:	<b>Not Known</b>
P.O.#:	<b>881_1</b>	Surveyor:	<b>M. Pielacha</b>	PSR:	<b>P-503-083-082</b>
Customer:	<b>Hobart, IN</b>	Clean Date:		Shape:	<b>C</b>

Street:	<b>Off Guyer Street</b>	Flow Control:	
City:	<b>Hobart, IN</b>	Year Renewed:	
Location:	<b>Yard</b>	Tape/Media #:	<b>881</b>
Purpose:	<b>Routine Assessment</b>	Dia/Height:	<b>10"</b>
Use:	<b>Sanitary</b>	Material:	<b>VCP</b>
Drain Area:		Lining:	
Category:	<b>NA</b>		
Comment:

Location Details:		Direction of Survey:	<b>Upstream</b>
US MH:	<b>M-503-82</b>	DS MH:	<b>M-503-83</b>
		Total Length Surveyed (ft):	<b>176.6</b>

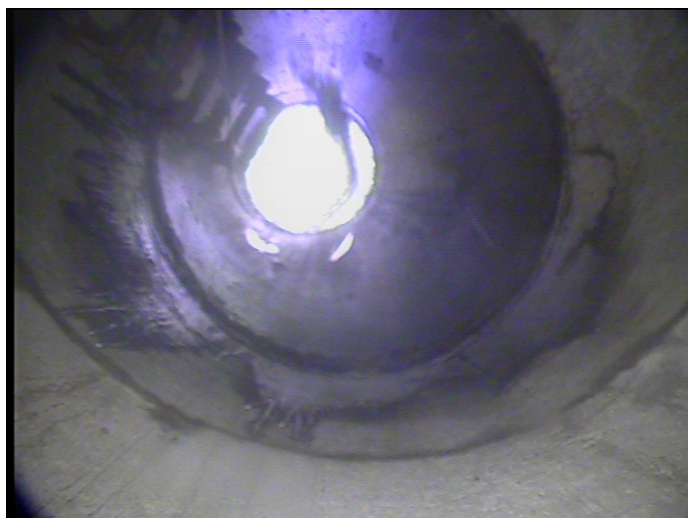
Code: **AMH**  
 Description: **Manhole**

Distance (ft): **.0**  
 Structural Grade: **0**  
 O&M Grade: **0**  
 Clock Start/From:  
 Clock To:  
 1st Value:  
 2nd Value:  
 Value Percent:  
 Continuous Index:  
 Within 8" of Joint: **NO**  
 Remarks: **M-503-83**

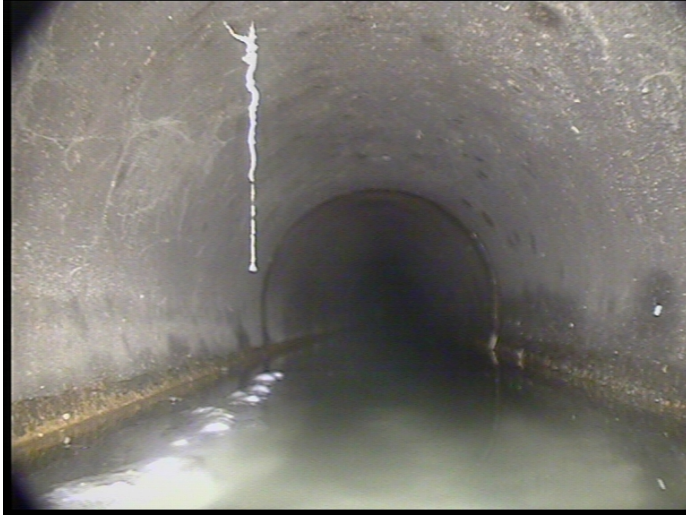
Code: **MWL**  
Description: **Water Level**

Distance (ft): **.0**  
Structural Grade: **0**  
O&M Grade: **0**  
Clock Start/From:  
Clock To:  
1st Value:  
2nd Value:  
Value Percent: **10.000**  
Continuous Index:  
Within 8" of Joint: **NO**  
Remarks:

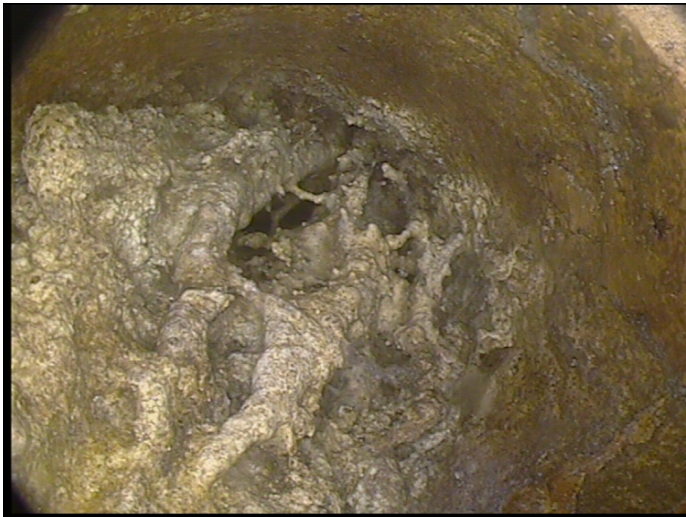
Code: **TFD**  
Description: **Tap Factory Defective**

Distance (ft): **30.2**  
Structural Grade: **0**  
O&M Grade: **2**  
Clock Start/From: **10**  
Clock To:  
1st Value: **4.000**  
2nd Value:  
Value Percent:  
Continuous Index:  
Within 8" of Joint: **NO**  
Remarks: **Defective**

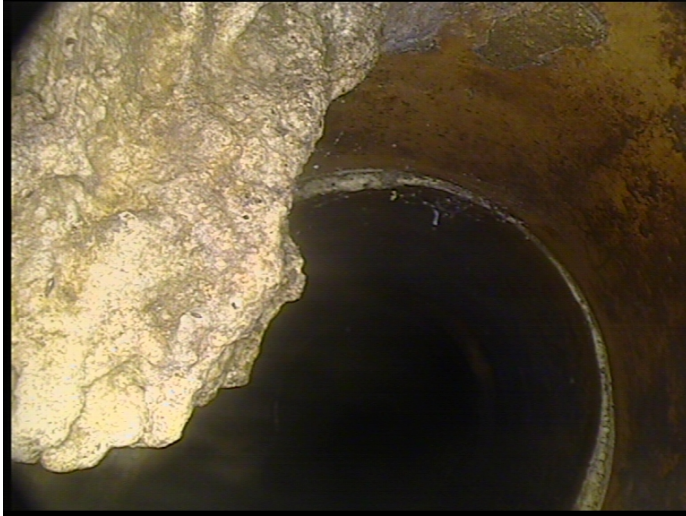
Code:	<b>DAE</b>
Description:	<b>Deposits Attached Encrustation</b>
Distance (ft):	<b>30.2</b>
Structural Grade:	<b>0</b>
O&M Grade:	<b>3</b>
Clock Start/From:	<b>7</b>
Clock To:	<b>10</b>
1st Value:	
2nd Value:	
Value Percent:	<b>15.000</b>
Continuous Index:	
Within 8" of Joint:	<b>YES</b>
Remarks:

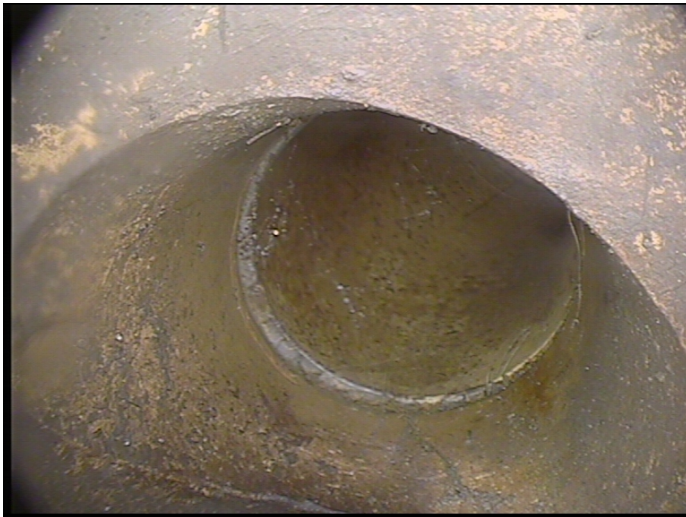
Code:	<b>TF</b>
Description:	<b>Tap Factory</b>
Distance (ft):	<b>32.0</b>
Structural Grade:	<b>0</b>
O&M Grade:	<b>0</b>
Clock Start/From:	<b>2</b>
Clock To:	
1st Value:	<b>4.000</b>
2nd Value:	
Value Percent:	
Continuous Index:	
Within 8" of Joint:	<b>NO</b>
Remarks:

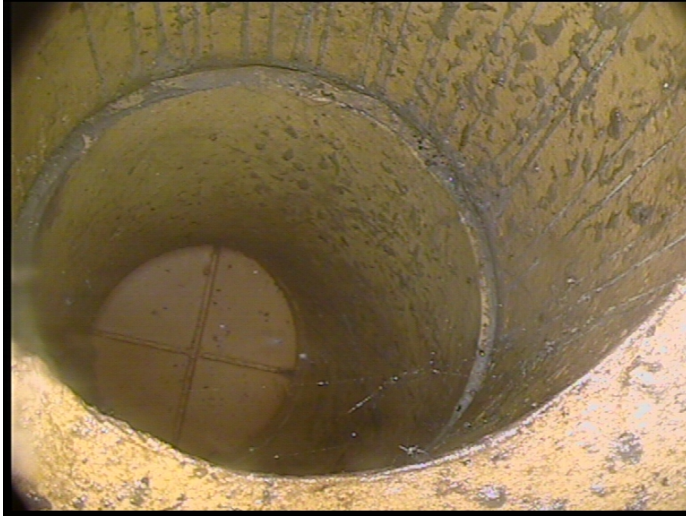
Code: **TFC**  
Description: **Tap Factory Capped**

Distance (ft): **83.6**  
Structural Grade: **0**  
O&M Grade: **0**  
Clock Start/From: **10**  
Clock To:  
1st Value: **4.000**  
2nd Value:  
Value Percent:  
Continuous Index:  
Within 8" of Joint: **NO**  
Remarks:

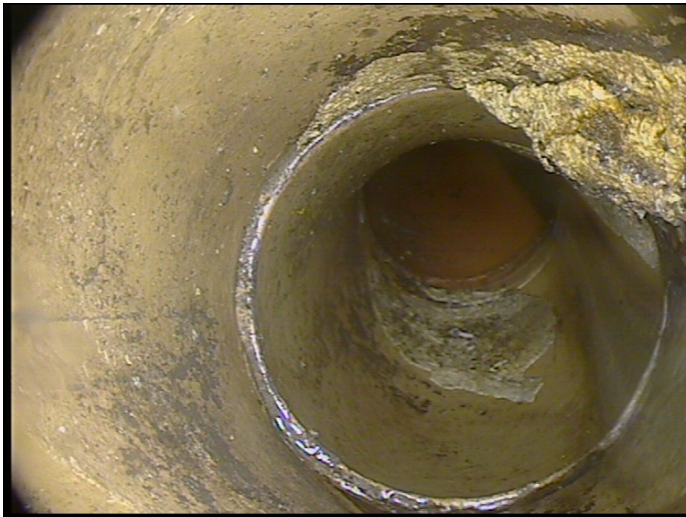
Code: **TFA**  
Description: **Tap Factory Active**

Distance (ft): **85.5**  
Structural Grade: **0**  
O&M Grade: **0**  
Clock Start/From: **2**  
Clock To:  
1st Value: **4.000**  
2nd Value:  
Value Percent:  
Continuous Index:  
Within 8" of Joint: **NO**  
Remarks:

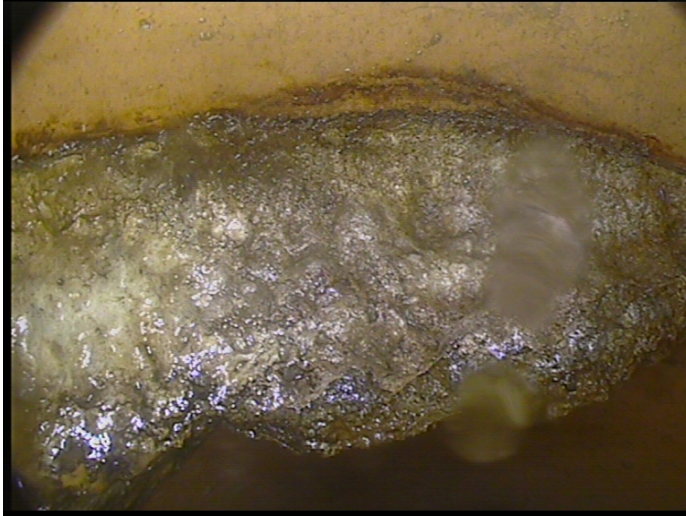
Code:	<b>DAE</b>
Description:	<b>Deposits Attached Encrustation</b>
Distance (ft):	<b>137.8</b>
Structural Grade:	<b>0</b>
O&M Grade:	<b>2</b>
Clock Start/From:	<b>7</b>
Clock To:	<b>11</b>
1st Value:	
2nd Value:	
Value Percent:	<b>5.000</b>
Continuous Index:	
Within 8" of Joint:	<b>YES</b>
Remarks:

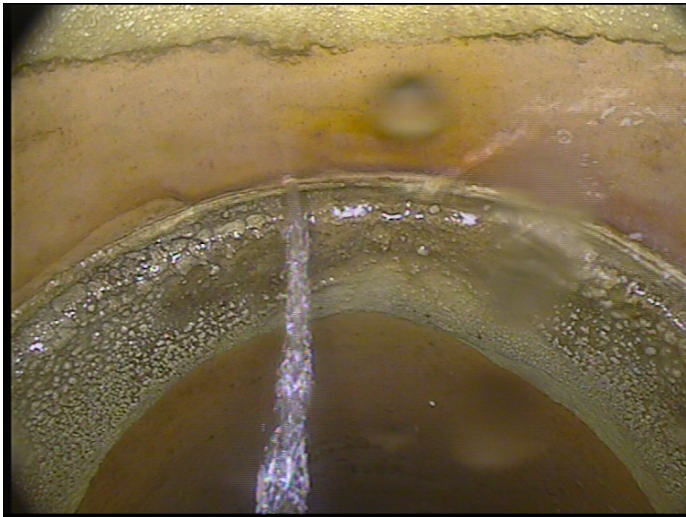
Code:	<b>IR</b>
Description:	<b>Infil Runner</b>
Distance (ft):	<b>145.3</b>
Structural Grade:	<b>0</b>
O&M Grade:	<b>4</b>
Clock Start/From:	<b>12</b>
Clock To:	
1st Value:	
2nd Value:	
Value Percent:	
Continuous Index:	
Within 8" of Joint:	<b>YES</b>
Remarks:

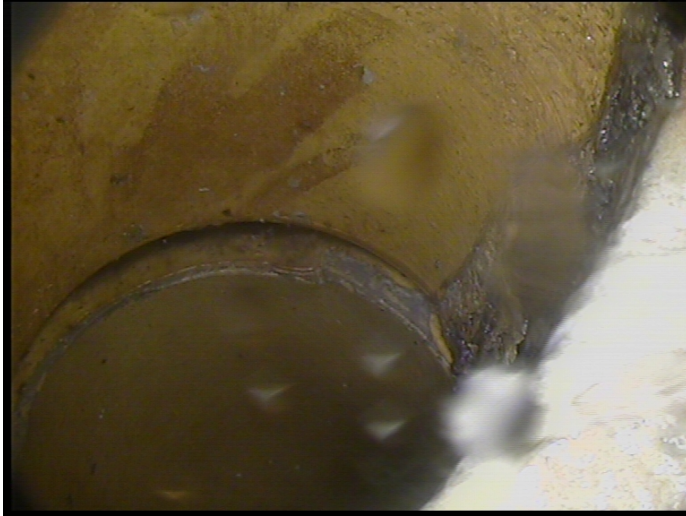
Code: **TFA**  
Description: **Tap Factory Active**

Distance (ft): **156.9**  
Structural Grade: **0**  
O&M Grade: **0**  
Clock Start/From: **2**  
Clock To:  
1st Value: **4.000**  
2nd Value:  
Value Percent:  
Continuous Index:  
Within 8" of Joint: **NO**  
Remarks:

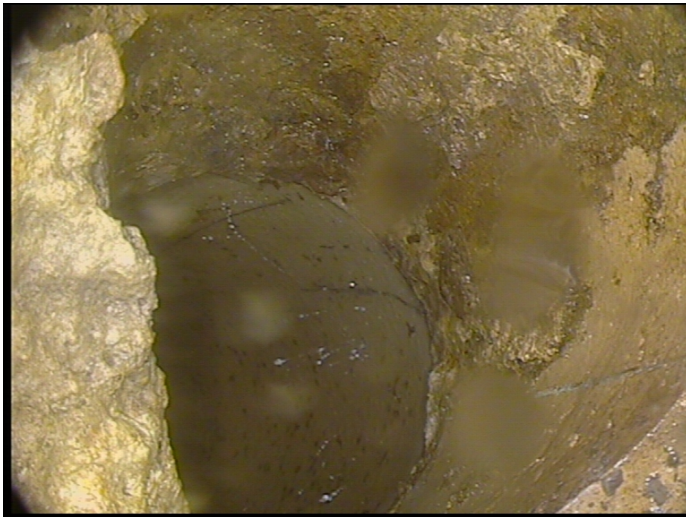
Code: **TF**  
Description: **Tap Factory**

Distance (ft): **159.3**  
Structural Grade: **0**  
O&M Grade: **0**  
Clock Start/From: **10**  
Clock To:  
1st Value: **4.000**  
2nd Value:  
Value Percent:  
Continuous Index:  
Within 8" of Joint: **NO**  
Remarks:

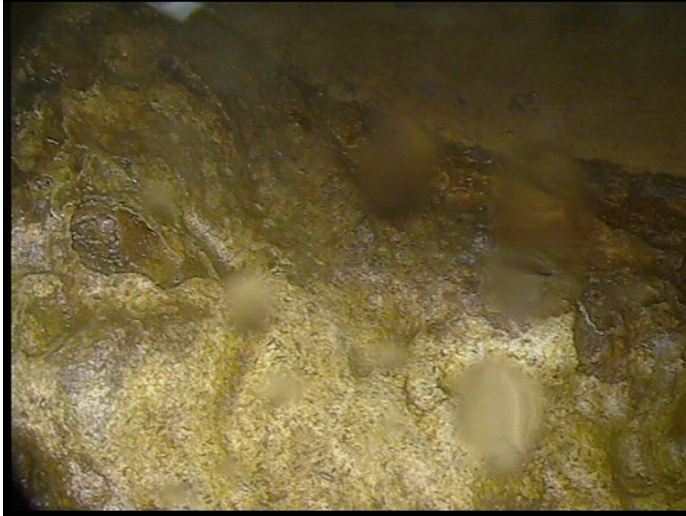
Code:	<b>DAE</b>
Description:	<b>Deposits Attached Encrustation</b>
Distance (ft):	<b>159.3</b>
Structural Grade:	<b>0</b>
O&M Grade:	<b>2</b>
Clock Start/From:	<b>7</b>
Clock To:	<b>10</b>
1st Value:	
2nd Value:	
Value Percent:	<b>5.000</b>
Continuous Index:	
Within 8" of Joint:	<b>YES</b>
Remarks:

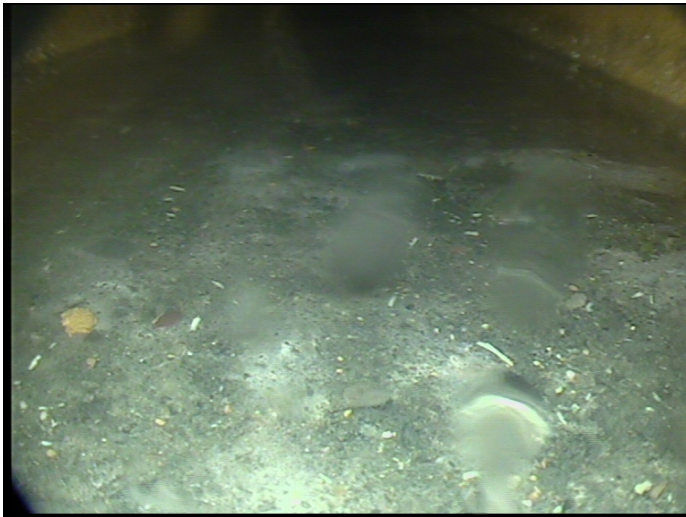
Code:	<b>DSF</b>
Description:	<b>Deposits Settled Fine</b>
Distance (ft):	<b>176.6</b>
Structural Grade:	<b>0</b>
O&M Grade:	<b>3</b>
Clock Start/From:	<b>4</b>
Clock To:	<b>8</b>
1st Value:	
2nd Value:	
Value Percent:	<b>15.000</b>
Continuous Index:	
Within 8" of Joint:	<b>NO</b>
Remarks:

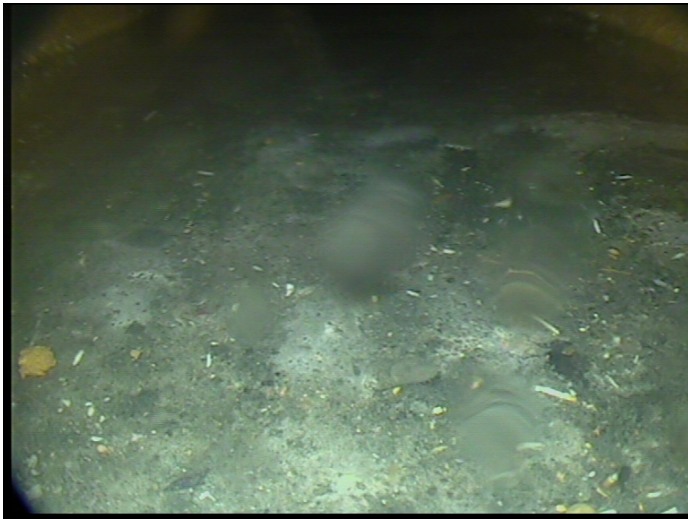
Code:	<b>MSA</b>
Description:	<b>Abandoned Survey</b>
Distance (ft):	<b>176.6</b>
Structural Grade:	<b>0</b>
O&M Grade:	<b>0</b>
Clock Start/From:	
Clock To:	
1st Value:	
2nd Value:	
Value Percent:	
Continuous Index:	
Within 8" of Joint:	<b>NO</b>
Remarks:	<b>deep sediment</b>
