Profile/Photo Observation Report

Date:	04/13/2018	Weather:		Coding:	PACP 6.0
Pipe Length (ft):	272.4	Owner:	NA	Pre Clean:	Not Known
P.O.#:		Surveyor:	Jen Costello	PSR:	P-503-084-083
Customer:		Clean Date:	01/01/1900	Shape:	C

Street:	ALLEY BETWEEN N WILSON ST & N G	Flow Control:	Not Controlled
City:	Hobart, IN	Year Renewed:	
Location:	Other	Tape/Media #:	
Purpose:	Not Known	Dia/Height:	10"
Use:	Sanitary	Material:	VCP
Drain Area:	NA	Lining:	
Category:	NA		
Comment:

Location Details:		Direction of Survey:	Downstream
US MH:	M-503-083	DS MH:	M-503-084
		Total Length Surveyed (ft):	23.4

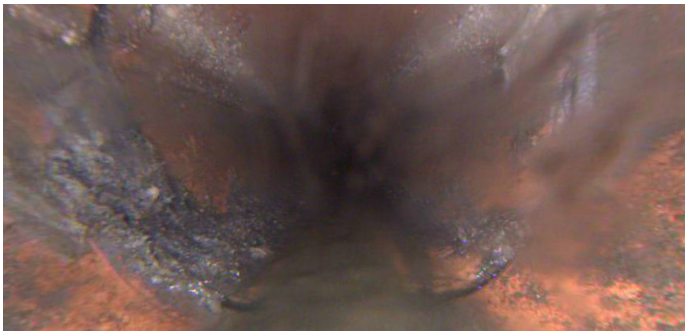
Code: **AMH**
Description: **Manhole**

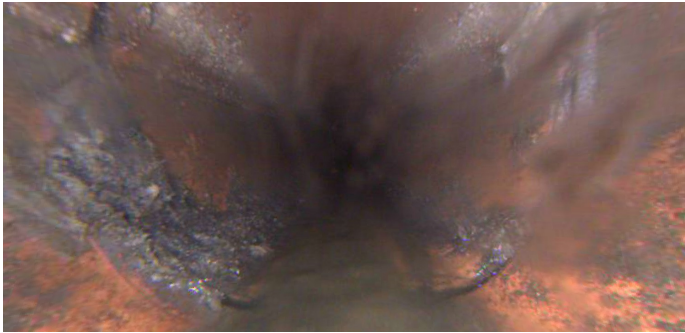
Code:	MWL
Description:	Water Level

Distance (ft):	.0
Structural Grade:	0
O&M Grade:	0
Clock Start/From:	
Clock To:	
1st Value:	
2nd Value:	
Value Percent:	5.000
Continuous Index:	
Within 8" of Joint:	NO
Remarks:

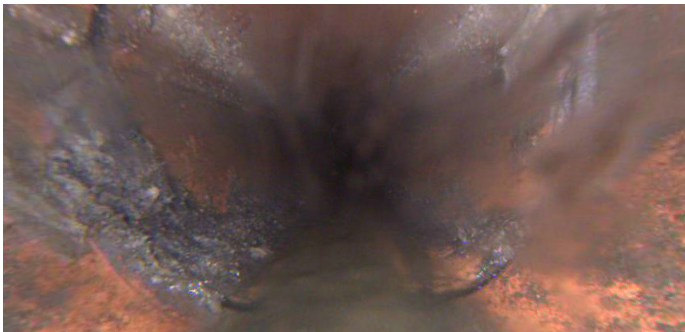
Code:	DAGS
Description:	Deposits Attached Grease

Distance (ft):	.0
Structural Grade:	0
O&M Grade:	2
Clock Start/From:	8
Clock To:	4
1st Value:	
2nd Value:	
Value Percent:	5.000
Continuous Index:	S01
Within 8" of Joint:	NO
Remarks:

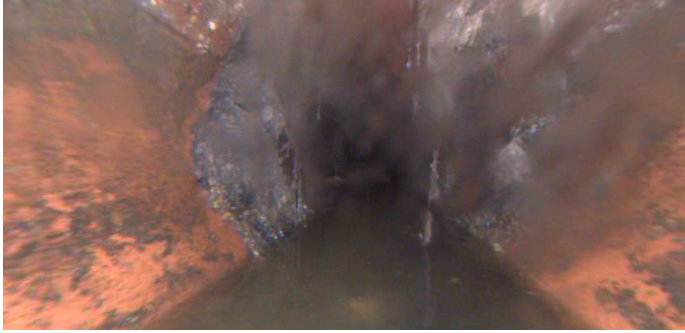
Code: **RMJ**
Description: **Roots Medium Joint**

Distance (ft): **5.8**
Structural Grade: **0**
O&M Grade: **3**
Clock Start/From: **8**
Clock To: **4**
1st Value:
2nd Value:
Value Percent: **20.000**
Continuous Index:
Within 8" of Joint: **YES**
Remarks:

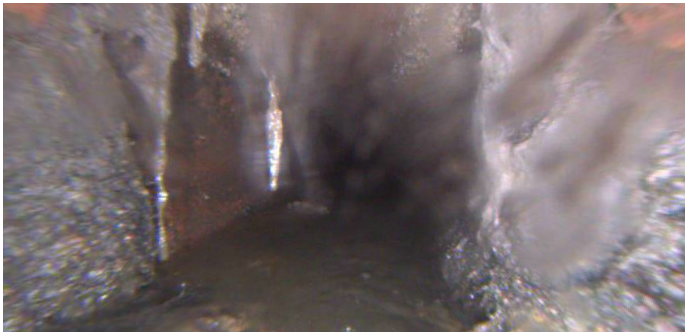
Code: **RMJ**
Description: **Roots Medium Joint**

Distance (ft): **8.1**
Structural Grade: **0**
O&M Grade: **3**
Clock Start/From: **8**
Clock To: **4**
1st Value:
2nd Value:
Value Percent: **20.000**
Continuous Index:
Within 8" of Joint: **YES**
Remarks:

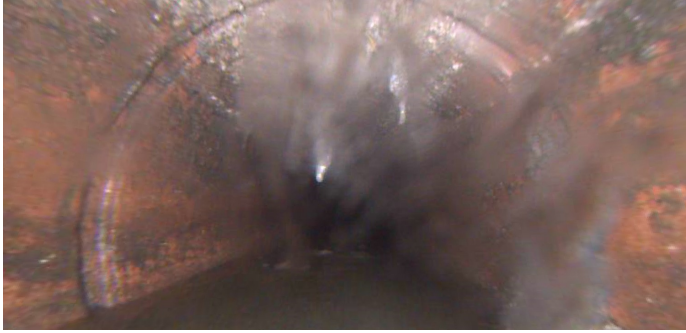
Code: **RMJ**
Description: **Roots Medium Joint**

Distance (ft): **12.9**
Structural Grade: **0**
O&M Grade: **3**
Clock Start/From: **8**
Clock To: **4**
1st Value:
2nd Value:
Value Percent: **5.000**
Continuous Index:
Within 8" of Joint: **YES**
Remarks:

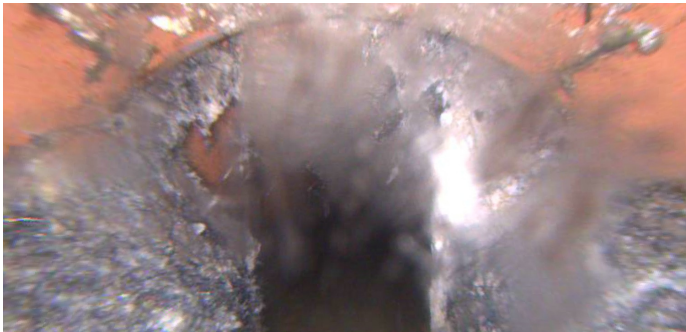
Code: **RMJ**
Description: **Roots Medium Joint**

Distance (ft): **18.0**
Structural Grade: **0**
O&M Grade: **3**
Clock Start/From: **8**
Clock To: **4**
1st Value:
2nd Value:
Value Percent: **30.000**
Continuous Index:
Within 8" of Joint: **YES**
Remarks:

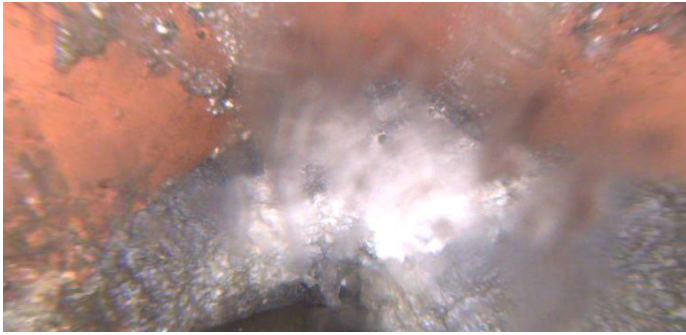
Code: **RBJ**
Description: **Roots Ball Joint**

Distance (ft): **22.5**
Structural Grade: **0**
O&M Grade: **4**
Clock Start/From: **7**
Clock To: **5**
1st Value:
2nd Value:
Value Percent: **90.000**
Continuous Index:
Within 8" of Joint: **YES**
Remarks:
