Profile/Photo Observation Report

Street:	ALLEY BETWEEN N WILSON ST & N G	Flow Control:	Not Controlled
City:	Hobart, IN	Year Renewed:	
Location:	Other	Tape/Media #:	
Purpose:	Not Known	Dia/Height:	10"
Use:	Sanitary	Material:	VCP
Drain Area:	NA	Lining:	
Category:	NA		
Comment:

Location Details:		Direction of Survey:	Downstream
US MH:	M-503-086	DS MH:	M-503-085
		Total Length Surveyed (ft):	109.6

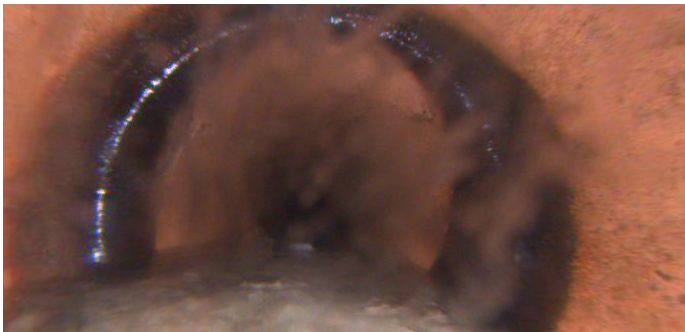
Code:	IW
Description:	Infil Weeper

Distance (ft):	5.1
Structural Grade:	0
O&M Grade:	2
Clock Start/From:	8
Clock To:	4
1st Value:	
2nd Value:	
Value Percent:	
Continuous Index:	
Within 8" of Joint:	YES
Remarks:

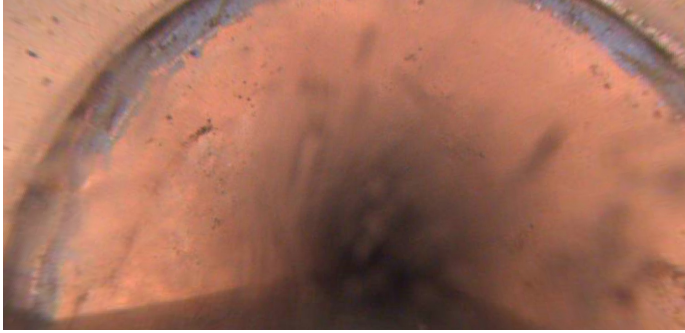
Code: **FC**
Description: **Fracture Circumferential**

Distance (ft): **10.4**
Structural Grade: **2**
O&M Grade: **0**
Clock Start/From: **9**
Clock To: **11**
1st Value:
2nd Value:
Value Percent:
Continuous Index:
Within 8" of Joint: **YES**
Remarks:

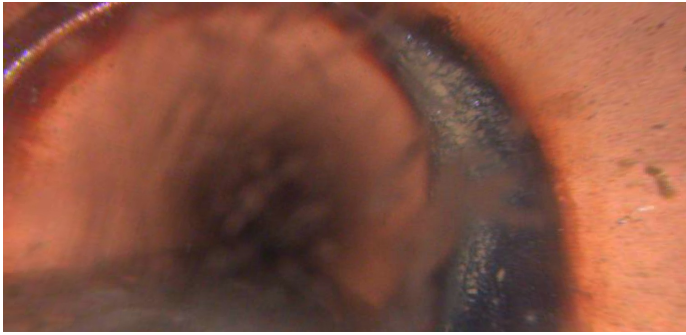
Code: **IW**
Description: **Infil Weeper**

Distance (ft): **42.3**
Structural Grade: **0**
O&M Grade: **2**
Clock Start/From: **8**
Clock To: **4**
1st Value:
2nd Value:
Value Percent:
Continuous Index:
Within 8" of Joint: **YES**
Remarks:

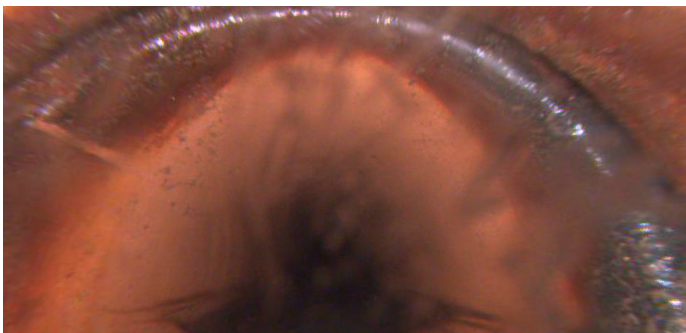
Code: **IW**
Description: **Infil Weeper**

Distance (ft): **52.5**
Structural Grade: **0**
O&M Grade: **2**
Clock Start/From: **8**
Clock To: **4**
1st Value:
2nd Value:
Value Percent:
Continuous Index:
Within 8" of Joint: **YES**
Remarks:

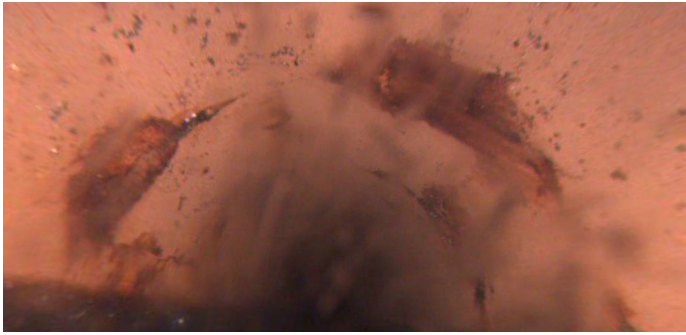
Code: **FC**
Description: **Fracture Circumferential**

Distance (ft): **55.8**
Structural Grade: **2**
O&M Grade: **0**
Clock Start/From: **8**
Clock To: **4**
1st Value:
2nd Value:
Value Percent:
Continuous Index:
Within 8" of Joint:
Remarks:

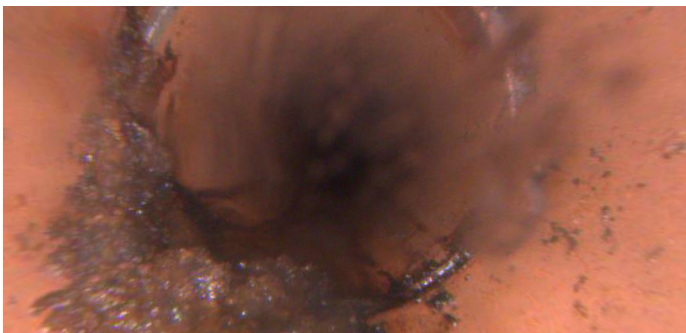
Code: **DAZ**
Description: **Deposits Attached Other**

Distance (ft): **77.4**
Structural Grade: **0**
O&M Grade: **2**
Clock Start/From: **7**
Clock To: **9**
1st Value:
2nd Value:
Value Percent: **5.000**
Continuous Index:
Within 8" of Joint: **YES**
Remarks:

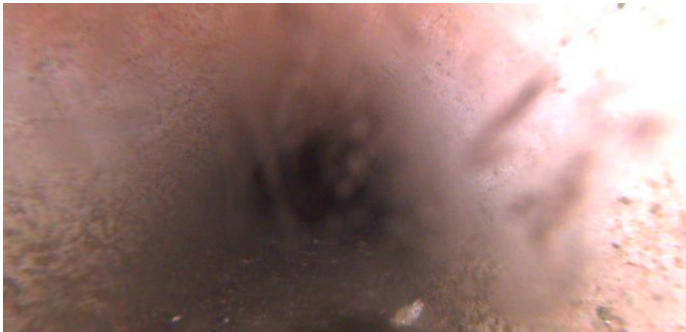
Code: **DSF**
Description: **Deposits Settled Fine**

Distance (ft): **106.3**
Structural Grade: **0**
O&M Grade: **2**
Clock Start/From: **5**
Clock To: **7**
1st Value:
2nd Value:
Value Percent: **5.000**
Continuous Index:
Within 8" of Joint: **NO**
Remarks:
