Profile/Photo Observation Report

Street:	W 40TH AVE	Flow Control:	Not Controlled
City:	Hobart, IN	Year Renewed:	
Location:	Other	Tape/Media #:	
Purpose:	Not Known	Dia/Height:	8"
Use:	Sanitary	Material:	PVC
Drain Area:	NA	Lining:	
Category:	NA		
Comment:

Location Details:		Direction of Survey:	Upstream
US MH:	M-503-089	DS MH:	M-503-090
		Total Length Surveyed (ft):	7.9

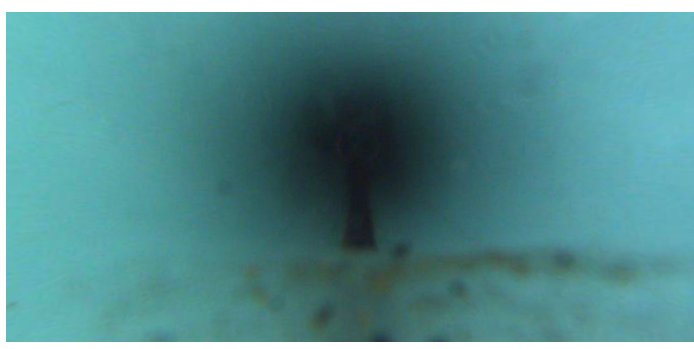
Code: **AMH**
Description: **Manhole**

Distance (ft): **.0**
Structural Grade: **0**
O&M Grade: **0**
Clock Start/From:
Clock To:
1st Value:
2nd Value:
Value Percent:
Continuous Index:
Within 8" of Joint: **NO**
Remarks: **M-503-090**

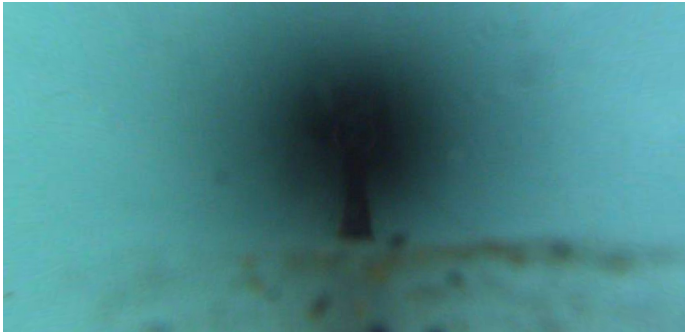
Code:	MWL
Description:	Water Level

Distance (ft):	.0
Structural Grade:	0
O&M Grade:	0
Clock Start/From:	
Clock To:	
1st Value:	
2nd Value:	
Value Percent:	5.000
Continuous Index:	
Within 8" of Joint:	NO
Remarks:

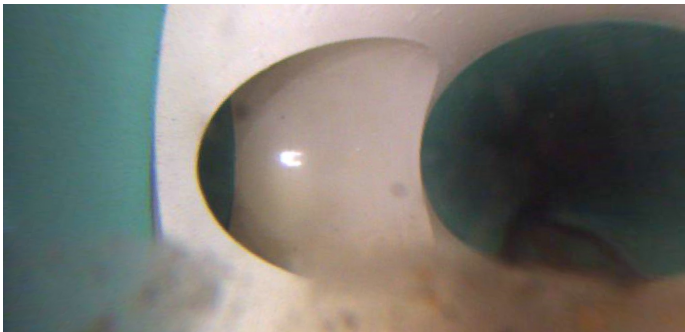
Code:	TF
Description:	Tap Factory

Distance (ft):	5.6
Structural Grade:	0
O&M Grade:	0
Clock Start/From:	9
Clock To:	
1st Value:	4.000
2nd Value:	
Value Percent:	
Continuous Index:	
Within 8" of Joint:	
Remarks:

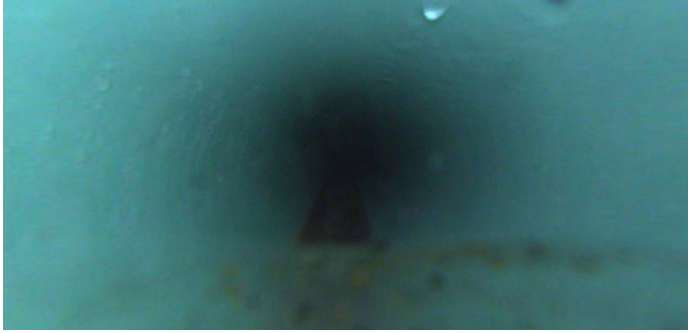
Code:	MSA
Description:	Abandoned Survey
Distance (ft):	7.9
Structural Grade:	0
O&M Grade:	0
Clock Start/From:	
Clock To:	
1st Value:	
2nd Value:	
Value Percent:	
Continuous Index:	
Within 8" of Joint:	NO
Remarks:	UNKNOWN
