## Profile/Photo Observation Report

Street:	<b>40th. Ave.</b>	Flow Control:	<b>Not Controlled</b>
City:	<b>Hobart, IN</b>	Year Renewed:	
Location:	<b>Light Highway</b>	Tape/Media #:	
Purpose:	<b>Routine Assessment</b>	Dia/Height:	<b>8"</b>
Use:	<b>Sanitary</b>	Material:	<b>PVC</b>
Drain Area:	<b>NA</b>	Lining:	
Category:	<b>NA</b>		
Comment:

Location Details:		Direction of Survey:	<b>Downstream</b>
US MH:	<b>M-503-089</b>	DS MH:	<b>M-503-090</b>
		Total Length Surveyed (ft):	<b>439.8</b>

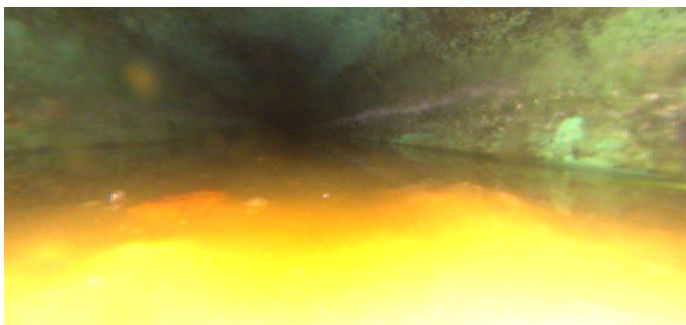
Code: **AMH**  
Description: **Manhole**

Distance (ft): **.0**  
Structural Grade: **0**  
O&M Grade: **0**  
Clock Start/From:  
Clock To:  
1st Value:  
2nd Value:  
Value Percent:  
Continuous Index:  
Within 8" of Joint: **NO**  
Remarks: **M-503-089**

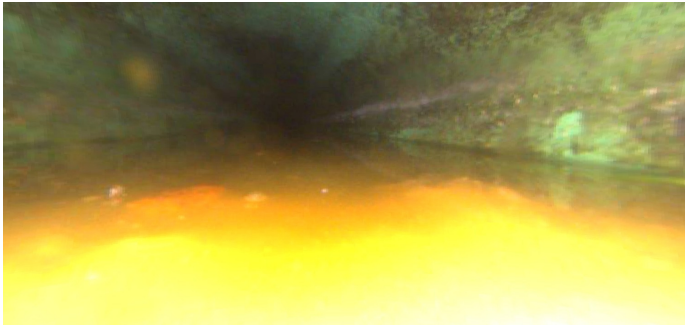
Code:	<b>MWL</b>
Description:	<b>Water Level</b>

Distance (ft):	<b>.0</b>
Structural Grade:	<b>0</b>
O&M Grade:	<b>0</b>
Clock Start/From:	
Clock To:	
1st Value:	
2nd Value:	
Value Percent:	<b>15.000</b>
Continuous Index:	
Within 8" of Joint:	<b>NO</b>
Remarks:

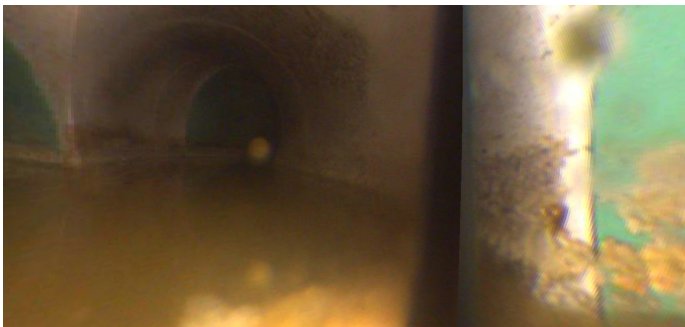
Code:	<b>TFA</b>
Description:	<b>Tap Factory Active</b>

Distance (ft):	<b>16.8</b>
Structural Grade:	<b>0</b>
O&M Grade:	<b>0</b>
Clock Start/From:	<b>3</b>
Clock To:	
1st Value:	<b>6.000</b>
2nd Value:	
Value Percent:	
Continuous Index:	
Within 8" of Joint:	
Remarks:

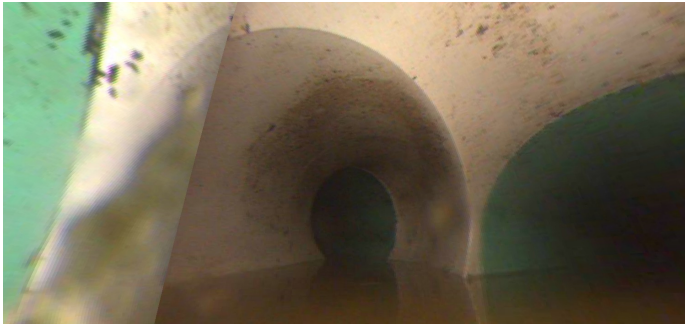
Code: **TFA**  
Description: **Tap Factory Active**

Distance (ft): **25.8**  
Structural Grade: **0**  
O&M Grade: **0**  
Clock Start/From: **9**  
Clock To:  
1st Value: **6.000**  
2nd Value:  
Value Percent:  
Continuous Index:  
Within 8" of Joint:  
Remarks:

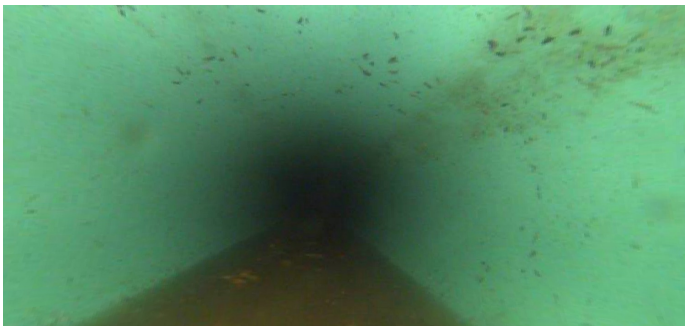
Code: **MWL**  
Description: **Water Level**

Distance (ft): **70.9**  
Structural Grade: **0**  
O&M Grade: **0**  
Clock Start/From:  
Clock To:  
1st Value:  
2nd Value:  
Value Percent: **10.000**  
Continuous Index:  
Within 8" of Joint: **NO**  
Remarks:

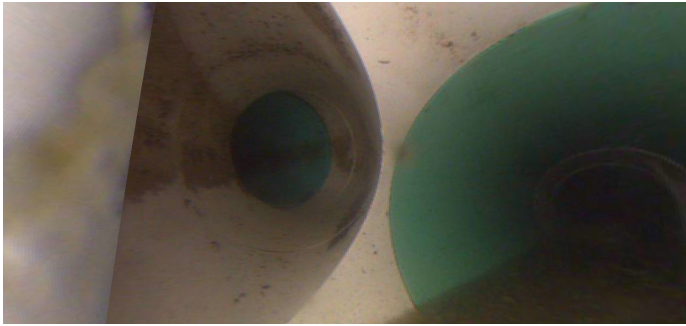
Code: **TF**  
Description: **Tap Factory**

Distance (ft): **106.3**  
Structural Grade: **0**  
O&M Grade: **0**  
Clock Start/From: **9**  
Clock To:  
1st Value: **6.000**  
2nd Value:  
Value Percent:  
Continuous Index:  
Within 8" of Joint:  
Remarks:

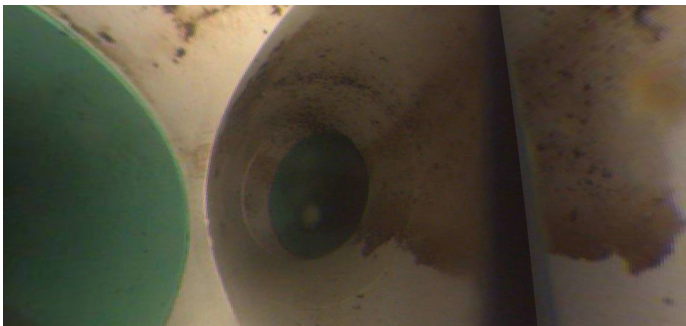
Code: **TF**  
Description: **Tap Factory**

Distance (ft): **108.8**  
Structural Grade: **0**  
O&M Grade: **0**  
Clock Start/From: **3**  
Clock To:  
1st Value: **6.000**  
2nd Value:  
Value Percent:  
Continuous Index:  
Within 8" of Joint:  
Remarks:

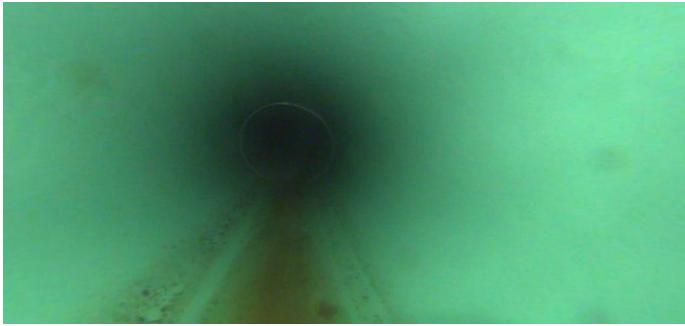
Code: **MWL**  
Description: **Water Level**

Distance (ft): **184.6**  
Structural Grade: **0**  
O&M Grade: **0**  
Clock Start/From:  
Clock To:  
1st Value:  
2nd Value:  
Value Percent: **5.000**  
Continuous Index:  
Within 8" of Joint: **NO**  
Remarks:

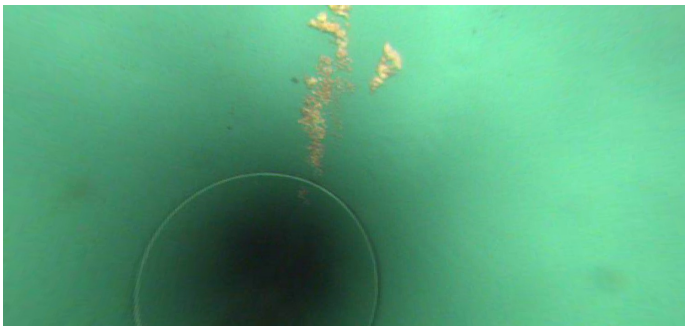
Code: **DAGS**  
Description: **Deposits Attached Grease**

Distance (ft): **198.8**  
Structural Grade: **0**  
O&M Grade: **2**  
Clock Start/From: **1**  
Clock To:  
1st Value:  
2nd Value:  
Value Percent: **5.000**  
Continuous Index:  
Within 8" of Joint:  
Remarks:

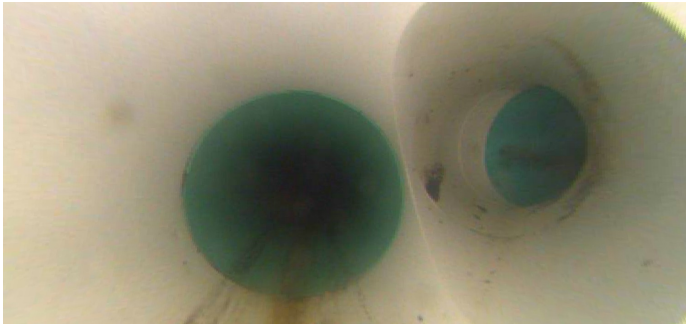
Code: **TF**  
Description: **Tap Factory**

Distance (ft): **214.8**  
Structural Grade: **0**  
O&M Grade: **0**  
Clock Start/From: **3**  
Clock To:  
1st Value: **6.000**  
2nd Value:  
Value Percent:  
Continuous Index:  
Within 8" of Joint:  
Remarks:

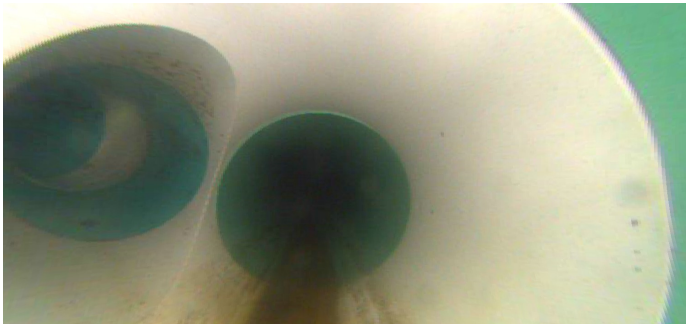
Code: **TF**  
Description: **Tap Factory**

Distance (ft): **231.0**  
Structural Grade: **0**  
O&M Grade: **0**  
Clock Start/From: **9**  
Clock To:  
1st Value: **6.000**  
2nd Value:  
Value Percent:  
Continuous Index:  
Within 8" of Joint:  
Remarks:

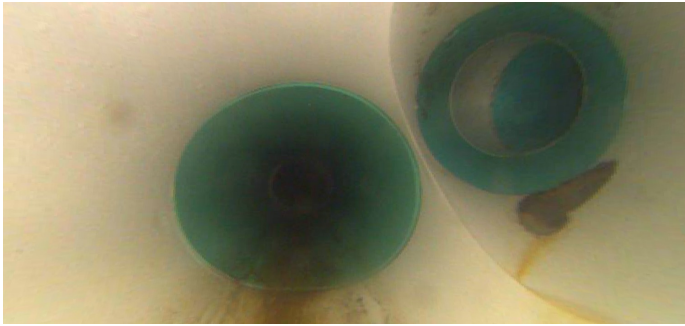
Code: **TF**  
Description: **Tap Factory**

Distance (ft): **311.8**  
Structural Grade: **0**  
O&M Grade: **0**  
Clock Start/From: **2**  
Clock To:  
1st Value: **6.000**  
2nd Value:  
Value Percent:  
Continuous Index:  
Within 8" of Joint:  
Remarks:

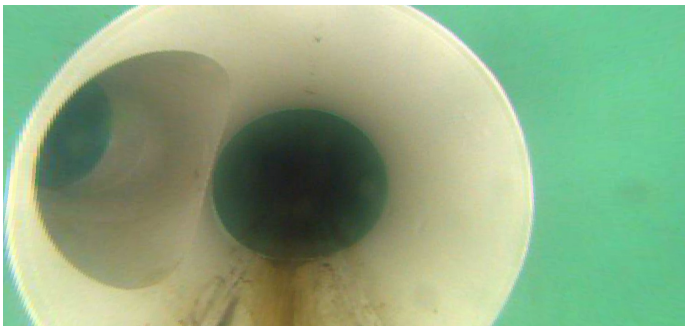
Code: **TF**  
Description: **Tap Factory**

Distance (ft): **314.4**  
Structural Grade: **0**  
O&M Grade: **0**  
Clock Start/From: **9**  
Clock To:  
1st Value: **6.000**  
2nd Value:  
Value Percent:  
Continuous Index:  
Within 8" of Joint:  
Remarks:

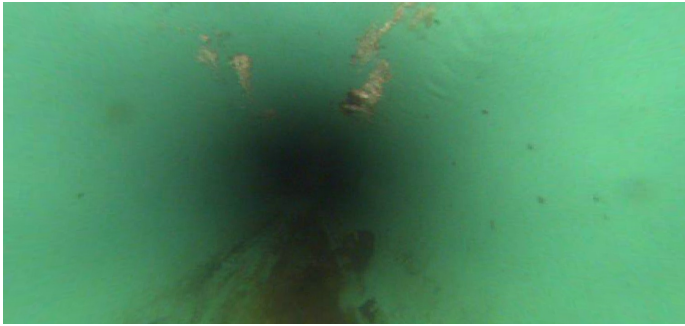
Code: **DAGS**  
Description: **Deposits Attached Grease**

Distance (ft): **334.7**  
Structural Grade: **0**  
O&M Grade: **2**  
Clock Start/From: **11**  
Clock To: **1**  
1st Value:  
2nd Value:  
Value Percent: **5.000**  
Continuous Index:  
Within 8" of Joint: **NO**  
Remarks:

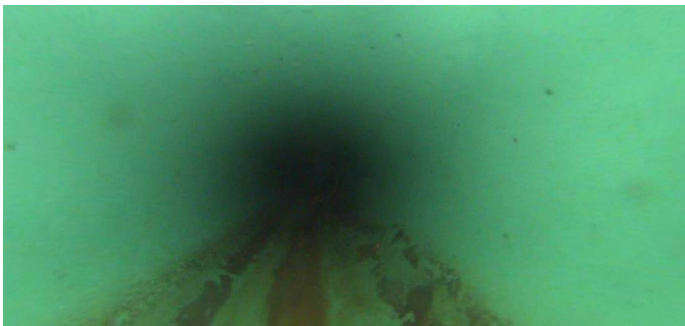
Code: **MSA**  
Description: **Abandoned Survey**

Distance (ft): **439.8**  
Structural Grade: **0**  
O&M Grade: **0**  
Clock Start/From:  
Clock To:  
1st Value:  
2nd Value:  
Value Percent:  
Continuous Index:  
Within 8" of Joint: **NO**  
Remarks: **ROBOT HAS STOPPED**
