Profile/Photo Observation Report

Location Details:		Direction of Survey:	Downstream
US MH:	M-503-091	DS MH:	M-503-092
		Total Length Surveyed (ft):	125.3

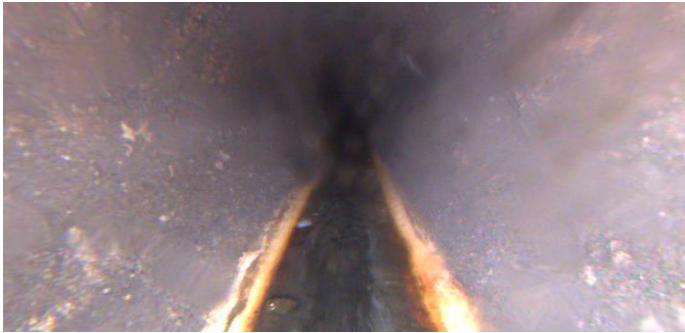
Code:	MWL
Description:	Water Level

Distance (ft):	.0
Structural Grade:	0
O&M Grade:	0
Clock Start/From:	
Clock To:	
1st Value:	
2nd Value:	
Value Percent:	5.000
Continuous Index:	
Within 8" of Joint:	NO
Remarks:

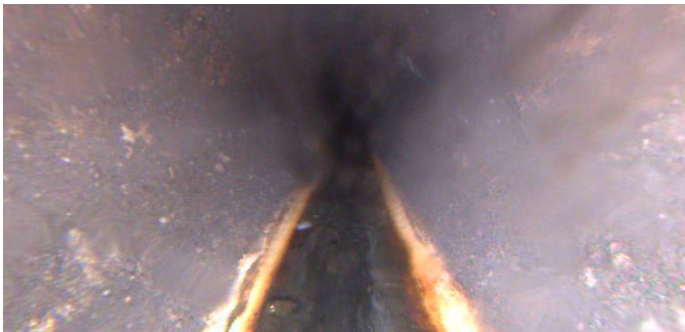
Code:	DAGS
Description:	Deposits Attached Grease

Distance (ft):	.0
Structural Grade:	0
O&M Grade:	2
Clock Start/From:	7
Clock To:	5
1st Value:	
2nd Value:	
Value Percent:	5.000
Continuous Index:	S01
Within 8" of Joint:	NO
Remarks:

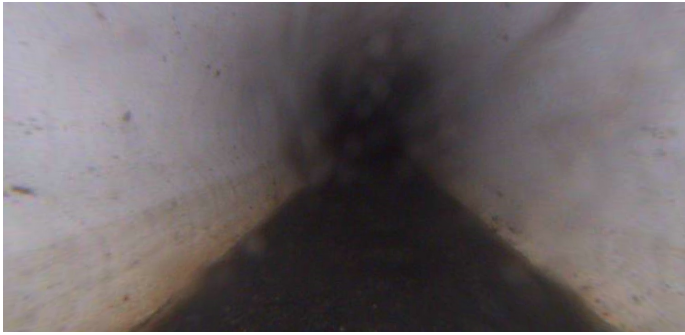
Code: **DAGS**
Description: **Deposits Attached Grease**

Distance (ft): **47.7**
Structural Grade: **0**
O&M Grade: **2**
Clock Start/From: **7**
Clock To: **5**
1st Value:
2nd Value:
Value Percent: **5.000**
Continuous Index: **F01**
Within 8" of Joint: **NO**
Remarks:

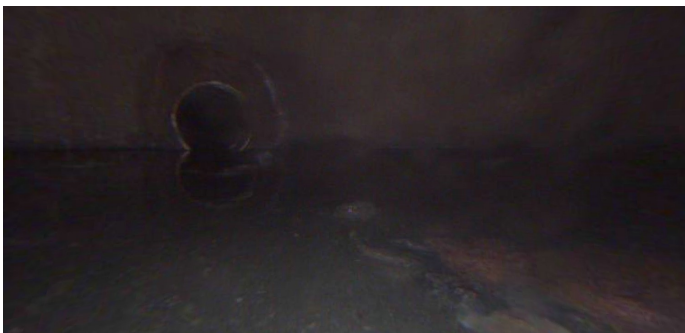
Code: **AMH**
Description: **Manhole**

Distance (ft): **125.3**
Structural Grade: **0**
O&M Grade: **0**
Clock Start/From:
Clock To:
1st Value:
2nd Value:
Value Percent:
Continuous Index:
Within 8" of Joint: **NO**
Remarks: **M-503-092**
