Profile/Photo Observation Report

| Date: | 04/24/2018 | Weather: | | Coding: | PACP 6.0 |

| Street: | Wisconsin Street | Flow Control: | Not Controlled |
| US MH: | M-504-004 | DS MH: | M-504-003 |

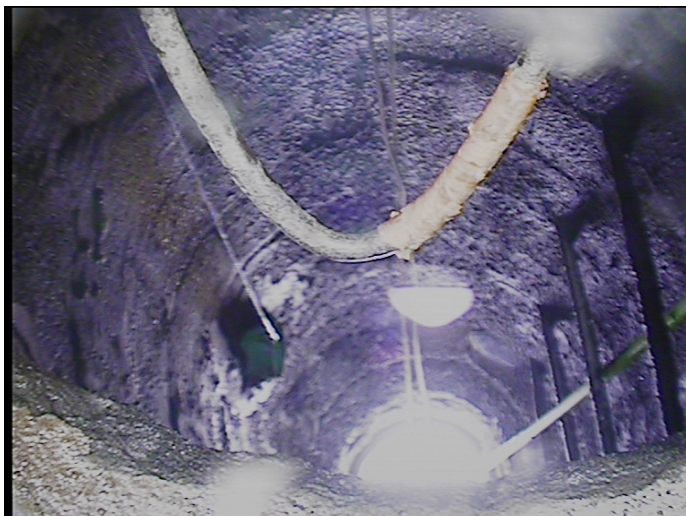
Code: **AMH**
 Description: **Manhole**

Distance (ft): **.0**
 Structural Grade: **0**
 O&M Grade: **0**
 Clock Start/From:
 Clock To:
 1st Value:
 2nd Value:
 Value Percent:
 Continuous Index:
 Within 8" of Joint: **NO**
 Remarks: **M-504-003**

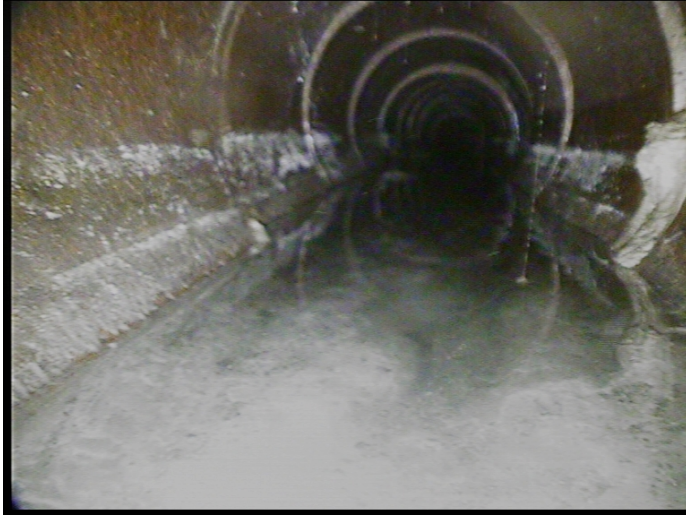
| Description: | Water Level |
| Value Percent: | 10.000 |

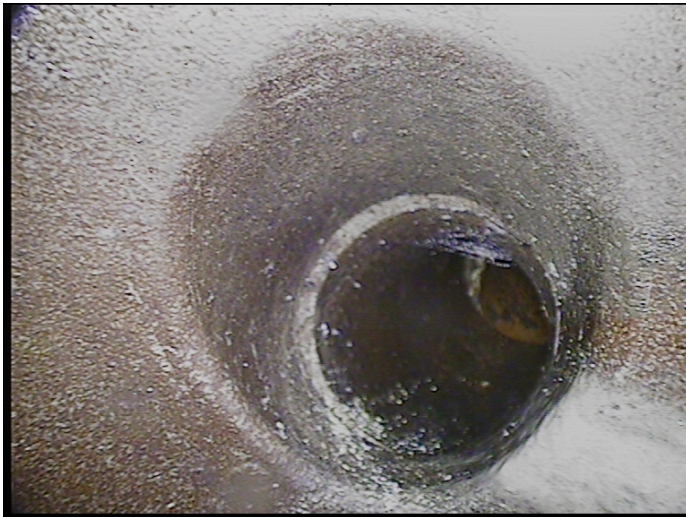
| Description: | Tap Factory |
| Distance (ft): | 8.1 |
| Clock Start/From: | 2 |

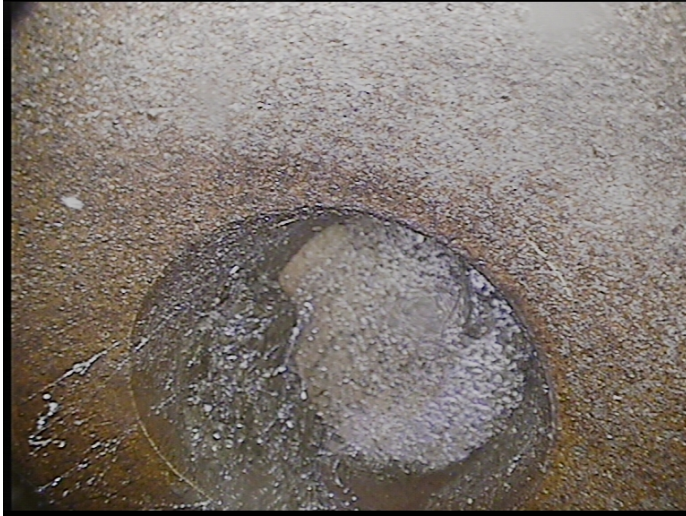
| Description: | Tap Factory Capped |
| Distance (ft): | 9.9 |
| Clock Start/From: | 10 |

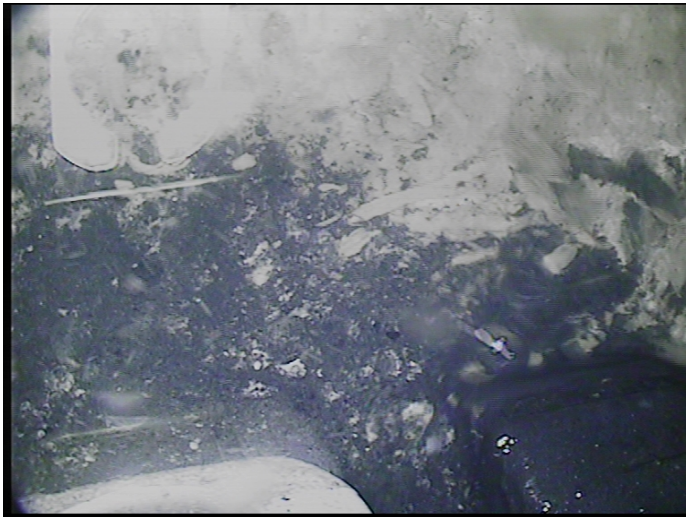
| Description: | Deposits Settled Fine |
| Distance (ft): | 10.0 |
| O&M Grade: | 3 |
| Value Percent: | 15.000 |

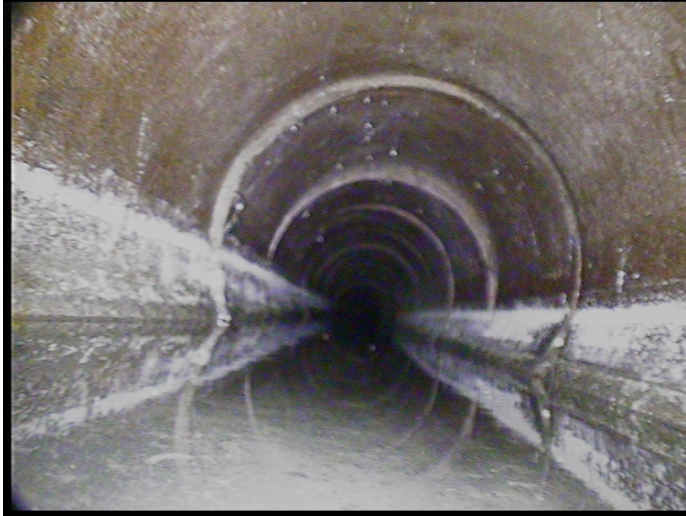
Code: **DSF**
Description: **Deposits Settled Fine**

Distance (ft): **26.5**
Structural Grade: **0**
O&M Grade: **3**
Clock Start/From: **5**
Clock To: **7**
1st Value:
2nd Value:
Value Percent: **15.000**
Continuous Index: **F01**
Within 8" of Joint: **NO**
Remarks:

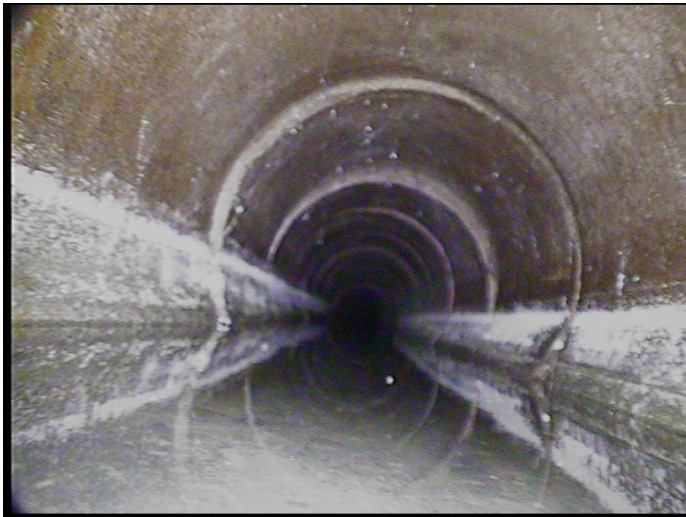
Code: **MSA**
Description: **Abandoned Survey**

Distance (ft): **26.5**
Structural Grade: **0**
O&M Grade: **0**
Clock Start/From:
Clock To:
1st Value:
2nd Value:
Value Percent:
Continuous Index:
Within 8" of Joint: **NO**
Remarks: **deep sediment**
