## Profile/Photo Observation Report

Date:	<b>04/25/2018</b>	Weather:		Coding:	<b>PACP 6.0</b>
Pipe Length (ft):	<b>157.2</b>	Owner:	<b>NA</b>	Pre Clean:	<b>Not Known</b>
P.O.#:		Surveyor:	<b>Jen Costello</b>	PSR:	<b>P-504-006-005</b>
Customer:		Clean Date:	<b>01/01/1900</b>	Shape:	<b>C</b>

Street:	<b>Summerlin</b>	Flow Control:	<b>Not Controlled</b>
City:	<b>Hobart, IN</b>	Year Renewed:	
Location:	<b>Light Highway</b>	Tape/Media #:	
Purpose:	<b>Not Known</b>	Dia/Height:	<b>12"</b>
Use:	<b>Sanitary</b>	Material:	<b>VCP</b>
Drain Area:	<b>NA</b>	Lining:	
Category:	<b>NA</b>		
Comment:

Location Details:		Direction of Survey:	<b>Upstream</b>
US MH:	<b>M-504-005</b>	DS MH:	<b>M-504-006</b>
		Total Length Surveyed (ft):	<b>106.3</b>

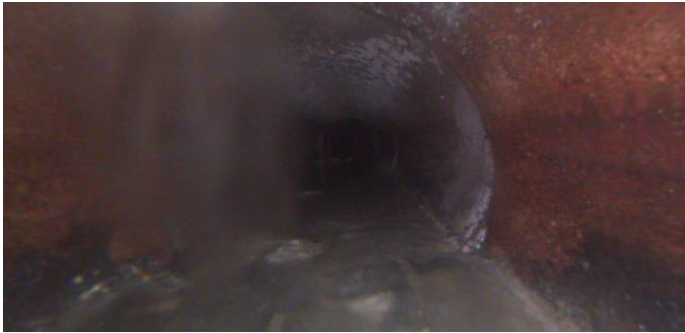
Code:	<b>MWL</b>
Description:	<b>Water Level</b>

Distance (ft):	<b>.0</b>
Structural Grade:	<b>0</b>
O&M Grade:	<b>0</b>
Clock Start/From:	
Clock To:	
1st Value:	
2nd Value:	
Value Percent:	<b>10.000</b>
Continuous Index:	
Within 8" of Joint:	<b>NO</b>
Remarks:

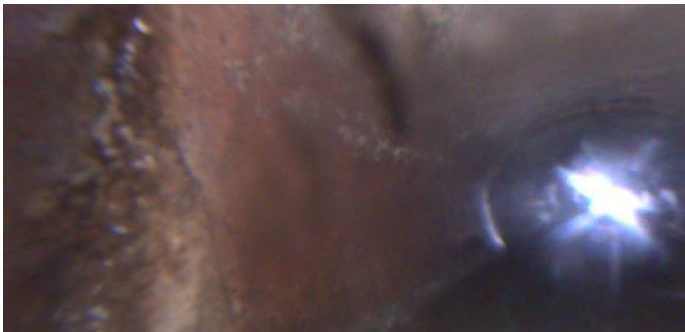
Code:	<b>DAE</b>
Description:	<b>Deposits Attached Encrustation</b>

Distance (ft):	<b>6.1</b>
Structural Grade:	<b>0</b>
O&M Grade:	<b>2</b>
Clock Start/From:	<b>1</b>
Clock To:	<b>4</b>
1st Value:	
2nd Value:	
Value Percent:	<b>5.000</b>
Continuous Index:	
Within 8" of Joint:	<b>YES</b>
Remarks:

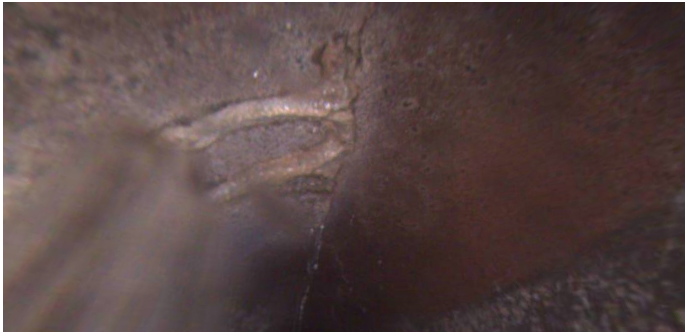
Code: **FL**  
Description: **Fracture Longitudinal**

Distance (ft): **10.2**  
Structural Grade: **3**  
O&M Grade: **0**  
Clock Start/From: **12**  
Clock To:  
1st Value:  
2nd Value:  
Value Percent:  
Continuous Index:  
Within 8" of Joint:  
Remarks:

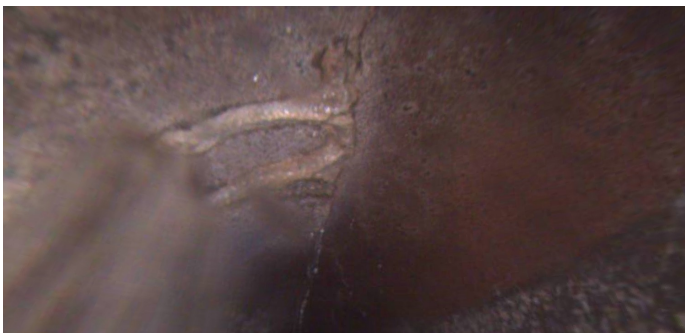
Code: **DAE**  
Description: **Deposits Attached Encrustation**

Distance (ft): **10.2**  
Structural Grade: **0**  
O&M Grade: **2**  
Clock Start/From: **10**  
Clock To: **12**  
1st Value:  
2nd Value:  
Value Percent: **5.000**  
Continuous Index:  
Within 8" of Joint: **NO**  
Remarks:

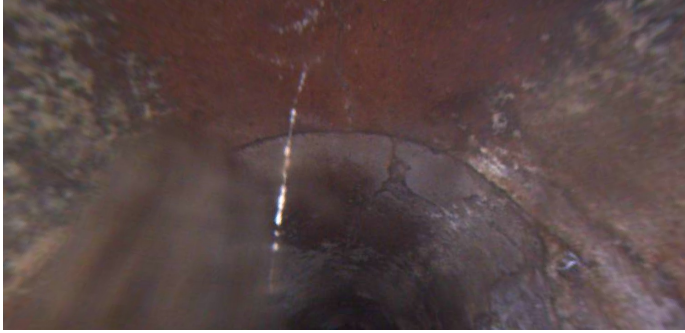
Code: **FL**  
Description: **Fracture Longitudinal**

Distance (ft): **13.7**  
Structural Grade: **3**  
O&M Grade: **0**  
Clock Start/From: **12**  
Clock To:  
1st Value:  
2nd Value:  
Value Percent:  
Continuous Index: **S01**  
Within 8" of Joint: **YES**  
Remarks:

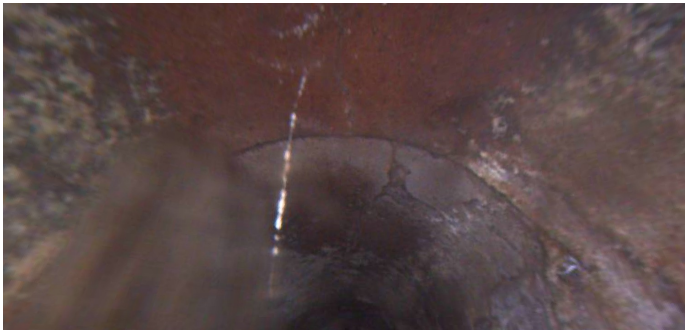
Code: **DAE**  
Description: **Deposits Attached Encrustation**

Distance (ft): **13.7**  
Structural Grade: **0**  
O&M Grade: **2**  
Clock Start/From: **8**  
Clock To: **4**  
1st Value:  
2nd Value:  
Value Percent: **5.000**  
Continuous Index: **S02**  
Within 8" of Joint: **YES**  
Remarks:

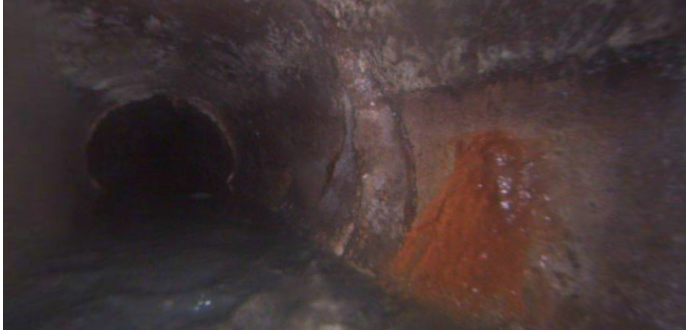
Code: **IW**  
Description: **Infil Weeper**

Distance (ft): **15.5**  
Structural Grade: **0**  
O&M Grade: **2**  
Clock Start/From: **3**  
Clock To:  
1st Value:  
2nd Value:  
Value Percent:  
Continuous Index:  
Within 8" of Joint:  
Remarks:

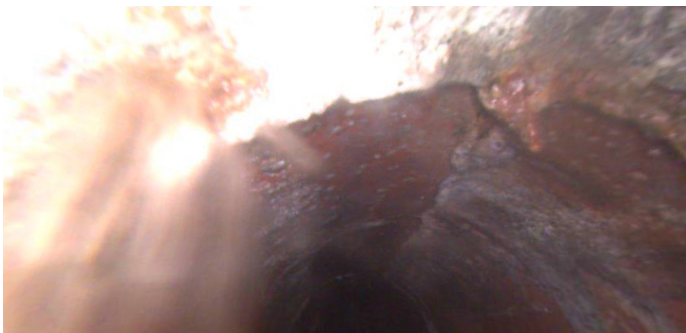
Code: **ID**  
Description: **Infil Dripper**

Distance (ft): **18.0**  
Structural Grade: **0**  
O&M Grade: **3**  
Clock Start/From: **12**  
Clock To:  
1st Value:  
2nd Value:  
Value Percent:  
Continuous Index:  
Within 8" of Joint: **YES**  
Remarks:

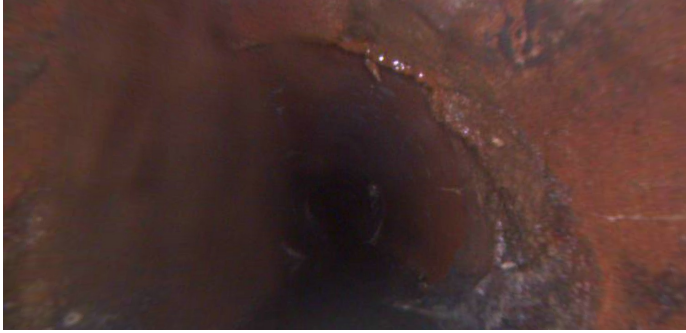
Code: **IW**  
Description: **Infil Weeper**

Distance (ft): **23.6**  
Structural Grade: **0**  
O&M Grade: **2**  
Clock Start/From: **8**  
Clock To: **4**  
1st Value:  
2nd Value:  
Value Percent:  
Continuous Index: **S03**  
Within 8" of Joint: **YES**  
Remarks:

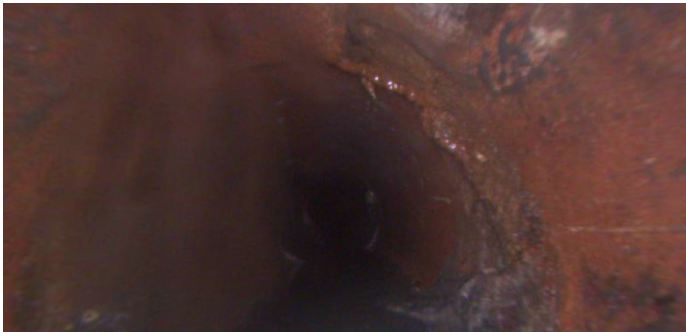
Code: **RMJ**  
Description: **Roots Medium Joint**

Distance (ft): **23.6**  
Structural Grade: **0**  
O&M Grade: **3**  
Clock Start/From: **8**  
Clock To: **4**  
1st Value:  
2nd Value:  
Value Percent: **10.000**  
Continuous Index: **S04**  
Within 8" of Joint: **YES**  
Remarks:

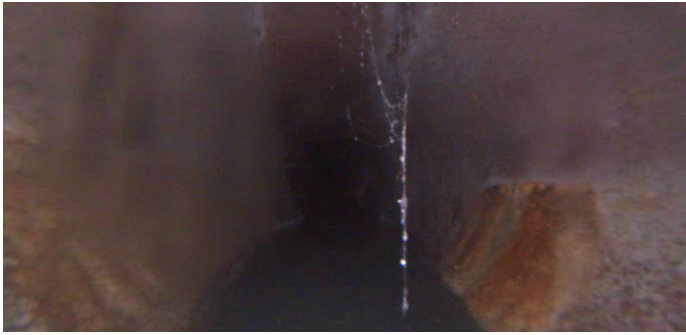
Code: **IW**  
Description: **Infil Weeper**

Distance (ft): **76.4**  
Structural Grade: **0**  
O&M Grade: **2**  
Clock Start/From: **8**  
Clock To: **4**  
1st Value:  
2nd Value:  
Value Percent:  
Continuous Index:  
Within 8" of Joint:  
Remarks:

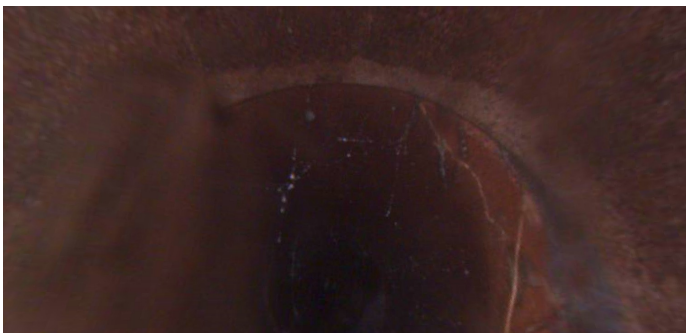
Code: **FM**  
Description: **Fracture Multiple**

Distance (ft): **90.1**  
Structural Grade: **4**  
O&M Grade: **0**  
Clock Start/From: **8**  
Clock To: **4**  
1st Value:  
2nd Value:  
Value Percent:  
Continuous Index:  
Within 8" of Joint: **YES**  
Remarks:

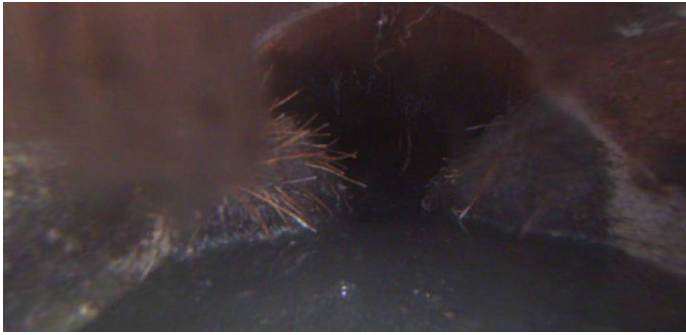
Code: **RMJ**  
Description: **Roots Medium Joint**

Distance (ft): **104.3**  
Structural Grade: **0**  
O&M Grade: **3**  
Clock Start/From: **8**  
Clock To: **4**  
1st Value:  
2nd Value:  
Value Percent: **40.000**  
Continuous Index:  
Within 8" of Joint: **YES**  
Remarks:

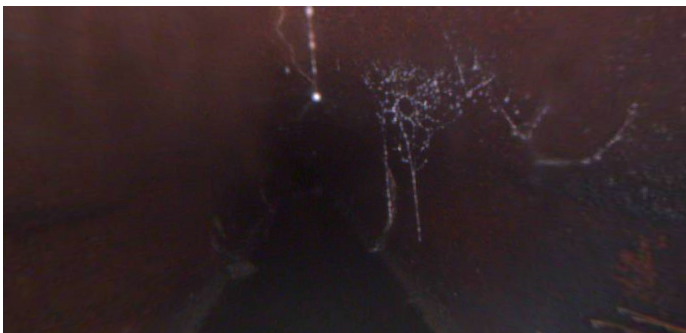
Code: **DAE**  
Description: **Deposits Attached Encrustation**

Distance (ft): **106.3**  
Structural Grade: **0**  
O&M Grade: **2**  
Clock Start/From: **8**  
Clock To: **4**  
1st Value:  
2nd Value:  
Value Percent: **5.000**  
Continuous Index: **F02**  
Within 8" of Joint: **YES**  
Remarks:

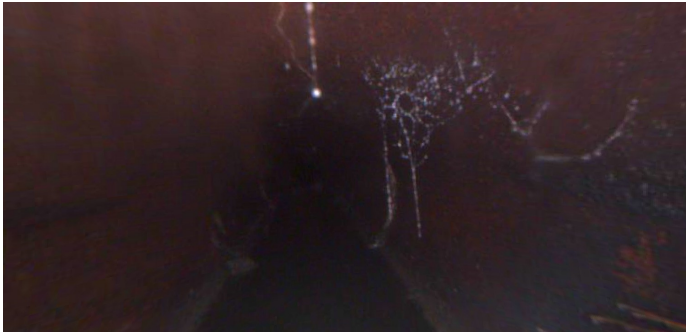
Code: **IW**  
Description: **Infil Weeper**

Distance (ft): **106.3**  
Structural Grade: **0**  
O&M Grade: **2**  
Clock Start/From: **8**  
Clock To: **4**  
1st Value:  
2nd Value:  
Value Percent:  
Continuous Index: **F03**  
Within 8" of Joint: **YES**  
Remarks:

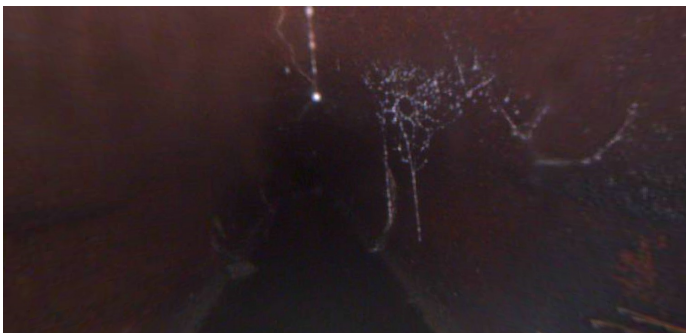
Code: **RMJ**  
Description: **Roots Medium Joint**

Distance (ft): **106.3**  
Structural Grade: **0**  
O&M Grade: **3**  
Clock Start/From: **8**  
Clock To: **4**  
1st Value:  
2nd Value:  
Value Percent: **10.000**  
Continuous Index: **F04**  
Within 8" of Joint: **YES**  
Remarks:

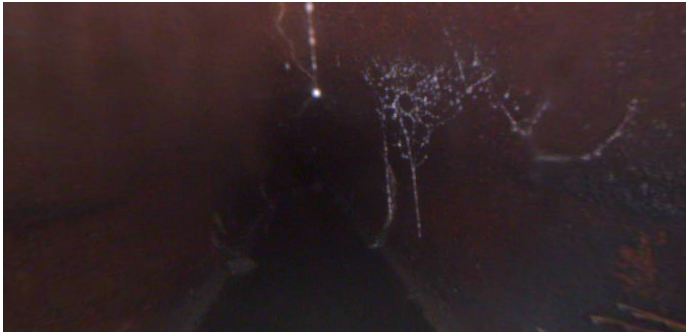
Code: **FL**  
Description: **Fracture Longitudinal**

Distance (ft): **106.3**  
Structural Grade: **3**  
O&M Grade: **0**  
Clock Start/From: **12**  
Clock To:  
1st Value:  
2nd Value:  
Value Percent:  
Continuous Index: **F01**  
Within 8" of Joint: **YES**  
Remarks:

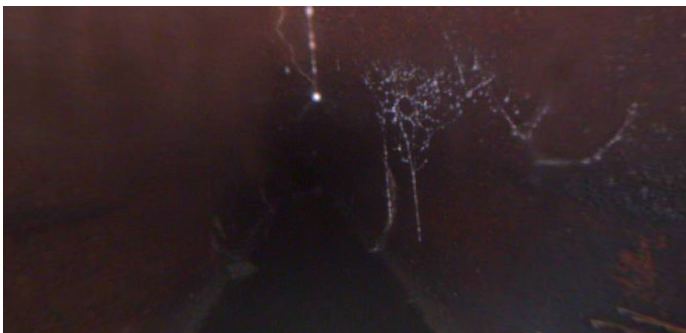
Code: **MSA**  
Description: **Abandoned Survey**

Distance (ft): **106.3**  
Structural Grade: **0**  
O&M Grade: **0**  
Clock Start/From:  
Clock To:  
1st Value:  
2nd Value:  
Value Percent:  
Continuous Index:  
Within 8" of Joint: **NO**  
Remarks: **roots**
