Profile/Photo Observation Report

Date:	04/25/2018	Weather:		Coding:	PACP 6.0
Pipe Length (ft):	193.4	Owner:	NA	Pre Clean:	Not Known
P.O.#:		Surveyor:	Jen Costello	PSR:	P-504-007-006
Customer:		Clean Date:	01/01/1900	Shape:	C

Street:	N CALIFORNIA ST	Flow Control:	Not Controlled
City:	Hobart, IN	Year Renewed:	
Location:	Light Highway	Tape/Media #:	
Purpose:	Not Known	Dia/Height:	10"
Use:	Sanitary	Material:	VCP
Drain Area:	NA	Lining:	
Category:	NA		
Comment:

Location Details:		Direction of Survey:	Downstream
US MH:	M-504-006	DS MH:	M-504-007
		Total Length Surveyed (ft):	82.8

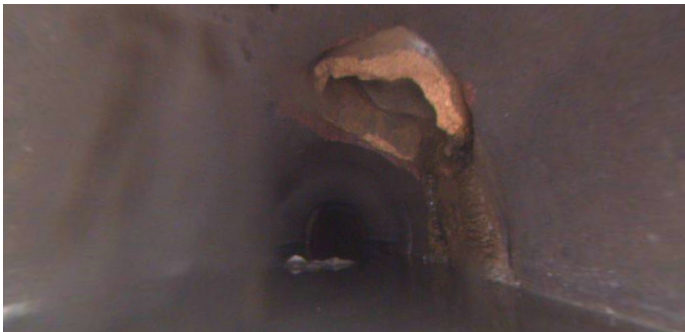
Code:	TBI
Description:	Tap Break-in Intruding

Distance (ft):	5.8
Structural Grade:	0
O&M Grade:	2
Clock Start/From:	1
Clock To:	
1st Value:	4.000
2nd Value:	1.000
Value Percent:	
Continuous Index:	
Within 8" of Joint:	
Remarks:

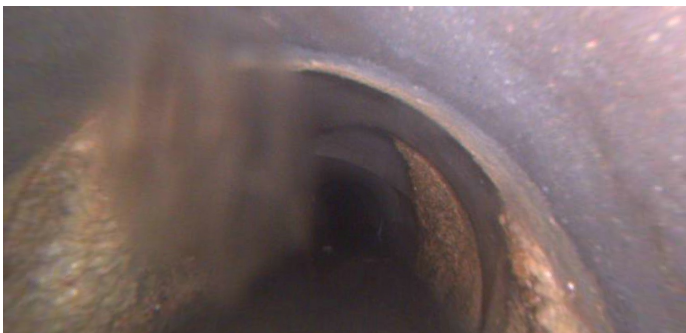
Code: **DAE**
Description: **Deposits Attached Encrustation**

Distance (ft): **9.5**
Structural Grade: **0**
O&M Grade: **2**
Clock Start/From: **8**
Clock To: **4**
1st Value:
2nd Value:
Value Percent: **5.000**
Continuous Index:
Within 8" of Joint: **YES**
Remarks:

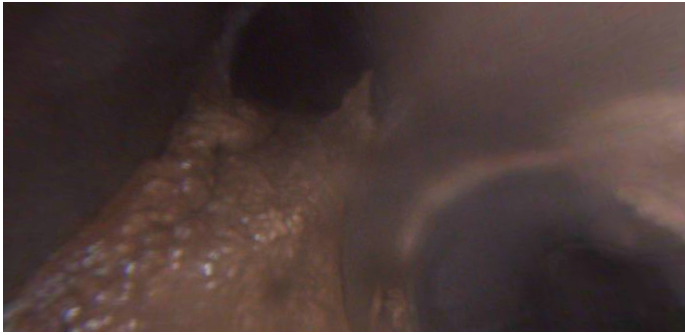
Code: **TFD**
Description: **Tap Factory Defective**

Distance (ft): **11.0**
Structural Grade: **0**
O&M Grade: **2**
Clock Start/From: **2**
Clock To:
1st Value: **4.000**
2nd Value:
Value Percent:
Continuous Index:
Within 8" of Joint:
Remarks: **dae**

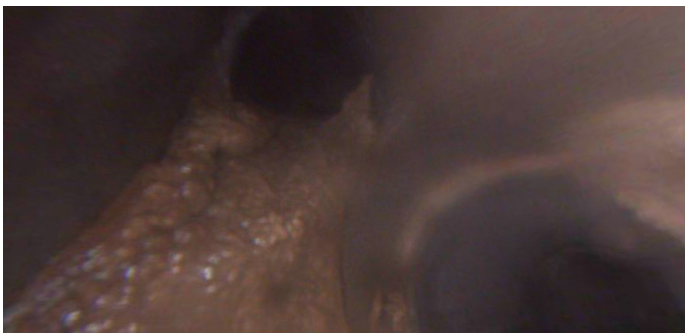
Code: **DAE**
Description: **Deposits Attached Encrustation**

Distance (ft): **11.0**
Structural Grade: **0**
O&M Grade: **2**
Clock Start/From: **1**
Clock To: **4**
1st Value:
2nd Value:
Value Percent: **5.000**
Continuous Index:
Within 8" of Joint: **NO**
Remarks:

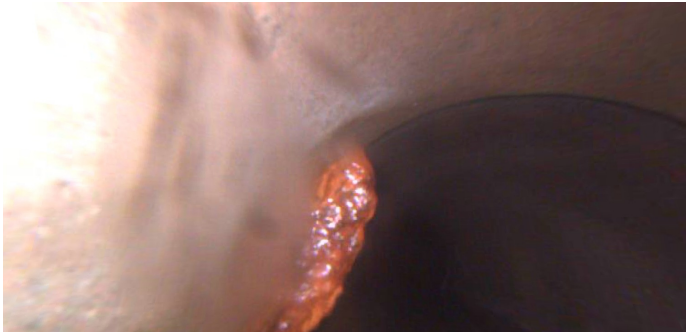
Code: **DAE**
Description: **Deposits Attached Encrustation**

Distance (ft): **12.1**
Structural Grade: **0**
O&M Grade: **2**
Clock Start/From: **8**
Clock To: **10**
1st Value:
2nd Value:
Value Percent: **5.000**
Continuous Index:
Within 8" of Joint: **YES**
Remarks:

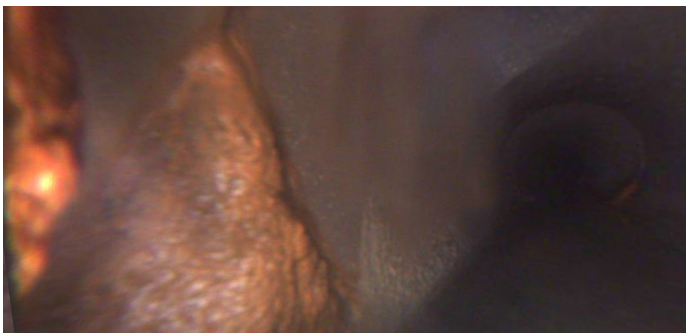
Code: **DAE**
Description: **Deposits Attached Encrustation**

Distance (ft): **14.9**
Structural Grade: **0**
O&M Grade: **2**
Clock Start/From: **8**
Clock To: **9**
1st Value:
2nd Value:
Value Percent: **5.000**
Continuous Index:
Within 8" of Joint: **YES**
Remarks:

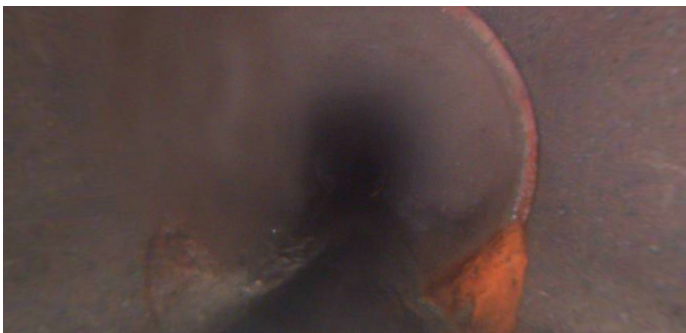
Code: **DAE**
Description: **Deposits Attached Encrustation**

Distance (ft): **17.1**
Structural Grade: **0**
O&M Grade: **2**
Clock Start/From: **8**
Clock To: **4**
1st Value:
2nd Value:
Value Percent: **5.000**
Continuous Index: **S01**
Within 8" of Joint: **YES**
Remarks:

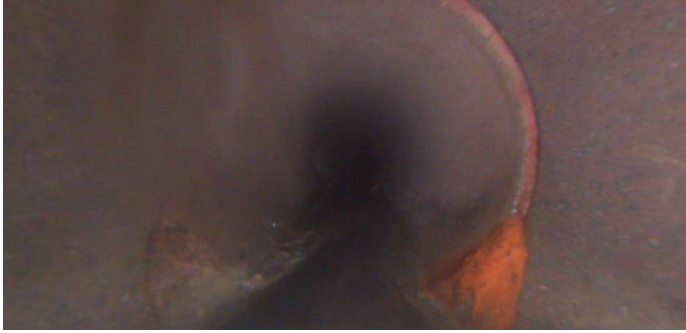
Code: **IW**
Description: **Infil Weeper**

Distance (ft): **17.1**
Structural Grade: **0**
O&M Grade: **2**
Clock Start/From: **8**
Clock To: **4**
1st Value:
2nd Value:
Value Percent:
Continuous Index: **S02**
Within 8" of Joint: **YES**
Remarks:

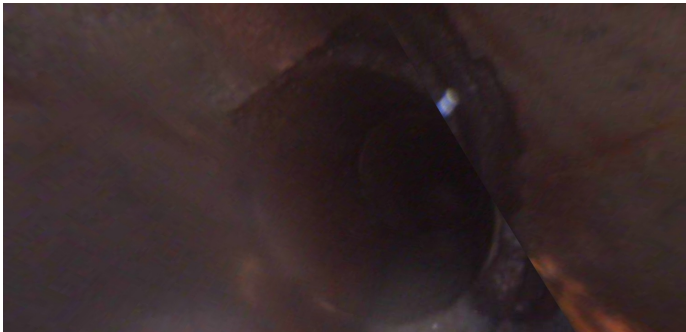
Code: **TBA**
Description: **Tap Break-in Active**

Distance (ft): **27.3**
Structural Grade: **0**
O&M Grade: **0**
Clock Start/From: **10**
Clock To:
1st Value: **4.000**
2nd Value:
Value Percent:
Continuous Index:
Within 8" of Joint:
Remarks:

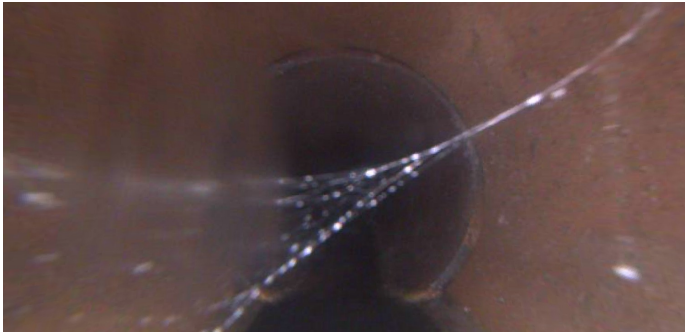
Code: **IW**
Description: **Infil Weeper**

Distance (ft): **42.6**
Structural Grade: **0**
O&M Grade: **2**
Clock Start/From: **8**
Clock To: **4**
1st Value:
2nd Value:
Value Percent:
Continuous Index: **F02**
Within 8" of Joint: **YES**
Remarks:

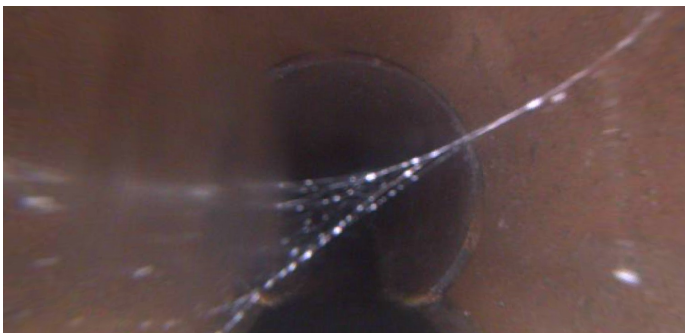
Code: **DAE**
Description: **Deposits Attached Encrustation**

Distance (ft): **42.6**
Structural Grade: **0**
O&M Grade: **2**
Clock Start/From: **8**
Clock To: **4**
1st Value:
2nd Value:
Value Percent: **5.000**
Continuous Index: **F01**
Within 8" of Joint: **YES**
Remarks:

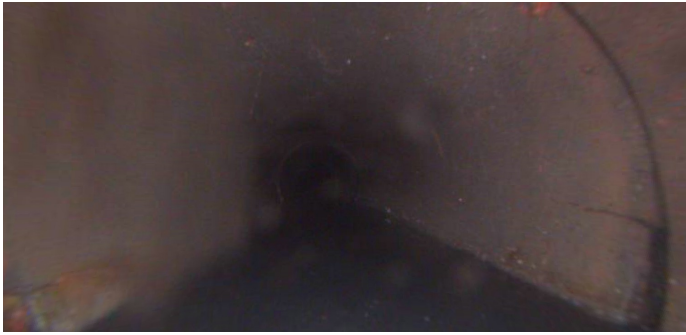
Code: **FM**
Description: **Fracture Multiple**

Distance (ft): **48.3**
Structural Grade: **4**
O&M Grade: **0**
Clock Start/From: **8**
Clock To: **4**
1st Value:
2nd Value:
Value Percent:
Continuous Index:
Within 8" of Joint: **YES**
Remarks:

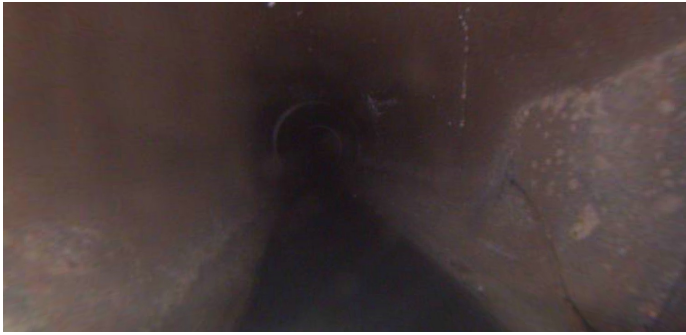
Code: **FM**
Description: **Fracture Multiple**

Distance (ft): **64.1**
Structural Grade: **4**
O&M Grade: **0**
Clock Start/From: **8**
Clock To: **4**
1st Value:
2nd Value:
Value Percent:
Continuous Index:
Within 8" of Joint: **YES**
Remarks:

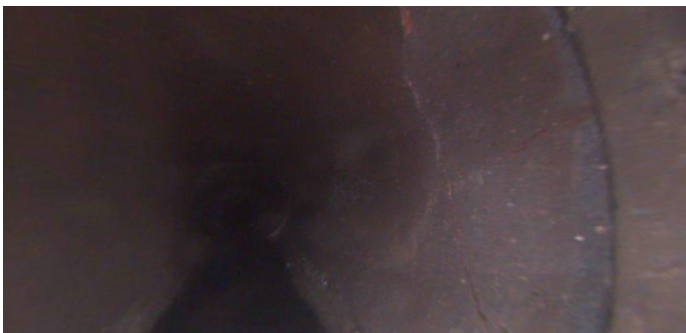
Code: **FM**
Description: **Fracture Multiple**

Distance (ft): **74.4**
Structural Grade: **4**
O&M Grade: **0**
Clock Start/From: **8**
Clock To: **4**
1st Value:
2nd Value:
Value Percent:
Continuous Index: **S03**
Within 8" of Joint: **YES**
Remarks:

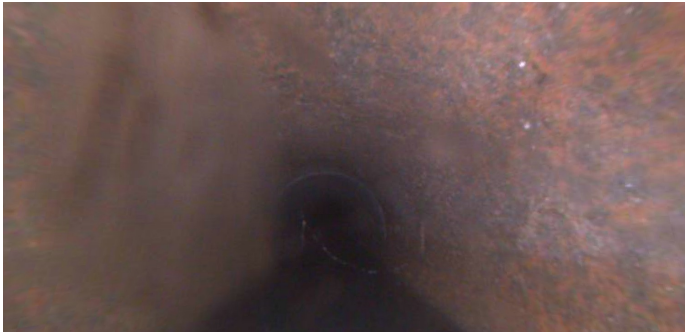
Code: **FM**
Description: **Fracture Multiple**

Distance (ft): **82.8**
Structural Grade: **4**
O&M Grade: **0**
Clock Start/From: **8**
Clock To: **4**
1st Value:
2nd Value:
Value Percent:
Continuous Index: **F03**
Within 8" of Joint: **YES**
Remarks:

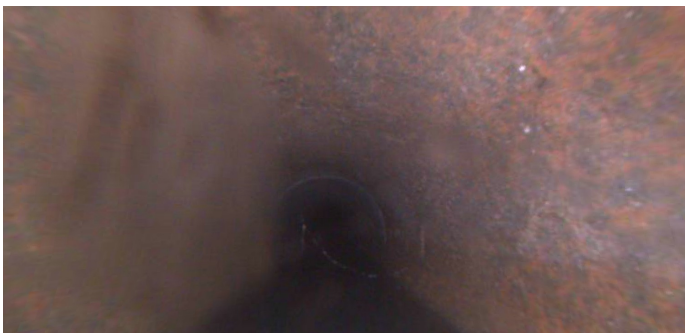
Code: **MSA**
Description: **Abandoned Survey**

Distance (ft): **82.8**
Structural Grade: **0**
O&M Grade: **0**
Clock Start/From:
Clock To:
1st Value:
2nd Value:
Value Percent:
Continuous Index:
Within 8" of Joint: **NO**
Remarks: **debris under water**
