Profile/Photo Observation Report

Date:	04/25/2018	Weather:		Coding:	PACP 6.0
Pipe Length (ft):	193.4	Owner:	NA	Pre Clean:	Not Known
P.O.#:		Surveyor:	Jen Costello	PSR:	P-504-007-006
Customer:		Clean Date:	01/01/1900	Shape:	C

Street:	Summerlin	Flow Control:	Not Controlled
City:	Hobart, IN	Year Renewed:	
Location:	Light Highway	Tape/Media #:	
Purpose:	Not Known	Dia/Height:	10"
Use:	Sanitary	Material:	VCP
Drain Area:	NA	Lining:	
Category:	NA		
Comment:

Location Details:		Direction of Survey:	Downstream
US MH:	M-504-006	DS MH:	M-504-007
		Total Length Surveyed (ft):	82.8

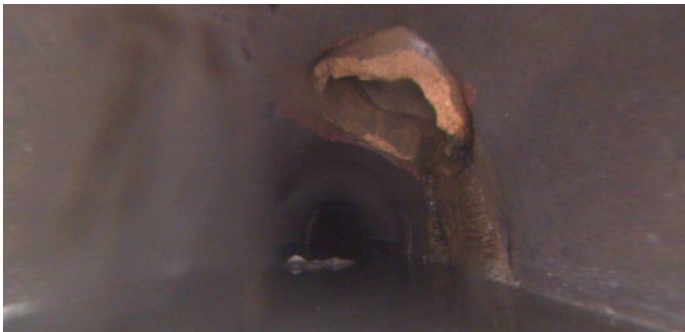
Code:	TBI
Description:	Tap Break-in Intruding

Distance (ft):	5.8
Structural Grade:	0
O&M Grade:	2
Clock Start/From:	1
Clock To:	
1st Value:	4.000
2nd Value:	1.000
Value Percent:	
Continuous Index:	
Within 8" of Joint:	
Remarks:

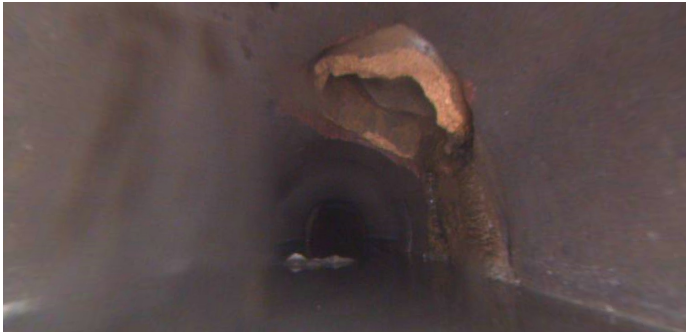
Code: **MWL**
Description: **Water Level**

Distance (ft): **5.8**
Structural Grade: **0**
O&M Grade: **0**
Clock Start/From:
Clock To:
1st Value:
2nd Value:
Value Percent: **40.000**
Continuous Index:
Within 8" of Joint: **NO**
Remarks:

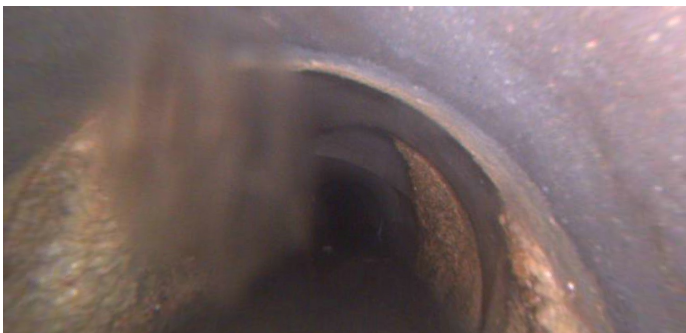
Code: **DAE**
Description: **Deposits Attached Encrustation**

Distance (ft): **9.5**
Structural Grade: **0**
O&M Grade: **2**
Clock Start/From: **8**
Clock To: **4**
1st Value:
2nd Value:
Value Percent: **5.000**
Continuous Index:
Within 8" of Joint: **YES**
Remarks:

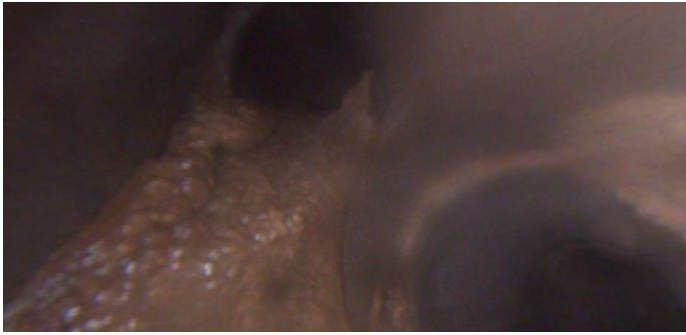
Code: **TFD**
Description: **Tap Factory Defective**

Distance (ft): **11.0**
Structural Grade: **0**
O&M Grade: **2**
Clock Start/From: **2**
Clock To:
1st Value: **4.000**
2nd Value:
Value Percent:
Continuous Index:
Within 8" of Joint:
Remarks: **dae**

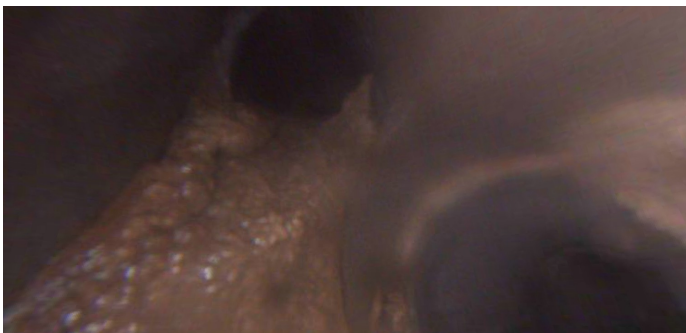
Code: **DAE**
Description: **Deposits Attached Encrustation**

Distance (ft): **11.0**
Structural Grade: **0**
O&M Grade: **2**
Clock Start/From: **1**
Clock To: **4**
1st Value:
2nd Value:
Value Percent: **5.000**
Continuous Index:
Within 8" of Joint: **NO**
Remarks:

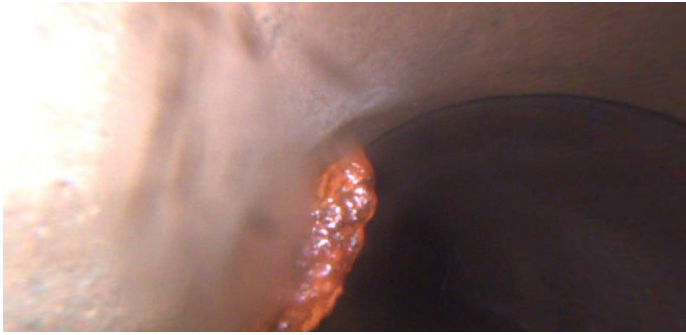
Code: **DAE**
Description: **Deposits Attached Encrustation**

Distance (ft): **12.1**
Structural Grade: **0**
O&M Grade: **2**
Clock Start/From: **8**
Clock To: **10**
1st Value:
2nd Value:
Value Percent: **5.000**
Continuous Index:
Within 8" of Joint: **YES**
Remarks:

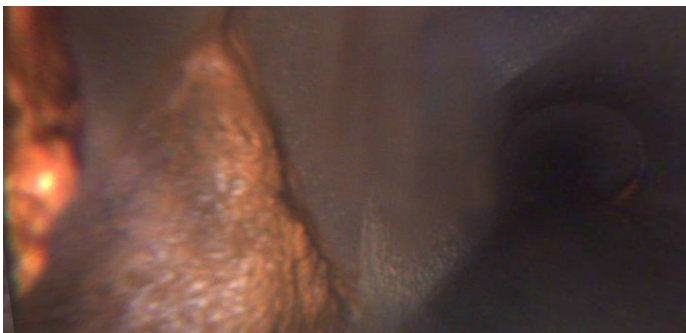
Code: **DAE**
Description: **Deposits Attached Encrustation**

Distance (ft): **14.9**
Structural Grade: **0**
O&M Grade: **2**
Clock Start/From: **8**
Clock To: **9**
1st Value:
2nd Value:
Value Percent: **5.000**
Continuous Index:
Within 8" of Joint: **YES**
Remarks:

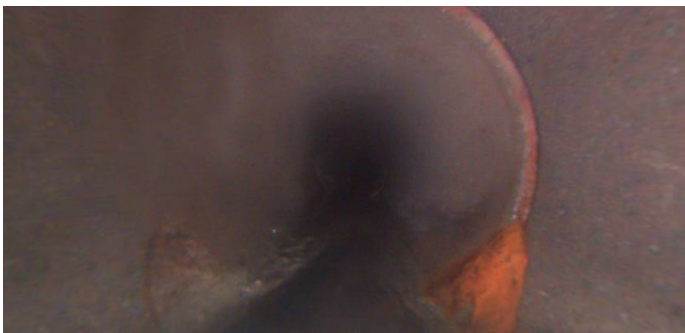
Code: **DAE**
Description: **Deposits Attached Encrustation**

Distance (ft): **17.1**
Structural Grade: **0**
O&M Grade: **2**
Clock Start/From: **8**
Clock To: **4**
1st Value:
2nd Value:
Value Percent: **5.000**
Continuous Index: **S01**
Within 8" of Joint: **YES**
Remarks:

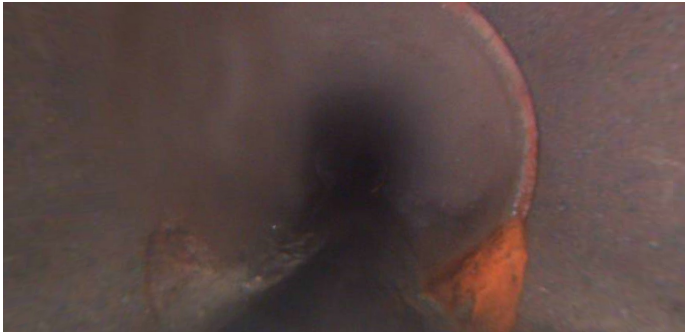
Code: **IW**
Description: **Infil Weeper**

Distance (ft): **17.1**
Structural Grade: **0**
O&M Grade: **2**
Clock Start/From: **8**
Clock To: **4**
1st Value:
2nd Value:
Value Percent:
Continuous Index: **S02**
Within 8" of Joint: **YES**
Remarks:

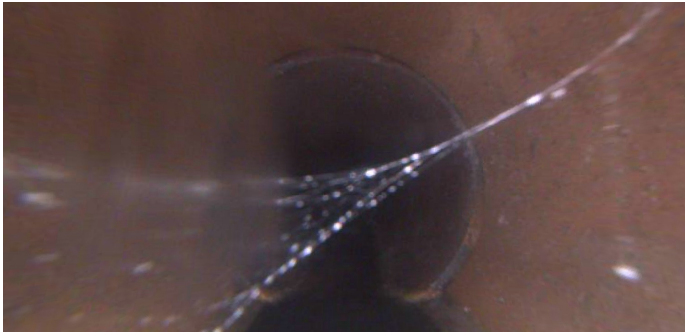
Code: **IW**
Description: **Infil Weeper**

Distance (ft): **42.6**
Structural Grade: **0**
O&M Grade: **2**
Clock Start/From: **8**
Clock To: **4**
1st Value:
2nd Value:
Value Percent:
Continuous Index: **F02**
Within 8" of Joint: **YES**
Remarks:

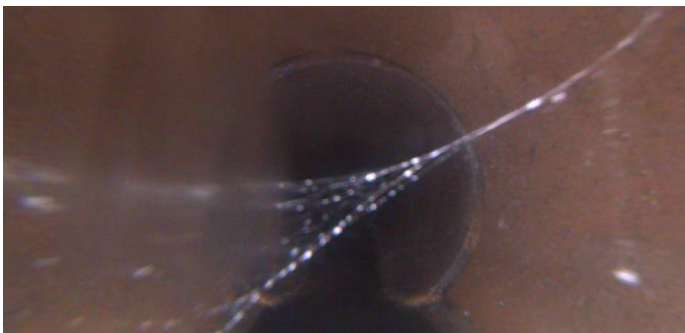
Code: **DAE**
Description: **Deposits Attached Encrustation**

Distance (ft): **42.6**
Structural Grade: **0**
O&M Grade: **2**
Clock Start/From: **8**
Clock To: **4**
1st Value:
2nd Value:
Value Percent: **5.000**
Continuous Index: **F01**
Within 8" of Joint: **YES**
Remarks:

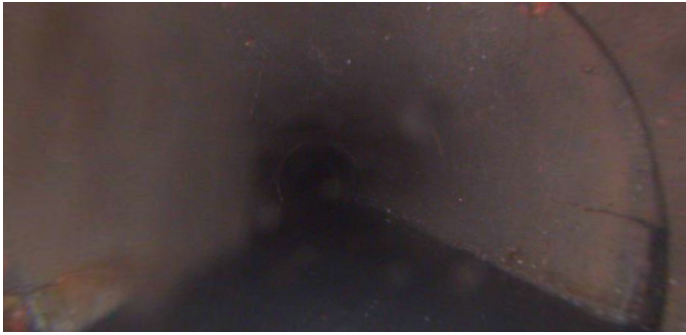
Code: **FM**
Description: **Fracture Multiple**

Distance (ft): **48.3**
Structural Grade: **4**
O&M Grade: **0**
Clock Start/From: **8**
Clock To: **4**
1st Value:
2nd Value:
Value Percent:
Continuous Index:
Within 8" of Joint: **YES**
Remarks:

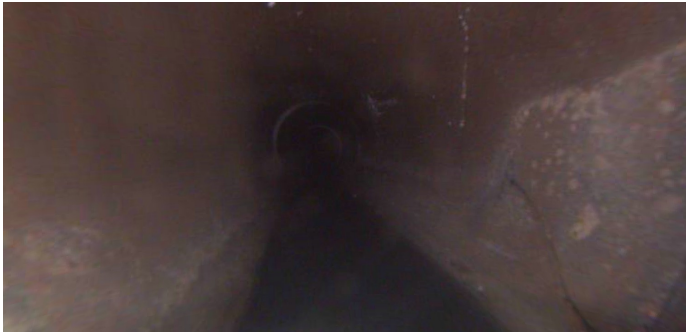
Code: **FM**
Description: **Fracture Multiple**

Distance (ft): **64.1**
Structural Grade: **4**
O&M Grade: **0**
Clock Start/From: **8**
Clock To: **4**
1st Value:
2nd Value:
Value Percent:
Continuous Index:
Within 8" of Joint: **YES**
Remarks:

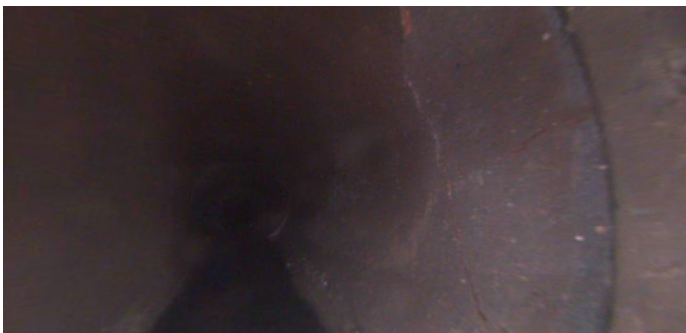
Code: **FM**
Description: **Fracture Multiple**

Distance (ft): **74.4**
Structural Grade: **4**
O&M Grade: **0**
Clock Start/From: **8**
Clock To: **4**
1st Value:
2nd Value:
Value Percent:
Continuous Index: **S03**
Within 8" of Joint: **YES**
Remarks:

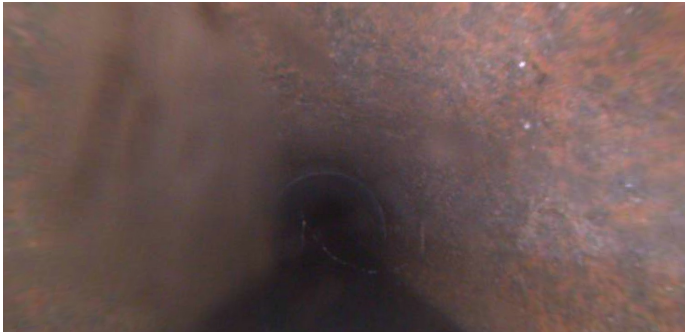
Code: **FM**
Description: **Fracture Multiple**

Distance (ft): **82.8**
Structural Grade: **4**
O&M Grade: **0**
Clock Start/From: **8**
Clock To: **4**
1st Value:
2nd Value:
Value Percent:
Continuous Index: **F03**
Within 8" of Joint: **YES**
Remarks:

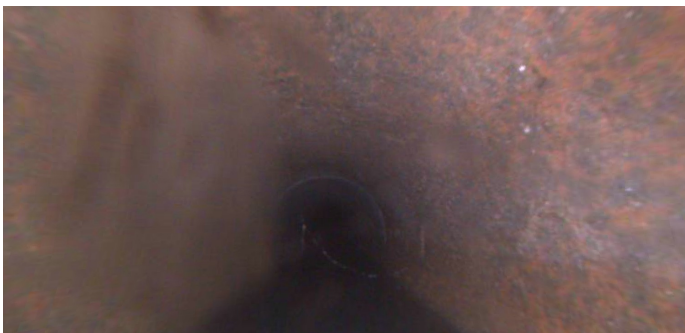
Code: **MSA**
Description: **Abandoned Survey**

Distance (ft): **82.8**
Structural Grade: **0**
O&M Grade: **0**
Clock Start/From:
Clock To:
1st Value:
2nd Value:
Value Percent:
Continuous Index:
Within 8" of Joint: **NO**
Remarks: **debris under water**
