Profile/Photo Observation Report

Street:	N CALIFORNIA ST & W HOME AVE	Flow Control:	Not Controlled
City:	Hobart, IN	Year Renewed:	
Location:	Light Highway	Tape/Media #:	
Purpose:	Not Known	Dia/Height:	12"
Use:	Sanitary	Material:	VCP
Drain Area:	NA	Lining:	
Category:	NA		
Comment:

Location Details:		Direction of Survey:	Downstream
US MH:	M-504-006	DS MH:	M-504-010
		Total Length Surveyed (ft):	14.1

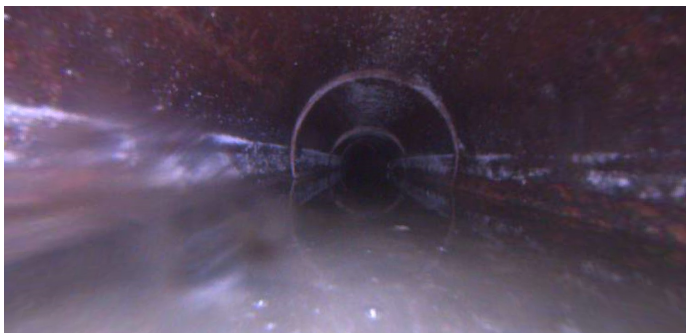
Code: **AMH**
Description: **Manhole**

Distance (ft): **.0**
Structural Grade: **0**
O&M Grade: **0**
Clock Start/From:
Clock To:
1st Value:
2nd Value:
Value Percent:
Continuous Index:
Within 8" of Joint: **NO**
Remarks: **M-504-006**

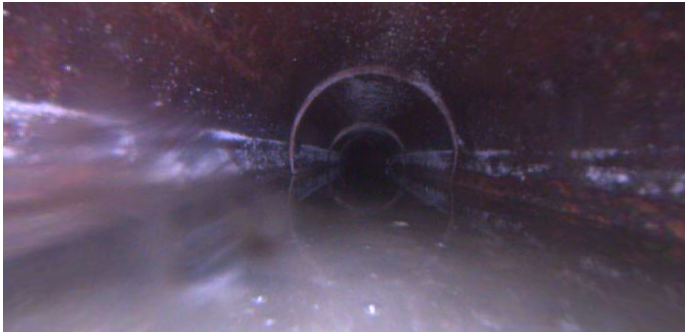
Code:	MWL
Description:	Water Level

Distance (ft):	.0
Structural Grade:	0
O&M Grade:	0
Clock Start/From:	
Clock To:	
1st Value:	
2nd Value:	
Value Percent:	30.000
Continuous Index:	
Within 8" of Joint:	NO
Remarks:

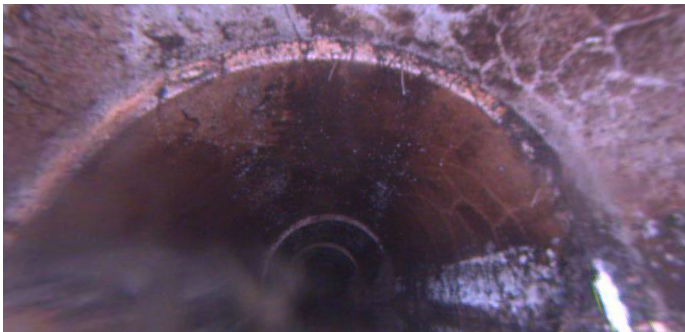
Code:	RFJ
Description:	Roots Fine Joint

Distance (ft):	6.1
Structural Grade:	0
O&M Grade:	1
Clock Start/From:	8
Clock To:	4
1st Value:	
2nd Value:	
Value Percent:	
Continuous Index:	
Within 8" of Joint:	YES
Remarks:

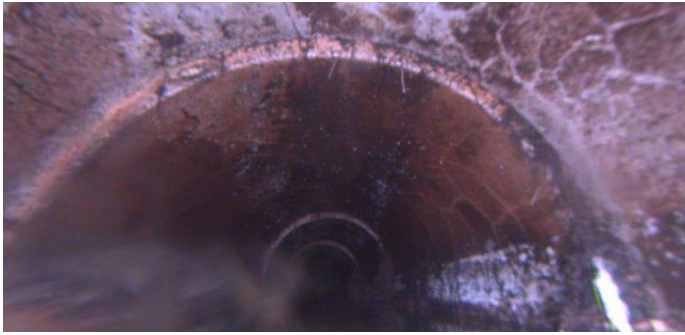
Code: **MB**
Description: **Missing Brick**

Distance (ft): **6.1**
Structural Grade: **4**
O&M Grade: **0**
Clock Start/From: **8**
Clock To: **4**
1st Value:
2nd Value:
Value Percent:
Continuous Index:
Within 8" of Joint: **NO**
Remarks:

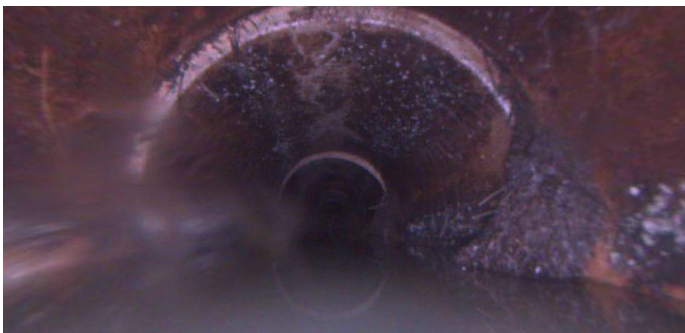
Code: **RMJ**
Description: **Roots Medium Joint**

Distance (ft): **7.8**
Structural Grade: **0**
O&M Grade: **3**
Clock Start/From: **8**
Clock To: **4**
1st Value:
2nd Value:
Value Percent: **10.000**
Continuous Index:
Within 8" of Joint: **YES**
Remarks:

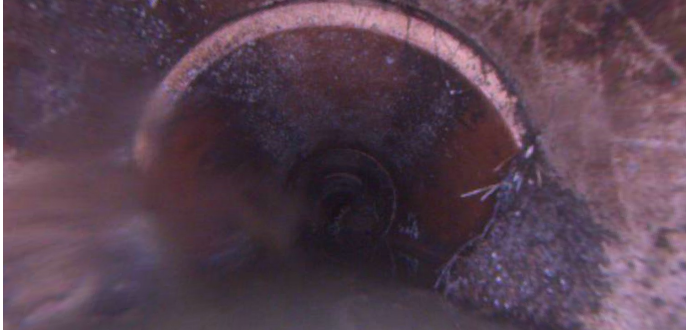
Code: **CM**
Description: **Crack Multiple**

Distance (ft): **9.7**
Structural Grade: **3**
O&M Grade: **0**
Clock Start/From: **8**
Clock To: **4**
1st Value:
2nd Value:
Value Percent:
Continuous Index:
Within 8" of Joint: **YES**
Remarks:

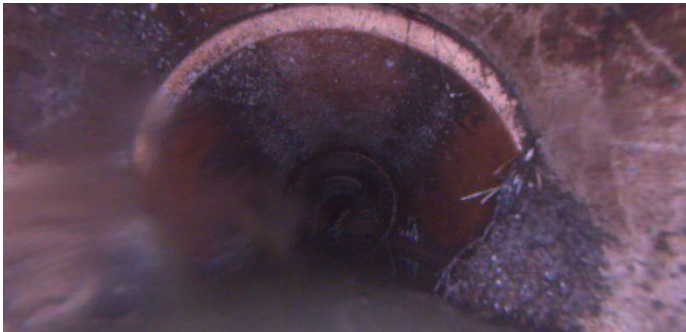
Code: **RMJ**
Description: **Roots Medium Joint**

Distance (ft): **9.7**
Structural Grade: **0**
O&M Grade: **3**
Clock Start/From: **8**
Clock To: **4**
1st Value:
2nd Value:
Value Percent: **10.000**
Continuous Index:
Within 8" of Joint: **YES**
Remarks:

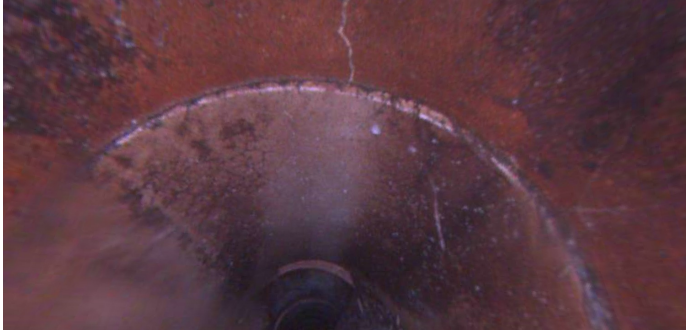
Code: **CL**
Description: **Crack Longitudinal**

Distance (ft): **11.9**
Structural Grade: **2**
O&M Grade: **0**
Clock Start/From: **12**
Clock To:
1st Value:
2nd Value:
Value Percent:
Continuous Index:
Within 8" of Joint: **YES**
Remarks:

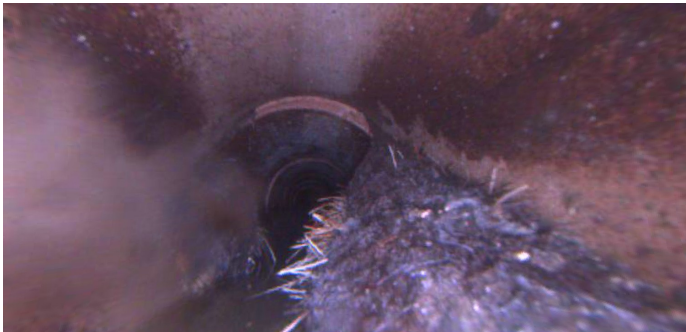
Code: **RMJ**
Description: **Roots Medium Joint**

Distance (ft): **12.9**
Structural Grade: **0**
O&M Grade: **3**
Clock Start/From: **8**
Clock To: **4**
1st Value:
2nd Value:
Value Percent: **40.000**
Continuous Index:
Within 8" of Joint: **YES**
Remarks:

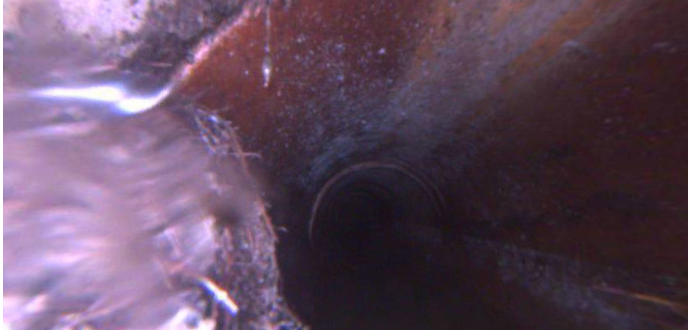
Code:	MSA
Description:	Abandoned Survey
Distance (ft):	14.1
Structural Grade:	0
O&M Grade:	0
Clock Start/From:	
Clock To:	
1st Value:	
2nd Value:	
Value Percent:	
Continuous Index:	
Within 8" of Joint:	NO
Remarks:	roots
