## Profile/Photo Observation Report

Street:	<b>Summerlin</b>	Flow Control:	<b>Not Controlled</b>
City:	<b>Hobart, IN</b>	Year Renewed:	
Location:	<b>Light Highway</b>	Tape/Media #:	
Purpose:	<b>Not Known</b>	Dia/Height:	<b>12"</b>
Use:	<b>Sanitary</b>	Material:	<b>VCP</b>
Drain Area:	<b>NA</b>	Lining:	
Category:	<b>NA</b>		
Comment:

Location Details:		Direction of Survey:	<b>Downstream</b>
US MH:	<b>M-504-006</b>	DS MH:	<b>M-504-010</b>
		Total Length Surveyed (ft):	<b>14.1</b>

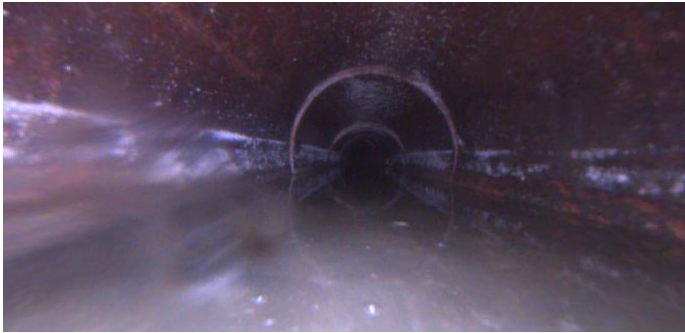
Code:	<b>MWL</b>
Description:	<b>Water Level</b>

Distance (ft):	<b>.0</b>
Structural Grade:	<b>0</b>
O&M Grade:	<b>0</b>
Clock Start/From:	
Clock To:	
1st Value:	
2nd Value:	
Value Percent:	<b>30.000</b>
Continuous Index:	
Within 8" of Joint:	<b>NO</b>
Remarks:

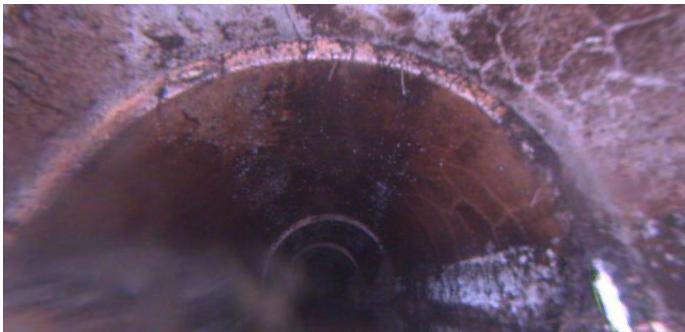
Code:	<b>RFJ</b>
Description:	<b>Roots Fine Joint</b>

Distance (ft):	<b>6.1</b>
Structural Grade:	<b>0</b>
O&M Grade:	<b>1</b>
Clock Start/From:	<b>8</b>
Clock To:	<b>4</b>
1st Value:	
2nd Value:	
Value Percent:	
Continuous Index:	
Within 8" of Joint:	<b>YES</b>
Remarks:

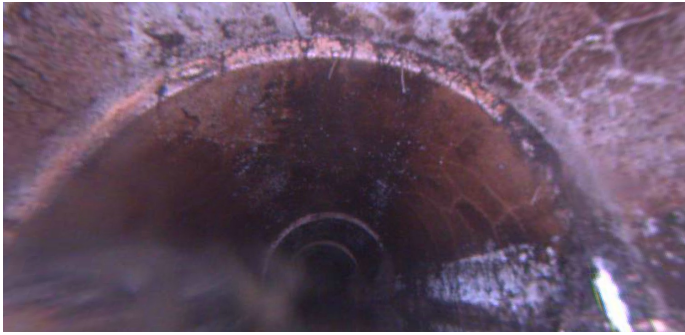
Code: **MB**  
Description: **Missing Brick**

Distance (ft): **6.1**  
Structural Grade: **4**  
O&M Grade: **0**  
Clock Start/From: **8**  
Clock To: **4**  
1st Value:  
2nd Value:  
Value Percent:  
Continuous Index:  
Within 8" of Joint: **NO**  
Remarks:

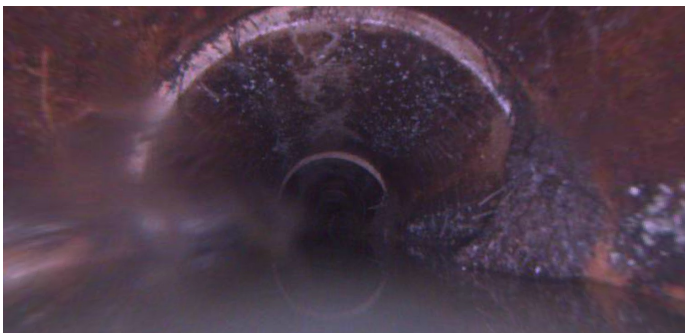
Code: **RMJ**  
Description: **Roots Medium Joint**

Distance (ft): **7.8**  
Structural Grade: **0**  
O&M Grade: **3**  
Clock Start/From: **8**  
Clock To: **4**  
1st Value:  
2nd Value:  
Value Percent: **10.000**  
Continuous Index:  
Within 8" of Joint: **YES**  
Remarks:

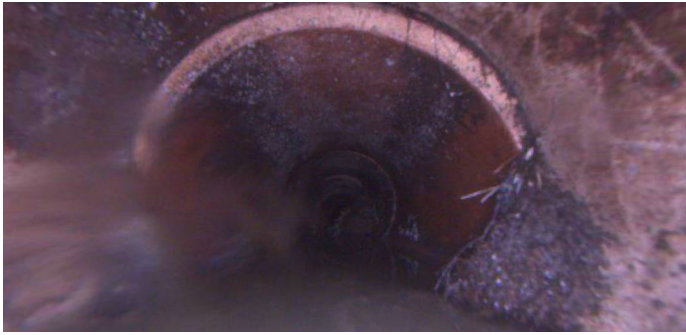
Code: **CM**  
Description: **Crack Multiple**

Distance (ft): **9.7**  
Structural Grade: **3**  
O&M Grade: **0**  
Clock Start/From: **8**  
Clock To: **4**  
1st Value:  
2nd Value:  
Value Percent:  
Continuous Index:  
Within 8" of Joint: **YES**  
Remarks:

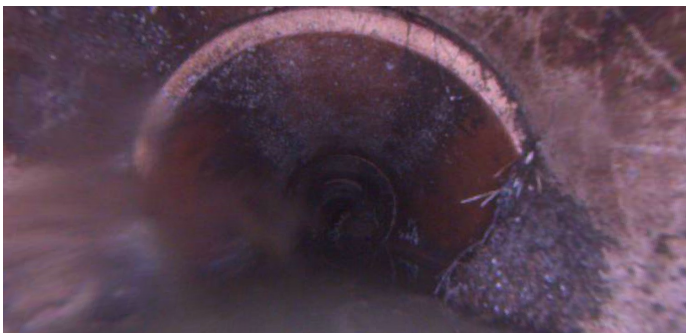
Code: **RMJ**  
Description: **Roots Medium Joint**

Distance (ft): **9.7**  
Structural Grade: **0**  
O&M Grade: **3**  
Clock Start/From: **8**  
Clock To: **4**  
1st Value:  
2nd Value:  
Value Percent: **10.000**  
Continuous Index:  
Within 8" of Joint: **YES**  
Remarks:

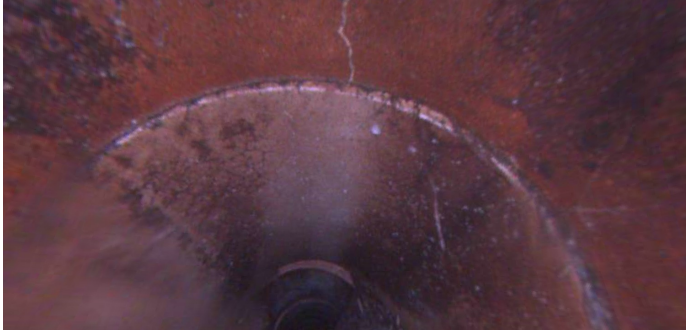
Code: **CL**  
Description: **Crack Longitudinal**

Distance (ft): **11.9**  
Structural Grade: **2**  
O&M Grade: **0**  
Clock Start/From: **12**  
Clock To:  
1st Value:  
2nd Value:  
Value Percent:  
Continuous Index:  
Within 8" of Joint: **YES**  
Remarks:

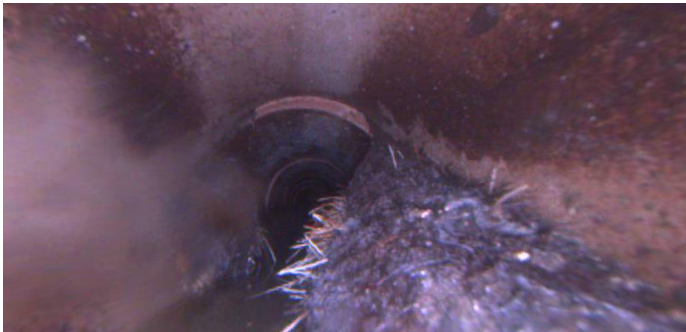
Code: **RMJ**  
Description: **Roots Medium Joint**

Distance (ft): **12.9**  
Structural Grade: **0**  
O&M Grade: **3**  
Clock Start/From: **8**  
Clock To: **4**  
1st Value:  
2nd Value:  
Value Percent: **40.000**  
Continuous Index:  
Within 8" of Joint: **YES**  
Remarks:

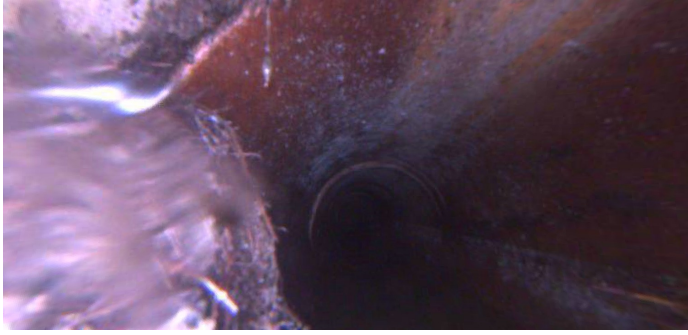
Code:	<b>MSA</b>
Description:	<b>Abandoned Survey</b>
Distance (ft):	<b>14.1</b>
Structural Grade:	<b>0</b>
O&M Grade:	<b>0</b>
Clock Start/From:	
Clock To:	
1st Value:	
2nd Value:	
Value Percent:	
Continuous Index:	
Within 8" of Joint:	<b>NO</b>
Remarks:	<b>roots</b>
