Profile/Photo Observation Report

Date:	04/20/2018	Weather:		Coding:	PACP 6.0
Pipe Length (ft):	188.8	Owner:	NA	Pre Clean:	Not Known
P.O.#:		Surveyor:	Byrd Fitzgerald	PSR:	P-504-008-007
Customer:		Clean Date:	01/01/1900	Shape:	C

Street:	N CALIFORNIA ST	Flow Control:	Not Controlled
City:	Hobart, IN	Year Renewed:	
Location:	Light Highway	Tape/Media #:	
Purpose:	Not Known	Dia/Height:	10"
Use:	Sanitary	Material:	VCP
Drain Area:	NA	Lining:	
Category:	NA		
Comment:

Location Details:		Direction of Survey:	Upstream
US MH:	M-504-007	DS MH:	M-504-008
		Total Length Surveyed (ft):	49.1

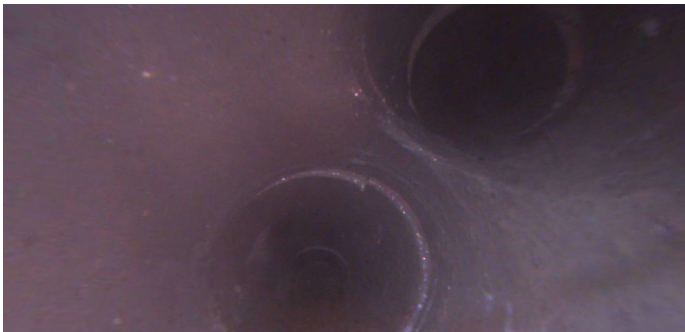
Code:	TF
Description:	Tap Factory

Distance (ft):	18.4
Structural Grade:	0
O&M Grade:	0
Clock Start/From:	1
Clock To:	
1st Value:	4.000
2nd Value:	
Value Percent:	
Continuous Index:	
Within 8" of Joint:	YES
Remarks:

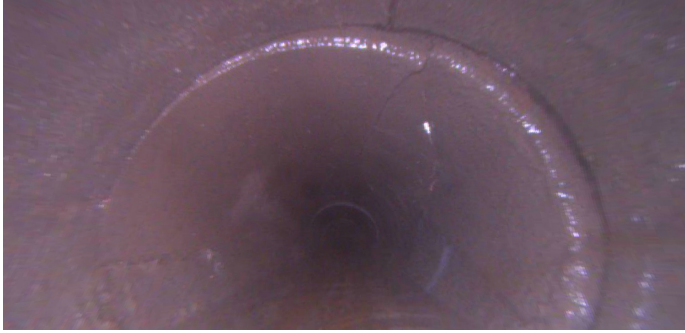
Code: **CM**
Description: **Crack Multiple**

Distance (ft): **19.1**
Structural Grade: **3**
O&M Grade: **0**
Clock Start/From: **7**
Clock To: **5**
1st Value:
2nd Value:
Value Percent:
Continuous Index: **S01**
Within 8" of Joint: **YES**
Remarks: **wandering**

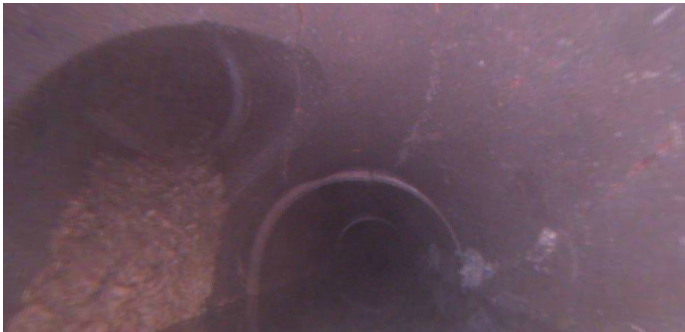
Code: **TFD**
Description: **Tap Factory Defective**

Distance (ft): **23.3**
Structural Grade: **0**
O&M Grade: **2**
Clock Start/From: **11**
Clock To:
1st Value: **4.000**
2nd Value:
Value Percent:
Continuous Index:
Within 8" of Joint: **YES**
Remarks: **partially blocked by dae**

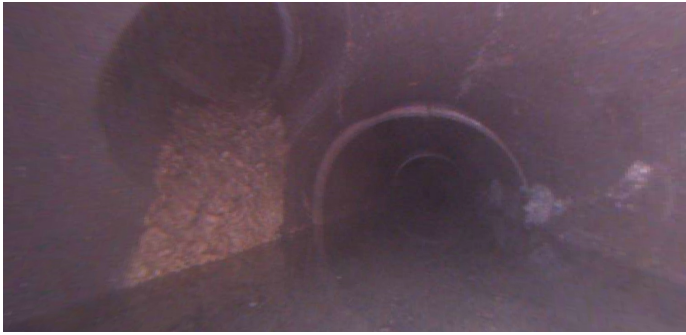
Code: **DAE**
Description: **Deposits Attached Encrustation**

Distance (ft): **23.3**
Structural Grade: **0**
O&M Grade: **2**
Clock Start/From: **8**
Clock To: **10**
1st Value:
2nd Value:
Value Percent: **5.000**
Continuous Index:
Within 8" of Joint: **NO**
Remarks:

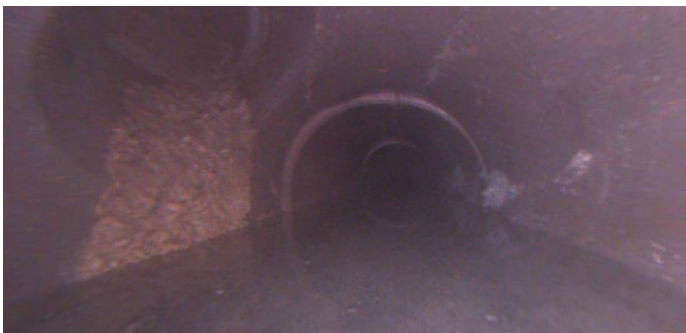
Code: **MWL**
Description: **Water Level**

Distance (ft): **23.3**
Structural Grade: **0**
O&M Grade: **0**
Clock Start/From:
Clock To:
1st Value:
2nd Value:
Value Percent: **25.000**
Continuous Index:
Within 8" of Joint: **NO**
Remarks:

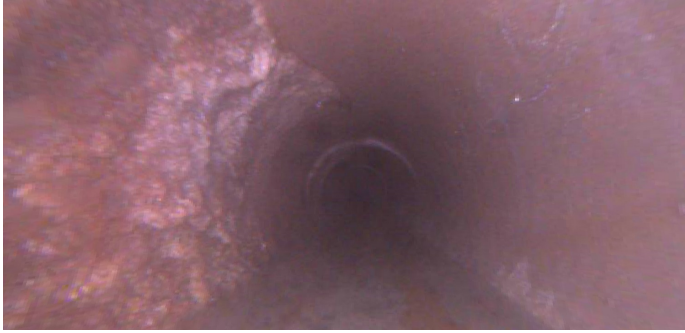
Code: **DAE**
Description: **Deposits Attached Encrustation**

Distance (ft): **32.4**
Structural Grade: **0**
O&M Grade: **2**
Clock Start/From: **7**
Clock To: **11**
1st Value:
2nd Value:
Value Percent: **5.000**
Continuous Index:
Within 8" of Joint: **NO**
Remarks:

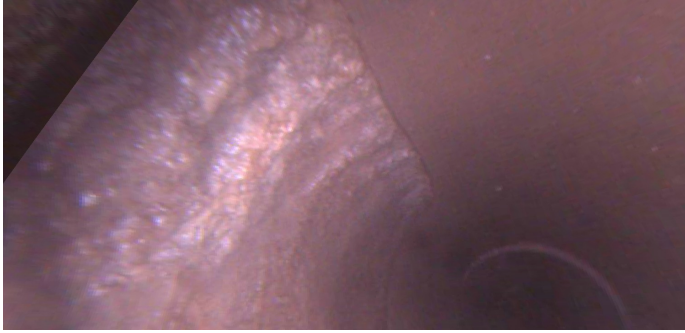
Code: **DAE**
Description: **Deposits Attached Encrustation**

Distance (ft): **34.9**
Structural Grade: **0**
O&M Grade: **2**
Clock Start/From: **8**
Clock To: **11**
1st Value:
2nd Value:
Value Percent: **5.000**
Continuous Index:
Within 8" of Joint: **NO**
Remarks:

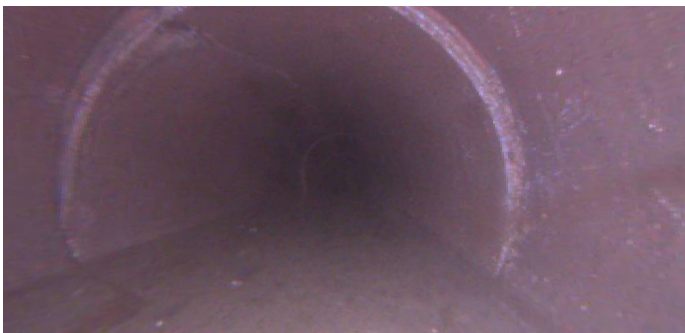
Code: **MSA**
Description: **Abandoned Survey**

Distance (ft): **49.1**
Structural Grade: **0**
O&M Grade: **0**
Clock Start/From:
Clock To:
1st Value:
2nd Value:
Value Percent:
Continuous Index:
Within 8" of Joint: **NO**
Remarks: **no blockage**

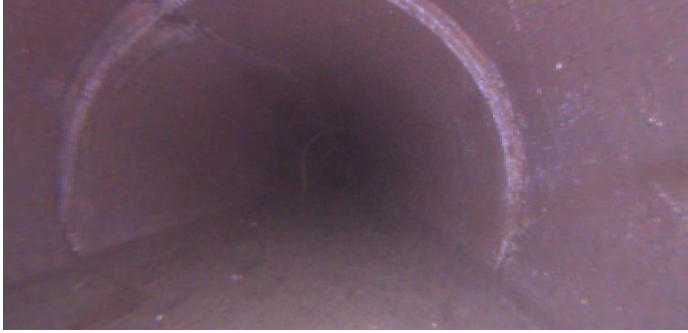
Code:	CM
Description:	Crack Multiple
Distance (ft):	49.1
Structural Grade:	3
O&M Grade:	0
Clock Start/From:	7
Clock To:	5
1st Value:	
2nd Value:	
Value Percent:	
Continuous Index:	F01
Within 8" of Joint:	YES
Remarks:	wandering
