## Profile/Photo Observation Report

Date:	<b>04/20/2018</b>	Weather:		Coding:	<b>PACP 6.0</b>
Pipe Length (ft):	<b>188.8</b>	Owner:	<b>NA</b>	Pre Clean:	<b>Not Known</b>
P.O.#:		Surveyor:	<b>Byrd Fitzgerald</b>	PSR:	<b>P-504-008-007</b>
Customer:		Clean Date:	<b>01/01/1900</b>	Shape:	<b>C</b>

Street:	<b>Summerlin</b>	Flow Control:	<b>Not Controlled</b>
City:	<b>Hobart, IN</b>	Year Renewed:	
Location:	<b>Light Highway</b>	Tape/Media #:	
Purpose:	<b>Not Known</b>	Dia/Height:	<b>10"</b>
Use:	<b>Sanitary</b>	Material:	<b>VCP</b>
Drain Area:	<b>NA</b>	Lining:	
Category:	<b>NA</b>		
Comment:

Location Details:		Direction of Survey:	<b>Upstream</b>
US MH:	<b>M-504-007</b>	DS MH:	<b>M-504-008</b>
		Total Length Surveyed (ft):	<b>49.1</b>

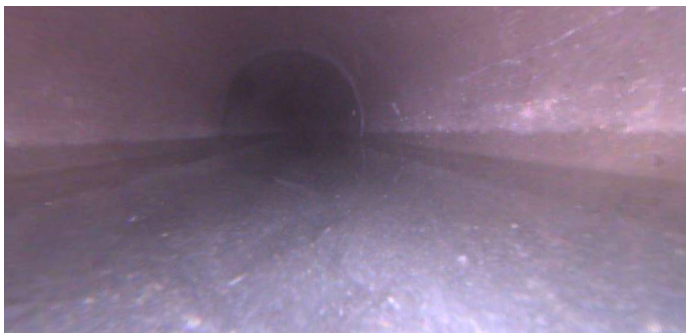
Code: **AMH**  
Description: **Manhole**

Distance (ft): **.0**  
Structural Grade: **0**  
O&M Grade: **0**  
Clock Start/From:  
Clock To:  
1st Value:  
2nd Value:  
Value Percent:  
Continuous Index:  
Within 8" of Joint: **NO**  
Remarks: **M-504-007**

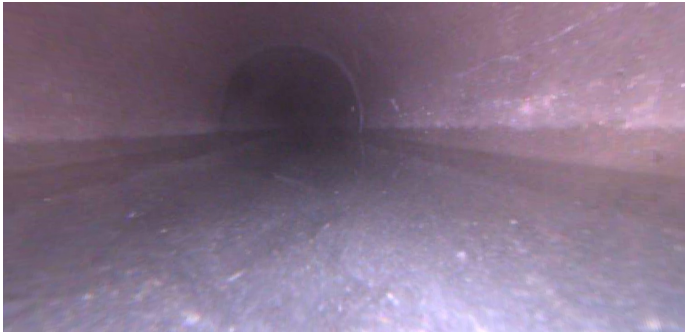
Code:	<b>MWL</b>
Description:	<b>Water Level</b>

Distance (ft):	<b>.0</b>
Structural Grade:	<b>0</b>
O&M Grade:	<b>0</b>
Clock Start/From:	
Clock To:	
1st Value:	
2nd Value:	
Value Percent:	<b>10.000</b>
Continuous Index:	
Within 8" of Joint:	<b>NO</b>
Remarks:

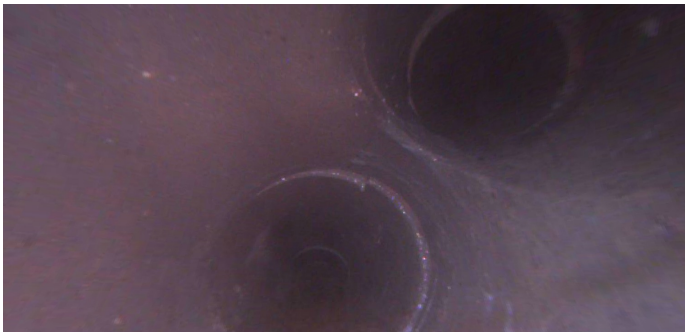
Code:	<b>TF</b>
Description:	<b>Tap Factory</b>

Distance (ft):	<b>18.4</b>
Structural Grade:	<b>0</b>
O&M Grade:	<b>0</b>
Clock Start/From:	<b>1</b>
Clock To:	
1st Value:	<b>4.000</b>
2nd Value:	
Value Percent:	
Continuous Index:	
Within 8" of Joint:	<b>YES</b>
Remarks:

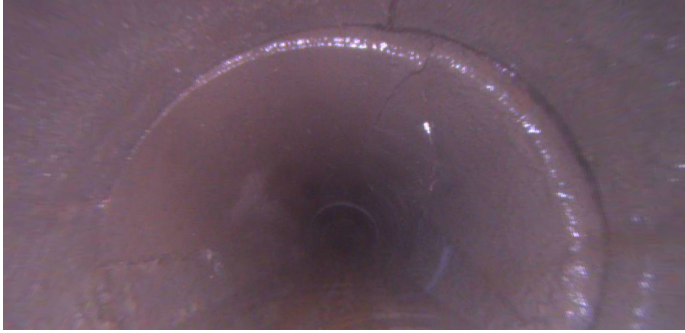
Code: **CM**  
Description: **Crack Multiple**

Distance (ft): **19.1**  
Structural Grade: **3**  
O&M Grade: **0**  
Clock Start/From: **7**  
Clock To: **5**  
1st Value:  
2nd Value:  
Value Percent:  
Continuous Index: **S01**  
Within 8" of Joint: **YES**  
Remarks: **wandering**

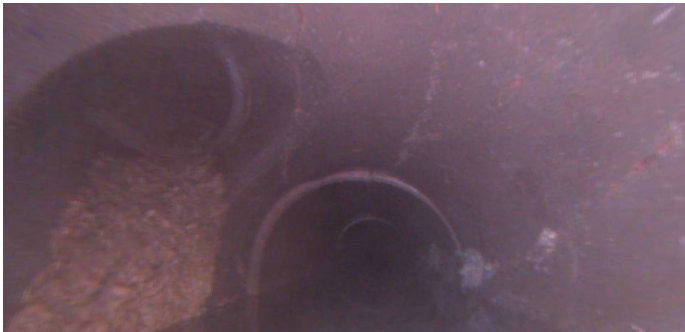
Code: **TFD**  
Description: **Tap Factory Defective**

Distance (ft): **23.3**  
Structural Grade: **0**  
O&M Grade: **2**  
Clock Start/From: **11**  
Clock To:  
1st Value: **4.000**  
2nd Value:  
Value Percent:  
Continuous Index:  
Within 8" of Joint: **YES**  
Remarks: **partially blocked by dae**

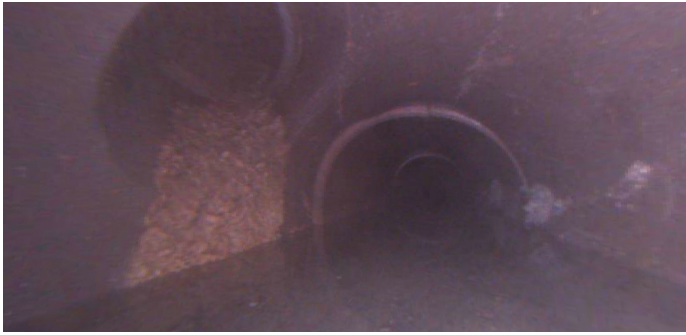
Code: **DAE**  
Description: **Deposits Attached Encrustation**

Distance (ft): **23.3**  
Structural Grade: **0**  
O&M Grade: **2**  
Clock Start/From: **8**  
Clock To: **10**  
1st Value:  
2nd Value:  
Value Percent: **5.000**  
Continuous Index:  
Within 8" of Joint: **NO**  
Remarks:

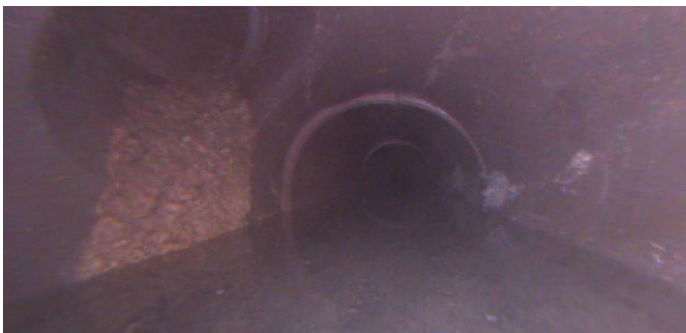
Code: **MWL**  
Description: **Water Level**

Distance (ft): **23.3**  
Structural Grade: **0**  
O&M Grade: **0**  
Clock Start/From:  
Clock To:  
1st Value:  
2nd Value:  
Value Percent: **25.000**  
Continuous Index:  
Within 8" of Joint: **NO**  
Remarks:

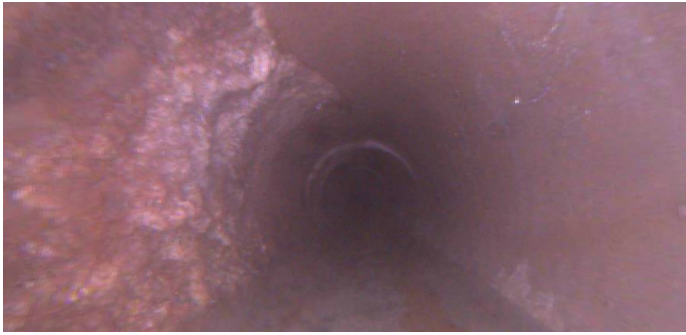
Code: **DAE**  
Description: **Deposits Attached Encrustation**

Distance (ft): **32.4**  
Structural Grade: **0**  
O&M Grade: **2**  
Clock Start/From: **7**  
Clock To: **11**  
1st Value:  
2nd Value:  
Value Percent: **5.000**  
Continuous Index:  
Within 8" of Joint: **NO**  
Remarks:

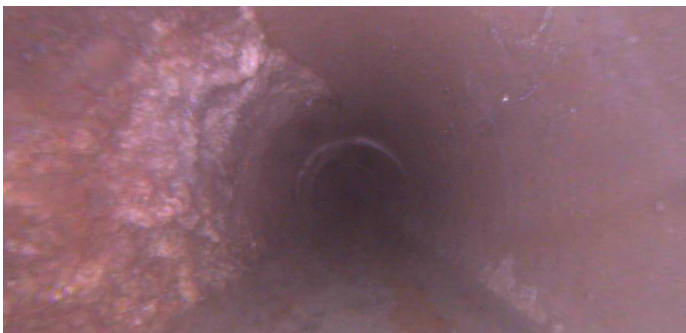
Code: **MWL**  
Description: **Water Level**

Distance (ft): **32.4**  
Structural Grade: **0**  
O&M Grade: **0**  
Clock Start/From:  
Clock To:  
1st Value:  
2nd Value:  
Value Percent: **5.000**  
Continuous Index:  
Within 8" of Joint: **NO**  
Remarks:

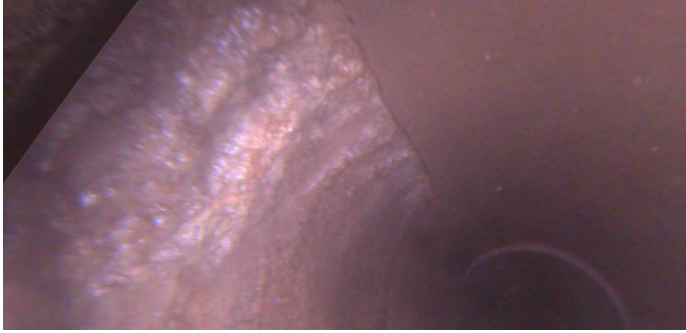
Code: **DAE**  
Description: **Deposits Attached Encrustation**

Distance (ft): **34.9**  
Structural Grade: **0**  
O&M Grade: **2**  
Clock Start/From: **8**  
Clock To: **11**  
1st Value:  
2nd Value:  
Value Percent: **5.000**  
Continuous Index:  
Within 8" of Joint: **NO**  
Remarks:

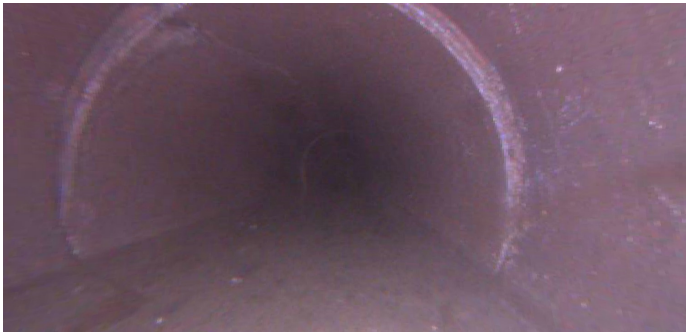
Code: **MSA**  
Description: **Abandoned Survey**

Distance (ft): **49.1**  
Structural Grade: **0**  
O&M Grade: **0**  
Clock Start/From:  
Clock To:  
1st Value:  
2nd Value:  
Value Percent:  
Continuous Index:  
Within 8" of Joint: **NO**  
Remarks: **no blockage**

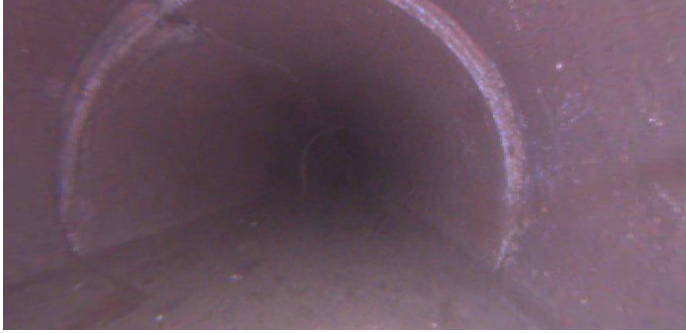
Code:	<b>CM</b>
Description:	<b>Crack Multiple</b>
Distance (ft):	<b>49.1</b>
Structural Grade:	<b>3</b>
O&M Grade:	<b>0</b>
Clock Start/From:	<b>7</b>
Clock To:	<b>5</b>
1st Value:	
2nd Value:	
Value Percent:	
Continuous Index:	<b>F01</b>
Within 8" of Joint:	<b>YES</b>
Remarks:	<b>wandering</b>
