# Profile/Photo Observation Report

Date:	02/14/2024	Weather:		Coding:	PACP 7.0
Pipe Length (ft):	189.0	Owner:	City of Hobart	Pre Clean:	Heavy Cleaning
P.O.#:	YES502259	Surveyor:	S. Bucklin	PSR:	P-504-008-007
Customer:	City of Hobart	Clean Date:	10/08/2022	Shape:	C

Street:	N CALIFORNIA ST	Flow Control:	Not Controlled
City:	Hobart, IN	Year Renewed:	
Location:	Local rural streets with light traffic, t	Tape/Media #:	
Purpose:	Routine Assessment	Dia/Height:	10"
Use:	Sanitary Sewage Pipe	Material:	VCP
Drain Area:		Lining:	None
Category:	NA		
Comment:			
Location Details:		Direction of Survey:	Downstream
US MH:	M-504-007	DS MH:	M-504-008
		Total Length Surveyed (ft):	189.9

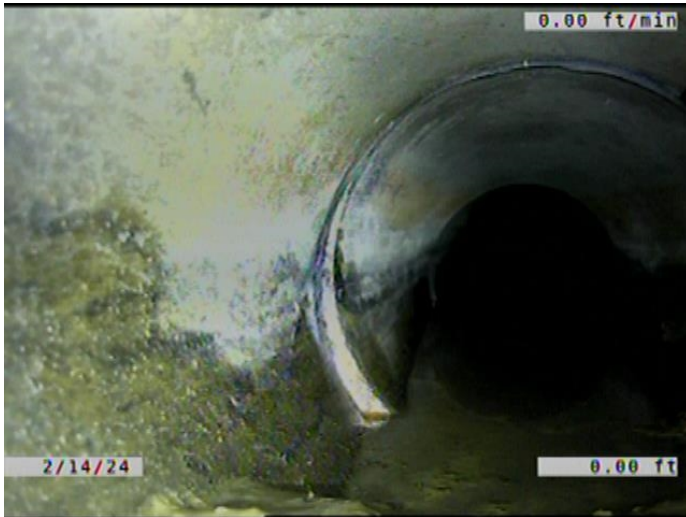
Code: **DSF**  
Description: **Deposits Settled Fine**

Distance (ft): **.0**  
Structural Grade: **0**  
O&M Grade: **2**  
Clock Start/From: **5**  
Clock To: **7**  
1st Value:  
2nd Value:  
Value Percent: **5.000**  
Continuous Index: **S01**  
Within 8" of Joint: **YES**  
Remarks:

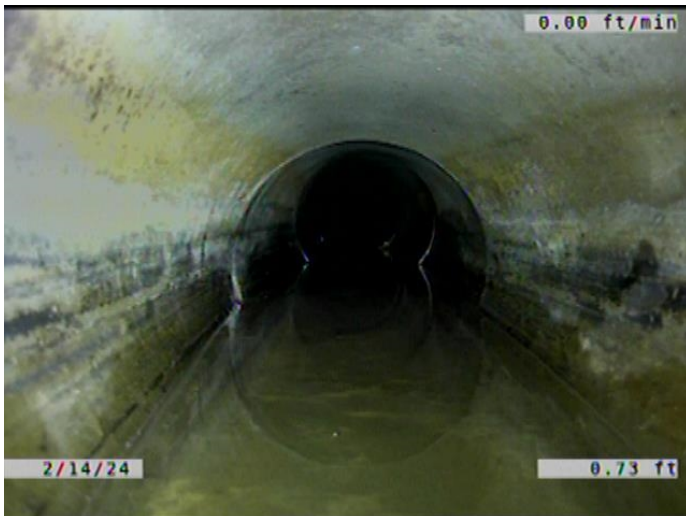
Code: **MWLS**  
Description: **Miscellaneous Water Level Sag**

Distance (ft): **.7**  
Structural Grade: **2**  
O&M Grade: **0**  
Clock Start/From:  
Clock To:  
1st Value:  
2nd Value:  
Value Percent: **15.000**  
Continuous Index: **S02**  
Within 8" of Joint: **NO**  
Remarks:

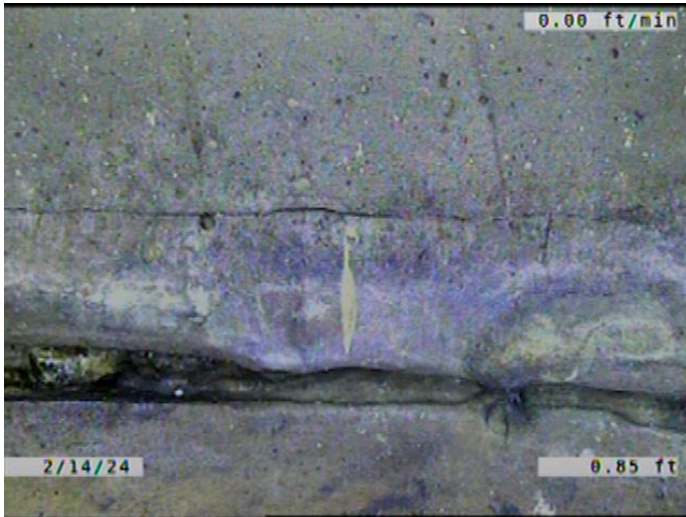
Code: **CC**  
Description: **Crack Circumferential**

Distance (ft): **.8**  
Structural Grade: **1**  
O&M Grade: **0**  
Clock Start/From: **11**  
Clock To: **1**  
1st Value:  
2nd Value:  
Value Percent:  
Continuous Index:  
Within 8" of Joint: **YES**  
Remarks:

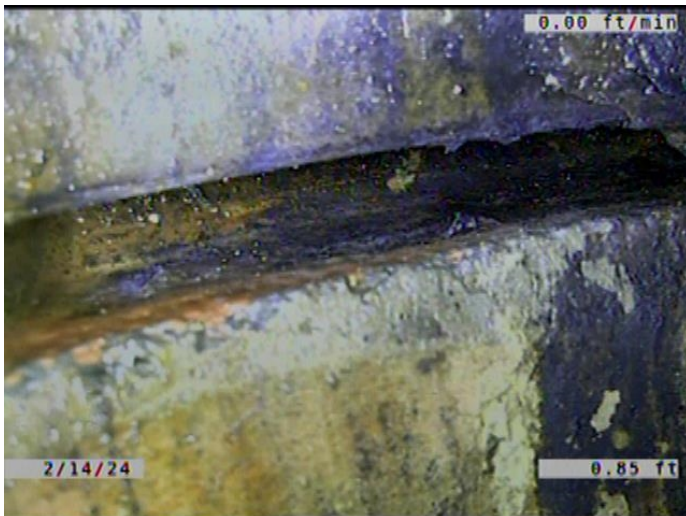
Code: **JAM**  
Description: **Joint Angular Medium**

Distance (ft): **.8**  
Structural Grade: **3**  
O&M Grade: **0**  
Clock Start/From:  
Clock To:  
1st Value:  
2nd Value:  
Value Percent:  
Continuous Index:  
Within 8" of Joint: **NO**  
Remarks:

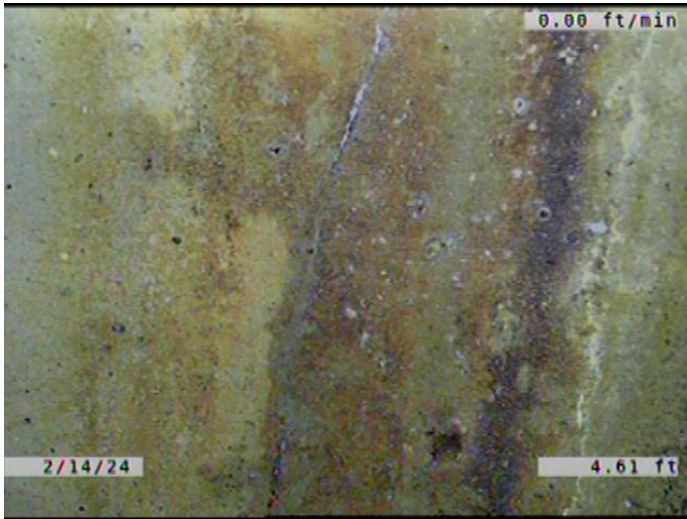
Code: **CL**  
Description: **Crack Longitudinal**

Distance (ft): **4.6**  
Structural Grade: **2**  
O&M Grade: **0**  
Clock Start/From: **2**  
Clock To:  
1st Value:  
2nd Value:  
Value Percent:  
Continuous Index:  
Within 8" of Joint: **YES**  
Remarks:

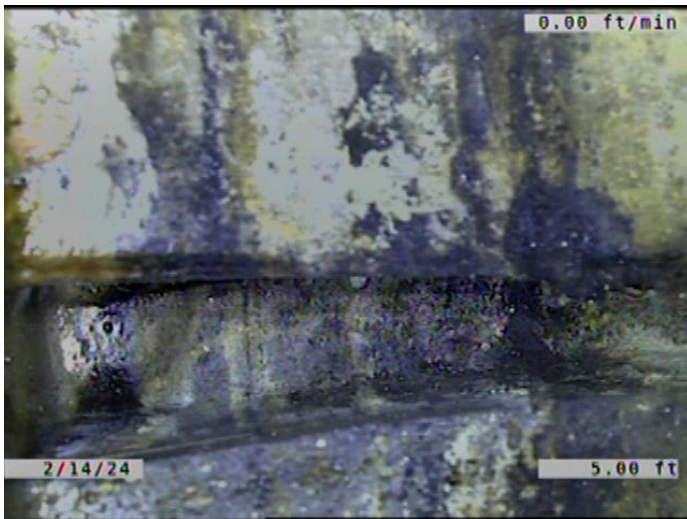
Code: **JAM**  
Description: **Joint Angular Medium**

Distance (ft): **5.0**  
Structural Grade: **3**  
O&M Grade: **0**  
Clock Start/From:  
Clock To:  
1st Value:  
2nd Value:  
Value Percent:  
Continuous Index:  
Within 8" of Joint: **NO**  
Remarks:

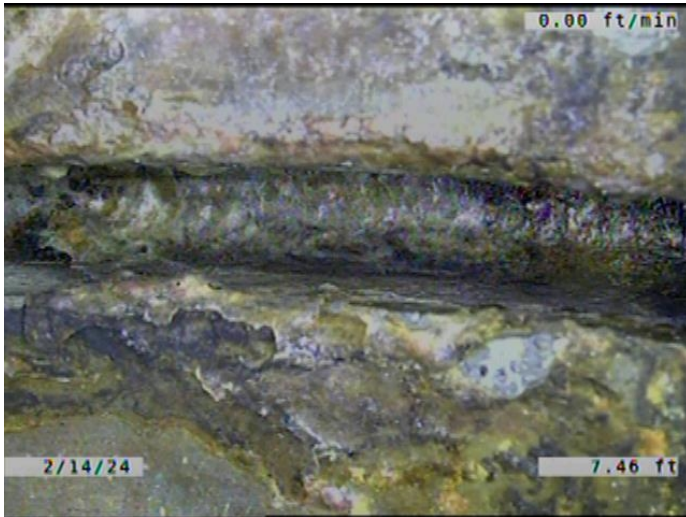
Code: **DAE**  
Description: **Deposits Attached Encrustation**

Distance (ft): **7.5**  
Structural Grade: **0**  
O&M Grade: **2**  
Clock Start/From: **7**  
Clock To: **5**  
1st Value:  
2nd Value:  
Value Percent: **5.000**  
Continuous Index: **S03**  
Within 8" of Joint: **YES**  
Remarks:

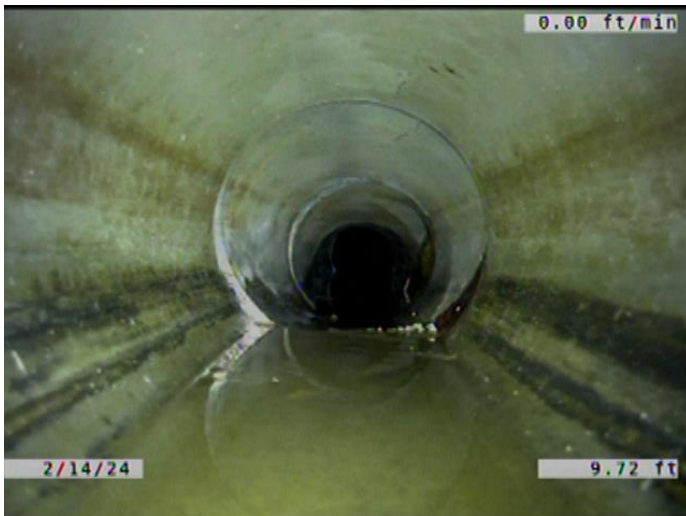
Code: **MWLS**  
Description: **Miscellaneous Water Level Sag**

Distance (ft): **9.7**  
Structural Grade: **2**  
O&M Grade: **0**  
Clock Start/From:  
Clock To:  
1st Value:  
2nd Value:  
Value Percent: **15.000**  
Continuous Index: **F02**  
Within 8" of Joint: **NO**  
Remarks:

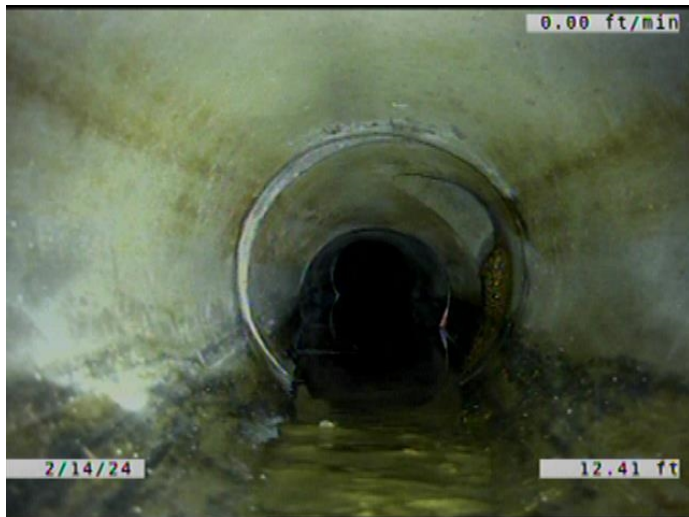
Code: **LD**  
Description: **Line Down**

Distance (ft): **12.4**  
Structural Grade: **0**  
O&M Grade: **1**  
Clock Start/From:  
Clock To:  
1st Value:  
2nd Value:  
Value Percent: **5.000**  
Continuous Index:  
Within 8" of Joint: **NO**  
Remarks:

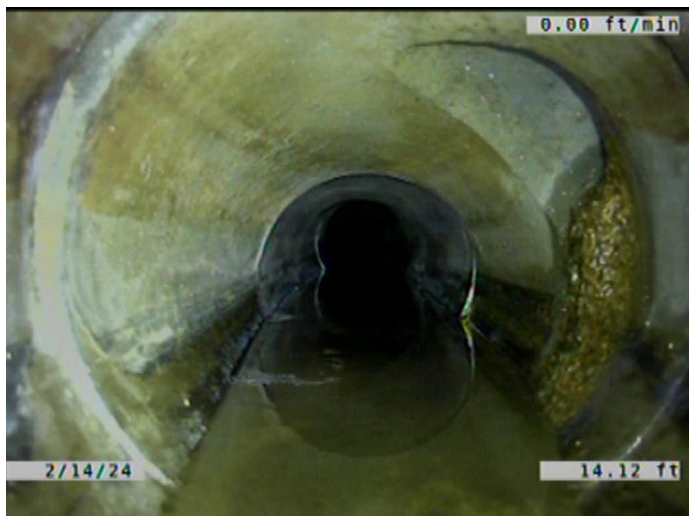
Code: **MWLS**  
Description: **Miscellaneous Water Level Sag**

Distance (ft): **14.1**  
Structural Grade: **2**  
O&M Grade: **0**  
Clock Start/From:  
Clock To:  
1st Value:  
2nd Value:  
Value Percent: **15.000**  
Continuous Index: **S04**  
Within 8" of Joint: **NO**  
Remarks:

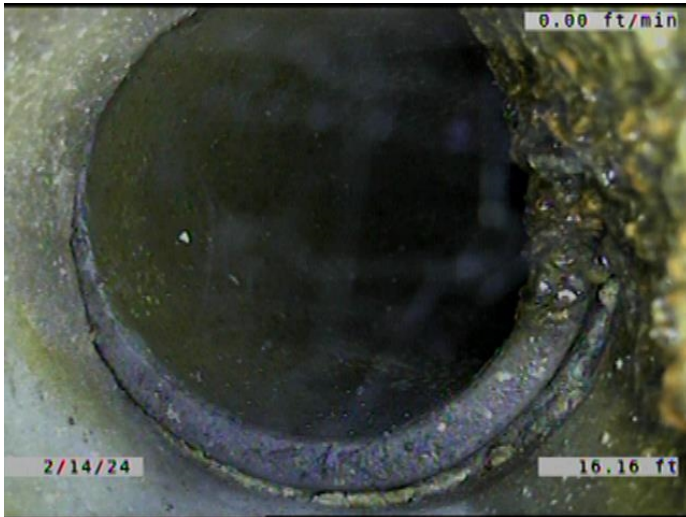
Code:	TFD
Description:	Tap Factory Defective
Distance (ft):	16.2
Structural Grade:	0
O&M Grade:	3
Clock Start/From:	2
Clock To:	
1st Value:	6.000
2nd Value:	
Value Percent:	
Continuous Index:	
Within 8" of Joint:	YES
Remarks:	CONSTANTLY RUNNING WATER. ENCRUSTATION COMING DOWN THE

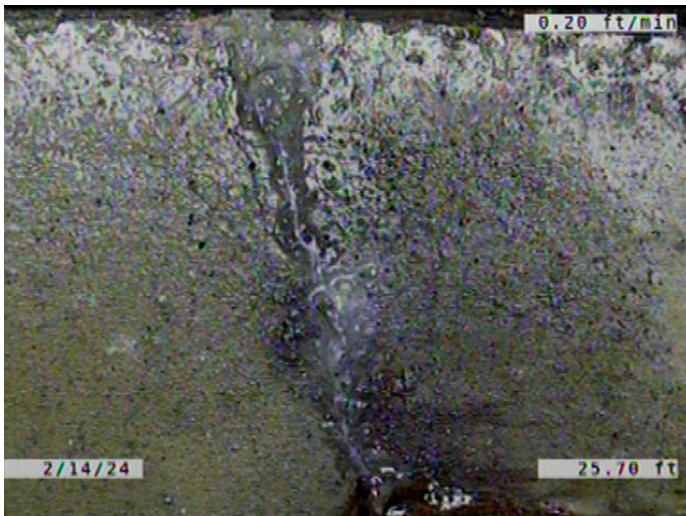
Code:	CM
Description:	Crack Multiple
Distance (ft):	25.7
Structural Grade:	3
O&M Grade:	0
Clock Start/From:	8
Clock To:	4
1st Value:	
2nd Value:	
Value Percent:	
Continuous Index:	S05
Within 8" of Joint:	YES
Remarks:

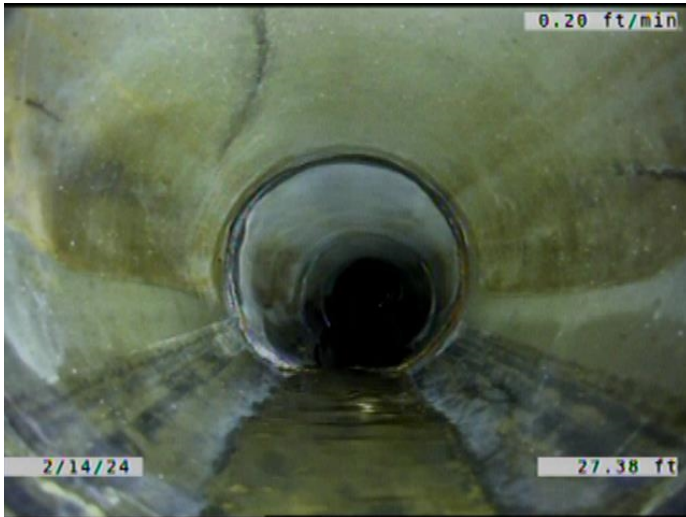
Code:	<b>MWLS</b>
Description:	<b>Miscellaneous Water Level Sag</b>
Distance (ft):	<b>27.4</b>
Structural Grade:	<b>2</b>
O&M Grade:	<b>0</b>
Clock Start/From:	
Clock To:	
1st Value:	
2nd Value:	
Value Percent:	<b>15.000</b>
Continuous Index:	<b>F04</b>
Within 8" of Joint:	<b>NO</b>
Remarks:

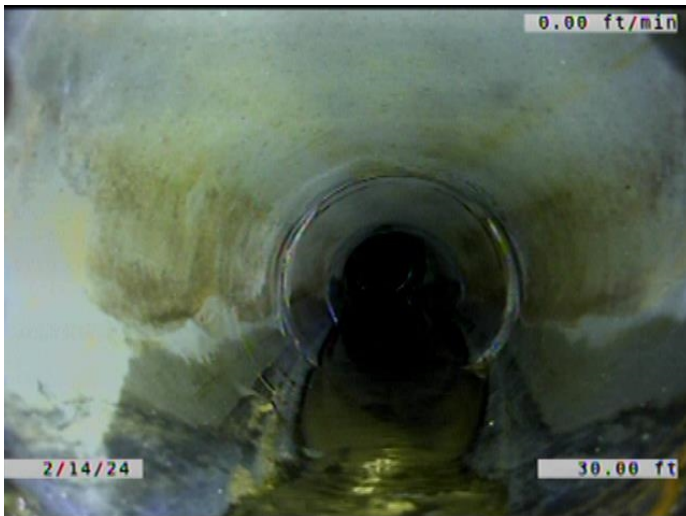
Code:	<b>LD</b>
Description:	<b>Line Down</b>
Distance (ft):	<b>30.0</b>
Structural Grade:	<b>0</b>
O&M Grade:	<b>1</b>
Clock Start/From:	
Clock To:	
1st Value:	
2nd Value:	
Value Percent:	<b>5.000</b>
Continuous Index:	
Within 8" of Joint:	<b>NO</b>
Remarks:

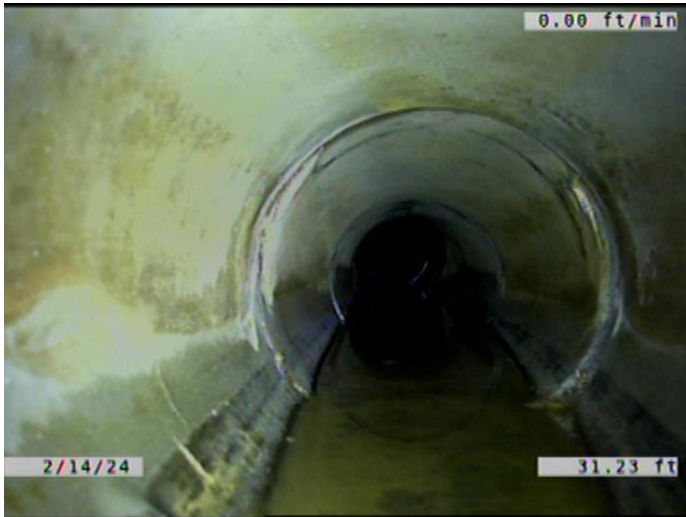
Code: **MWLS**  
Description: **Miscellaneous Water Level Sag**

Distance (ft): **31.2**  
Structural Grade: **2**  
O&M Grade: **0**  
Clock Start/From:  
Clock To:  
1st Value:  
2nd Value:  
Value Percent: **10.000**  
Continuous Index: **S06**  
Within 8" of Joint: **NO**  
Remarks:

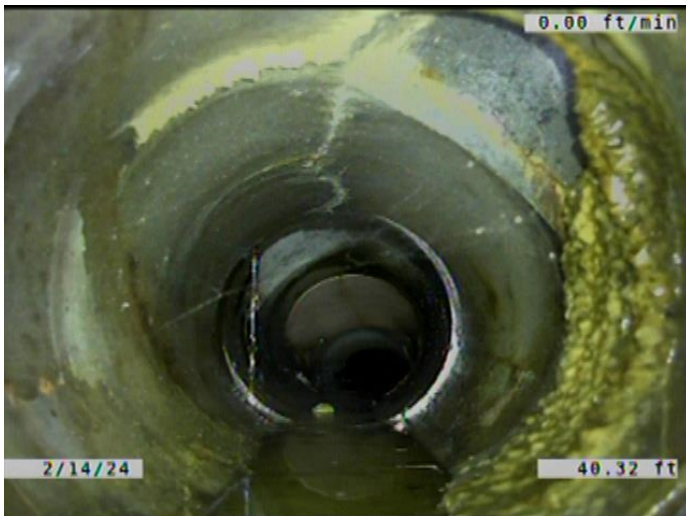
Code: **MWLS**  
Description: **Miscellaneous Water Level Sag**

Distance (ft): **40.3**  
Structural Grade: **2**  
O&M Grade: **0**  
Clock Start/From:  
Clock To:  
1st Value:  
2nd Value:  
Value Percent: **10.000**  
Continuous Index: **F06**  
Within 8" of Joint: **NO**  
Remarks:

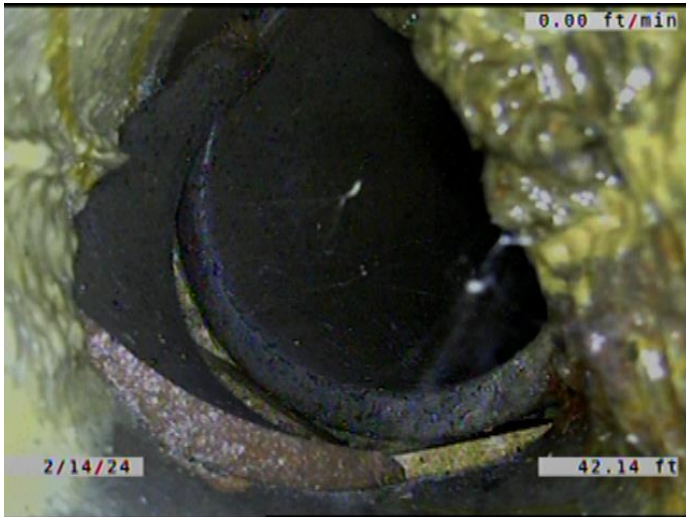
Code:	<b>TFD</b>
Description:	<b>Tap Factory Defective</b>
Distance (ft):	<b>42.1</b>
Structural Grade:	<b>0</b>
O&M Grade:	<b>3</b>
Clock Start/From:	<b>2</b>
Clock To:	
1st Value:	<b>6.000</b>
2nd Value:	
Value Percent:	
Continuous Index:	
Within 8" of Joint:	<b>YES</b>
Remarks:	<b>TAP BROKEN. SOIL VISIBLE. SERVICE OFFSET. ENCRUSTATION COMING D</b>

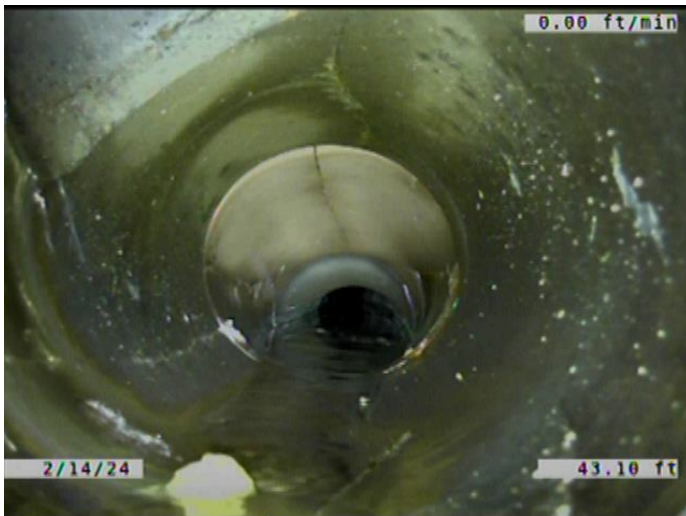
Code:	<b>CM</b>
Description:	<b>Crack Multiple</b>
Distance (ft):	<b>43.1</b>
Structural Grade:	<b>3</b>
O&M Grade:	<b>0</b>
Clock Start/From:	<b>8</b>
Clock To:	<b>4</b>
1st Value:	
2nd Value:	
Value Percent:	
Continuous Index:	<b>F05</b>
Within 8" of Joint:	<b>YES</b>
Remarks:

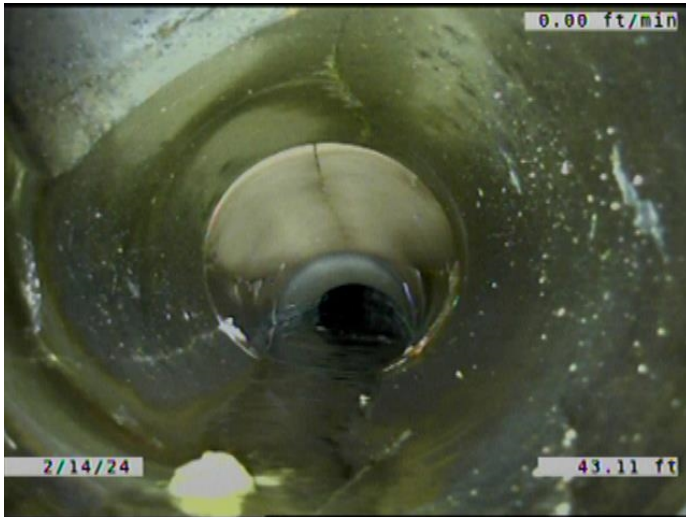
Code: **B**  
Description: **Broken**

Distance (ft): **43.1**  
Structural Grade: **4**  
O&M Grade: **0**  
Clock Start/From: **12**  
Clock To: **12**  
1st Value:  
2nd Value:  
Value Percent:  
Continuous Index: **S07**  
Within 8" of Joint: **YES**  
Remarks:

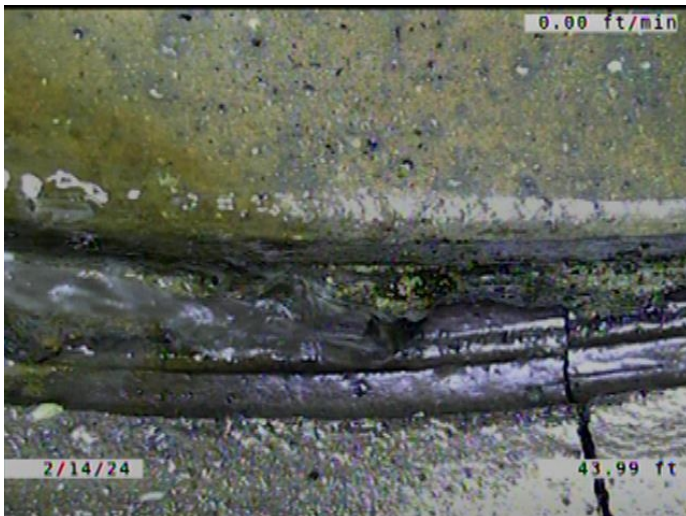
Code: **IRJ**  
Description: **Infiltration Runner Joint**

Distance (ft): **44.0**  
Structural Grade: **0**  
O&M Grade: **4**  
Clock Start/From: **11**  
Clock To:  
1st Value:  
2nd Value:  
Value Percent:  
Continuous Index:  
Within 8" of Joint: **YES**  
Remarks:

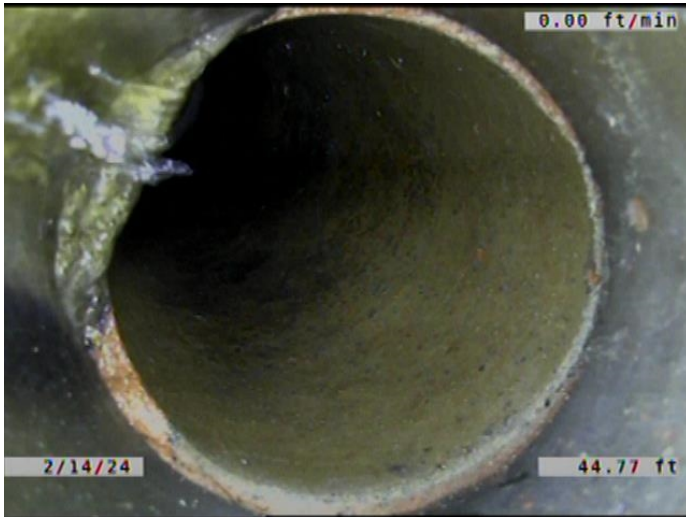
Code: **TFD**  
Description: **Tap Factory Defective**

Distance (ft): **44.8**  
Structural Grade: **0**  
O&M Grade: **3**  
Clock Start/From: **11**  
Clock To:  
1st Value: **6.000**

2nd Value:  
Value Percent:  
Continuous Index:  
Within 8" of Joint: **YES**  
Remarks: **TAP BROKEN. CONSTANTLY  
RUNNING WATER.**

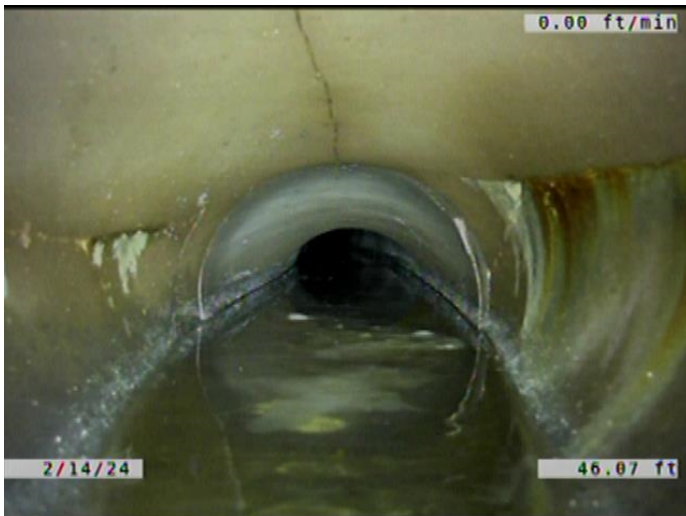
Code: **MWLS**  
Description: **Miscellaneous Water Level Sag**

Distance (ft): **46.1**  
Structural Grade: **4**  
O&M Grade: **0**  
Clock Start/From:  
Clock To:  
1st Value:  
2nd Value:  
Value Percent: **55.000**

Continuous Index: **S08**  
Within 8" of Joint: **NO**  
Remarks:

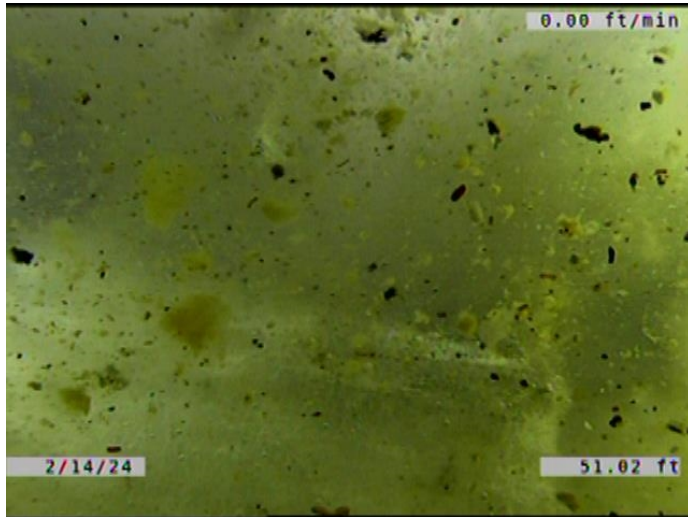
Code:	<b>MCU</b>
Description:	<b>Miscellaneous Camera Underwater</b>
Distance (ft):	<b>51.0</b>
Structural Grade:	<b>0</b>
O&M Grade:	<b>4</b>
Clock Start/From:	
Clock To:	
1st Value:	
2nd Value:	
Value Percent:	
Continuous Index:	<b>S09</b>
Within 8" of Joint:	<b>NO</b>
Remarks:

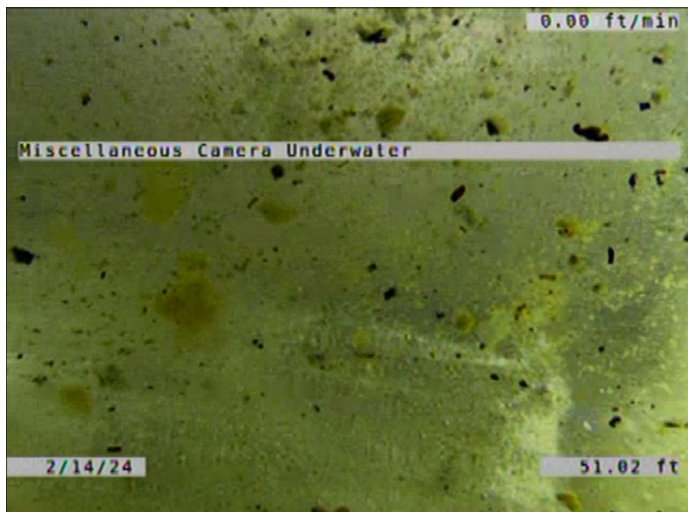
Code:	<b>B</b>
Description:	<b>Broken</b>
Distance (ft):	<b>51.0</b>
Structural Grade:	<b>4</b>
O&M Grade:	<b>0</b>
Clock Start/From:	<b>12</b>
Clock To:	<b>12</b>
1st Value:	
2nd Value:	
Value Percent:	
Continuous Index:	<b>F07</b>
Within 8" of Joint:	<b>YES</b>
Remarks:

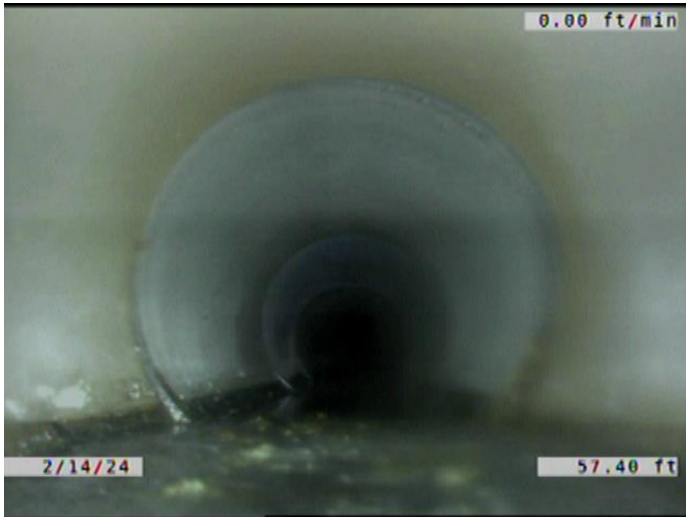
Code:	<b>MCU</b>
Description:	<b>Miscellaneous Camera Underwater</b>
Distance (ft):	<b>57.4</b>
Structural Grade:	<b>0</b>
O&M Grade:	<b>4</b>
Clock Start/From:	
Clock To:	
1st Value:	
2nd Value:	
Value Percent:	
Continuous Index:	<b>F09</b>
Within 8" of Joint:	<b>NO</b>
Remarks:

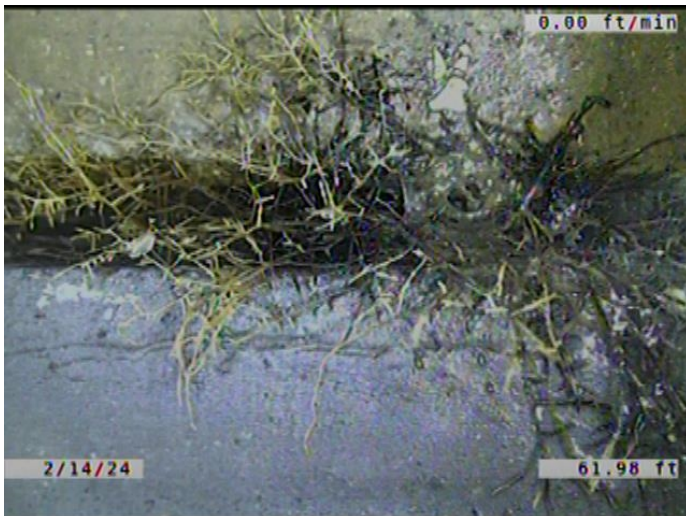
Code:	<b>RFJ</b>
Description:	<b>Roots Fine Joint</b>
Distance (ft):	<b>62.0</b>
Structural Grade:	<b>0</b>
O&M Grade:	<b>1</b>
Clock Start/From:	<b>7</b>
Clock To:	<b>5</b>
1st Value:	
2nd Value:	
Value Percent:	
Continuous Index:	<b>S10</b>
Within 8" of Joint:	<b>YES</b>
Remarks:

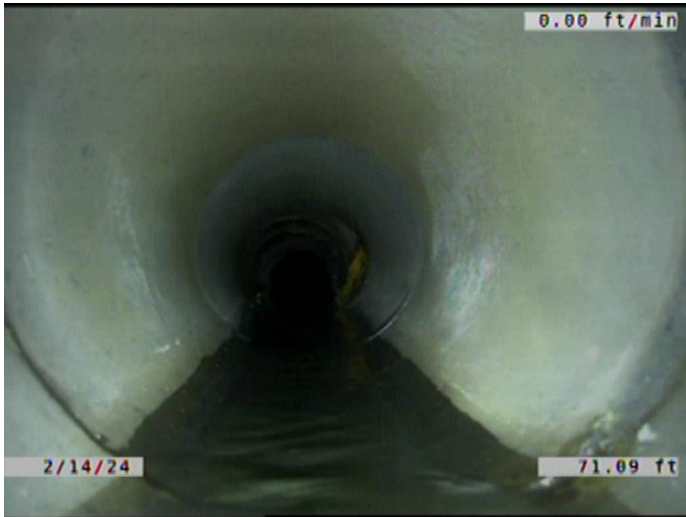
Code:	<b>MWLS</b>
Description:	<b>Miscellaneous Water Level Sag</b>
Distance (ft):	<b>71.1</b>
Structural Grade:	<b>4</b>
O&M Grade:	<b>0</b>
Clock Start/From:	
Clock To:	
1st Value:	
2nd Value:	
Value Percent:	<b>55.000</b>
Continuous Index:	<b>F08</b>
Within 8" of Joint:	<b>NO</b>
Remarks:

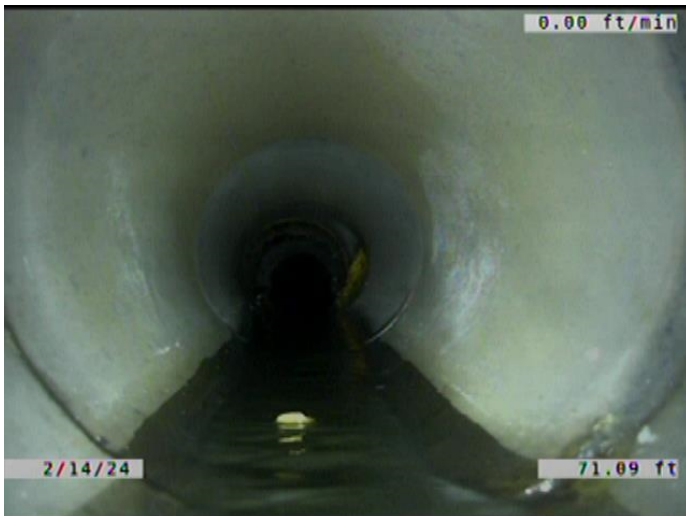
Code:	<b>RFJ</b>
Description:	<b>Roots Fine Joint</b>
Distance (ft):	<b>71.1</b>
Structural Grade:	<b>0</b>
O&M Grade:	<b>1</b>
Clock Start/From:	<b>7</b>
Clock To:	<b>5</b>
1st Value:	
2nd Value:	
Value Percent:	
Continuous Index:	<b>F10</b>
Within 8" of Joint:	<b>YES</b>
Remarks:

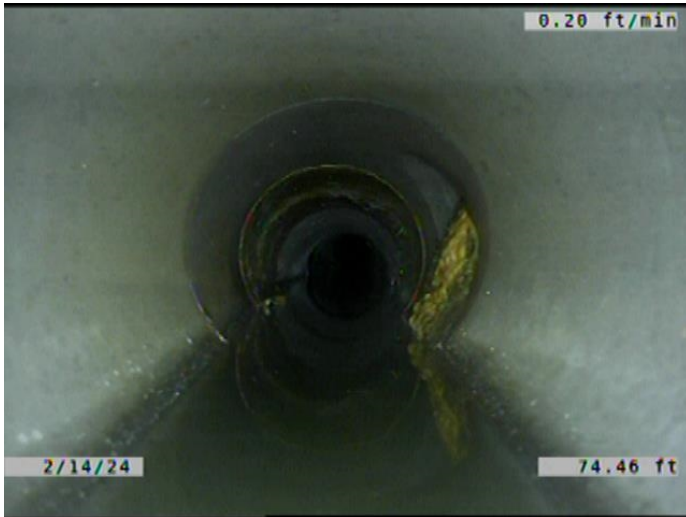
Code: **MWLS**  
Description: **Miscellaneous Water Level Sag**

Distance (ft): **74.4**  
Structural Grade: **2**  
O&M Grade: **0**  
Clock Start/From:  
Clock To:  
1st Value:  
2nd Value:  
Value Percent: **30.000**  
Continuous Index: **S11**  
Within 8" of Joint: **NO**  
Remarks:

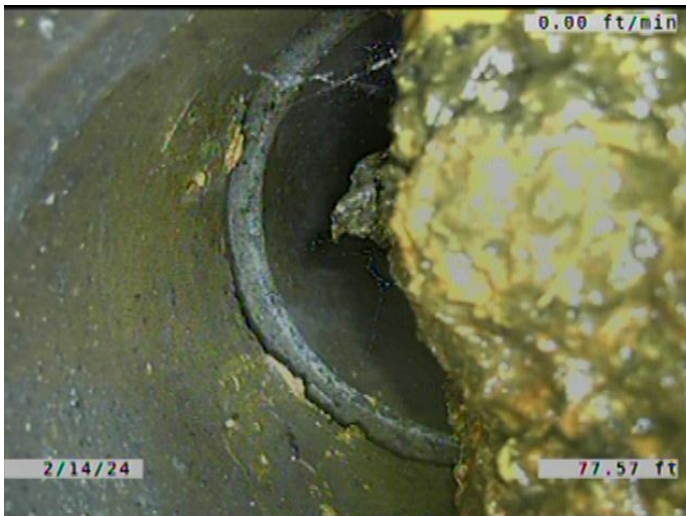
Code: **TFD**  
Description: **Tap Factory Defective**

Distance (ft): **77.6**  
Structural Grade: **0**  
O&M Grade: **3**  
Clock Start/From: **2**  
Clock To:  
1st Value: **6.000**  
2nd Value:  
Value Percent:  
Continuous Index:  
Within 8" of Joint: **YES**  
Remarks: **TAP 80% PLUGGED WITH ENCRUSTATION. ENCRUSTATION CO**

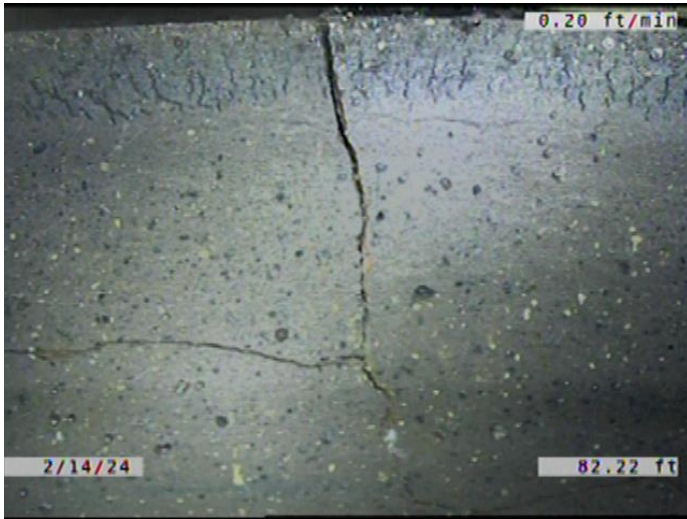
Code: **FM**  
Description: **Fracture Multiple**

Distance (ft): **82.2**  
Structural Grade: **4**  
O&M Grade: **0**  
Clock Start/From: **10**  
Clock To: **2**  
1st Value:  
2nd Value:  
Value Percent:  
Continuous Index:  
Within 8" of Joint: **YES**  
Remarks:

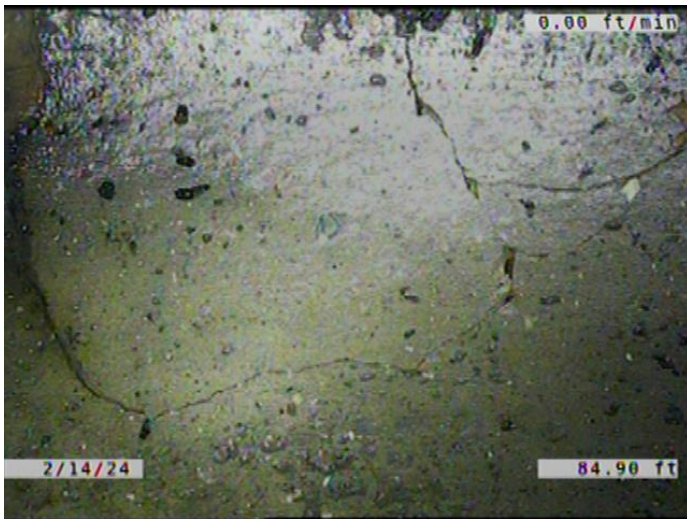
Code: **FM**  
Description: **Fracture Multiple**

Distance (ft): **84.9**  
Structural Grade: **4**  
O&M Grade: **0**  
Clock Start/From: **9**  
Clock To: **12**  
1st Value:  
2nd Value:  
Value Percent:  
Continuous Index:  
Within 8" of Joint: **YES**  
Remarks:

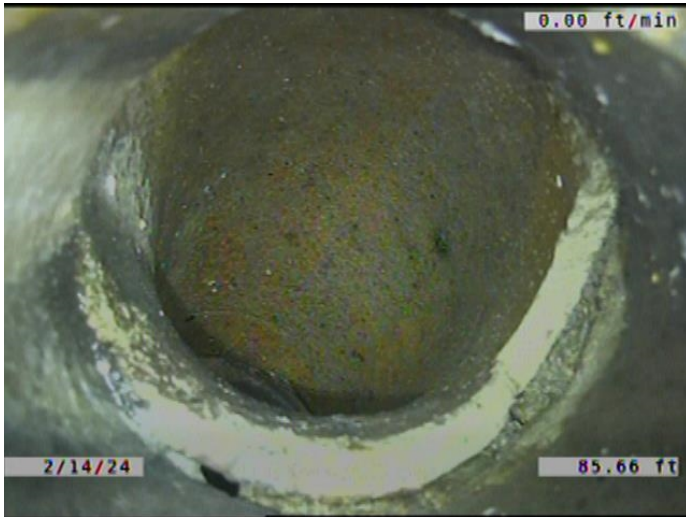
Code: **TFD**  
Description: **Tap Factory Defective**

Distance (ft): **85.7**  
Structural Grade: **0**  
O&M Grade: **3**  
Clock Start/From: **10**  
Clock To:  
1st Value: **6.000**  
2nd Value:  
Value Percent:  
Continuous Index:  
Within 8" of Joint: **YES**  
Remarks: **TAP BROKEN. SERVICE OFFSET WITH VOID AND SOIL VISIBLE.**

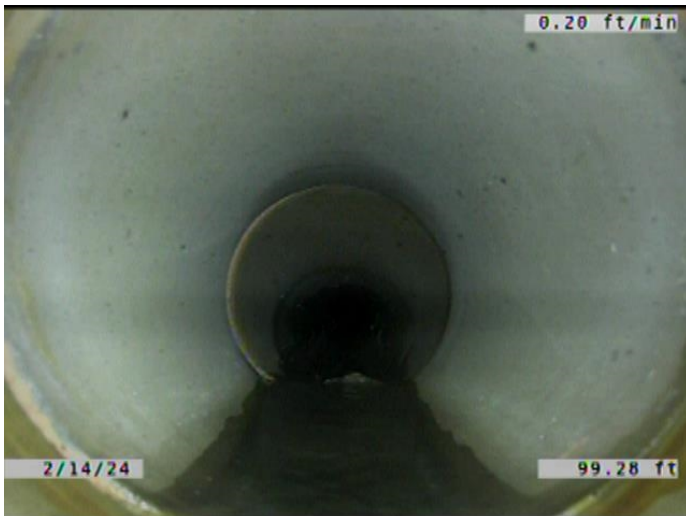
Code: **MWLS**  
Description: **Miscellaneous Water Level Sag**

Distance (ft): **99.3**  
Structural Grade: **2**  
O&M Grade: **0**  
Clock Start/From:  
Clock To:  
1st Value:  
2nd Value:  
Value Percent: **30.000**  
Continuous Index: **F11**  
Within 8" of Joint: **NO**  
Remarks:

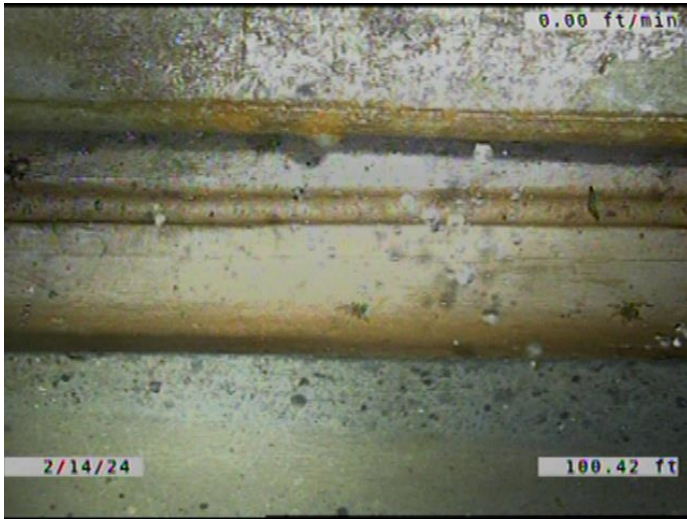
Code: **JAM**  
Description: **Joint Angular Medium**

Distance (ft): **100.4**  
Structural Grade: **3**  
O&M Grade: **0**  
Clock Start/From:  
Clock To:  
1st Value:  
2nd Value:  
Value Percent:  
Continuous Index:  
Within 8" of Joint: **NO**  
Remarks:

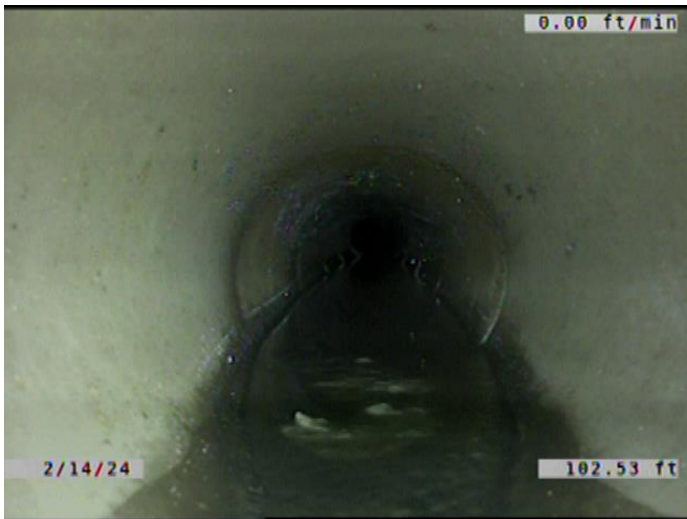
Code: **LD**  
Description: **Line Down**

Distance (ft): **102.5**  
Structural Grade: **0**  
O&M Grade: **1**  
Clock Start/From:  
Clock To:  
1st Value:  
2nd Value:  
Value Percent: **5.000**  
Continuous Index:  
Within 8" of Joint: **NO**  
Remarks:

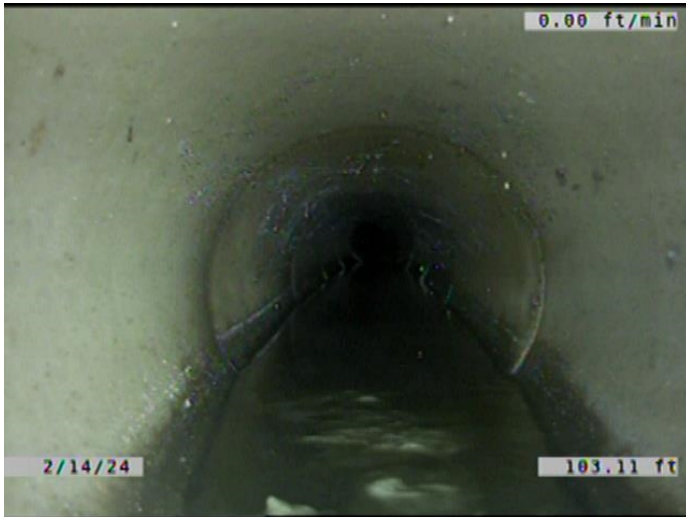
Code: **MWLS**  
Description: **Miscellaneous Water Level Sag**

Distance (ft): **103.1**  
Structural Grade: **2**  
O&M Grade: **0**  
Clock Start/From:  
Clock To:  
1st Value:  
2nd Value:  
Value Percent: **25.000**  
Continuous Index: **S12**  
Within 8" of Joint: **NO**  
Remarks:

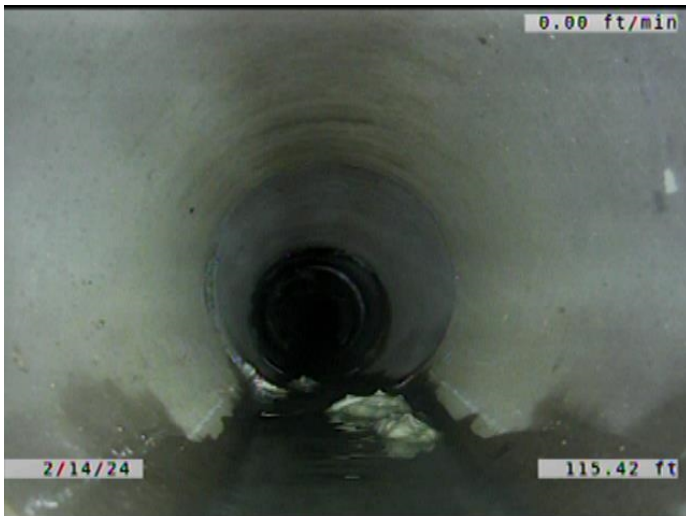
Code: **MWLS**  
Description: **Miscellaneous Water Level Sag**

Distance (ft): **115.4**  
Structural Grade: **2**  
O&M Grade: **0**  
Clock Start/From:  
Clock To:  
1st Value:  
2nd Value:  
Value Percent: **25.000**  
Continuous Index: **F12**  
Within 8" of Joint: **NO**  
Remarks:

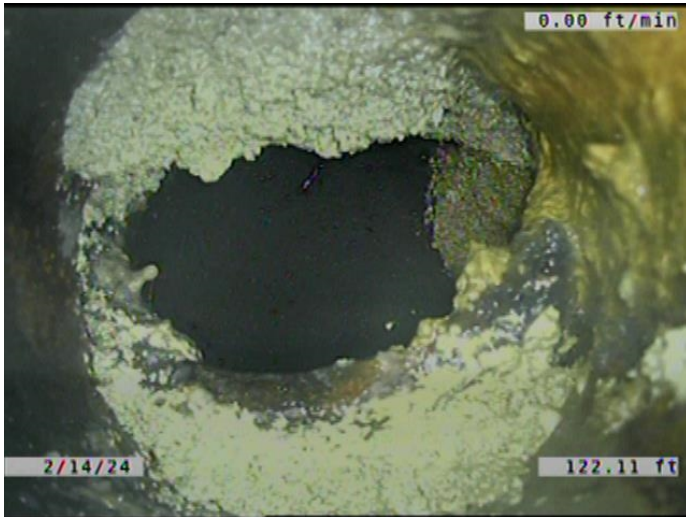
Code:	<b>TFD</b>
Description:	<b>Tap Factory Defective</b>
Distance (ft):	<b>122.1</b>
Structural Grade:	<b>0</b>
O&M Grade:	<b>3</b>
Clock Start/From:	<b>1</b>
Clock To:	
1st Value:	<b>6.000</b>
2nd Value:	
Value Percent:	
Continuous Index:	
Within 8" of Joint:	<b>YES</b>
Remarks:	<b>SERVICE LARGE OFFSET. CONSTANTLY RUNNING WATER. EN</b>

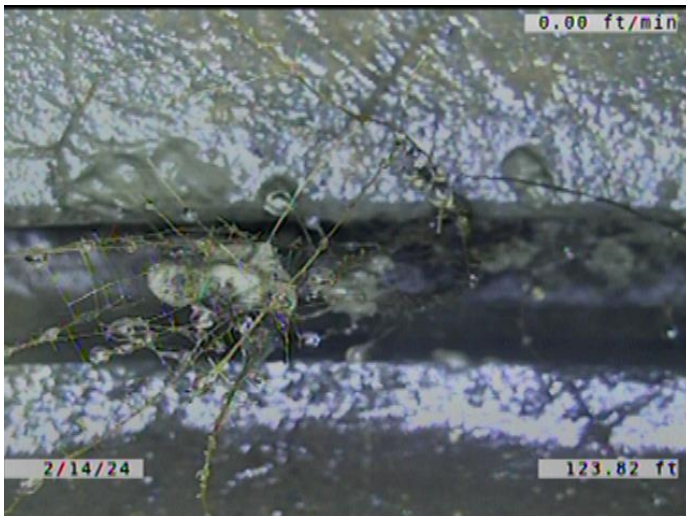
Code:	<b>RFJ</b>
Description:	<b>Roots Fine Joint</b>
Distance (ft):	<b>123.8</b>
Structural Grade:	<b>0</b>
O&M Grade:	<b>1</b>
Clock Start/From:	<b>7</b>
Clock To:	<b>5</b>
1st Value:	
2nd Value:	
Value Percent:	
Continuous Index:	<b>S13</b>
Within 8" of Joint:	<b>YES</b>
Remarks:

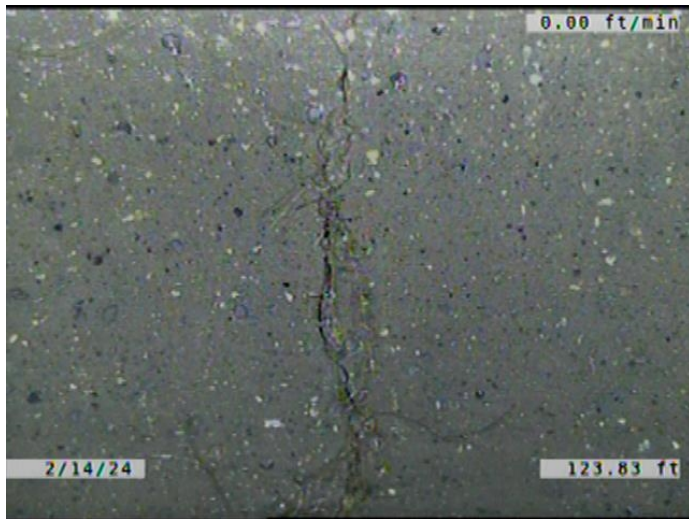
Code: **FM**  
 Description: **Fracture Multiple**

Distance (ft): **123.8**  
 Structural Grade: **4**  
 O&M Grade: **0**  
 Clock Start/From: **10**  
 Clock To: **2**  
 1st Value:  
 2nd Value:  
 Value Percent:  
 Continuous Index: **S14**  
 Within 8" of Joint: **YES**  
 Remarks:

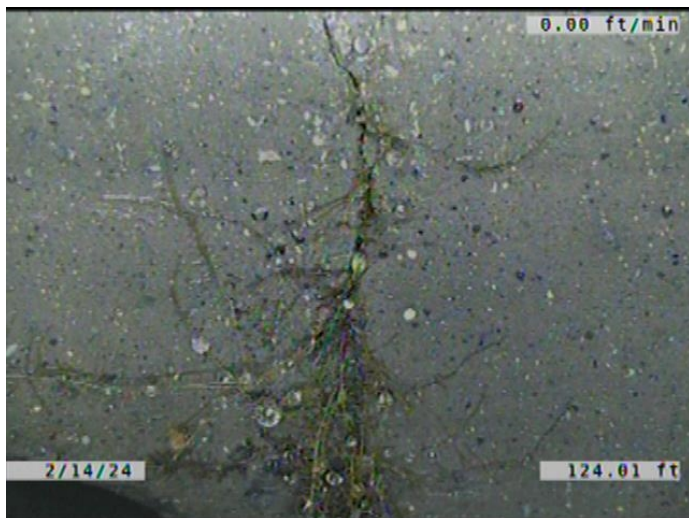
Code: **RFB**  
 Description: **Roots Fine Barrel**

Distance (ft): **124.0**  
 Structural Grade: **0**  
 O&M Grade: **2**  
 Clock Start/From: **11**  
 Clock To: **1**  
 1st Value:  
 2nd Value:  
 Value Percent:  
 Continuous Index:  
 Within 8" of Joint: **NO**  
 Remarks:

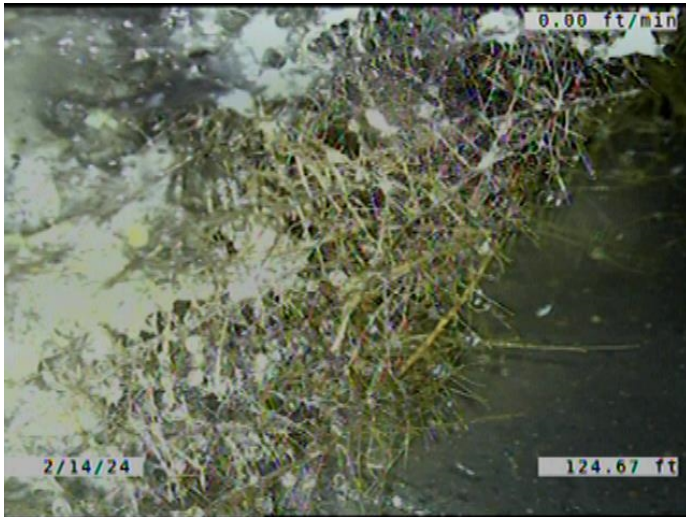
Code: **RFC**  
Description: **Roots Fine Connection**

Distance (ft): **124.7**  
Structural Grade: **0**  
O&M Grade: **1**  
Clock Start/From: **10**  
Clock To: **11**  
1st Value:  
2nd Value:  
Value Percent:  
Continuous Index:  
Within 8" of Joint: **NO**  
Remarks:

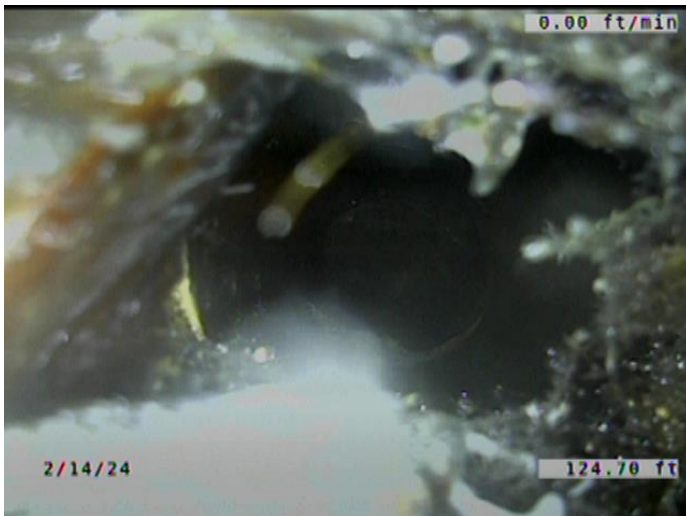
Code: **TFD**  
Description: **Tap Factory Defective**

Distance (ft): **124.7**  
Structural Grade: **0**  
O&M Grade: **3**  
Clock Start/From: **10**  
Clock To:  
1st Value: **6.000**  
2nd Value:  
Value Percent:  
Continuous Index:  
Within 8" of Joint: **YES**  
Remarks: **TAP CRACKED. ROOTS GROWING IN THE JOINTS AND INTO THE MAIN. C**

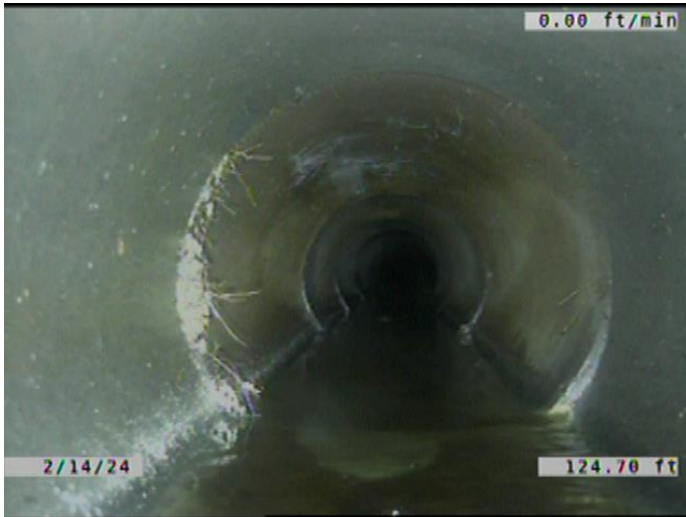
Code: **MWLS**  
Description: **Miscellaneous Water Level Sag**

Distance (ft): **124.7**  
Structural Grade: **2**  
O&M Grade: **0**  
Clock Start/From:  
Clock To:  
1st Value:  
2nd Value:  
Value Percent: **15.000**  
Continuous Index: **S15**  
Within 8" of Joint: **NO**  
Remarks:

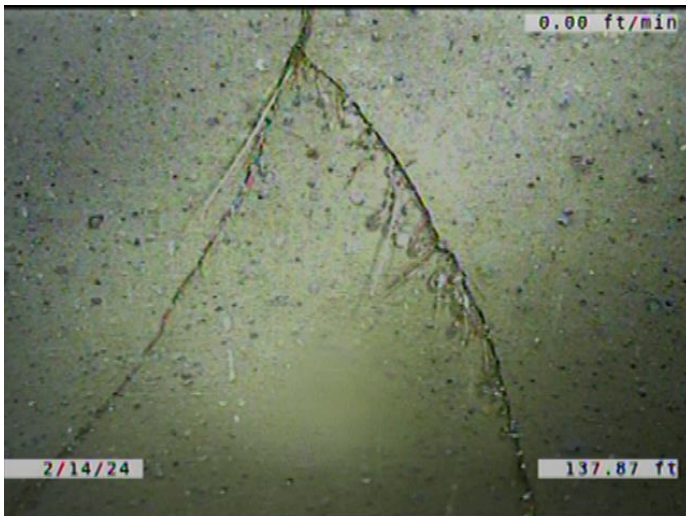
Code: **RFB**  
Description: **Roots Fine Barrel**

Distance (ft): **137.9**  
Structural Grade: **0**  
O&M Grade: **2**  
Clock Start/From: **10**  
Clock To: **2**  
1st Value:  
2nd Value:  
Value Percent:  
Continuous Index:  
Within 8" of Joint: **NO**  
Remarks:

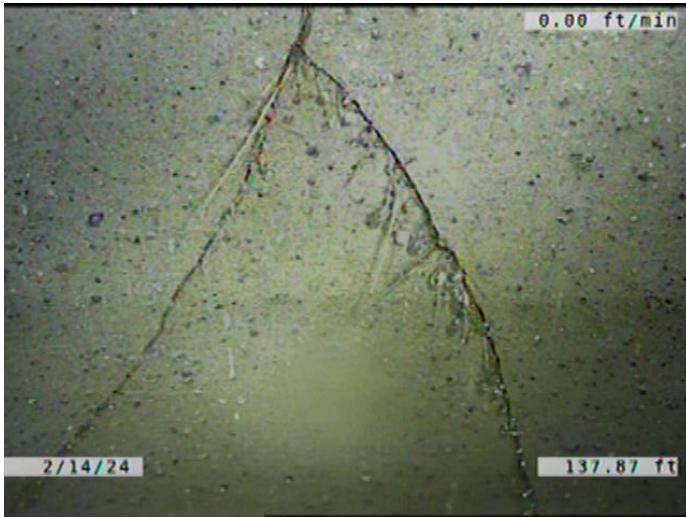
Code: **FM**  
Description: **Fracture Multiple**

Distance (ft): **137.9**  
Structural Grade: **4**  
O&M Grade: **0**  
Clock Start/From: **10**  
Clock To: **2**  
1st Value:  
2nd Value:  
Value Percent:  
Continuous Index: **F14**  
Within 8" of Joint: **YES**  
Remarks:

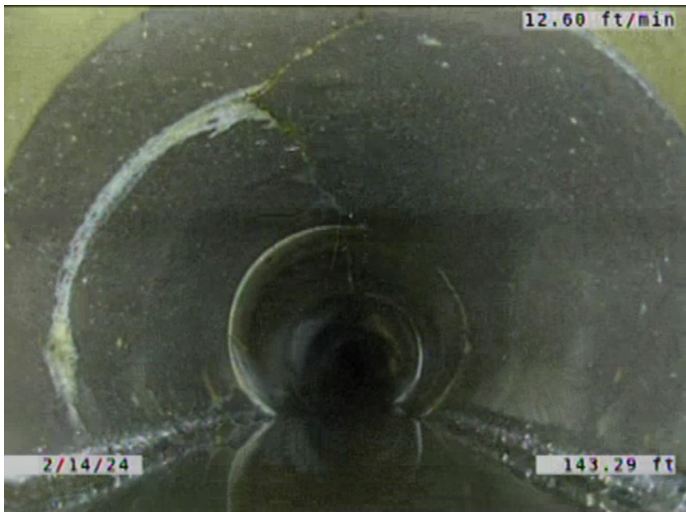
Code: **B**  
Description: **Broken**

Distance (ft): **143.3**  
Structural Grade: **4**  
O&M Grade: **0**  
Clock Start/From: **12**  
Clock To: **12**  
1st Value:  
2nd Value:  
Value Percent:  
Continuous Index:  
Within 8" of Joint: **YES**  
Remarks:

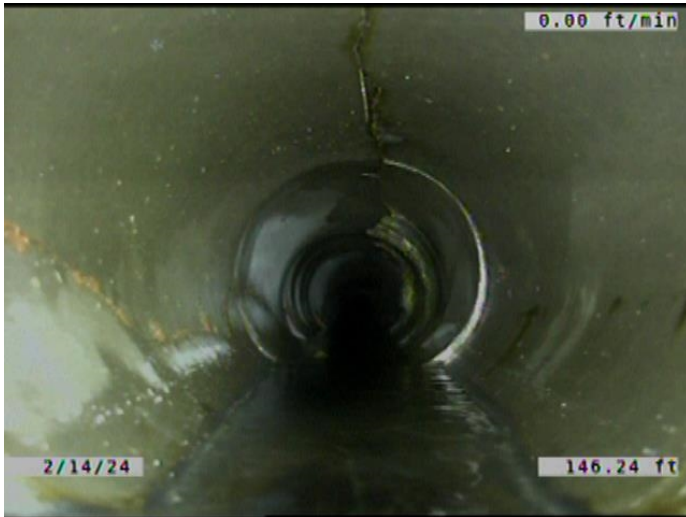
Code: **MWLS**  
Description: **Miscellaneous Water Level Sag**

Distance (ft): **146.2**  
Structural Grade: **2**  
O&M Grade: **0**  
Clock Start/From:  
Clock To:  
1st Value:  
2nd Value:  
Value Percent: **15.000**  
Continuous Index: **F15**  
Within 8" of Joint: **NO**  
Remarks:

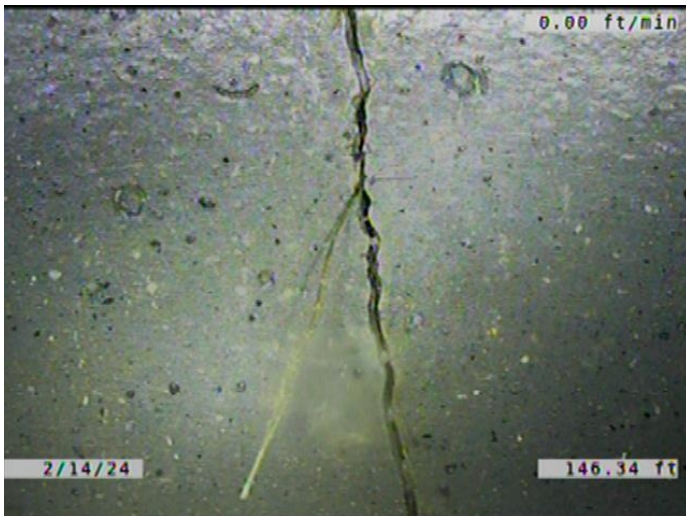
Code: **RFB**  
Description: **Roots Fine Barrel**

Distance (ft): **146.3**  
Structural Grade: **0**  
O&M Grade: **2**  
Clock Start/From: **12**  
Clock To:  
1st Value:  
2nd Value:  
Value Percent:  
Continuous Index: **S17**  
Within 8" of Joint: **NO**  
Remarks:

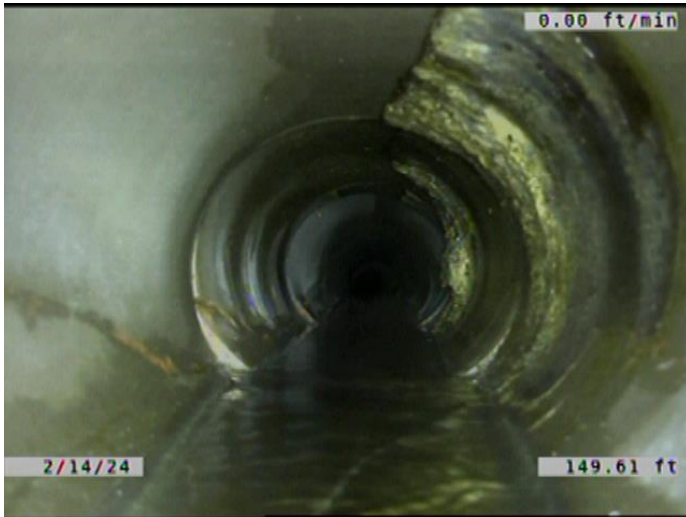
Code: **RFB**  
Description: **Roots Fine Barrel**

Distance (ft): **149.6**  
Structural Grade: **0**  
O&M Grade: **2**  
Clock Start/From: **12**  
Clock To:  
1st Value:  
2nd Value:  
Value Percent:  
Continuous Index: **F17**  
Within 8" of Joint: **NO**  
Remarks:

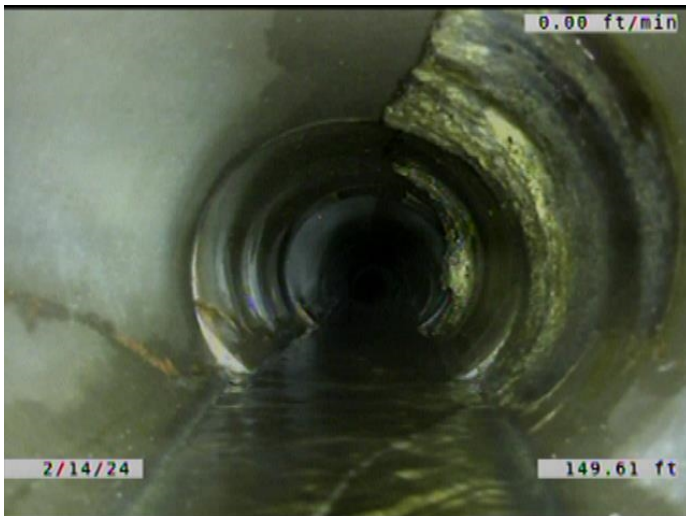
Code: **RFJ**  
Description: **Roots Fine Joint**

Distance (ft): **149.6**  
Structural Grade: **0**  
O&M Grade: **1**  
Clock Start/From: **7**  
Clock To: **5**  
1st Value:  
2nd Value:  
Value Percent:  
Continuous Index: **F13**  
Within 8" of Joint: **YES**  
Remarks:
