# Profile/Photo Observation Report

Date:	02/14/2024	Weather:		Coding:	PACP 7.0
Pipe Length (ft):	189.0	Owner:	City of Hobart	Pre Clean:	Heavy Cleaning
P.O.#:	YES502259	Surveyor:	S. Bucklin	PSR:	P-504-008-007
Customer:	City of Hobart	Clean Date:	10/08/2022	Shape:	C

Street:	N CALIFORNIA ST	Flow Control:	Not Controlled
City:	Hobart, IN	Year Renewed:	
Location:	Local rural streets with light traffic, t	Tape/Media #:	
Purpose:	Routine Assessment	Dia/Height:	10"
Use:	Sanitary Sewage Pipe	Material:	VCP
Drain Area:		Lining:	None
Category:	NA		
Comment:			
Location Details:		Direction of Survey:	Downstream
US MH:	M-504-007	DS MH:	M-504-008
		Total Length Surveyed (ft):	189.9

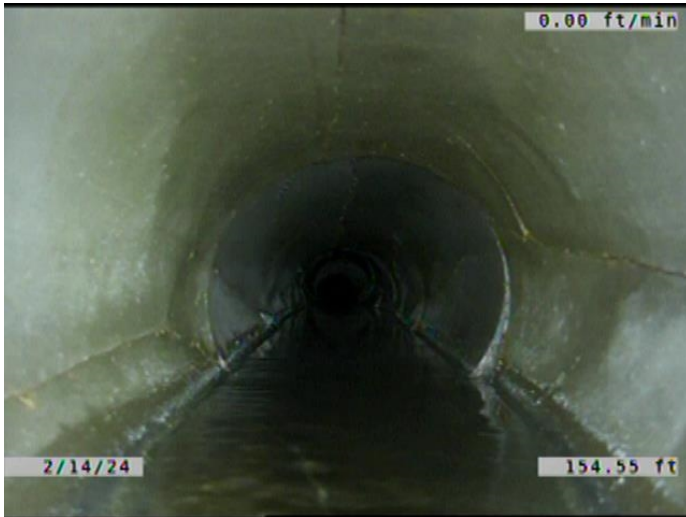
Code: **MWLS**  
Description: **Miscellaneous Water Level Sag**

Distance (ft): **154.6**  
Structural Grade: **2**  
O&M Grade: **0**  
Clock Start/From:  
Clock To:  
1st Value:  
2nd Value:  
Value Percent: **15.000**  
Continuous Index: **S18**  
Within 8" of Joint: **NO**  
Remarks:

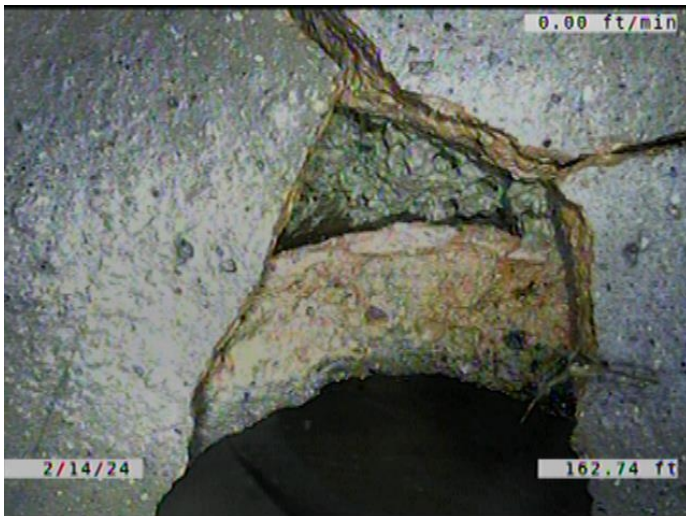
Code: **SMW**  
Description: **Surface Damage Missing Wall**

Distance (ft): **162.7**  
Structural Grade: **5**  
O&M Grade: **0**  
Clock Start/From: **1**  
Clock To:  
1st Value:  
2nd Value:  
Value Percent:  
Continuous Index:  
Within 8" of Joint: **YES**  
Remarks: **SOIL VISIBLE.**

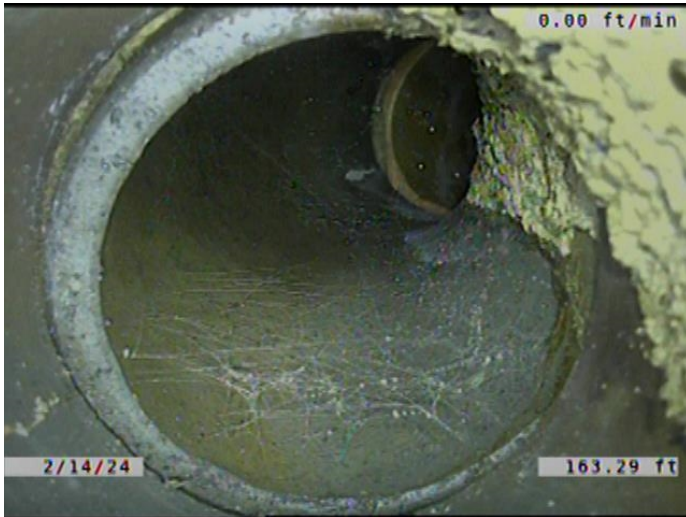
Code:	<b>TFD</b>
Description:	<b>Tap Factory Defective</b>
Distance (ft):	<b>163.3</b>
Structural Grade:	<b>0</b>
O&M Grade:	<b>3</b>
Clock Start/From:	<b>1</b>
Clock To:	
1st Value:	<b>6.000</b>
2nd Value:	
Value Percent:	
Continuous Index:	
Within 8" of Joint:	<b>YES</b>
Remarks:	<b>TAP BROKEN. PART OF THE TAP AND MAIN ARE MISSING. SERVICE OFFSE</b>

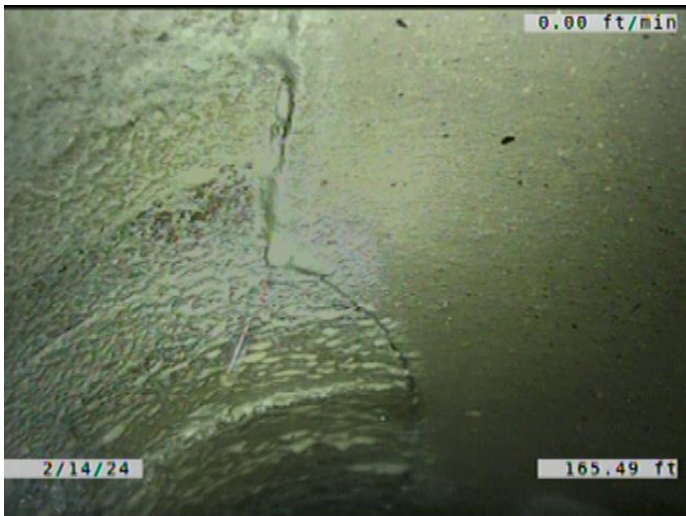
Code:	<b>IRB</b>
Description:	<b>Infiltration Runner Barrel</b>
Distance (ft):	<b>165.5</b>
Structural Grade:	<b>0</b>
O&M Grade:	<b>4</b>
Clock Start/From:	<b>11</b>
Clock To:	<b>1</b>
1st Value:	
2nd Value:	
Value Percent:	
Continuous Index:	<b>S19</b>
Within 8" of Joint:	<b>YES</b>
Remarks:

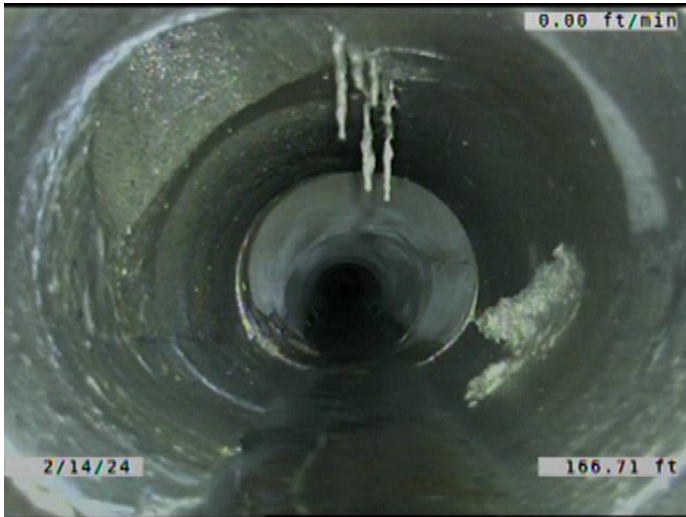
Code: **MWLS**  
Description: **Miscellaneous Water Level Sag**

Distance (ft): **166.7**  
Structural Grade: **2**  
O&M Grade: **0**  
Clock Start/From:  
Clock To:  
1st Value:  
2nd Value:  
Value Percent: **15.000**  
Continuous Index: **F18**  
Within 8" of Joint: **NO**  
Remarks:

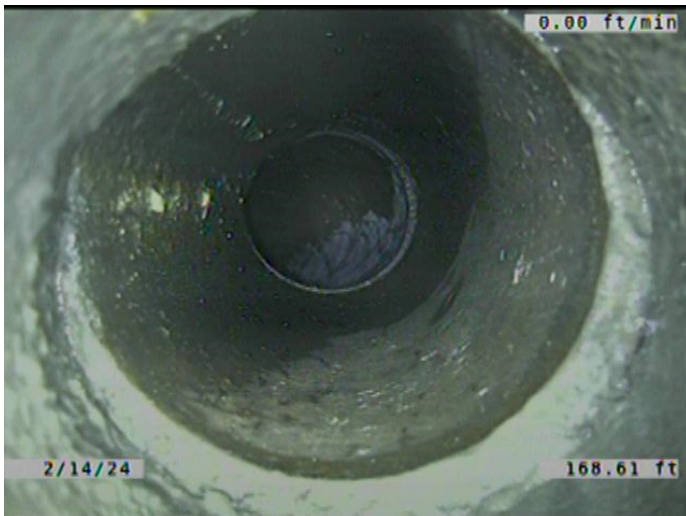
Code: **TFD**  
Description: **Tap Factory Defective**

Distance (ft): **168.6**  
Structural Grade: **0**  
O&M Grade: **3**  
Clock Start/From: **11**  
Clock To:  
1st Value: **6.000**  
2nd Value:  
Value Percent:  
Continuous Index:  
Within 8" of Joint: **YES**  
Remarks: **TAP BROKEN. SERVICE OFFSET. CONSTANTLY RUNNING WATER.**

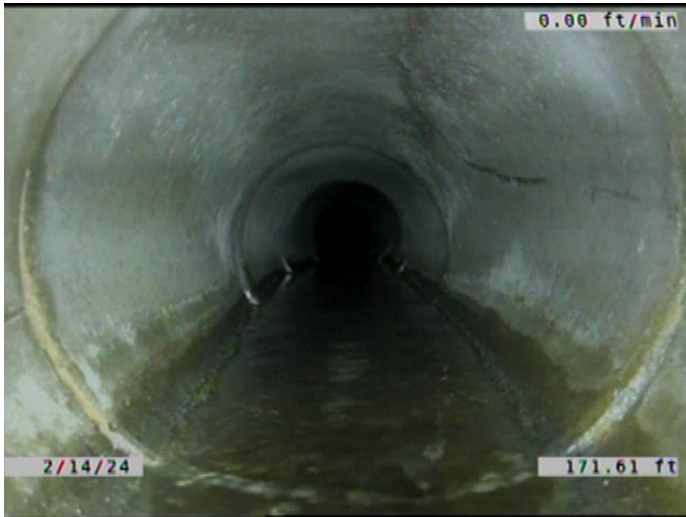
Code: **MWLS**  
Description: **Miscellaneous Water Level Sag**

Distance (ft): **171.6**  
Structural Grade: **2**  
O&M Grade: **0**  
Clock Start/From:  
Clock To:  
1st Value:  
2nd Value:  
Value Percent: **15.000**  
Continuous Index: **S20**  
Within 8" of Joint: **NO**  
Remarks:

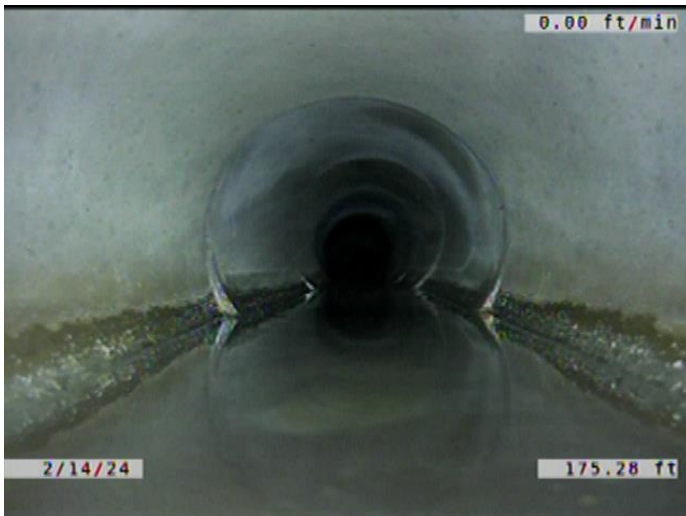
Code: **IRB**  
Description: **Infiltration Runner Barrel**

Distance (ft): **175.3**  
Structural Grade: **0**  
O&M Grade: **4**  
Clock Start/From: **11**  
Clock To: **1**  
1st Value:  
2nd Value:  
Value Percent:  
Continuous Index: **F19**  
Within 8" of Joint: **YES**  
Remarks:

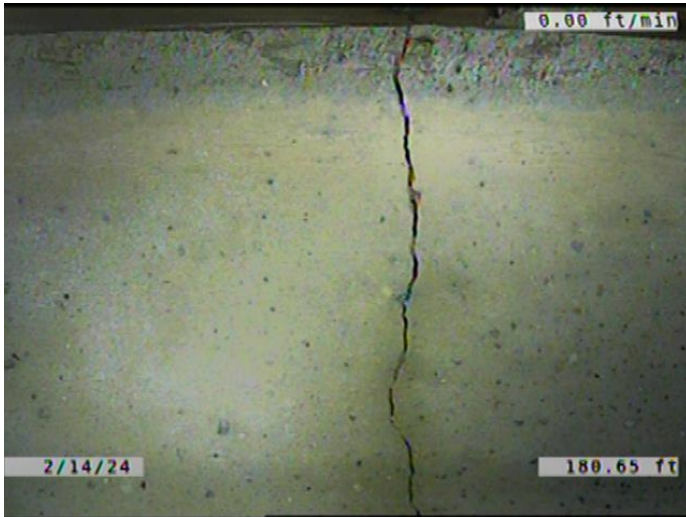
Code: **CM**  
Description: **Crack Multiple**

Distance (ft): **180.6**  
Structural Grade: **3**  
O&M Grade: **0**  
Clock Start/From: **12**  
Clock To: **12**  
1st Value:  
2nd Value:  
Value Percent:  
Continuous Index: **S21**  
Within 8" of Joint: **YES**  
Remarks:

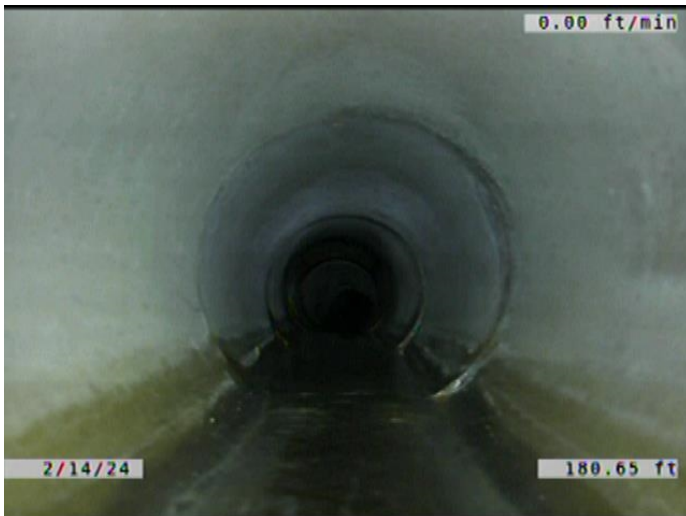
Code: **MWLS**  
Description: **Miscellaneous Water Level Sag**

Distance (ft): **180.7**  
Structural Grade: **2**  
O&M Grade: **0**  
Clock Start/From:  
Clock To:  
1st Value:  
2nd Value:  
Value Percent: **15.000**  
Continuous Index: **F20**  
Within 8" of Joint: **NO**  
Remarks:

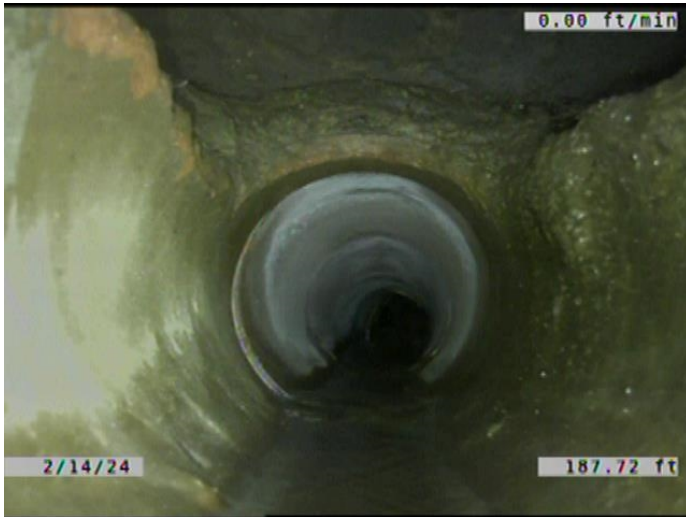
Code: **CM**  
Description: **Crack Multiple**

Distance (ft): **187.7**  
Structural Grade: **3**  
O&M Grade: **0**  
Clock Start/From: **12**  
Clock To: **12**  
1st Value:  
2nd Value:  
Value Percent:  
Continuous Index: **F21**  
Within 8" of Joint: **YES**  
Remarks:

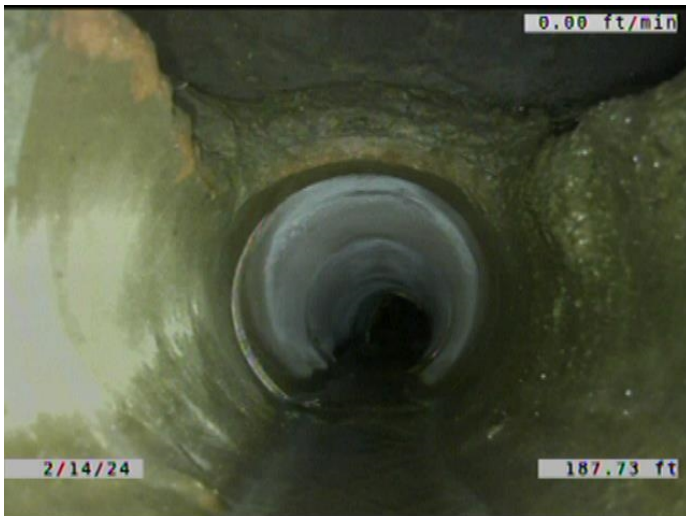
Code: **DSF**  
Description: **Deposits Settled Fine**

Distance (ft): **187.7**  
Structural Grade: **0**  
O&M Grade: **2**  
Clock Start/From: **5**  
Clock To: **7**  
1st Value:  
2nd Value:  
Value Percent: **5.000**  
Continuous Index: **F01**  
Within 8" of Joint: **YES**  
Remarks:

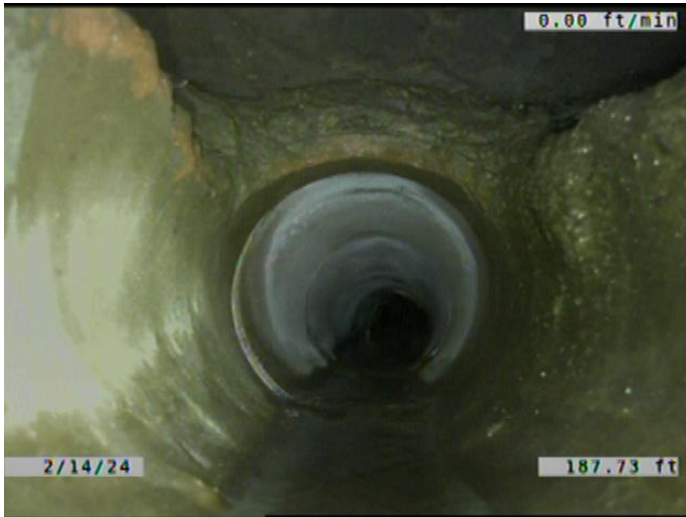
Code: **DAE**  
 Description: **Deposits Attached Encrustation**

Distance (ft): **187.7**  
 Structural Grade: **0**  
 O&M Grade: **2**  
 Clock Start/From: **7**  
 Clock To: **5**  
 1st Value:  
 2nd Value:  
 Value Percent: **5.000**  
 Continuous Index: **F03**  
 Within 8" of Joint: **YES**  
 Remarks:
