Profile/Photo Observation Report

| Street: | W HOME AVE | Flow Control: | Not Controlled |
| City: | Hobart, IN | Year Renewed: | |
| US MH: | M-504-010 | DS MH: | M-504-011 |

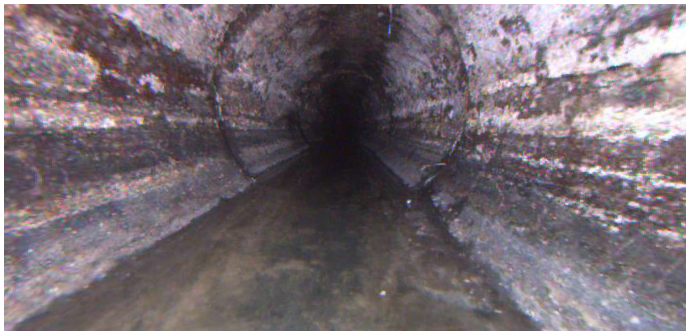
Code: **AMH**
Description: **Manhole**

Distance (ft): **.0**
Structural Grade: **0**
O&M Grade: **0**
Clock Start/From:
Clock To:
1st Value:
2nd Value:
Value Percent:
Continuous Index:
Within 8" of Joint: **NO**
Remarks: **M-504-010**

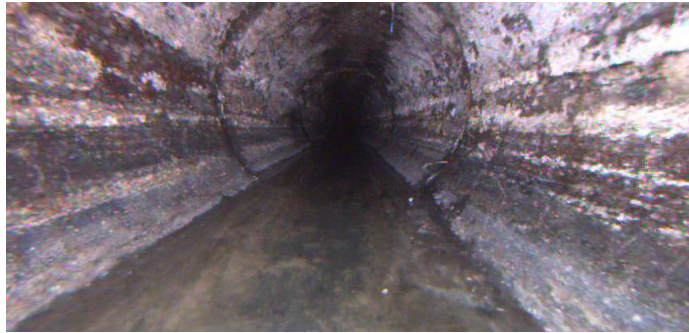
Code: **MWL**
Description: **Water Level**

Distance (ft): **.0**
Structural Grade: **0**
O&M Grade: **0**
Clock Start/From:
Clock To:
1st Value:
2nd Value:
Value Percent: **10.000**
Continuous Index:
Within 8" of Joint: **NO**
Remarks:

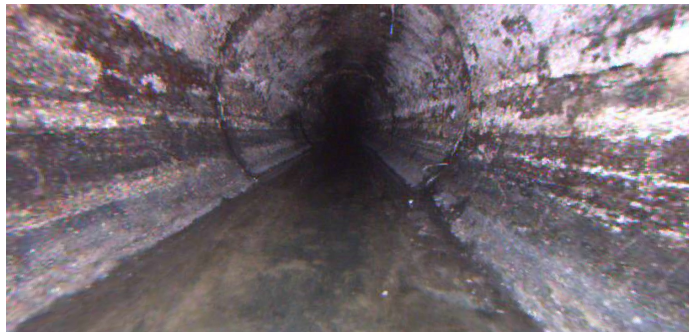
Code: **DAE**
Description: **Deposits Attached Encrustation**

| | Position | Code | Observation | Video (sec) | Grade |
|--|---|---|---|---|---|
| | .0 | DAE(S01) | Deposits Attached Encrustation | 32 | M 2 |

Distance (ft): **.0**
Structural Grade: **0**
O&M Grade: **2**
Clock Start/From: **8**
Clock To: **4**
1st Value:
2nd Value:
Value Percent: **5.000**
Continuous Index: **S01**
Within 8" of Joint: **NO**
Remarks:

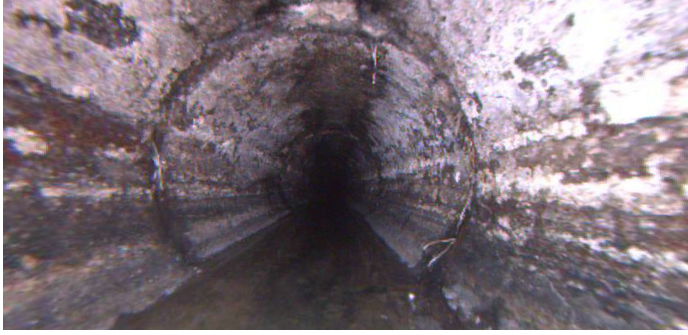
Code: **RFJ**
Description: **Roots Fine Joint**

| | Position | Code | Observation | Video (sec) | Grade |
|--|---|---|---|---|---|
| | 1.0 | RFJ(S02) | Roots Fine Joint | 46 | M 1 |

Distance (ft): **1.0**
Structural Grade: **0**
O&M Grade: **1**
Clock Start/From: **8**
Clock To: **4**
1st Value:
2nd Value:
Value Percent:
Continuous Index: **S02**
Within 8" of Joint: **YES**
Remarks:

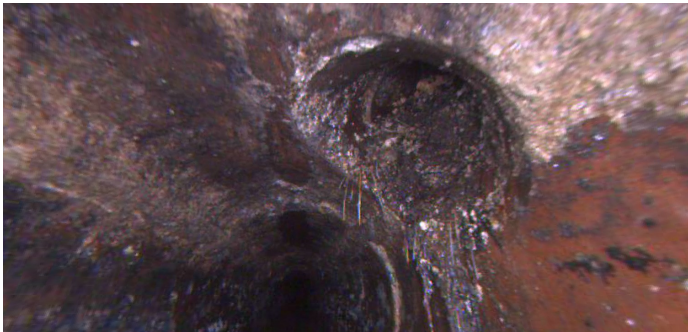
Code: **TFD**
Description: **Tap Factory Defective**

| | Position | Code | Observation | Video (sec) | Grade |
|--|---|---|---|---|---|
| | 21.2 | TFD | Tap Factory Defective | 98 | M 2 |

Distance (ft): **21.2**
Structural Grade: **0**
O&M Grade: **2**
Clock Start/From: **1**
Clock To:
1st Value: **4.000**
2nd Value:
Value Percent:
Continuous Index:
Within 8" of Joint:
Remarks: **RML**

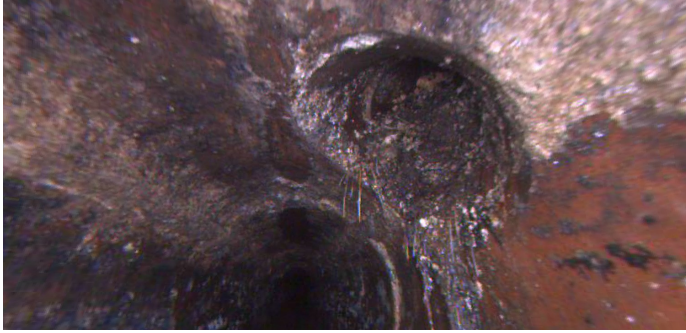
Code: **RML**
Description: **Roots Medium Lateral**

| | Position | Code | Observation | Video (sec) | Grade |
|--|---|---|---|---|---|
| | 21.2 | RML | Roots Medium Lateral | 109 | M 3 |

Distance (ft): **21.2**
Structural Grade: **0**
O&M Grade: **3**
Clock Start/From: **1**
Clock To:
1st Value:
2nd Value:
Value Percent: **5.000**
Continuous Index:
Within 8" of Joint: **NO**
Remarks:

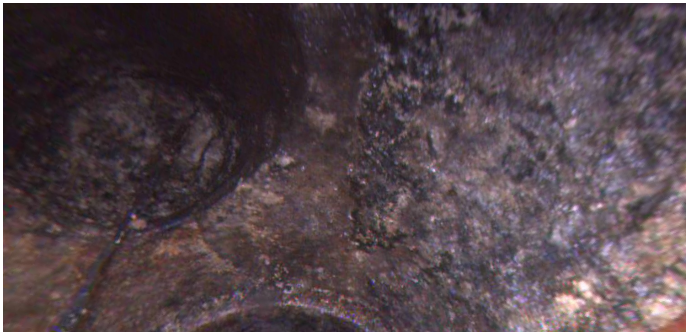
Code: **TFC**
Description: **Tap Factory Capped**

| | Position | Code | Observation | Video (sec) | Grade |
|--|---|---|---|---|---|
| | 54.0 | TFC | Tap Factory Capped | 187 | NA |

Distance (ft): **54.0**
Structural Grade: **0**
O&M Grade: **0**
Clock Start/From: **11**
Clock To:
1st Value: **4.000**
2nd Value:
Value Percent:
Continuous Index:
Within 8" of Joint:
Remarks: **RFL**

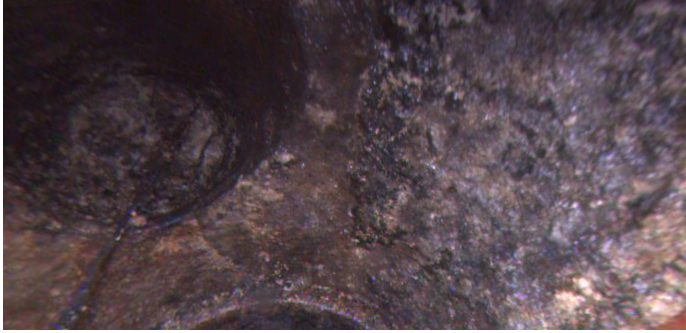
Code: **RFL**
Description: **Roots Fine Lateral**

| | Position | Code | Observation | Video (sec) | Grade |
|--|---|---|---|---|---|
| | 54.0 | RFL | Roots Fine Lateral | 198 | M 1 |

Distance (ft): **54.0**
Structural Grade: **0**
O&M Grade: **1**
Clock Start/From: **11**
Clock To:
1st Value:
2nd Value:
Value Percent:
Continuous Index:
Within 8" of Joint: **NO**
Remarks:

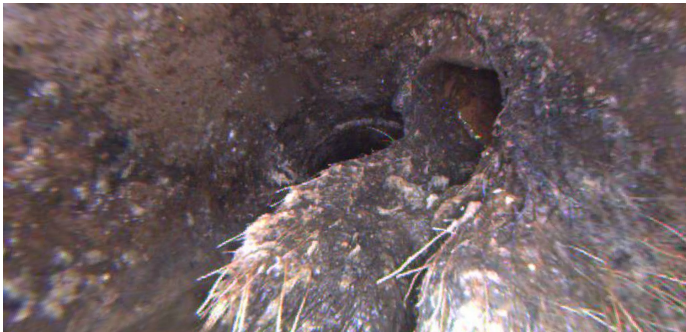
Code: **TBD**
Description: **Tap Break-in Defective**

| | Position | Code | Observation | Video (sec) | Grade |
|--|---|---|---|---|---|
| | 56.9 | TBD | Tap Break-in Defective | 216 | M 3 |

Distance (ft): **56.9**
Structural Grade: **0**
O&M Grade: **3**
Clock Start/From: **1**
Clock To:
1st Value: **4.000**
2nd Value:
Value Percent:
Continuous Index:
Within 8" of Joint:
Remarks: **ROOTS**

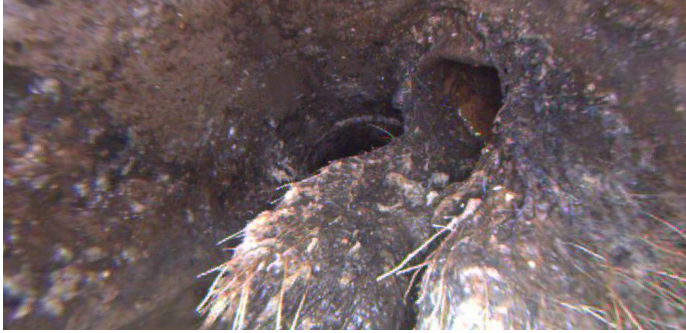
Code: **RBC**
Description: **Roots Ball Connection**

| | Position | Code | Observation | Video (sec) | Grade |
|--|---|---|---|---|---|
| | 56.9 | RBC | Roots Ball Connection | 227 | M 4 |

Distance (ft): **56.9**
Structural Grade: **0**
O&M Grade: **4**
Clock Start/From: **1**
Clock To: **6**
1st Value:
2nd Value:
Value Percent: **70.000**
Continuous Index:
Within 8" of Joint: **NO**
Remarks:

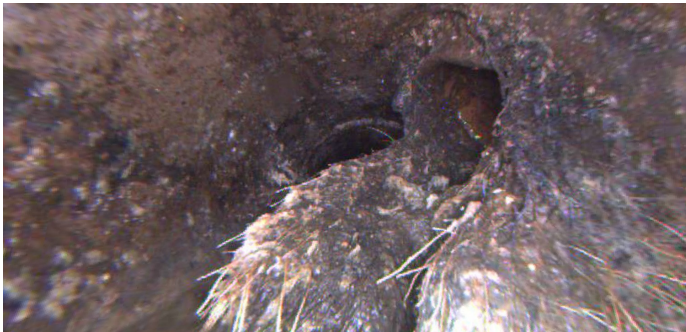
Code: **RFJ**
Description: **Roots Fine Joint**

| | Position | Code | Observation | Video (sec) | Grade |
|--|---|---|---|---|---|
| | 56.9 | RFJ(F02) | Roots Fine Joint | 238 | M 1 |

Distance (ft): **56.9**
Structural Grade: **0**
O&M Grade: **1**
Clock Start/From: **8**
Clock To: **4**
1st Value:
2nd Value:
Value Percent:
Continuous Index: **F02**
Within 8" of Joint: **YES**
Remarks:

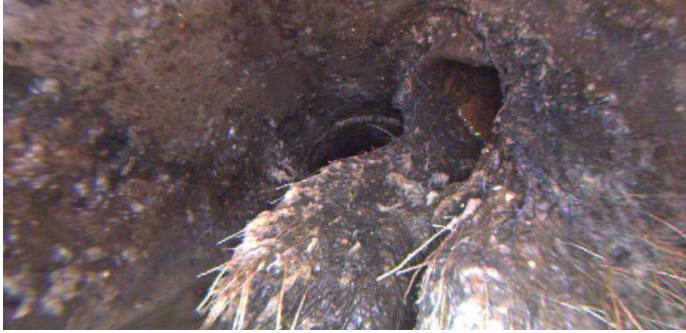
Code: **DAE**
Description: **Deposits Attached Encrustation**

| | Position | Code | Observation | Video (sec) | Grade |
|--|---|---|---|---|---|
| | 56.9 | DAE(F01) | Deposits Attached Encrustation | 249 | M 2 |

Distance (ft): **56.9**
Structural Grade: **0**
O&M Grade: **2**
Clock Start/From: **8**
Clock To: **4**
1st Value:
2nd Value:
Value Percent: **5.000**
Continuous Index: **F01**
Within 8" of Joint: **NO**
Remarks:

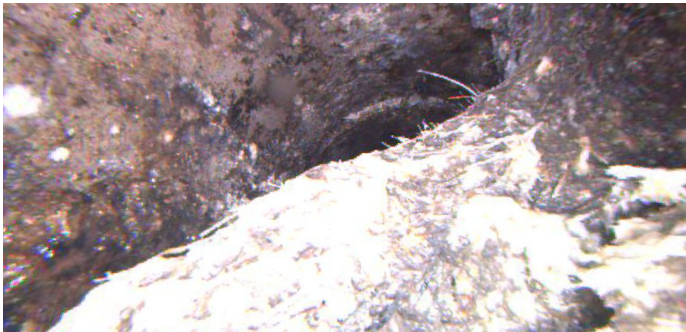
Code: **MSA**
Description: **Abandoned Survey**

| Comment: | P_C at 61 ft roots . FLOW direction wrong | | |

| | Position | Code | Observation | Video (sec) | Grade |
|--|---|---|---|---|---|
| | 62.4 | MSA | Abandoned Survey | 271 | NA |

Distance (ft): **62.4**
Structural Grade: **0**
O&M Grade: **0**
Clock Start/From:
Clock To:
1st Value:
2nd Value:
Value Percent:
Continuous Index:
Within 8" of Joint: **NO**
Remarks: **ROOTS**
