## Profile/Photo Observation Report

Date:	<b>04/24/2018</b>	Weather:		Coding:	<b>PACP 6.0</b>
Pipe Length (ft):	<b>165.8</b>	Owner:	<b>NA</b>	Pre Clean:	<b>No Pre-Cleaning</b>
P.O.#:		Surveyor:	<b>Jen Costello</b>	PSR:	<b>P-504-011-010</b>
Customer:		Clean Date:	<b>01/01/1900</b>	Shape:	<b>C</b>

Street:	<b>FOXCROFT STREET</b>	Flow Control:	<b>Not Controlled</b>
City:	<b>Hobart, IN</b>	Year Renewed:	
Location:	<b>Yard</b>	Tape/Media #:	
Purpose:	<b>Routine Assessment</b>	Dia/Height:	<b>12"</b>
Use:	<b>Sanitary</b>	Material:	<b>VCP</b>
Drain Area:	<b>NA</b>	Lining:	
Category:	<b>NA</b>		
Comment:	<b>P_C at 61 ft roots . FLOW direction wrong</b>		
Location Details:		Direction of Survey:	<b>Downstream</b>
US MH:	<b>M-504-010</b>	DS MH:	<b>M-504-011</b>
		Total Length Surveyed (ft):	<b>62.4</b>

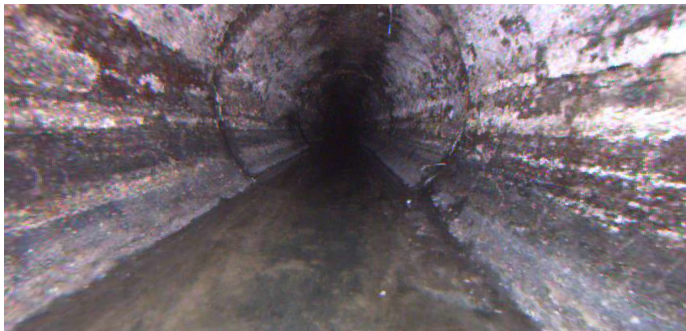
Code: **AMH**  
Description: **Manhole**

Distance (ft): **.0**  
Structural Grade: **0**  
O&M Grade: **0**  
Clock Start/From:  
Clock To:  
1st Value:  
2nd Value:  
Value Percent:  
Continuous Index:  
Within 8" of Joint: **NO**  
Remarks: **M-504-010**

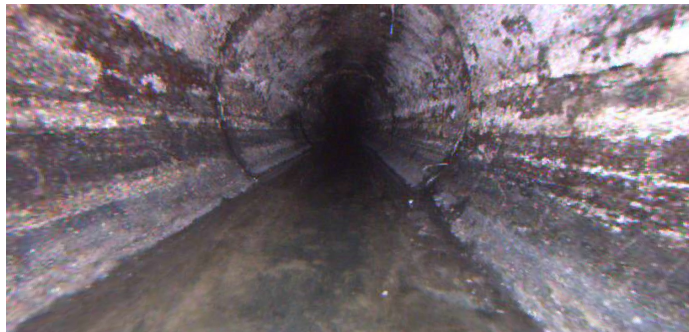
Code: **DAE**  
Description: **Deposits Attached Encrustation**

Distance (ft): **.0**  
Structural Grade: **0**  
O&M Grade: **2**  
Clock Start/From: **8**  
Clock To: **4**  
1st Value:  
2nd Value:  
Value Percent: **5.000**  
Continuous Index: **S01**  
Within 8" of Joint: **NO**  
Remarks:

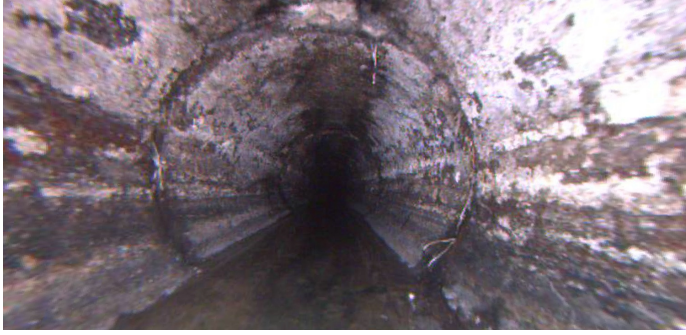
Code: **RFJ**  
Description: **Roots Fine Joint**

Distance (ft): **1.0**  
Structural Grade: **0**  
O&M Grade: **1**  
Clock Start/From: **8**  
Clock To: **4**  
1st Value:  
2nd Value:  
Value Percent:  
Continuous Index: **S02**  
Within 8" of Joint: **YES**  
Remarks:

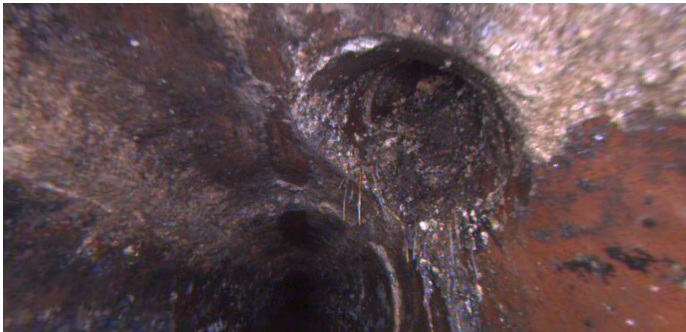
Code: **TFD**  
Description: **Tap Factory Defective**

Distance (ft): **21.2**  
Structural Grade: **0**  
O&M Grade: **2**  
Clock Start/From: **1**  
Clock To:  
1st Value: **4.000**  
2nd Value:  
Value Percent:  
Continuous Index:  
Within 8" of Joint:  
Remarks: **RML**

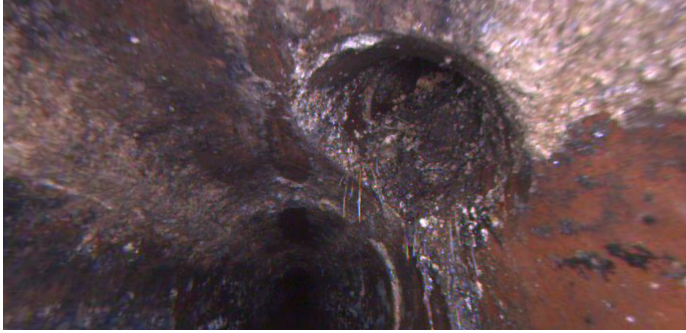
Code: **RML**  
Description: **Roots Medium Lateral**

Distance (ft): **21.2**  
Structural Grade: **0**  
O&M Grade: **3**  
Clock Start/From: **1**  
Clock To:  
1st Value:  
2nd Value:  
Value Percent: **5.000**  
Continuous Index:  
Within 8" of Joint: **NO**  
Remarks:

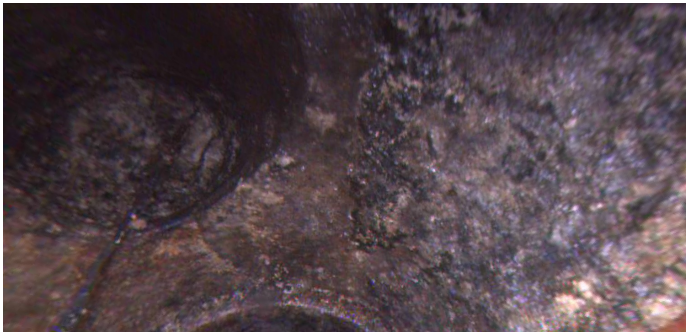
Code: **TFC**  
Description: **Tap Factory Capped**

Distance (ft): **54.0**  
Structural Grade: **0**  
O&M Grade: **0**  
Clock Start/From: **11**  
Clock To:  
1st Value: **4.000**  
2nd Value:  
Value Percent:  
Continuous Index:  
Within 8" of Joint:  
Remarks: **RFL**

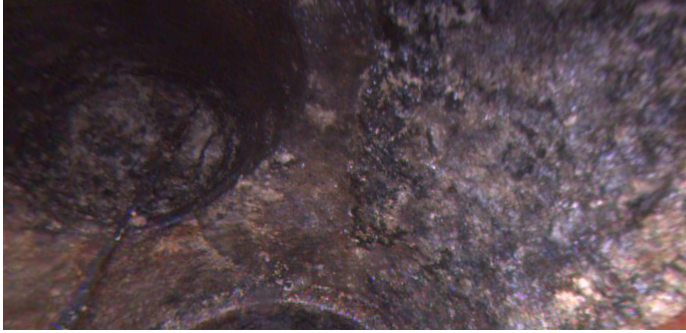
Code: **RFL**  
Description: **Roots Fine Lateral**

Distance (ft): **54.0**  
Structural Grade: **0**  
O&M Grade: **1**  
Clock Start/From: **11**  
Clock To:  
1st Value:  
2nd Value:  
Value Percent:  
Continuous Index:  
Within 8" of Joint: **NO**  
Remarks:

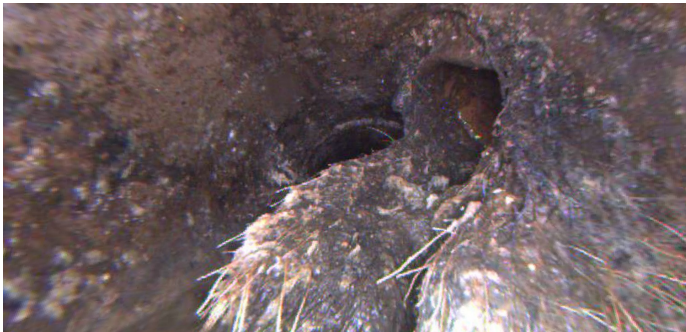
Code: **TBD**  
Description: **Tap Break-in Defective**

Distance (ft): **56.9**  
Structural Grade: **0**  
O&M Grade: **3**  
Clock Start/From: **1**  
Clock To:  
1st Value: **4.000**  
2nd Value:  
Value Percent:  
Continuous Index:  
Within 8" of Joint:  
Remarks: **ROOTS**

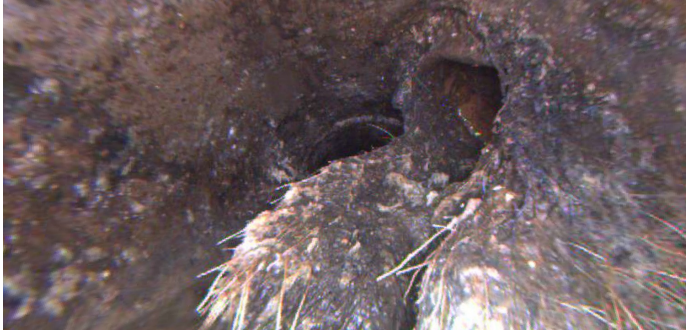
Code: **RBC**  
Description: **Roots Ball Connection**

Distance (ft): **56.9**  
Structural Grade: **0**  
O&M Grade: **4**  
Clock Start/From: **1**  
Clock To: **6**  
1st Value:  
2nd Value:  
Value Percent: **70.000**  
Continuous Index:  
Within 8" of Joint: **NO**  
Remarks:

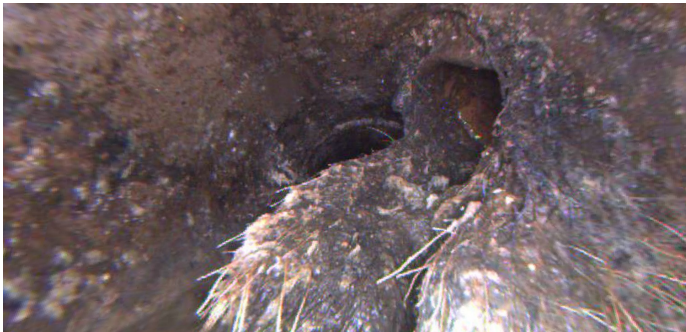
Code: **RFJ**  
Description: **Roots Fine Joint**

Distance (ft): **56.9**  
Structural Grade: **0**  
O&M Grade: **1**  
Clock Start/From: **8**  
Clock To: **4**  
1st Value:  
2nd Value:  
Value Percent:  
Continuous Index: **F02**  
Within 8" of Joint: **YES**  
Remarks:

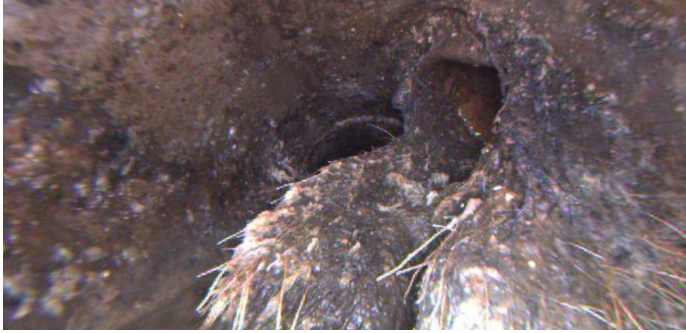
Code: **DAE**  
Description: **Deposits Attached Encrustation**

Distance (ft): **56.9**  
Structural Grade: **0**  
O&M Grade: **2**  
Clock Start/From: **8**  
Clock To: **4**  
1st Value:  
2nd Value:  
Value Percent: **5.000**  
Continuous Index: **F01**  
Within 8" of Joint: **NO**  
Remarks:

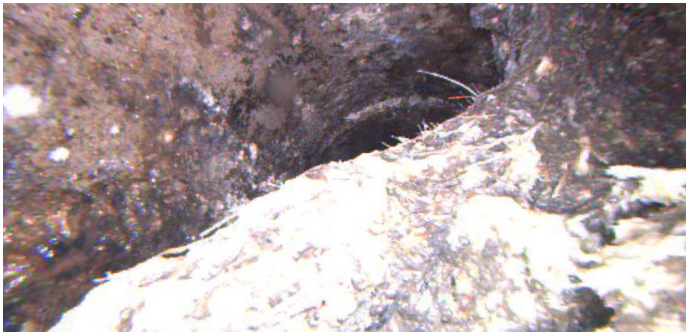
Code: **MSA**  
Description: **Abandoned Survey**

Distance (ft): **62.4**  
Structural Grade: **0**  
O&M Grade: **0**  
Clock Start/From:  
Clock To:  
1st Value:  
2nd Value:  
Value Percent:  
Continuous Index:  
Within 8" of Joint: **NO**  
Remarks: **ROOTS**
