Profile/Photo Observation Report

Date:	04/24/2018	Weather:		Coding:	PACP 6.0
Pipe Length (ft):	146.2	Owner:	NA	Pre Clean:	No Pre-Cleaning
P.O.#:		Surveyor:	Jen Costello	PSR:	P-504-012-011
Customer:		Clean Date:	01/01/1900	Shape:	C

Street:	W HOME AVE	Flow Control:	Not Controlled
City:	Hobart, IN	Year Renewed:	
Location:	Yard	Tape/Media #:	
Purpose:	Routine Assessment	Dia/Height:	12"
Use:	Sanitary	Material:	VCP
Drain Area:	NA	Lining:	
Category:	NA		
Comment:	R_M at 26 ft roots .Flow direction wrong		
Location Details:		Direction of Survey:	Downstream
US MH:	M-504-011	DS MH:	M-504-012
		Total Length Surveyed (ft):	27.2

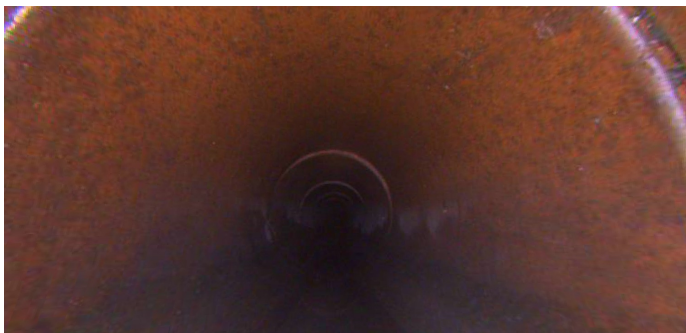
Code: **AMH**
Description: **Manhole**

Distance (ft): **.0**
Structural Grade: **0**
O&M Grade: **0**
Clock Start/From:
Clock To:
1st Value:
2nd Value:
Value Percent:
Continuous Index:
Within 8" of Joint: **NO**
Remarks: **M-504-011**

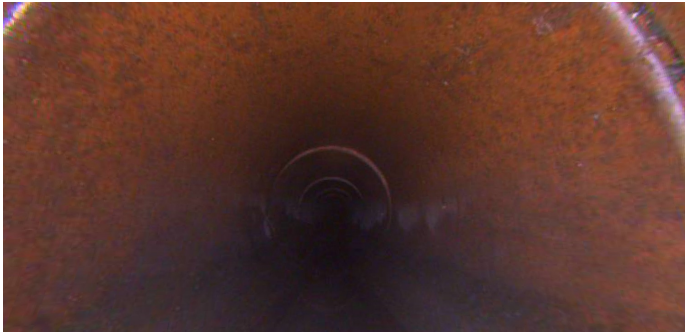
Code:	MWL
Description:	Water Level

Distance (ft):	.0
Structural Grade:	0
O&M Grade:	0
Clock Start/From:	
Clock To:	
1st Value:	
2nd Value:	
Value Percent:	5.000
Continuous Index:	
Within 8" of Joint:	NO
Remarks:

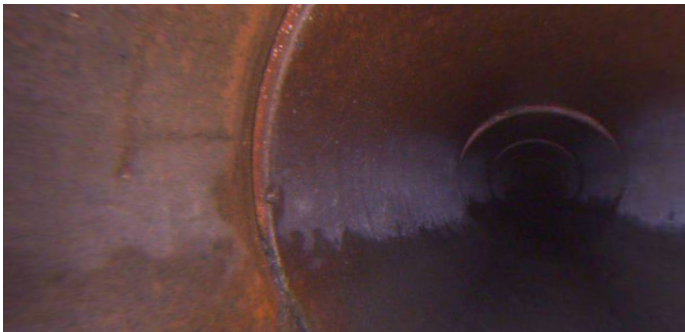
Code:	CL
Description:	Crack Longitudinal

Distance (ft):	4.8
Structural Grade:	2
O&M Grade:	0
Clock Start/From:	9
Clock To:	
1st Value:	
2nd Value:	
Value Percent:	
Continuous Index:	
Within 8" of Joint:	YES
Remarks:

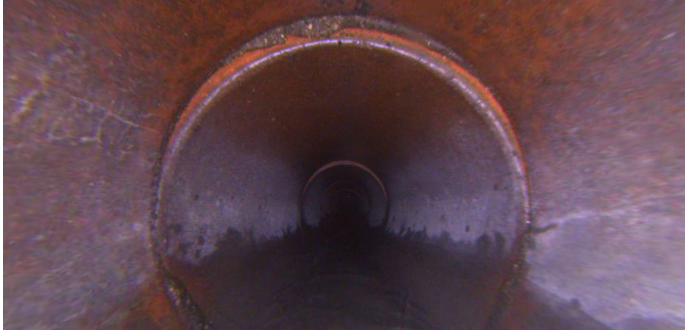
Code: **CM**
Description: **Crack Multiple**

Distance (ft): **6.6**
Structural Grade: **3**
O&M Grade: **0**
Clock Start/From: **8**
Clock To: **4**
1st Value:
2nd Value:
Value Percent:
Continuous Index: **S01**
Within 8" of Joint: **YES**
Remarks:

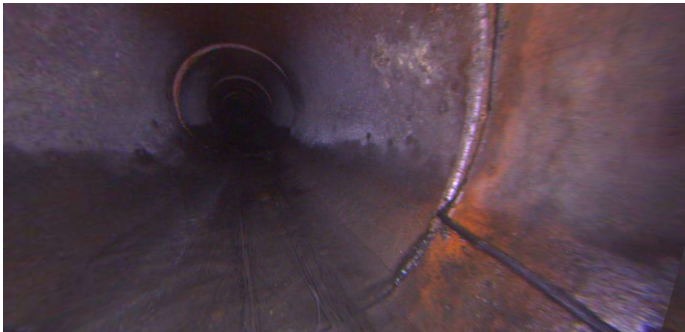
Code: **RFJ**
Description: **Roots Fine Joint**

Distance (ft): **13.0**
Structural Grade: **0**
O&M Grade: **1**
Clock Start/From: **4**
Clock To:
1st Value:
2nd Value:
Value Percent:
Continuous Index:
Within 8" of Joint: **YES**
Remarks:

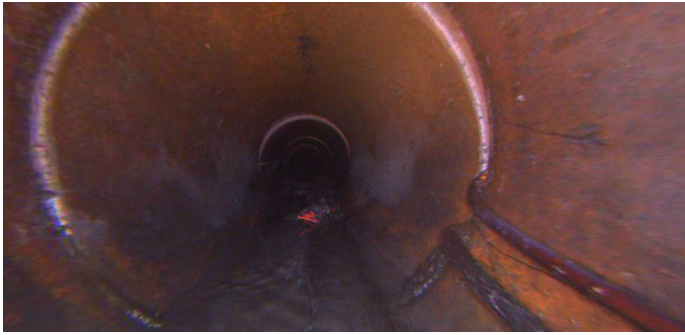
Code: **RMJ**
Description: **Roots Medium Joint**

Distance (ft): **18.8**
Structural Grade: **0**
O&M Grade: **3**
Clock Start/From: **3**
Clock To: **4**
1st Value:
2nd Value:
Value Percent: **5.000**
Continuous Index:
Within 8" of Joint: **YES**
Remarks:

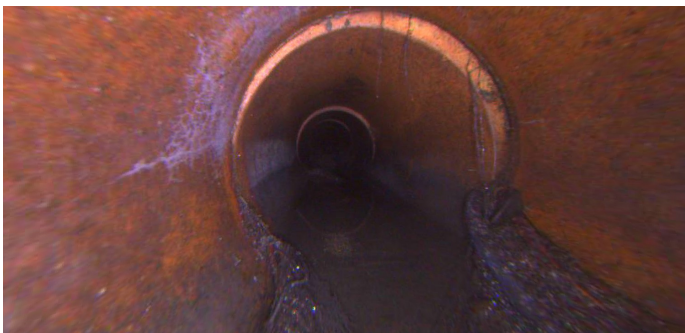
Code: **RMJ**
Description: **Roots Medium Joint**

Distance (ft): **22.6**
Structural Grade: **0**
O&M Grade: **3**
Clock Start/From: **7**
Clock To: **5**
1st Value:
2nd Value:
Value Percent: **10.000**
Continuous Index:
Within 8" of Joint: **YES**
Remarks:

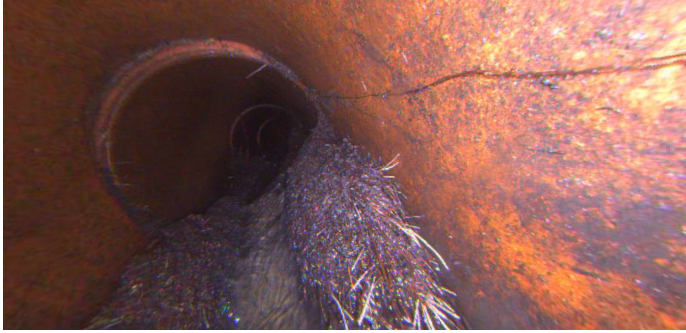
Code: **RMJ**
Description: **Roots Medium Joint**

Distance (ft): **27.2**
Structural Grade: **0**
O&M Grade: **3**
Clock Start/From: **3**
Clock To: **9**
1st Value:
2nd Value:
Value Percent: **20.000**
Continuous Index:
Within 8" of Joint: **YES**
Remarks:

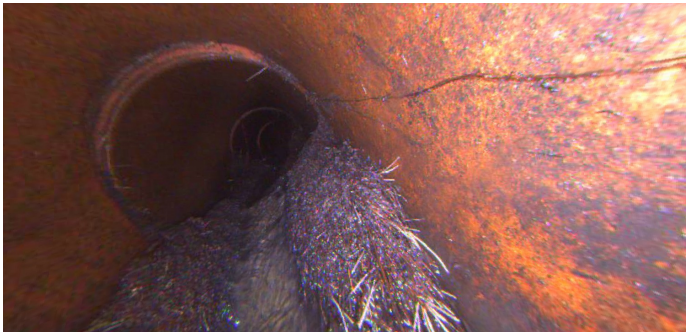
Code: **CM**
Description: **Crack Multiple**

Distance (ft): **27.2**
Structural Grade: **3**
O&M Grade: **0**
Clock Start/From: **8**
Clock To: **4**
1st Value:
2nd Value:
Value Percent:
Continuous Index: **F01**
Within 8" of Joint: **YES**
Remarks:

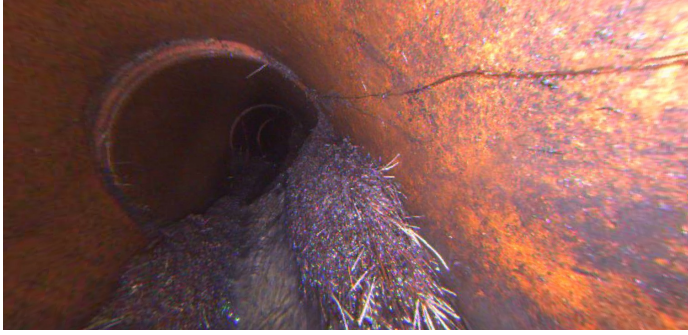
Code:	MSA
Description:	Abandoned Survey
Distance (ft):	27.2
Structural Grade:	0
O&M Grade:	0
Clock Start/From:	
Clock To:	
1st Value:	
2nd Value:	
Value Percent:	
Continuous Index:	
Within 8" of Joint:	NO
Remarks:	roots
