Profile/Photo Observation Report

| Street: | FOXCROFT STREET | Flow Control: | Not Controlled |
| City: | Hobart, IN | Year Renewed: | |
| US MH: | M-504-011 | DS MH: | M-504-012 |

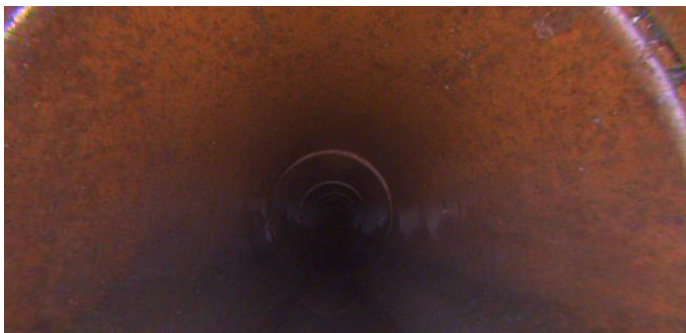
Code: **AMH**
Description: **Manhole**

Distance (ft): **.0**
Structural Grade: **0**
O&M Grade: **0**
Clock Start/From:
Clock To:
1st Value:
2nd Value:
Value Percent:
Continuous Index:
Within 8" of Joint: **NO**
Remarks: **M-504-011**

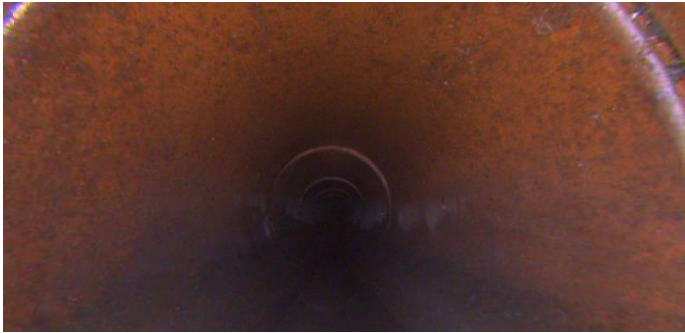
| Code: | MWL |
| Description: | Water Level |

| Value Percent: | 5.000 |

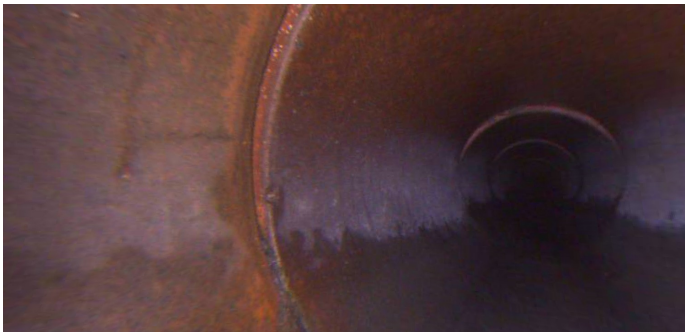
| Code: | CL |
| Description: | Crack Longitudinal |

| Distance (ft): | 4.8 |
| Structural Grade: | 2 |
| Clock Start/From: | 9 |
| Within 8" of Joint: | YES |

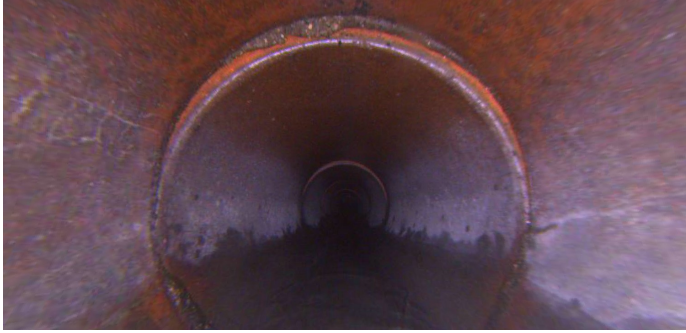
Code: **CM**
Description: **Crack Multiple**

Distance (ft): **6.6**
Structural Grade: **3**
O&M Grade: **0**
Clock Start/From: **8**
Clock To: **4**
1st Value:
2nd Value:
Value Percent:
Continuous Index: **S01**
Within 8" of Joint: **YES**
Remarks:

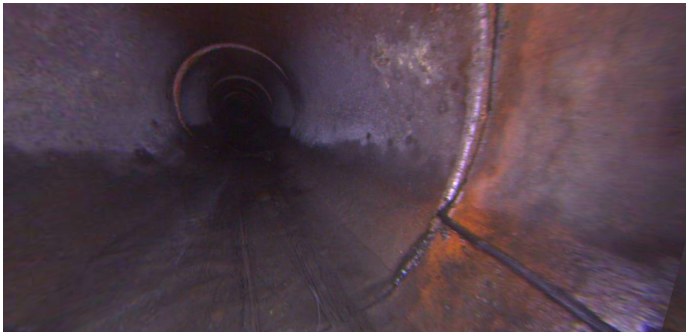
Code: **RFJ**
Description: **Roots Fine Joint**

Distance (ft): **13.0**
Structural Grade: **0**
O&M Grade: **1**
Clock Start/From: **4**
Clock To:
1st Value:
2nd Value:
Value Percent:
Continuous Index:
Within 8" of Joint: **YES**
Remarks:

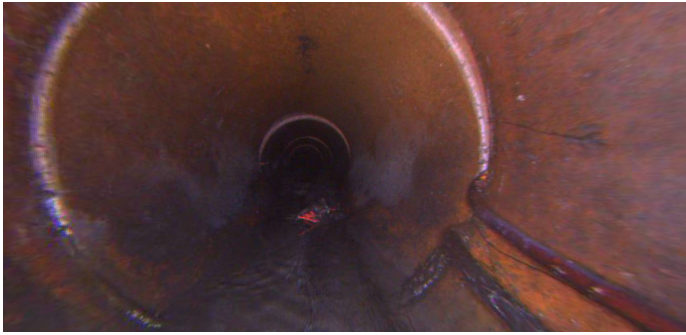
Code: **RMJ**
Description: **Roots Medium Joint**

Distance (ft): **18.8**
Structural Grade: **0**
O&M Grade: **3**
Clock Start/From: **3**
Clock To: **4**
1st Value:
2nd Value:
Value Percent: **5.000**
Continuous Index:
Within 8" of Joint: **YES**
Remarks:

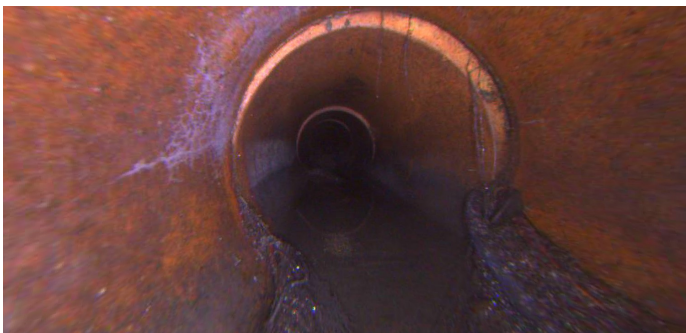
Code: **RMJ**
Description: **Roots Medium Joint**

Distance (ft): **22.6**
Structural Grade: **0**
O&M Grade: **3**
Clock Start/From: **7**
Clock To: **5**
1st Value:
2nd Value:
Value Percent: **10.000**
Continuous Index:
Within 8" of Joint: **YES**
Remarks:

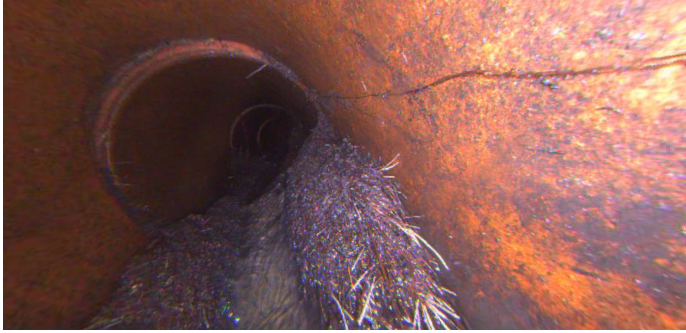
Code: **RMJ**
Description: **Roots Medium Joint**

Distance (ft): **27.2**
Structural Grade: **0**
O&M Grade: **3**
Clock Start/From: **3**
Clock To: **9**
1st Value:
2nd Value:
Value Percent: **20.000**
Continuous Index:
Within 8" of Joint: **YES**
Remarks:

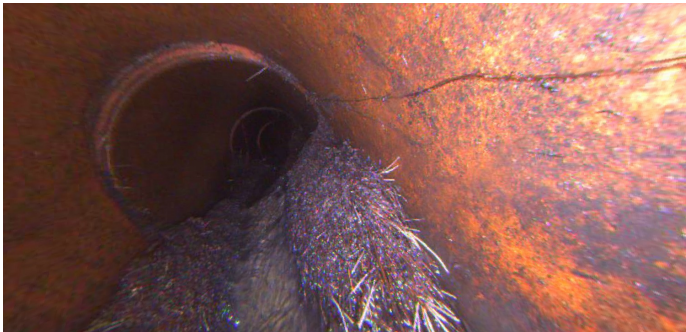
Code: **CM**
Description: **Crack Multiple**

Distance (ft): **27.2**
Structural Grade: **3**
O&M Grade: **0**
Clock Start/From: **8**
Clock To: **4**
1st Value:
2nd Value:
Value Percent:
Continuous Index: **F01**
Within 8" of Joint: **YES**
Remarks:

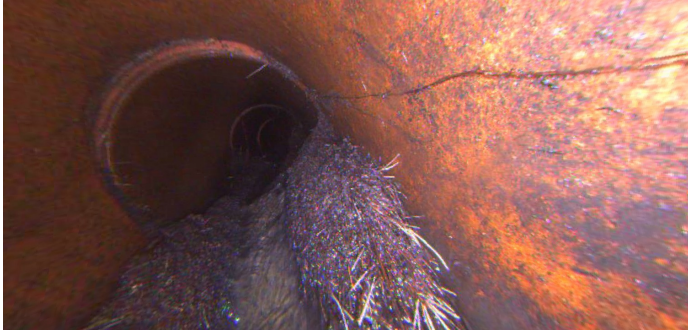
| Code: | MSA |
| Description: | Abandoned Survey |
| Distance (ft): | 27.2 |
| Remarks: | roots |
