## Profile/Photo Observation Report

Date:	<b>04/24/2018</b>	Weather:		Coding:	<b>PACP 6.0</b>
Pipe Length (ft):	<b>146.2</b>	Owner:	<b>NA</b>	Pre Clean:	<b>No Pre-Cleaning</b>
P.O.#:		Surveyor:	<b>Jen Costello</b>	PSR:	<b>P-504-012-011</b>
Customer:		Clean Date:	<b>01/01/1900</b>	Shape:	<b>C</b>

Street:	<b>W HOME AVE</b>	Flow Control:	<b>Not Controlled</b>
City:	<b>Hobart, IN</b>	Year Renewed:	
Location:	<b>Yard</b>	Tape/Media #:	
Purpose:	<b>Routine Assessment</b>	Dia/Height:	<b>12"</b>
Use:	<b>Sanitary</b>	Material:	<b>VCP</b>
Drain Area:	<b>NA</b>	Lining:	
Category:	<b>NA</b>		
Comment:	<b>P_C at 38 ft root / debris. Flow direction wrong</b>		
Location Details:		Direction of Survey:	<b>Downstream</b>
US MH:	<b>M-504-011</b>	DS MH:	<b>M-504-012</b>
		Total Length Surveyed (ft):	<b>40.0</b>

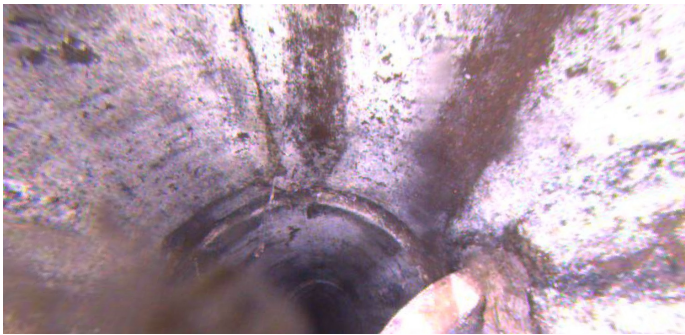
Code: **FL**  
Description: **Fracture Longitudinal**

Distance (ft): **.0**  
Structural Grade: **3**  
O&M Grade: **0**  
Clock Start/From: **12**  
Clock To:  
1st Value:  
2nd Value:  
Value Percent:  
Continuous Index:  
Within 8" of Joint: **YES**  
Remarks:

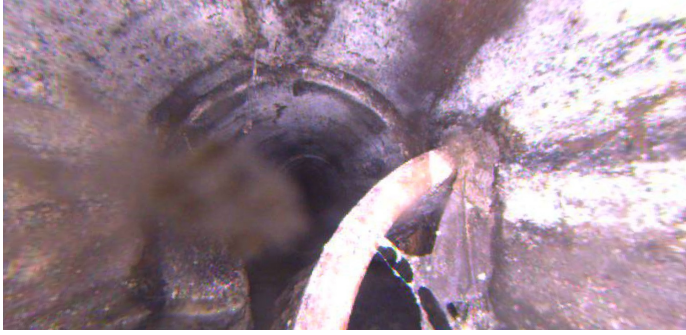
Code:	<b>OBM</b>
Description:	<b>Obstacle Pipe Material</b>
Distance (ft):	<b>.0</b>
Structural Grade:	<b>0</b>
O&M Grade:	<b>2</b>
Clock Start/From:	<b>3</b>
Clock To:	<b>6</b>
1st Value:	
2nd Value:	
Value Percent:	<b>10.000</b>
Continuous Index:	
Within 8" of Joint:	<b>NO</b>
Remarks:

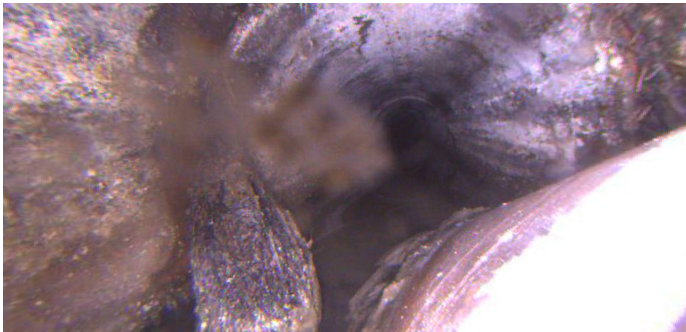
Code:	<b>RMJ</b>
Description:	<b>Roots Medium Joint</b>
Distance (ft):	<b>.5</b>
Structural Grade:	<b>0</b>
O&M Grade:	<b>3</b>
Clock Start/From:	<b>7</b>
Clock To:	<b>9</b>
1st Value:	
2nd Value:	
Value Percent:	<b>10.000</b>
Continuous Index:	
Within 8" of Joint:	<b>YES</b>
Remarks:

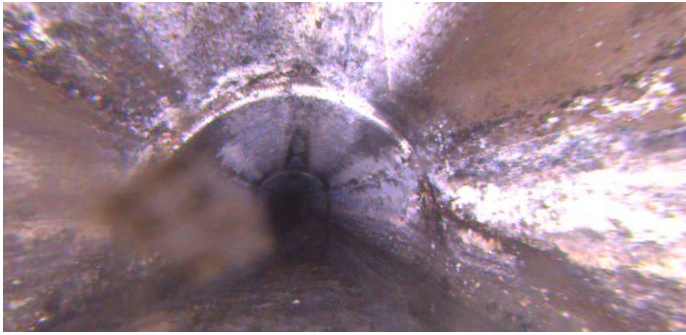
Code: **FL**  
Description: **Fracture Longitudinal**

Distance (ft): **3.5**  
Structural Grade: **3**  
O&M Grade: **0**  
Clock Start/From: **3**  
Clock To:  
1st Value:  
2nd Value:  
Value Percent:  
Continuous Index:  
Within 8" of Joint: **YES**  
Remarks:

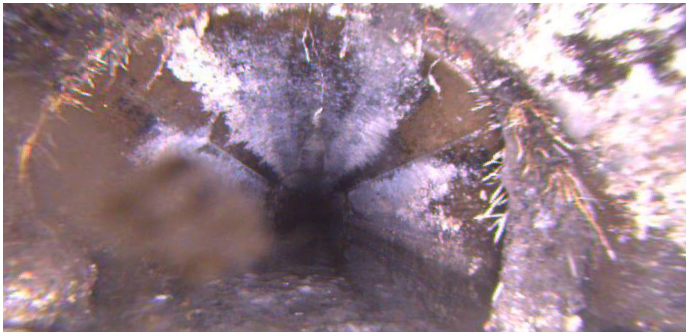
Code: **RMJ**  
Description: **Roots Medium Joint**

Distance (ft): **9.0**  
Structural Grade: **0**  
O&M Grade: **3**  
Clock Start/From: **8**  
Clock To: **4**  
1st Value:  
2nd Value:  
Value Percent: **10.000**  
Continuous Index: **S01**  
Within 8" of Joint: **YES**  
Remarks:

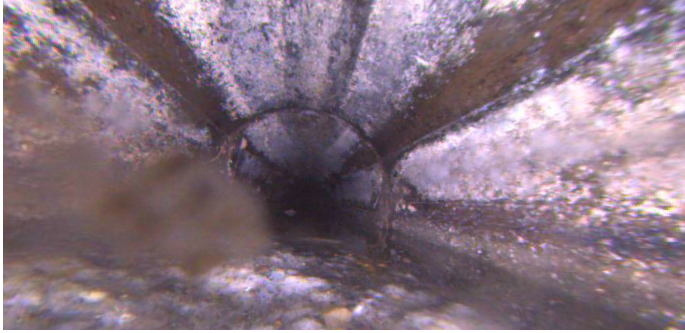
Code: **DAGS**  
Description: **Deposits Attached Grease**

Distance (ft): **10.6**  
Structural Grade: **0**  
O&M Grade: **2**  
Clock Start/From: **8**  
Clock To: **4**  
1st Value:  
2nd Value:  
Value Percent: **5.000**  
Continuous Index: **S02**  
Within 8" of Joint: **NO**  
Remarks:

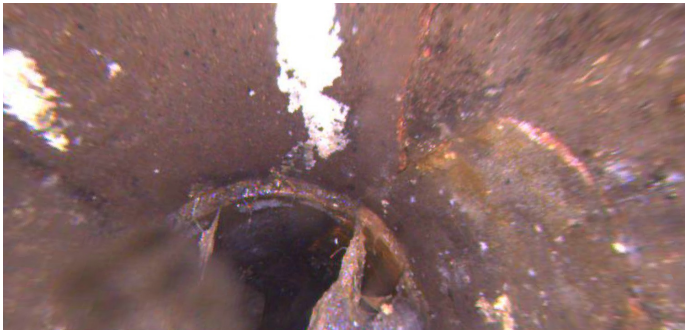
Code: **FM**  
Description: **Fracture Multiple**

Distance (ft): **23.7**  
Structural Grade: **4**  
O&M Grade: **0**  
Clock Start/From: **1**  
Clock To: **3**  
1st Value:  
2nd Value:  
Value Percent:  
Continuous Index:  
Within 8" of Joint: **YES**  
Remarks:

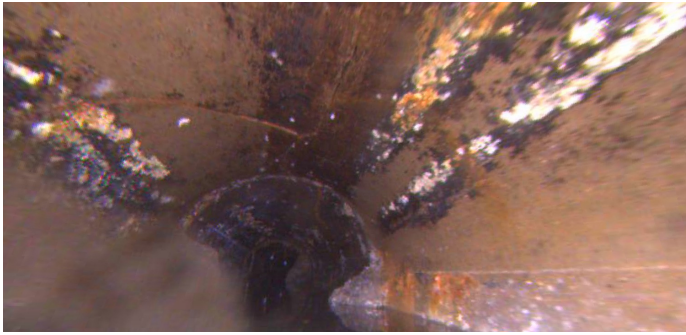
Code: **FM**  
Description: **Fracture Multiple**

Distance (ft): **25.8**  
Structural Grade: **4**  
O&M Grade: **0**  
Clock Start/From: **11**  
Clock To: **4**  
1st Value:  
2nd Value:  
Value Percent:  
Continuous Index:  
Within 8" of Joint:  
Remarks:

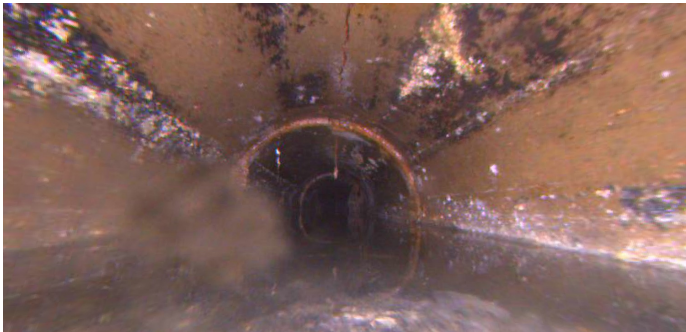
Code: **FL**  
Description: **Fracture Longitudinal**

Distance (ft): **31.0**  
Structural Grade: **3**  
O&M Grade: **0**  
Clock Start/From: **12**  
Clock To:  
1st Value:  
2nd Value:  
Value Percent:  
Continuous Index: **S03**  
Within 8" of Joint: **YES**  
Remarks:

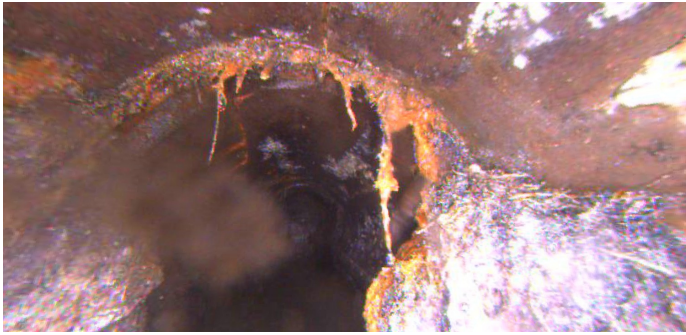
Code: **RMJ**  
Description: **Roots Medium Joint**

Distance (ft): **39.4**  
Structural Grade: **0**  
O&M Grade: **3**  
Clock Start/From: **8**  
Clock To: **4**  
1st Value:  
2nd Value:  
Value Percent: **30.000**  
Continuous Index:  
Within 8" of Joint: **YES**  
Remarks:

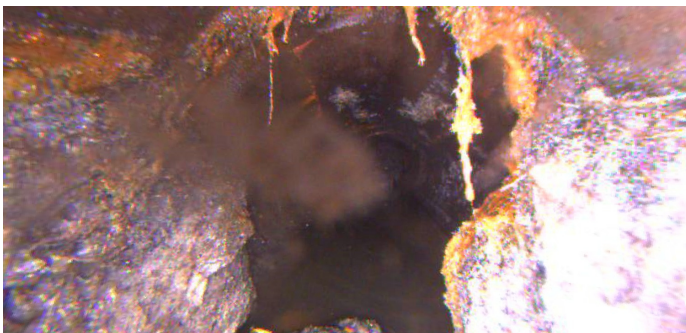
Code: **DAGS**  
Description: **Deposits Attached Grease**

Distance (ft): **40.0**  
Structural Grade: **0**  
O&M Grade: **2**  
Clock Start/From: **8**  
Clock To: **4**  
1st Value:  
2nd Value:  
Value Percent: **5.000**  
Continuous Index: **F02**  
Within 8" of Joint: **NO**  
Remarks:

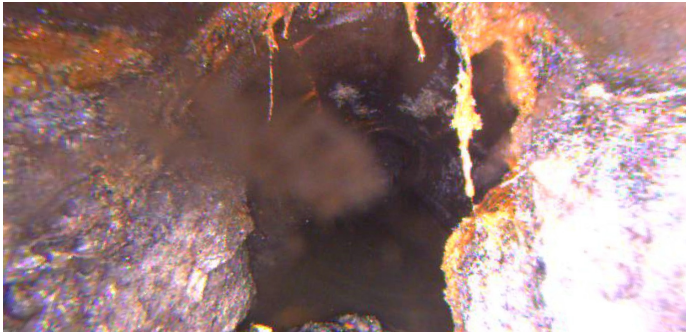
Code: **RMJ**  
Description: **Roots Medium Joint**

Distance (ft): **40.0**  
Structural Grade: **0**  
O&M Grade: **3**  
Clock Start/From: **8**  
Clock To: **4**  
1st Value:  
2nd Value:  
Value Percent: **10.000**  
Continuous Index: **F01**  
Within 8" of Joint: **YES**  
Remarks:

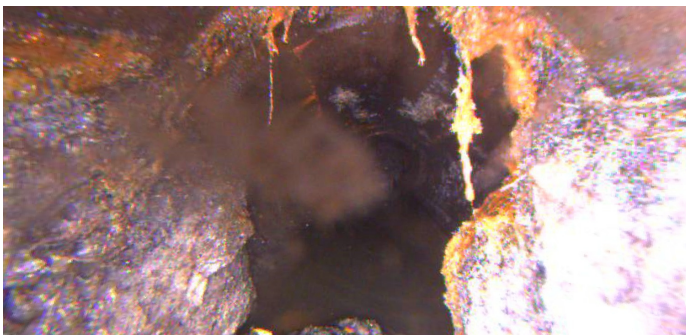
Code: **FL**  
Description: **Fracture Longitudinal**

Distance (ft): **40.0**  
Structural Grade: **3**  
O&M Grade: **0**  
Clock Start/From: **12**  
Clock To:  
1st Value:  
2nd Value:  
Value Percent:  
Continuous Index: **F03**  
Within 8" of Joint: **YES**  
Remarks:

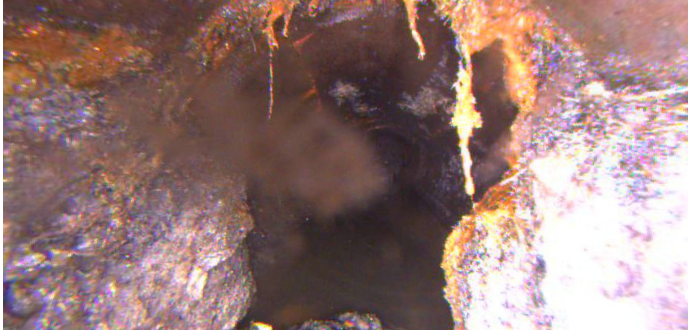
Code:	<b>MSA</b>
Description:	<b>Abandoned Survey</b>
Distance (ft):	<b>40.0</b>
Structural Grade:	<b>0</b>
O&M Grade:	<b>0</b>
Clock Start/From:	
Clock To:	
1st Value:	
2nd Value:	
Value Percent:	
Continuous Index:	
Within 8" of Joint:	<b>NO</b>
Remarks:	<b>ROOTS</b>
