Profile/Photo Observation Report

Street:	FOXCROFT STREET	Flow Control:	Not Controlled
City:	Hobart, IN	Year Renewed:	
Location:	Yard	Tape/Media #:	
Purpose:	Routine Assessment	Dia/Height:	12"
Use:	Sanitary	Material:	VCP
Drain Area:	NA	Lining:	
Category:	NA		
Comment:	P_C at 38 ft root / debris. Flow direction wrong		
Location Details:		Direction of Survey:	Downstream
US MH:	M-504-011	DS MH:	M-504-012
		Total Length Surveyed (ft):	40.0

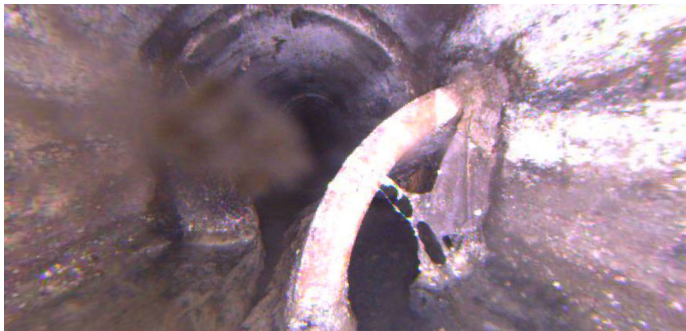
Code: **AMH**
Description: **Manhole**

Distance (ft): **.0**
Structural Grade: **0**
O&M Grade: **0**
Clock Start/From:
Clock To:
1st Value:
2nd Value:
Value Percent:
Continuous Index:
Within 8" of Joint: **NO**
Remarks: **M-504-011**

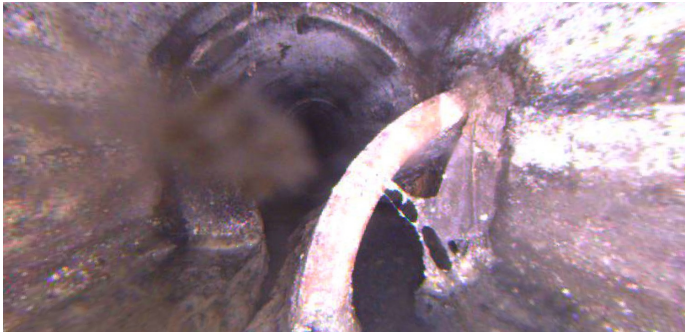
Code:	MWL
Description:	Water Level

Distance (ft):	.0
Structural Grade:	0
O&M Grade:	0
Clock Start/From:	
Clock To:	
1st Value:	
2nd Value:	
Value Percent:	10.000
Continuous Index:	
Within 8" of Joint:	NO
Remarks:

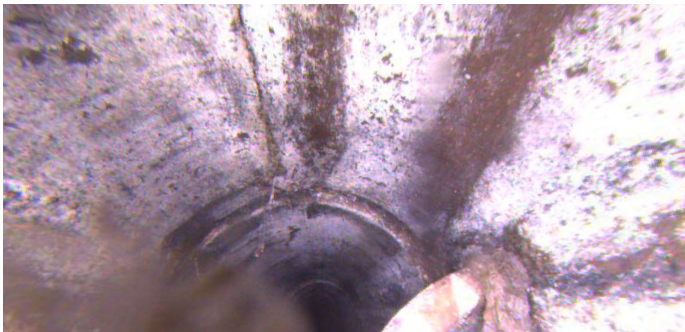
Code:	FL
Description:	Fracture Longitudinal

Distance (ft):	.0
Structural Grade:	3
O&M Grade:	0
Clock Start/From:	12
Clock To:	
1st Value:	
2nd Value:	
Value Percent:	
Continuous Index:	
Within 8" of Joint:	YES
Remarks:

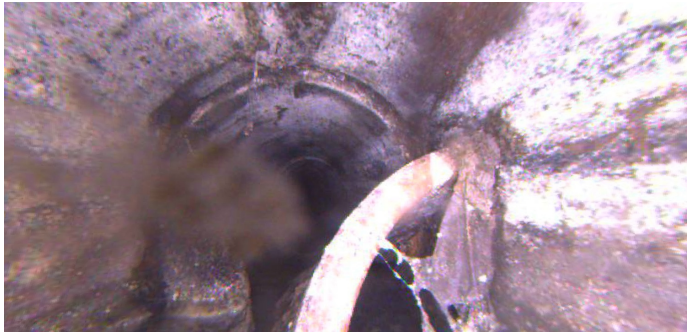
Code:	OBM
Description:	Obstacle Pipe Material
Distance (ft):	.0
Structural Grade:	0
O&M Grade:	2
Clock Start/From:	3
Clock To:	6
1st Value:	
2nd Value:	
Value Percent:	10.000
Continuous Index:	
Within 8" of Joint:	NO
Remarks:

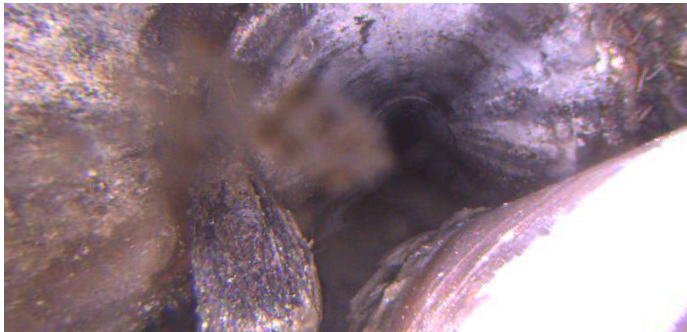
Code:	RMJ
Description:	Roots Medium Joint
Distance (ft):	.5
Structural Grade:	0
O&M Grade:	3
Clock Start/From:	7
Clock To:	9
1st Value:	
2nd Value:	
Value Percent:	10.000
Continuous Index:	
Within 8" of Joint:	YES
Remarks:

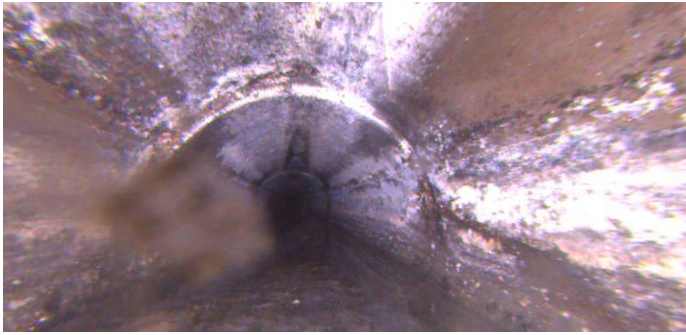
Code: **FL**
Description: **Fracture Longitudinal**

Distance (ft): **3.5**
Structural Grade: **3**
O&M Grade: **0**
Clock Start/From: **3**
Clock To:
1st Value:
2nd Value:
Value Percent:
Continuous Index:
Within 8" of Joint: **YES**
Remarks:

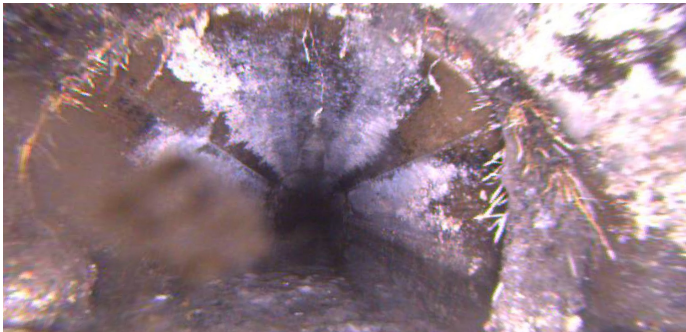
Code: **RMJ**
Description: **Roots Medium Joint**

Distance (ft): **9.0**
Structural Grade: **0**
O&M Grade: **3**
Clock Start/From: **8**
Clock To: **4**
1st Value:
2nd Value:
Value Percent: **10.000**
Continuous Index: **S01**
Within 8" of Joint: **YES**
Remarks:

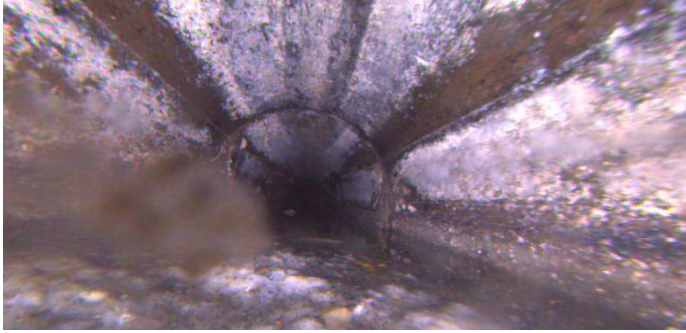
Code: **DAGS**
Description: **Deposits Attached Grease**

Distance (ft): **10.6**
Structural Grade: **0**
O&M Grade: **2**
Clock Start/From: **8**
Clock To: **4**
1st Value:
2nd Value:
Value Percent: **5.000**
Continuous Index: **S02**
Within 8" of Joint: **NO**
Remarks:

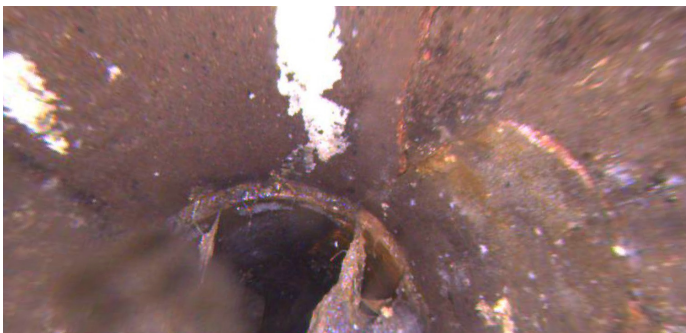
Code: **FM**
Description: **Fracture Multiple**

Distance (ft): **23.7**
Structural Grade: **4**
O&M Grade: **0**
Clock Start/From: **1**
Clock To: **3**
1st Value:
2nd Value:
Value Percent:
Continuous Index:
Within 8" of Joint: **YES**
Remarks:

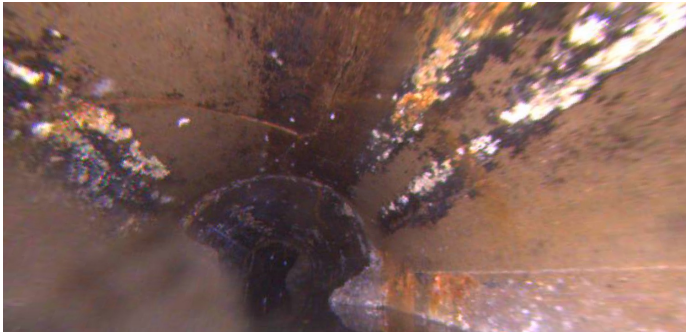
Code: **FM**
Description: **Fracture Multiple**

Distance (ft): **25.8**
Structural Grade: **4**
O&M Grade: **0**
Clock Start/From: **11**
Clock To: **4**
1st Value:
2nd Value:
Value Percent:
Continuous Index:
Within 8" of Joint:
Remarks:

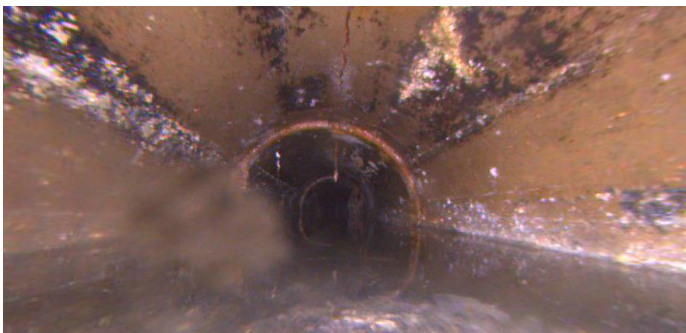
Code: **FL**
Description: **Fracture Longitudinal**

Distance (ft): **31.0**
Structural Grade: **3**
O&M Grade: **0**
Clock Start/From: **12**
Clock To:
1st Value:
2nd Value:
Value Percent:
Continuous Index: **S03**
Within 8" of Joint: **YES**
Remarks:

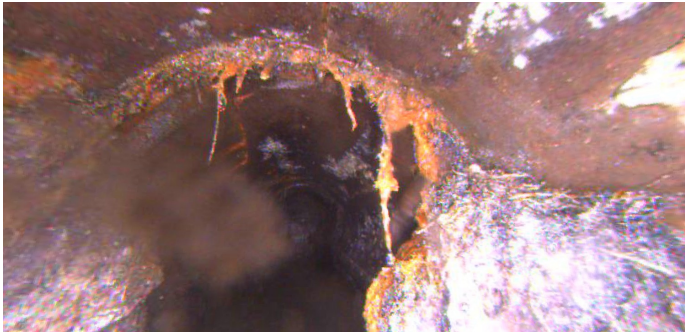
Code: **RMJ**
Description: **Roots Medium Joint**

Distance (ft): **39.4**
Structural Grade: **0**
O&M Grade: **3**
Clock Start/From: **8**
Clock To: **4**
1st Value:
2nd Value:
Value Percent: **30.000**
Continuous Index:
Within 8" of Joint: **YES**
Remarks:

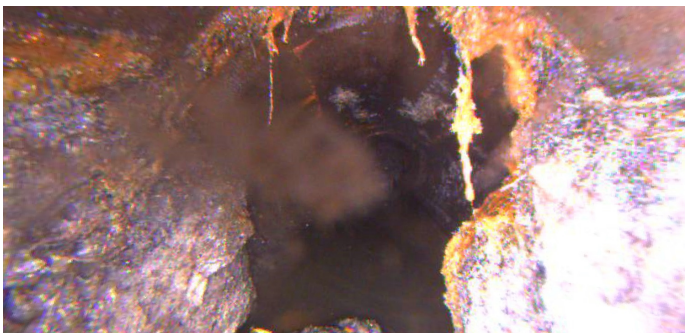
Code: **DAGS**
Description: **Deposits Attached Grease**

Distance (ft): **40.0**
Structural Grade: **0**
O&M Grade: **2**
Clock Start/From: **8**
Clock To: **4**
1st Value:
2nd Value:
Value Percent: **5.000**
Continuous Index: **F02**
Within 8" of Joint: **NO**
Remarks:

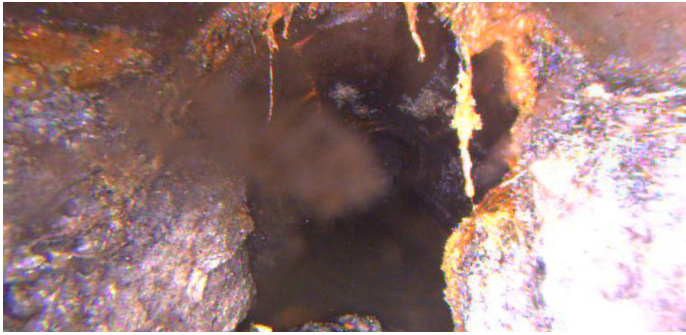
Code: **RMJ**
Description: **Roots Medium Joint**

Distance (ft): **40.0**
Structural Grade: **0**
O&M Grade: **3**
Clock Start/From: **8**
Clock To: **4**
1st Value:
2nd Value:
Value Percent: **10.000**
Continuous Index: **F01**
Within 8" of Joint: **YES**
Remarks:

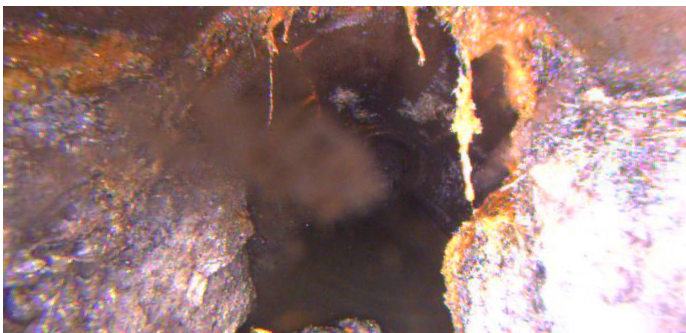
Code: **FL**
Description: **Fracture Longitudinal**

Distance (ft): **40.0**
Structural Grade: **3**
O&M Grade: **0**
Clock Start/From: **12**
Clock To:
1st Value:
2nd Value:
Value Percent:
Continuous Index: **F03**
Within 8" of Joint: **YES**
Remarks:

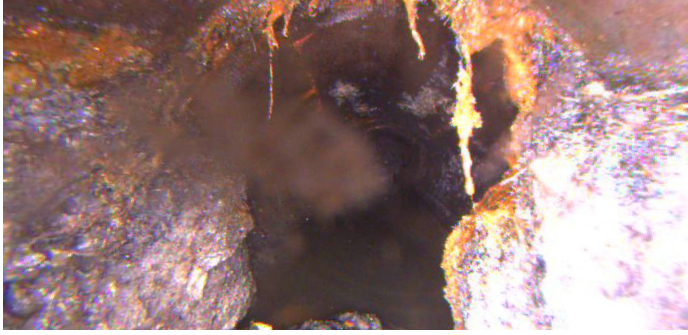
Code:	MSA
Description:	Abandoned Survey
Distance (ft):	40.0
Structural Grade:	0
O&M Grade:	0
Clock Start/From:	
Clock To:	
1st Value:	
2nd Value:	
Value Percent:	
Continuous Index:	
Within 8" of Joint:	NO
Remarks:	ROOTS
