RedZone
ROBOTICS

Street:	South California Street		Flow Control:	Not Controlled	
City:	Hobart, IN		Year Renewed:		
Location:	Alley		Tape/Media #:		
Purpose:	Routine Assessment		Dia/Height:	12"	
Use:	Sanitary Sewage Pipe		Material:	VCP	
Drain Area:			Lining:	None	
Category:	NA				
Comment:					
Location Details:			Direction of Survey:	Downstream	
US MH:	M-504-011	DS MH:	M-504-012	Total Length Surveyed (ft):	143.3

O&M Index:	1.77	O&M Quick:	2J1B	O&M Rating:	131.00
Structural Index:	2.75	Structural Quick:	4C34	Structural Rating:	162.00
Overall Index:	2.20	Overall Quick:	4C34	Overall Rating:	293.00

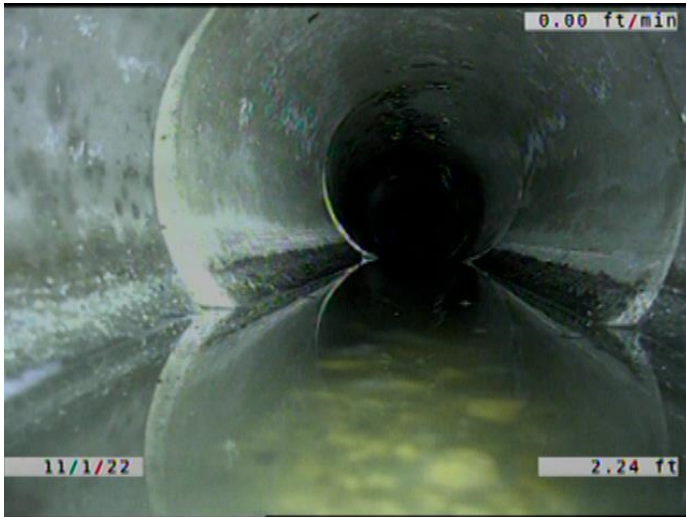
Code: **DSF**
Description: **Deposits Settled Fine**

Distance (ft): **2.2**
Structural Grade: **0**
O&M Grade: **2**
Clock Start/From: **5**
Clock To: **7**
1st Value:
2nd Value:
Value Percent: **5.000**
Continuous Index: **S01**
Within 8" of Joint: **YES**
Remarks:

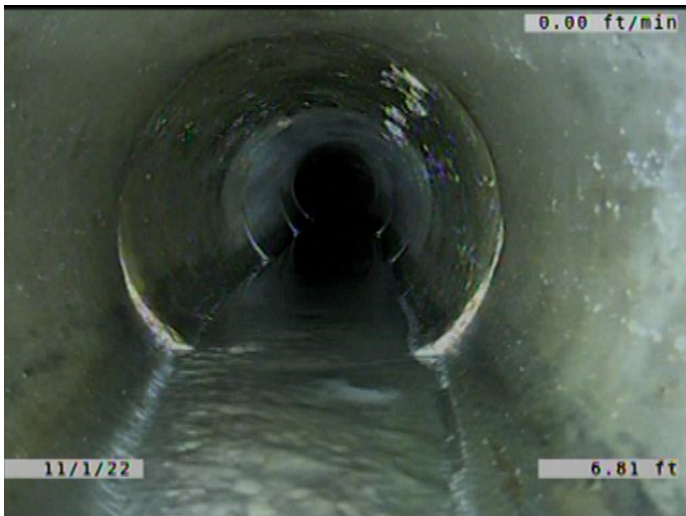
Code: **MWLS**
Description: **Miscellaneous Water Level Sag**

Distance (ft): **6.8**
Structural Grade: **2**
O&M Grade: **0**
Clock Start/From:
Clock To:
1st Value:
2nd Value:
Value Percent: **10.000**
Continuous Index: **S02**
Within 8" of Joint: **NO**
Remarks:

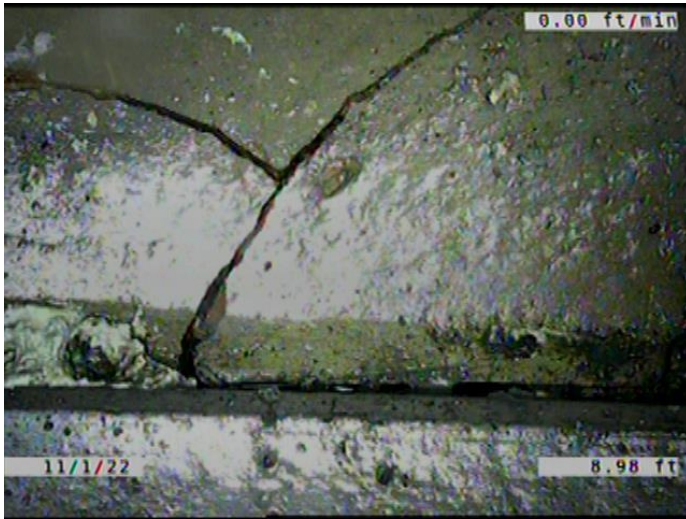
Code: **B**
 Description: **Broken**

Distance (ft): **9.0**
 Structural Grade: **4**
 O&M Grade: **0**
 Clock Start/From: **9**
 Clock To: **1**
 1st Value:
 2nd Value:
 Value Percent:
 Continuous Index:
 Within 8" of Joint: **YES**
 Remarks:

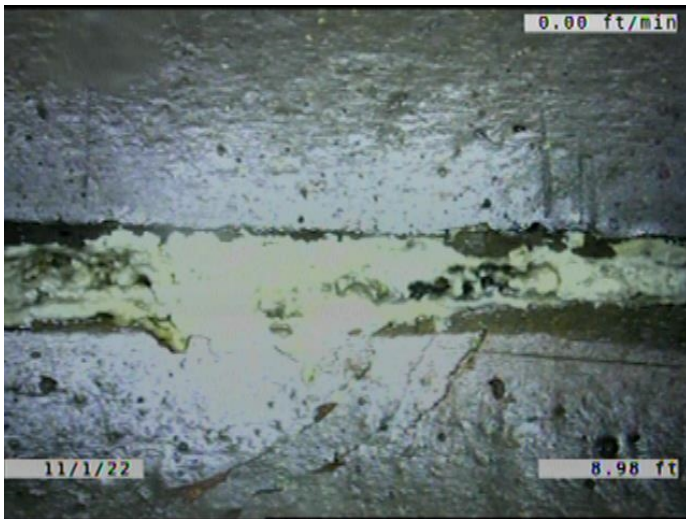
Code: **DAE**
 Description: **Deposits Attached Encrustation**

Distance (ft): **9.0**
 Structural Grade: **0**
 O&M Grade: **2**
 Clock Start/From: **12**
 Clock To: **2**
 1st Value:
 2nd Value:
 Value Percent: **5.000**
 Continuous Index:
 Within 8" of Joint: **YES**
 Remarks:

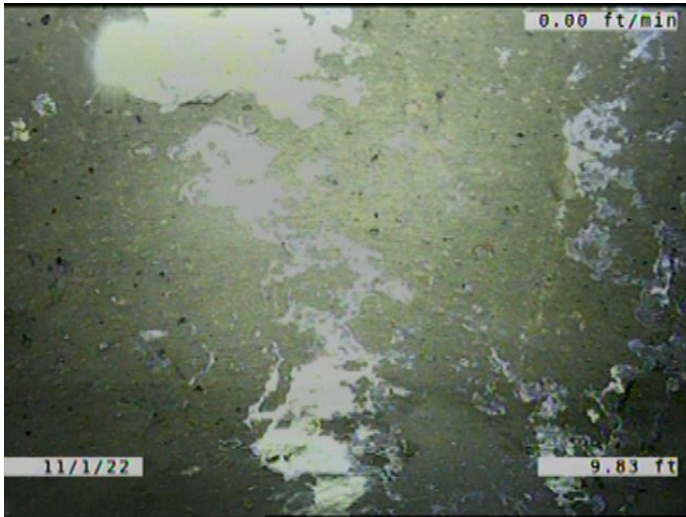
Code: **DAGS**
 Description: **Deposits Attached Grease**

Distance (ft): **9.8**
 Structural Grade: **0**
 O&M Grade: **2**
 Clock Start/From: **10**
 Clock To: **2**
 1st Value:
 2nd Value:
 Value Percent: **5.000**
 Continuous Index:
 Within 8" of Joint: **YES**
 Remarks:

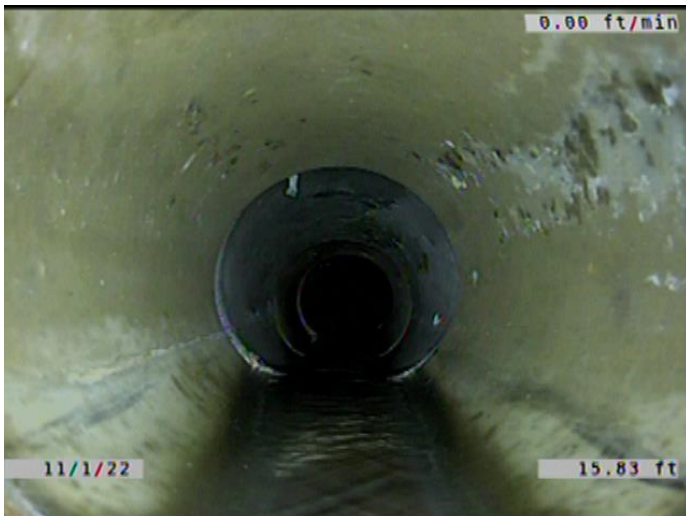
Code: **MWLS**
 Description: **Miscellaneous Water Level Sag**

Distance (ft): **15.8**
 Structural Grade: **2**
 O&M Grade: **0**
 Clock Start/From:
 Clock To:
 1st Value:
 2nd Value:
 Value Percent: **10.000**
 Continuous Index: **F02**
 Within 8" of Joint: **NO**
 Remarks:

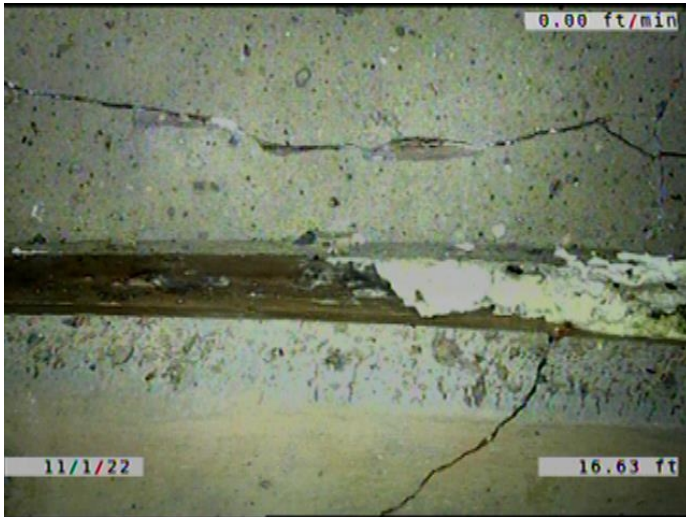
Code: **FM**
Description: **Fracture Multiple**

Distance (ft): **16.6**
Structural Grade: **4**
O&M Grade: **0**
Clock Start/From: **9**
Clock To: **1**
1st Value:
2nd Value:
Value Percent:
Continuous Index:
Within 8" of Joint: **YES**
Remarks:

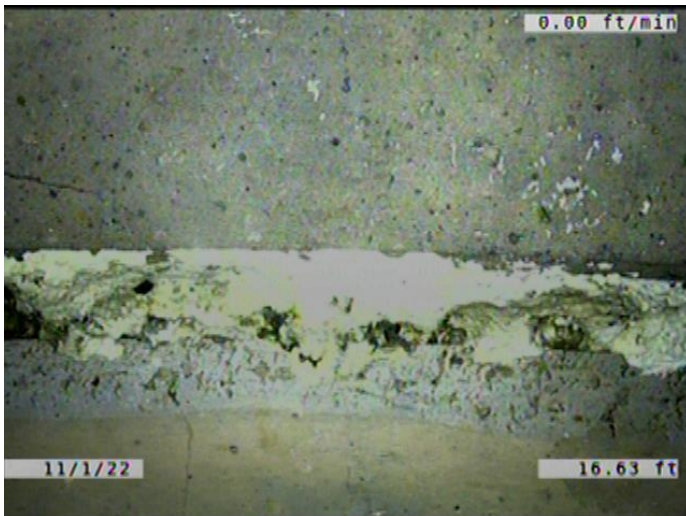
Code: **DAE**
Description: **Deposits Attached Encrustation**

Distance (ft): **16.6**
Structural Grade: **0**
O&M Grade: **2**
Clock Start/From: **11**
Clock To: **2**
1st Value:
2nd Value:
Value Percent: **5.000**
Continuous Index:
Within 8" of Joint: **YES**
Remarks:

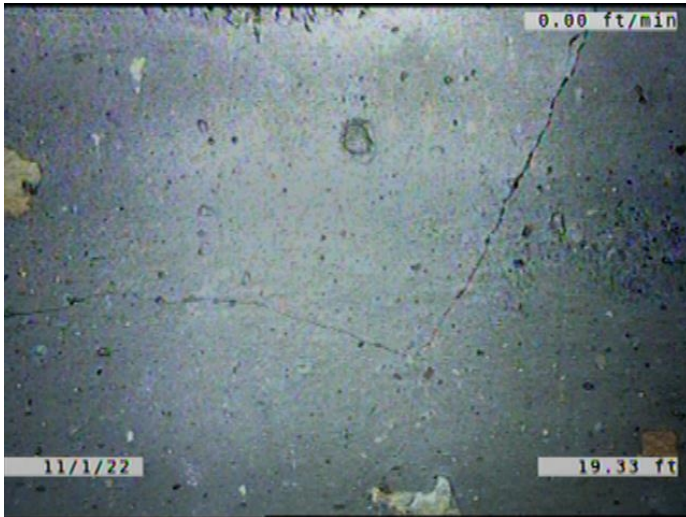
Code: **CM**
Description: **Crack Multiple**

Distance (ft): **19.3**
Structural Grade: **3**
O&M Grade: **0**
Clock Start/From: **9**
Clock To: **1**
1st Value:
2nd Value:
Value Percent:
Continuous Index:
Within 8" of Joint: **YES**
Remarks:

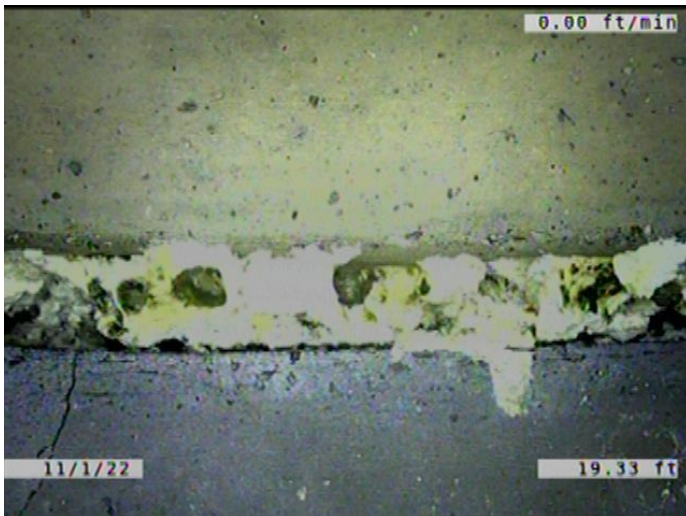
Code: **DAE**
Description: **Deposits Attached Encrustation**

Distance (ft): **19.3**
Structural Grade: **0**
O&M Grade: **2**
Clock Start/From: **9**
Clock To: **3**
1st Value:
2nd Value:
Value Percent: **5.000**
Continuous Index: **S03**
Within 8" of Joint: **YES**
Remarks:

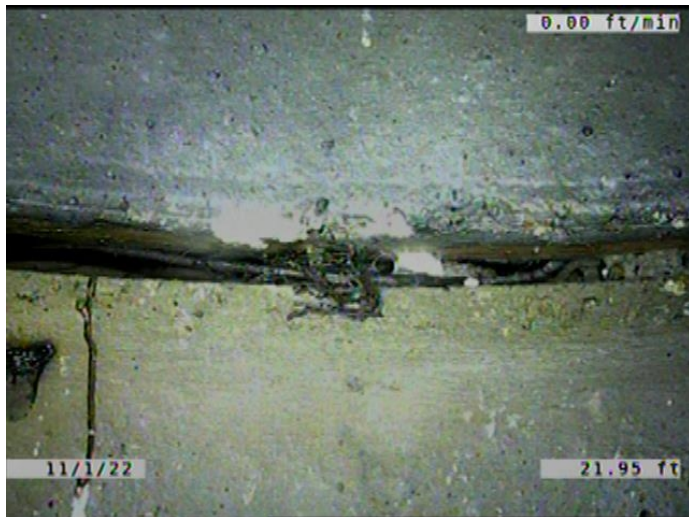
Code: **RFJ**
 Description: **Roots Fine Joint**

Distance (ft): **21.9**
 Structural Grade: **0**
 O&M Grade: **1**
 Clock Start/From: **9**
 Clock To: **11**
 1st Value:
 2nd Value:
 Value Percent:
 Continuous Index:
 Within 8" of Joint: **YES**
 Remarks:

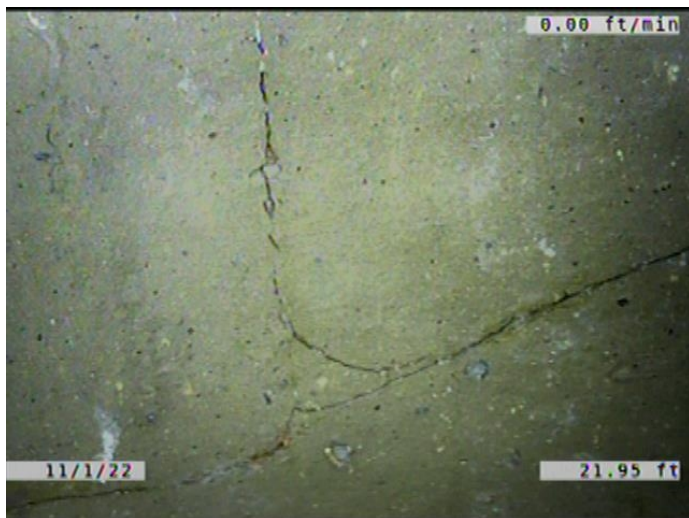
Code: **FM**
 Description: **Fracture Multiple**

Distance (ft): **21.9**
 Structural Grade: **4**
 O&M Grade: **0**
 Clock Start/From: **8**
 Clock To: **12**
 1st Value:
 2nd Value:
 Value Percent:
 Continuous Index:
 Within 8" of Joint: **YES**
 Remarks:

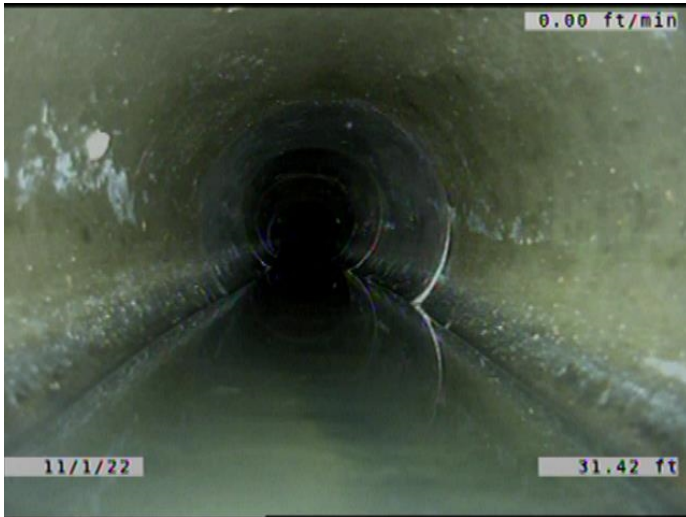
Code: **MWLS**
Description: **Miscellaneous Water Level Sag**

Distance (ft): **31.4**
Structural Grade: **2**
O&M Grade: **0**
Clock Start/From:
Clock To:
1st Value:
2nd Value:
Value Percent: **10.000**
Continuous Index:
Within 8" of Joint: **NO**
Remarks:

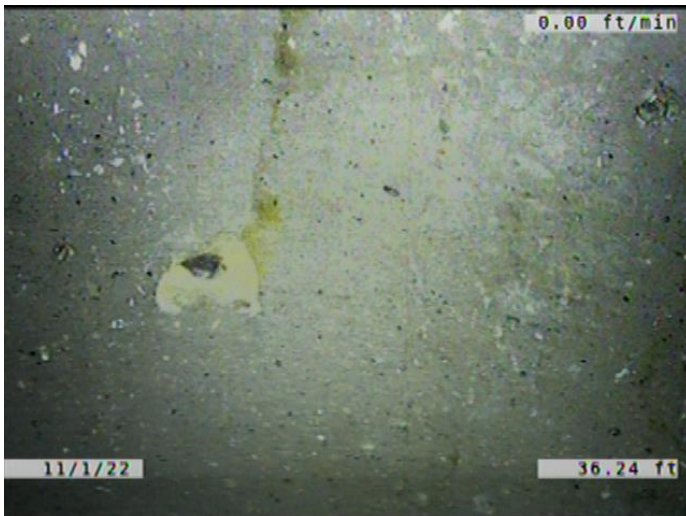
Code: **CL**
Description: **Crack Longitudinal**

Distance (ft): **36.2**
Structural Grade: **2**
O&M Grade: **0**
Clock Start/From: **2**
Clock To:
1st Value:
2nd Value:
Value Percent:
Continuous Index:
Within 8" of Joint: **YES**
Remarks:

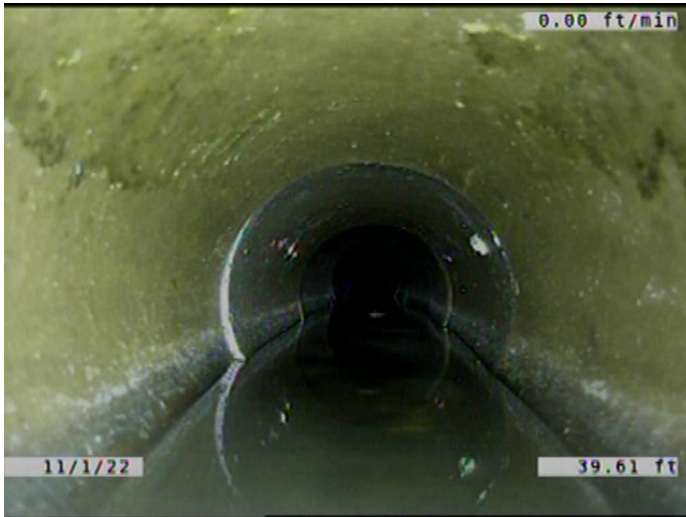
Code: **MWLS**
 Description: **Miscellaneous Water Level Sag**

Distance (ft): **39.6**
 Structural Grade: **2**
 O&M Grade: **0**
 Clock Start/From:
 Clock To:
 1st Value:
 2nd Value:
 Value Percent: **15.000**
 Continuous Index: **S04**
 Within 8" of Joint: **NO**
 Remarks:

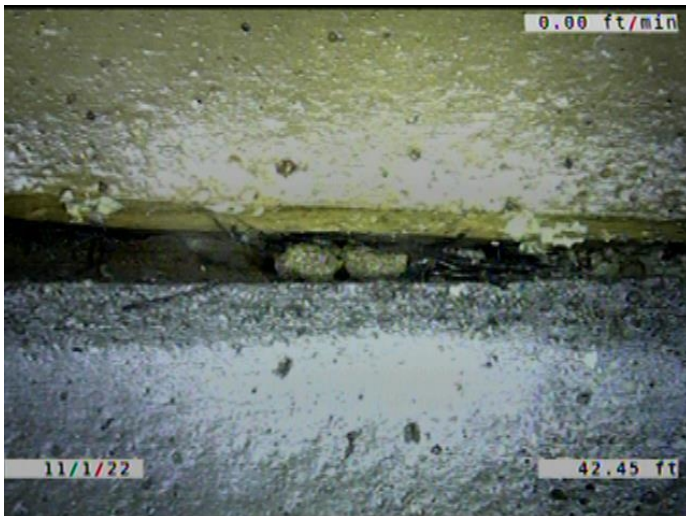
Code: **RFJ**
 Description: **Roots Fine Joint**

Distance (ft): **42.4**
 Structural Grade: **0**
 O&M Grade: **1**
 Clock Start/From: **11**
 Clock To: **2**
 1st Value:
 2nd Value:
 Value Percent:
 Continuous Index:
 Within 8" of Joint: **YES**
 Remarks:

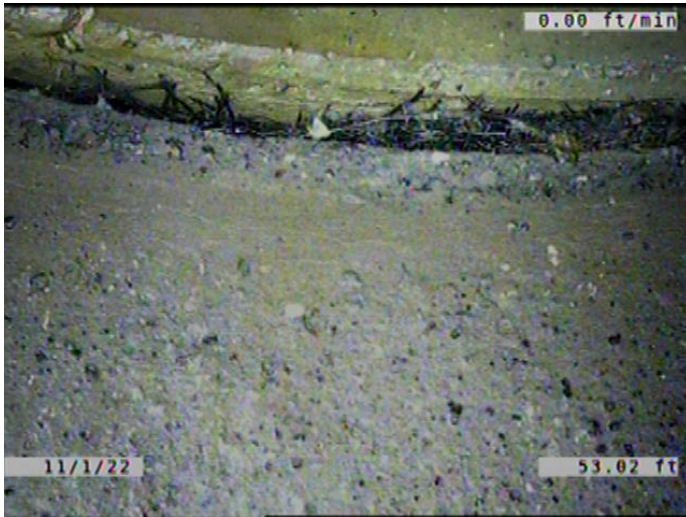
Code: **RFJ**
Description: **Roots Fine Joint**

Distance (ft): **53.0**
Structural Grade: **0**
O&M Grade: **1**
Clock Start/From: **9**
Clock To: **1**
1st Value:
2nd Value:
Value Percent:
Continuous Index:
Within 8" of Joint: **YES**
Remarks:

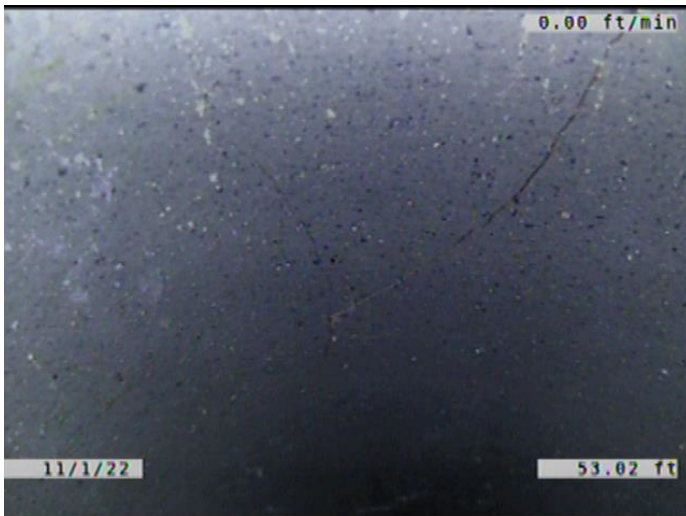
53.0	CM	Crack Multiple	800	S 3
55.3	SSS(S12)	Surface Damage Surface Spalling	891	S 2
55.3	B(S05)	Broken	909	S 4
57.0	MWLS(F04)	Miscellaneous Water Level Sag	950	S 2

Code: **CM**
Description: **Crack Multiple**

Distance (ft): **53.0**
Structural Grade: **3**
O&M Grade: **0**
Clock Start/From: **9**
Clock To: **12**
1st Value:
2nd Value:
Value Percent:
Continuous Index:
Within 8" of Joint: **YES**
Remarks:

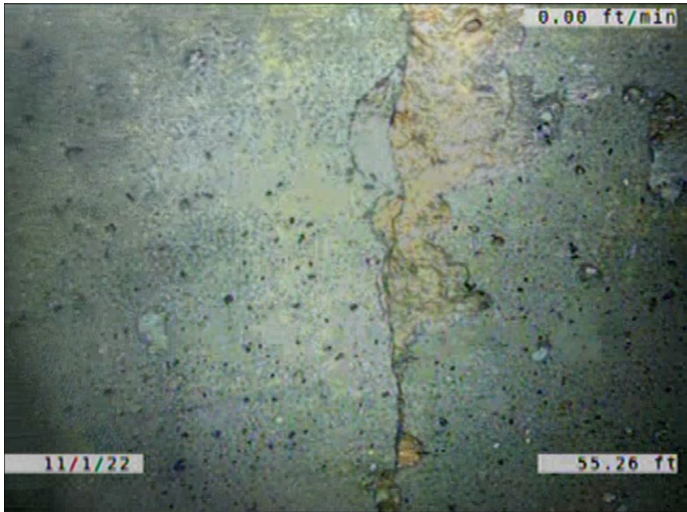
Code: **SSS**
Description: **Surface Damage Surface Spalling**

Distance (ft): **55.3**
Structural Grade: **2**
O&M Grade: **0**
Clock Start/From: **8**
Clock To: **4**
1st Value:
2nd Value:
Value Percent:
Continuous Index: **S12**
Within 8" of Joint: **YES**
Remarks:

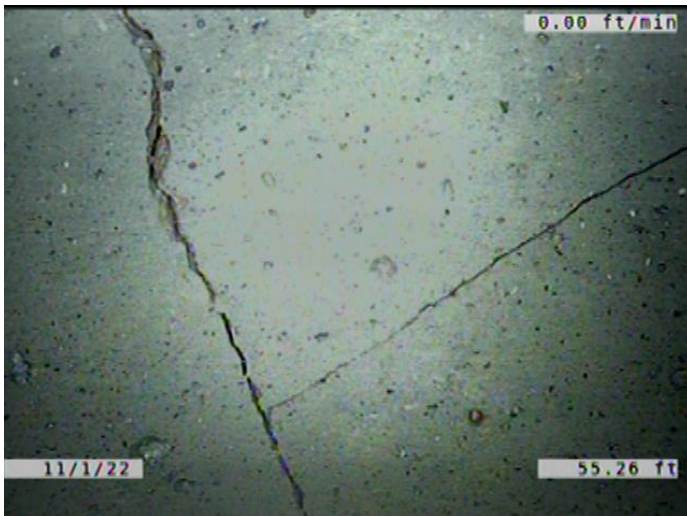
Code: **B**
Description: **Broken**

Distance (ft): **55.3**
Structural Grade: **4**
O&M Grade: **0**
Clock Start/From: **12**
Clock To: **12**
1st Value:
2nd Value:
Value Percent:
Continuous Index: **S05**
Within 8" of Joint: **YES**
Remarks:

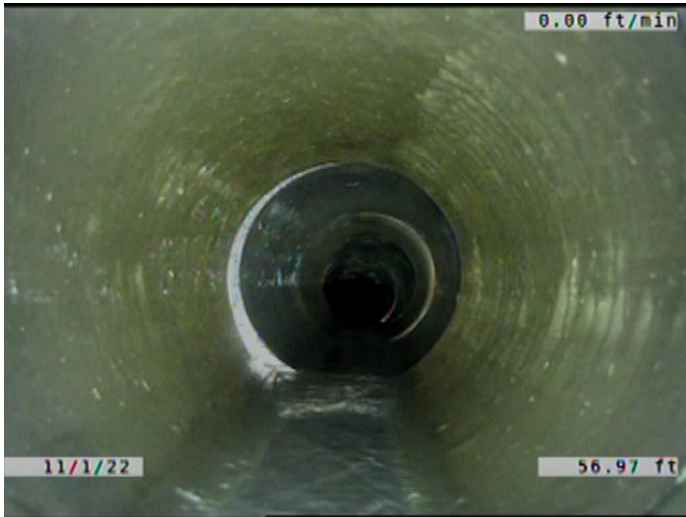
Code: **MWLS**
Description: **Miscellaneous Water Level Sag**

Distance (ft): **57.0**
Structural Grade: **2**
O&M Grade: **0**
Clock Start/From:
Clock To:
1st Value:
2nd Value:
Value Percent: **15.000**
Continuous Index: **F04**
Within 8" of Joint: **NO**
Remarks:

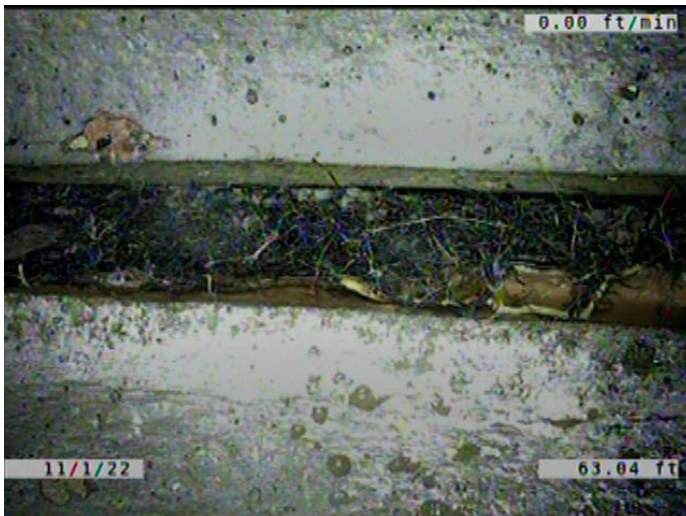
Code: **RFJ**
Description: **Roots Fine Joint**

Distance (ft): **63.0**
Structural Grade: **0**
O&M Grade: **1**
Clock Start/From: **8**
Clock To: **2**
1st Value:
2nd Value:
Value Percent:
Continuous Index:
Within 8" of Joint: **YES**
Remarks:

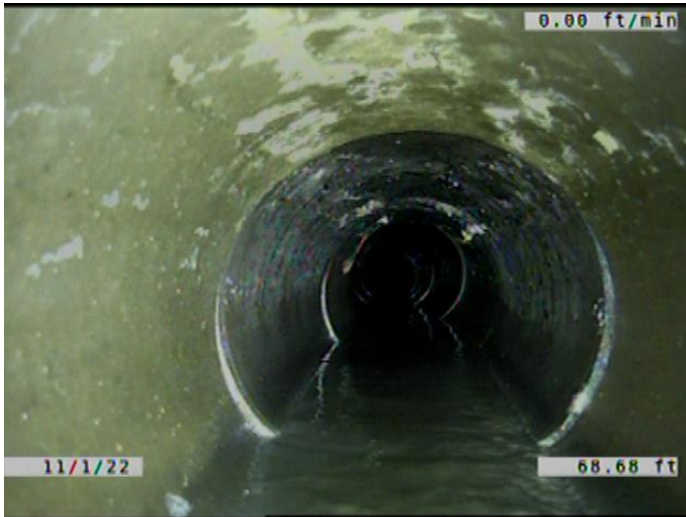
Code: **MWLS**
Description: **Miscellaneous Water Level Sag**

Distance (ft): **68.7**
Structural Grade: **2**
O&M Grade: **0**
Clock Start/From:
Clock To:
1st Value:
2nd Value:
Value Percent: **15.000**
Continuous Index: **S06**
Within 8" of Joint: **NO**
Remarks:

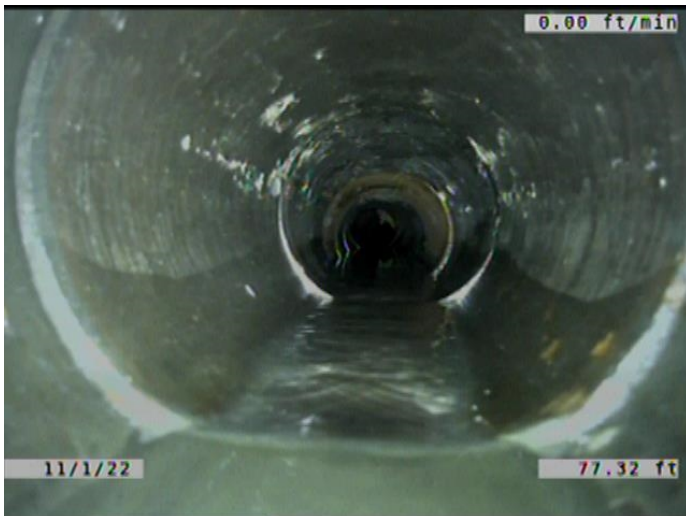
Code: **MWLS**
Description: **Miscellaneous Water Level Sag**

Distance (ft): **77.3**
Structural Grade: **2**
O&M Grade: **0**
Clock Start/From:
Clock To:
1st Value:
2nd Value:
Value Percent: **15.000**
Continuous Index: **F06**
Within 8" of Joint: **NO**
Remarks:

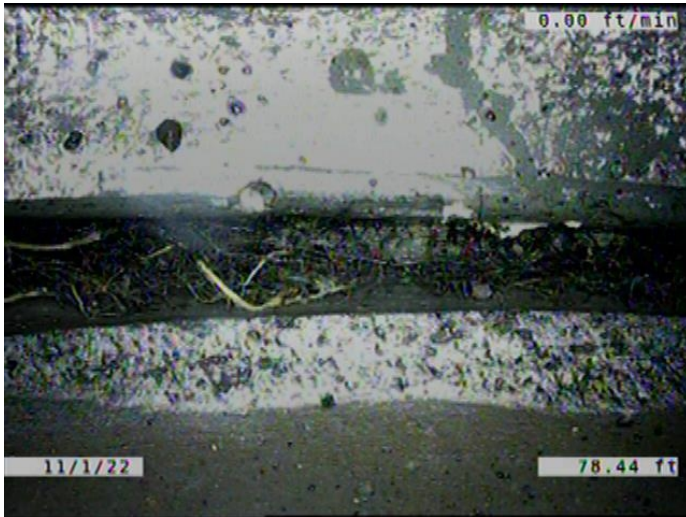
Code: **RFJ**
Description: **Roots Fine Joint**

Distance (ft): **78.4**
Structural Grade: **0**
O&M Grade: **1**
Clock Start/From: **8**
Clock To: **3**
1st Value:
2nd Value:
Value Percent:
Continuous Index: **S07**
Within 8" of Joint: **YES**
Remarks:

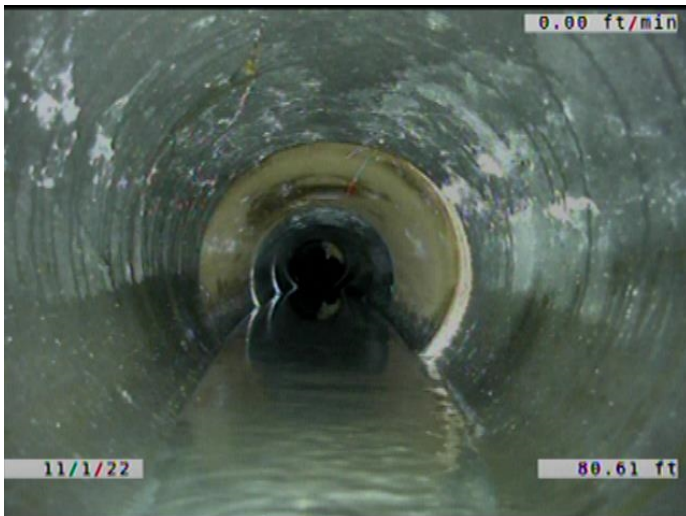
Code: **MWLS**
Description: **Miscellaneous Water Level Sag**

Distance (ft): **80.6**
Structural Grade: **2**
O&M Grade: **0**
Clock Start/From:
Clock To:
1st Value:
2nd Value:
Value Percent: **10.000**
Continuous Index: **S08**
Within 8" of Joint: **NO**
Remarks:

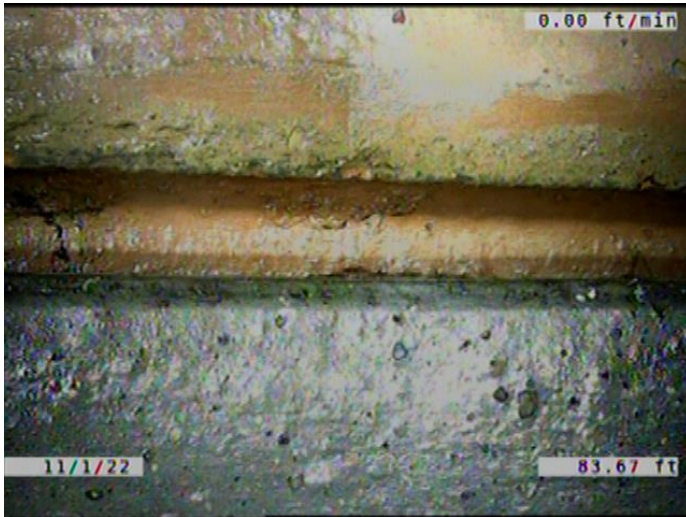
Code: **JAM**
 Description: **Joint Angular Medium**

Distance (ft): **83.7**
 Structural Grade: **3**
 O&M Grade: **0**
 Clock Start/From:
 Clock To:
 1st Value:
 2nd Value:
 Value Percent:
 Continuous Index:
 Within 8" of Joint: **NO**
 Remarks:

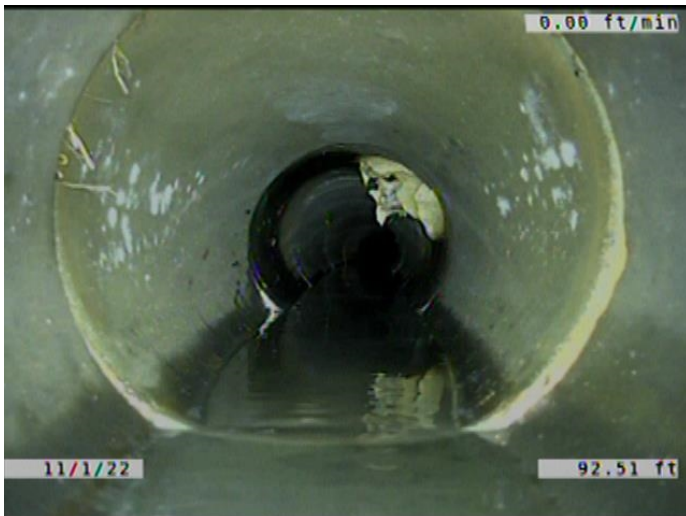
Code: **MWLS**
 Description: **Miscellaneous Water Level Sag**

Distance (ft): **92.5**
 Structural Grade: **2**
 O&M Grade: **0**
 Clock Start/From:
 Clock To:
 1st Value:
 2nd Value:
 Value Percent: **10.000**
 Continuous Index: **F08**
 Within 8" of Joint: **NO**
 Remarks:

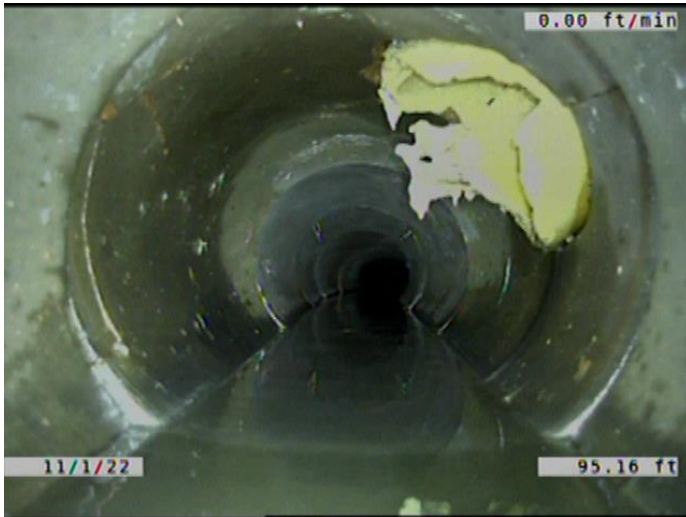
Code: **MWLS**
 Description: **Miscellaneous Water Level Sag**

Distance (ft): **95.2**
 Structural Grade: **2**
 O&M Grade: **0**
 Clock Start/From:
 Clock To:
 1st Value:
 2nd Value:
 Value Percent: **25.000**
 Continuous Index: **S09**
 Within 8" of Joint: **NO**
 Remarks:

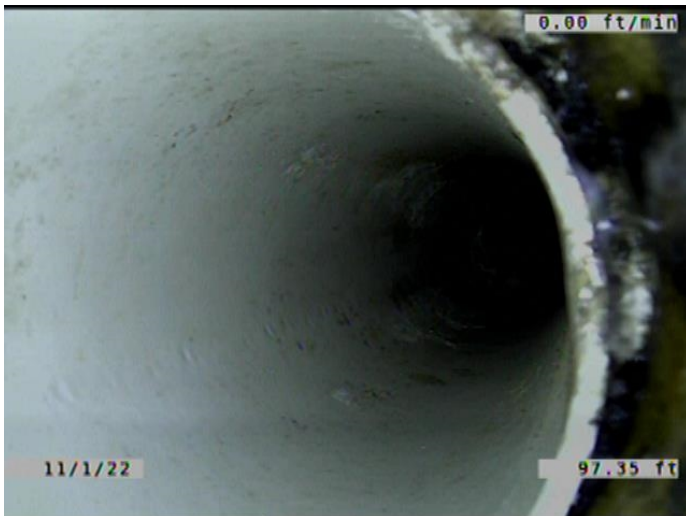
Code: **TBI**
 Description: **Tap Break-in Intruding**

Distance (ft): **97.3**
 Structural Grade: **0**
 O&M Grade: **2**
 Clock Start/From: **2**
 Clock To:
 1st Value: **4.000**
 2nd Value: **3.000**
 Value Percent:
 Continuous Index:
 Within 8" of Joint: **YES**
 Remarks:

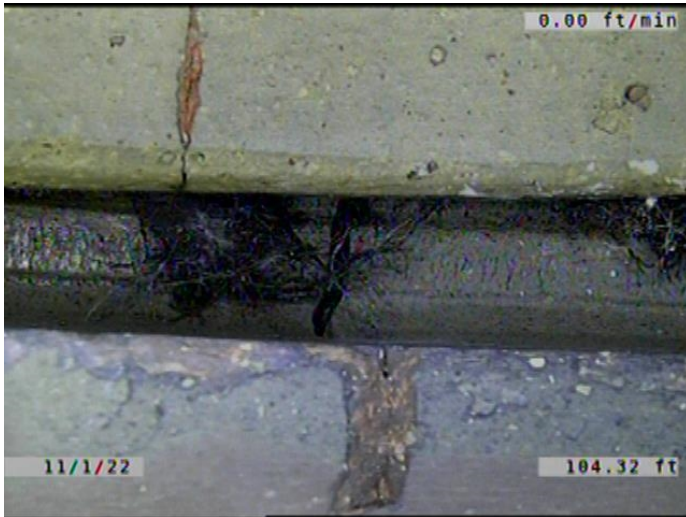
Code: **JAM**
 Description: **Joint Angular Medium**

Distance (ft): **104.3**
 Structural Grade: **3**
 O&M Grade: **0**
 Clock Start/From:
 Clock To:
 1st Value:
 2nd Value:
 Value Percent:
 Continuous Index:
 Within 8" of Joint: **NO**
 Remarks:

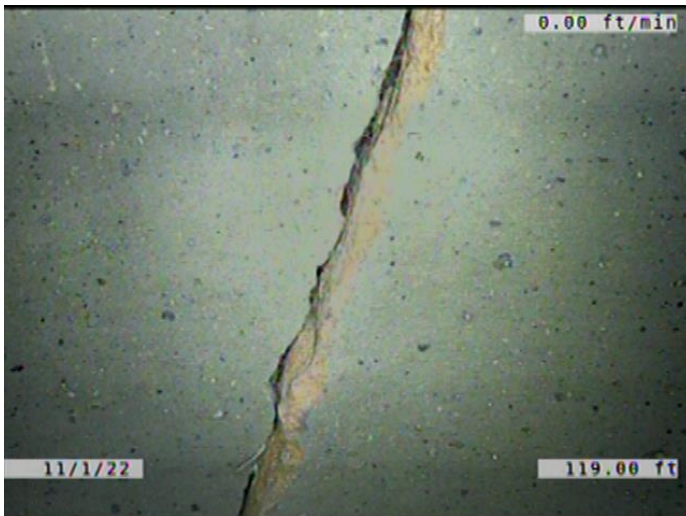
Code: **DR**
 Description: **Deformed Rigid**

Distance (ft): **119.0**
 Structural Grade: **4**
 O&M Grade: **0**
 Clock Start/From:
 Clock To:
 1st Value:
 2nd Value:
 Value Percent: **5.000**
 Continuous Index: **S10**
 Within 8" of Joint: **NO**
 Remarks:

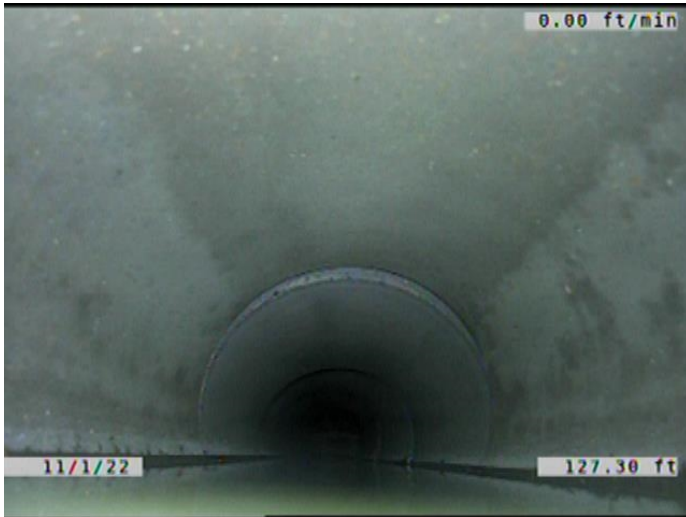
Code: **DR**
Description: **Deformed Rigid**

Distance (ft): **127.3**
Structural Grade: **4**
O&M Grade: **0**
Clock Start/From:
Clock To:
1st Value:
2nd Value:
Value Percent: **5.000**
Continuous Index: **F10**
Within 8" of Joint: **NO**
Remarks:

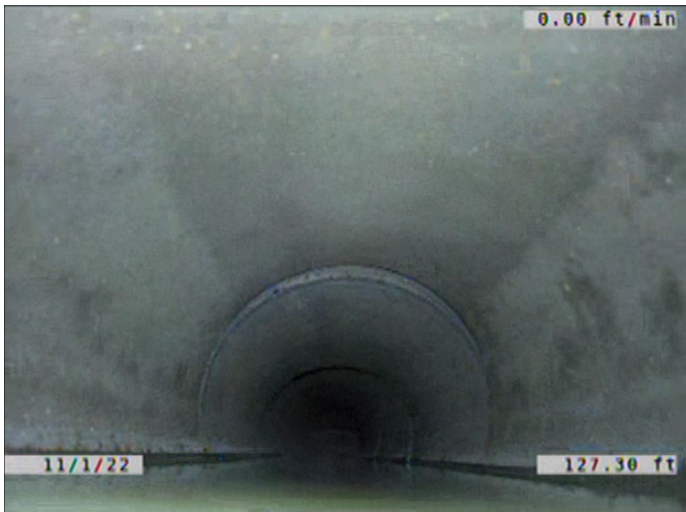
Code: **SSS**
Description: **Surface Damage Surface Spalling**

Distance (ft): **127.3**
Structural Grade: **2**
O&M Grade: **0**
Clock Start/From: **8**
Clock To: **4**
1st Value:
2nd Value:
Value Percent:
Continuous Index: **F12**
Within 8" of Joint: **YES**
Remarks:

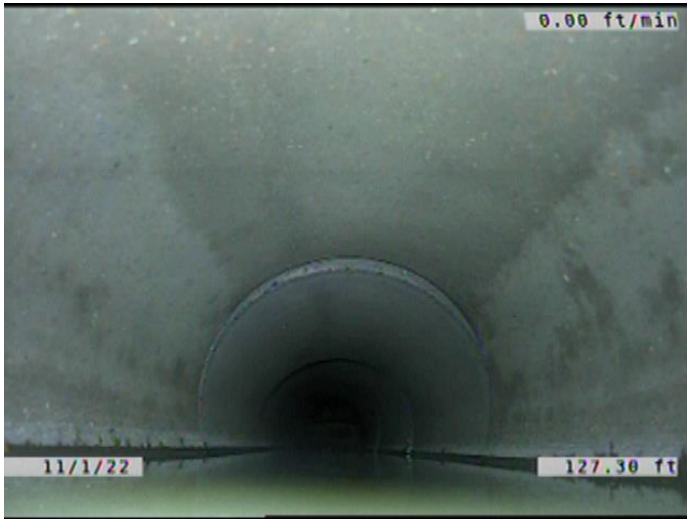
Code: **B**
Description: **Broken**

Distance (ft): **127.3**
Structural Grade: **4**
O&M Grade: **0**
Clock Start/From: **12**
Clock To: **12**
1st Value:
2nd Value:
Value Percent:
Continuous Index: **F05**
Within 8" of Joint: **YES**
Remarks:

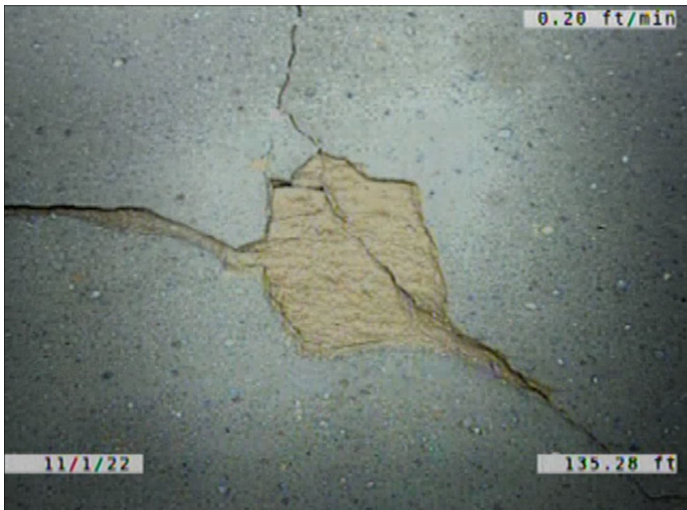
Code: **SSS**
Description: **Surface Damage Surface Spalling**

Distance (ft): **135.3**
Structural Grade: **2**
O&M Grade: **0**
Clock Start/From: **12**
Clock To:
1st Value:
2nd Value:
Value Percent:
Continuous Index:
Within 8" of Joint: **NO**
Remarks:

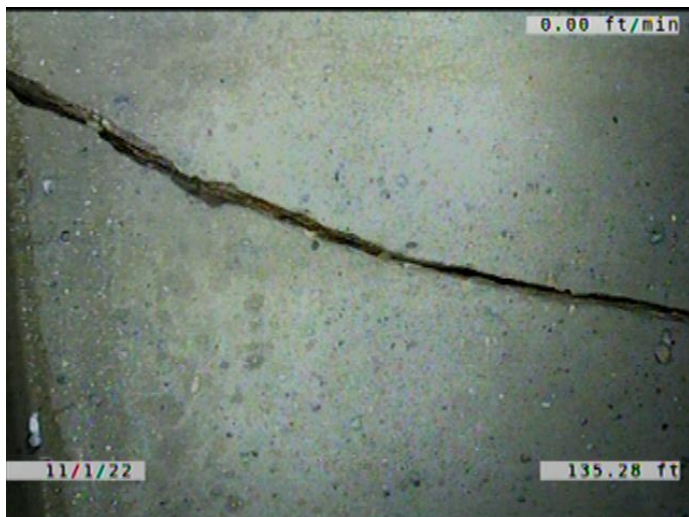
Code: **B**
Description: **Broken**

Distance (ft): **135.3**
Structural Grade: **4**
O&M Grade: **0**
Clock Start/From: **12**
Clock To: **12**
1st Value:
2nd Value:
Value Percent:
Continuous Index: **S11**
Within 8" of Joint: **YES**
Remarks:

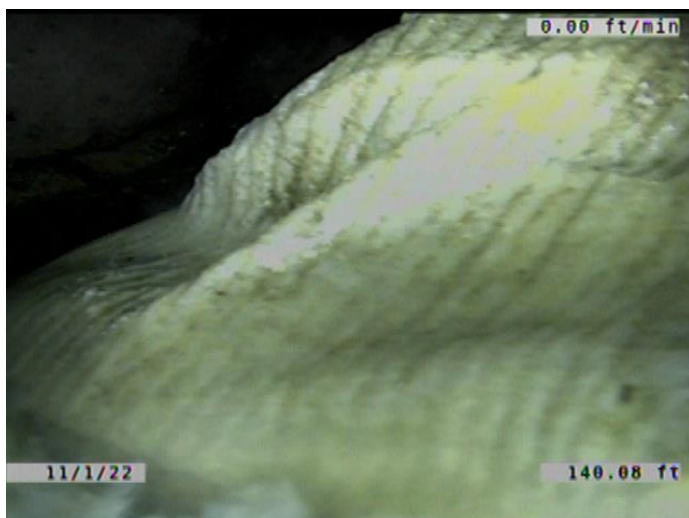
Code: **DAR**
Description: **Deposits Attached Ragging**

Distance (ft): **140.1**
Structural Grade: **0**
O&M Grade: **2**
Clock Start/From: **5**
Clock To: **7**
1st Value:
2nd Value:
Value Percent: **10.000**
Continuous Index:
Within 8" of Joint: **YES**
Remarks:

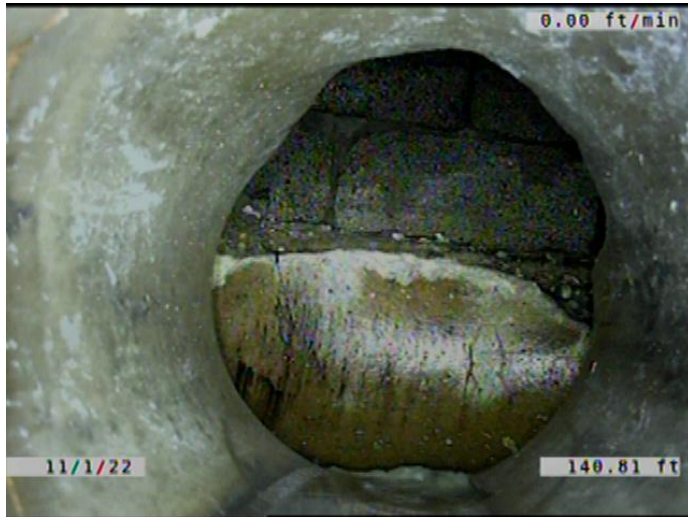
Code: **MWLS**
 Description: **Miscellaneous Water Level Sag**

Distance (ft): **140.8**
 Structural Grade: **2**
 O&M Grade: **0**
 Clock Start/From:
 Clock To:
 1st Value:
 2nd Value:
 Value Percent: **25.000**
 Continuous Index: **F09**
 Within 8" of Joint: **NO**
 Remarks:

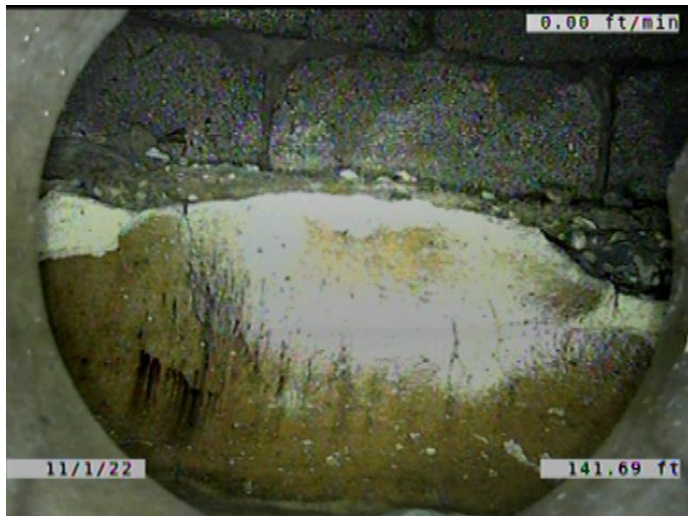
Code: **RFJ**
 Description: **Roots Fine Joint**

Distance (ft): **141.7**
 Structural Grade: **0**
 O&M Grade: **1**
 Clock Start/From: **8**
 Clock To: **3**
 1st Value:
 2nd Value:
 Value Percent:
 Continuous Index: **F07**
 Within 8" of Joint: **YES**
 Remarks:

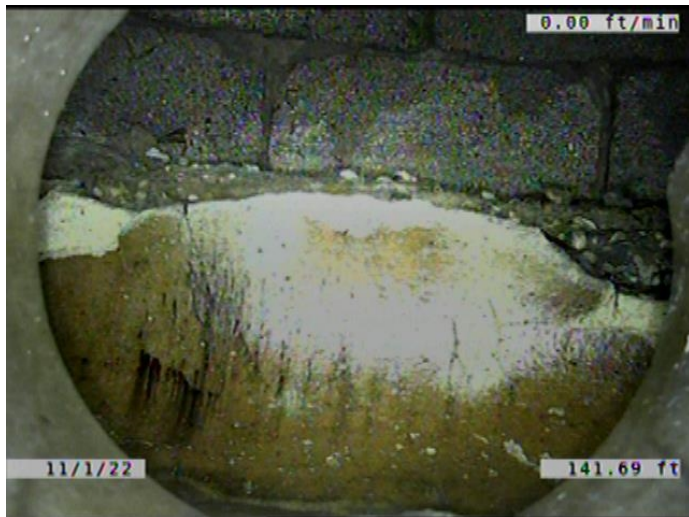
Code: **DSF**
Description: **Deposits Settled Fine**

Distance (ft): **141.7**
Structural Grade: **0**
O&M Grade: **2**
Clock Start/From: **5**
Clock To: **7**
1st Value:
2nd Value:
Value Percent: **5.000**
Continuous Index: **F01**
Within 8" of Joint: **YES**
Remarks:

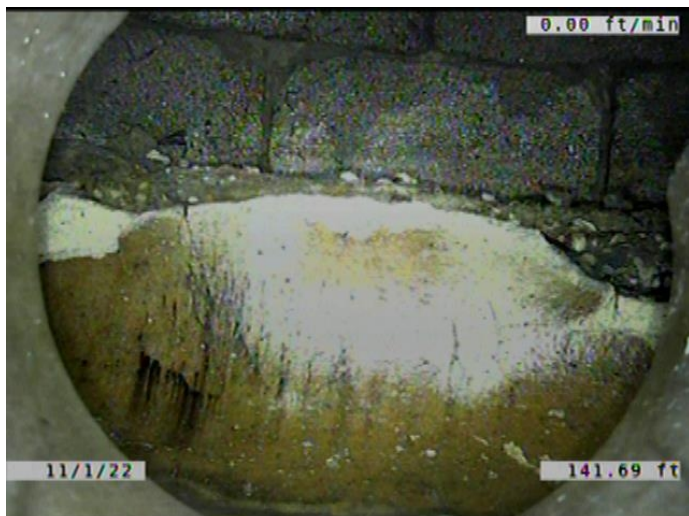
Code: **DAE**
Description: **Deposits Attached Encrustation**

Distance (ft): **141.7**
Structural Grade: **0**
O&M Grade: **2**
Clock Start/From: **9**
Clock To: **3**
1st Value:
2nd Value:
Value Percent: **5.000**
Continuous Index: **F03**
Within 8" of Joint: **YES**
Remarks:

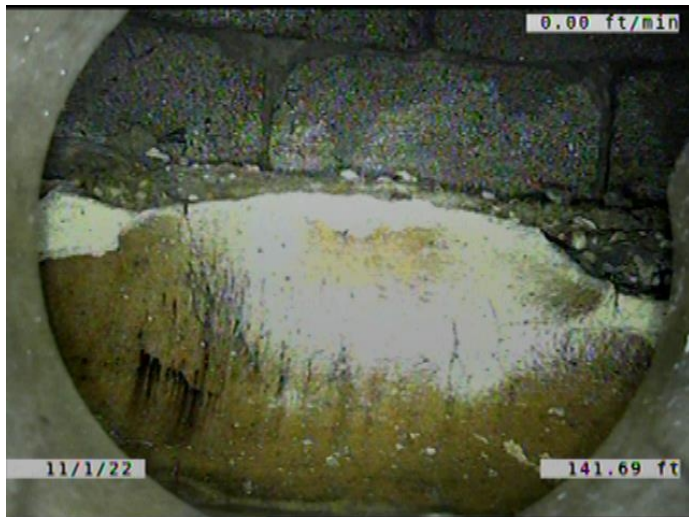
Code: **B**
 Description: **Broken**

Distance (ft): **141.7**
 Structural Grade: **4**
 O&M Grade: **0**
 Clock Start/From: **12**
 Clock To: **12**
 1st Value:
 2nd Value:
 Value Percent:
 Continuous Index: **F11**
 Within 8" of Joint: **YES**
 Remarks:
