Profile/Photo Observation Report

Street:	W HOME AVE	Flow Control:	Not Controlled
City:	Hobart, IN	Year Renewed:	
Location:	Light Highway	Tape/Media #:	
Purpose:	Not Known	Dia/Height:	12"
Use:	Sanitary	Material:	VCP
Drain Area:	NA	Lining:	
Category:	NA		
Comment:

Location Details:		Direction of Survey:	Downstream
US MH:	M-504-012	DS MH:	M-504-013
		Total Length Surveyed (ft):	75.4

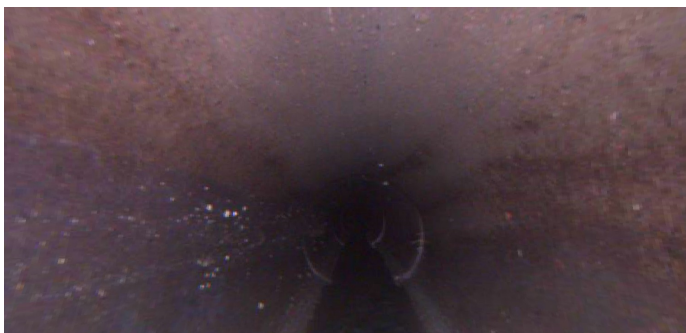
Code: **AMH**
Description: **Manhole**

Distance (ft): **.0**
Structural Grade: **0**
O&M Grade: **0**
Clock Start/From:
Clock To:
1st Value:
2nd Value:
Value Percent:
Continuous Index:
Within 8" of Joint: **NO**
Remarks: **M-504-012**

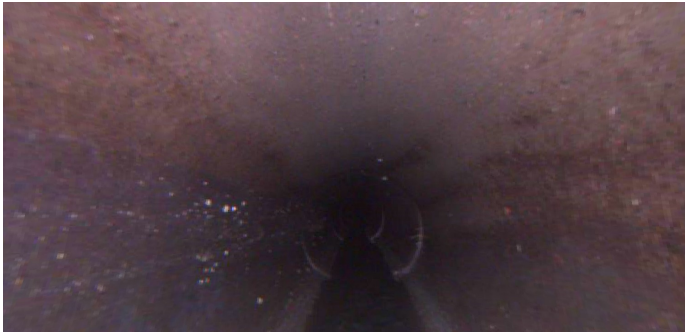
Code:	MWL
Description:	Water Level

Distance (ft):	.0
Structural Grade:	0
O&M Grade:	0
Clock Start/From:	
Clock To:	
1st Value:	
2nd Value:	
Value Percent:	5.000
Continuous Index:	
Within 8" of Joint:	NO
Remarks:

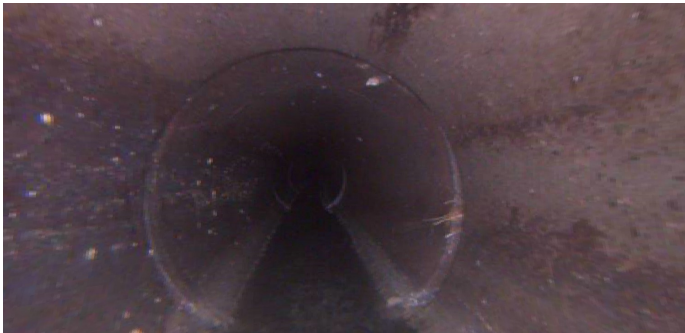
Code:	RFJ
Description:	Roots Fine Joint

Distance (ft):	2.5
Structural Grade:	0
O&M Grade:	1
Clock Start/From:	3
Clock To:	
1st Value:	
2nd Value:	
Value Percent:	
Continuous Index:	S01
Within 8" of Joint:	YES
Remarks:	wandering

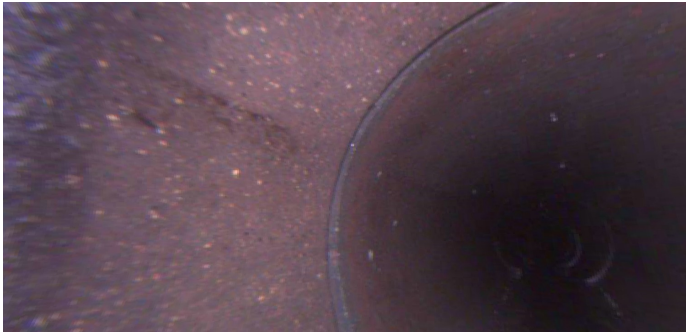
Code: **CL**
Description: **Crack Longitudinal**

Distance (ft): **15.3**
Structural Grade: **2**
O&M Grade: **0**
Clock Start/From: **10**
Clock To:
1st Value:
2nd Value:
Value Percent:
Continuous Index: **S02**
Within 8" of Joint: **YES**
Remarks:

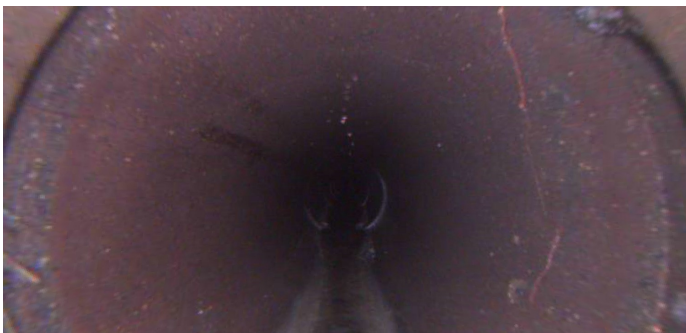
Code: **FS**
Description: **Fracture Spiral**

Distance (ft): **17.9**
Structural Grade: **3**
O&M Grade: **0**
Clock Start/From: **1**
Clock To: **4**
1st Value:
2nd Value:
Value Percent:
Continuous Index:
Within 8" of Joint: **YES**
Remarks:

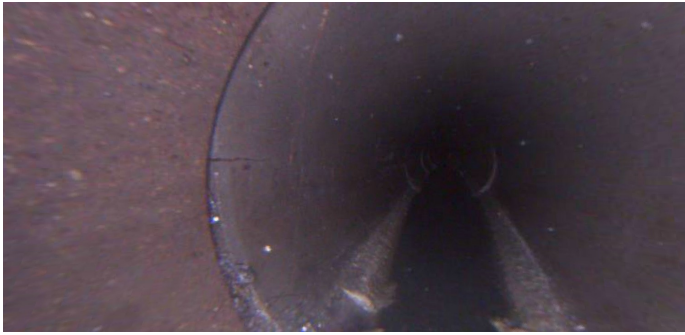
Code: **FM**
Description: **Fracture Multiple**

Distance (ft): **20.3**
Structural Grade: **4**
O&M Grade: **0**
Clock Start/From: **7**
Clock To: **11**
1st Value:
2nd Value:
Value Percent:
Continuous Index:
Within 8" of Joint: **YES**
Remarks:

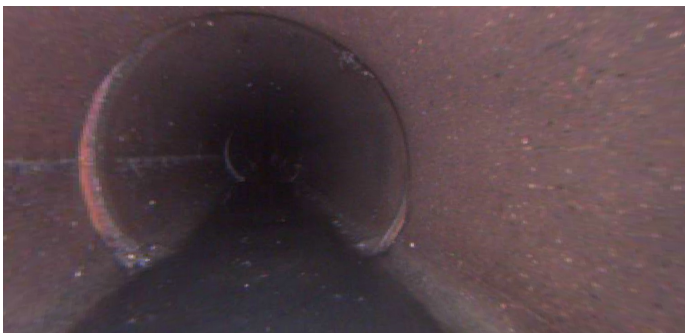
Code: **CL**
Description: **Crack Longitudinal**

Distance (ft): **25.2**
Structural Grade: **2**
O&M Grade: **0**
Clock Start/From: **10**
Clock To:
1st Value:
2nd Value:
Value Percent:
Continuous Index: **F02**
Within 8" of Joint: **YES**
Remarks:

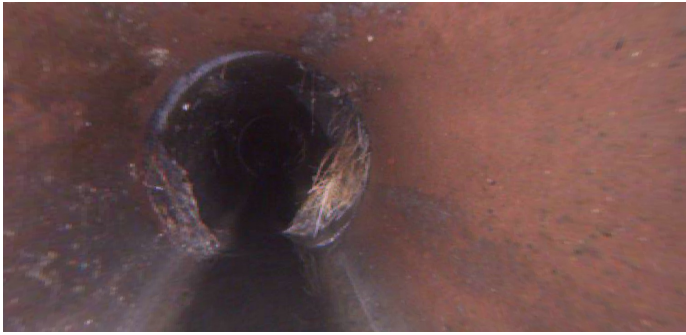
Code: **RMJ**
Description: **Roots Medium Joint**

Distance (ft): **35.0**
Structural Grade: **0**
O&M Grade: **3**
Clock Start/From: **7**
Clock To: **5**
1st Value:
2nd Value:
Value Percent: **5.000**
Continuous Index: **S03**
Within 8" of Joint: **YES**
Remarks: **wandering**

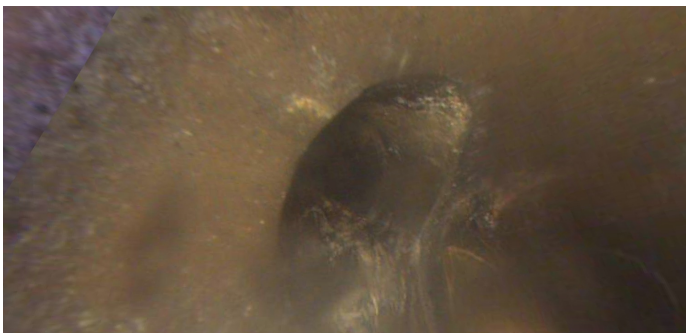
Code: **RFL**
Description: **Roots Fine Lateral**

Distance (ft): **37.4**
Structural Grade: **0**
O&M Grade: **1**
Clock Start/From: **9**
Clock To:
1st Value:
2nd Value:
Value Percent:
Continuous Index:
Within 8" of Joint: **NO**
Remarks:

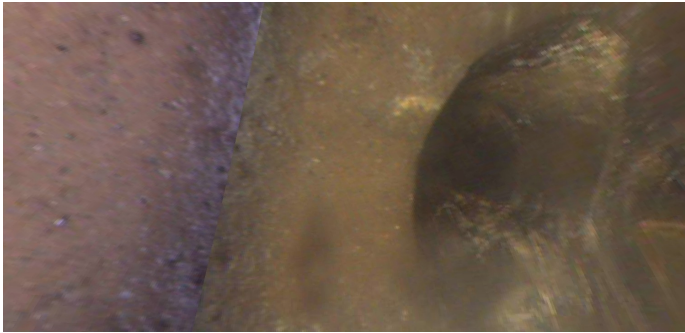
Code: **TFD**
Description: **Tap Factory Defective**

Distance (ft): **37.4**
Structural Grade: **0**
O&M Grade: **2**
Clock Start/From: **2**
Clock To:
1st Value: **4.000**
2nd Value:
Value Percent:
Continuous Index:
Within 8" of Joint: **YES**
Remarks: **partially blocked**

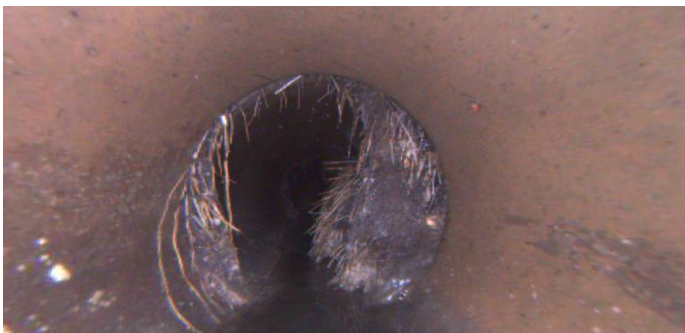
Code: **RMJ**
Description: **Roots Medium Joint**

Distance (ft): **73.7**
Structural Grade: **0**
O&M Grade: **3**
Clock Start/From: **8**
Clock To: **4**
1st Value:
2nd Value:
Value Percent: **30.000**
Continuous Index:
Within 8" of Joint: **YES**
Remarks:

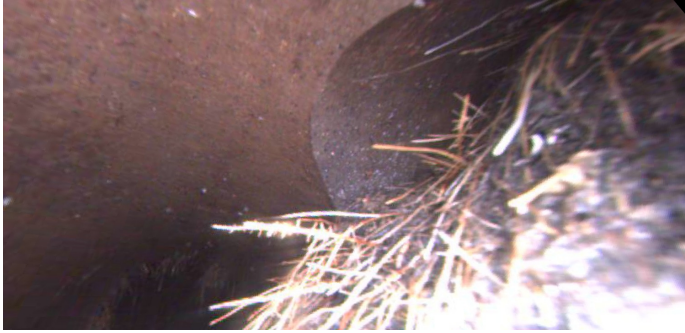
Code: **TFD**
Description: **Tap Factory Defective**

Distance (ft): **75.1**
Structural Grade: **0**
O&M Grade: **2**
Clock Start/From: **2**
Clock To:
1st Value: **4.000**
2nd Value:
Value Percent:
Continuous Index:
Within 8" of Joint:
Remarks: **roots**

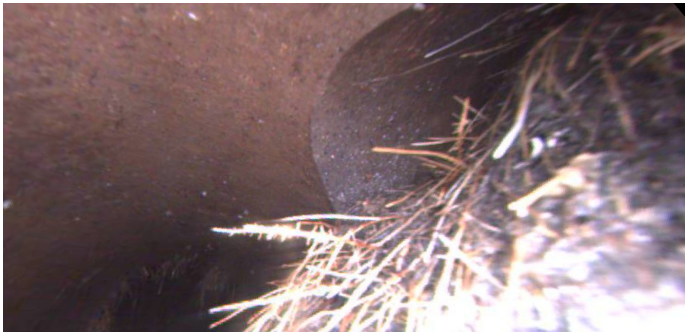
Code: **RML**
Description: **Roots Medium Lateral**

Distance (ft): **75.1**
Structural Grade: **0**
O&M Grade: **3**
Clock Start/From: **1**
Clock To: **4**
1st Value:
2nd Value:
Value Percent: **30.000**
Continuous Index:
Within 8" of Joint: **NO**
Remarks:

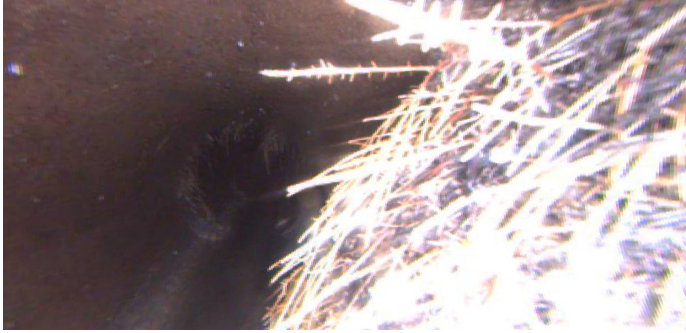
Code: **MSA**
Description: **Abandoned Survey**

Distance (ft): **75.4**
Structural Grade: **0**
O&M Grade: **0**
Clock Start/From:
Clock To:
1st Value:
2nd Value:
Value Percent:
Continuous Index:
Within 8" of Joint: **NO**
Remarks: **rbj**

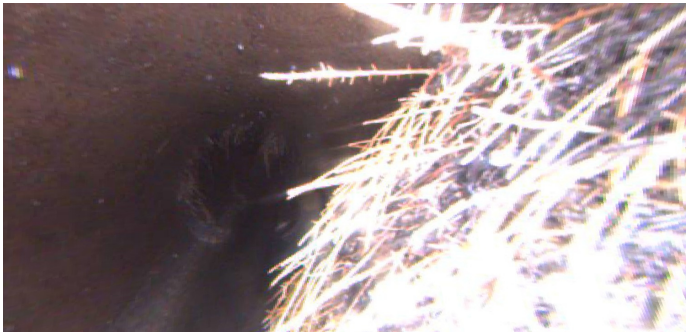
Code: **RFJ**
Description: **Roots Fine Joint**

Distance (ft): **75.4**
Structural Grade: **0**
O&M Grade: **1**
Clock Start/From: **3**
Clock To:
1st Value:
2nd Value:
Value Percent:
Continuous Index: **F01**
Within 8" of Joint: **YES**
Remarks: **wandering**

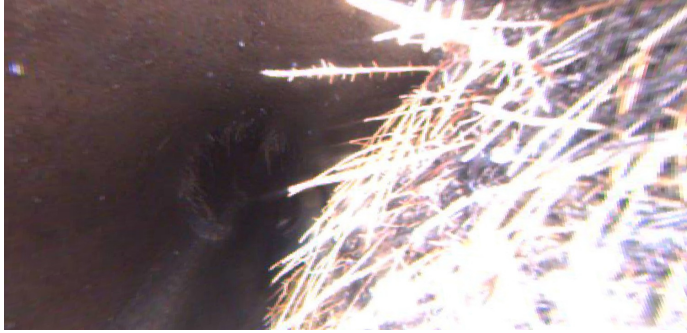
Code: **RMJ**
Description: **Roots Medium Joint**

Distance (ft): **75.4**
Structural Grade: **0**
O&M Grade: **3**
Clock Start/From: **7**
Clock To: **5**
1st Value:
2nd Value:
Value Percent: **5.000**
Continuous Index: **F03**
Within 8" of Joint: **YES**
Remarks: **wandering**
