Profile/Photo Observation Report

| Street: | Summerlin | Flow Control: | Not Controlled |
| City: | Hobart, IN | Year Renewed: | |

| US MH: | M-504-012 | DS MH: | M-504-013 |

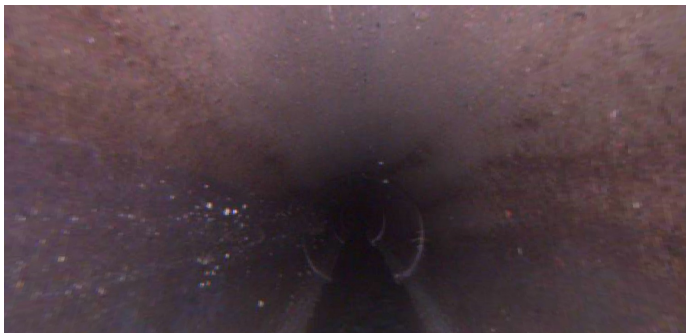
Code: **AMH**
Description: **Manhole**

Distance (ft): **.0**
Structural Grade: **0**
O&M Grade: **0**
Clock Start/From:
Clock To:
1st Value:
2nd Value:
Value Percent:
Continuous Index:
Within 8" of Joint: **NO**
Remarks: **M-504-012**

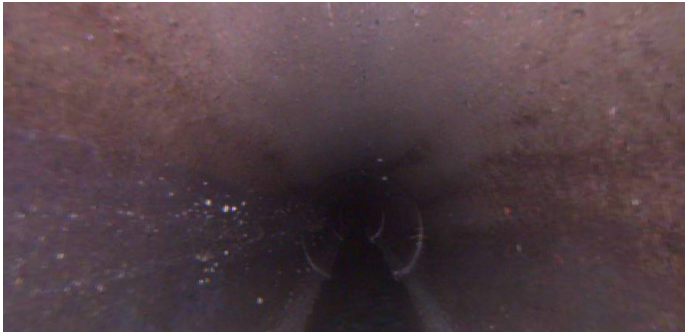
| Description: | Water Level |

| Value Percent: | 5.000 |

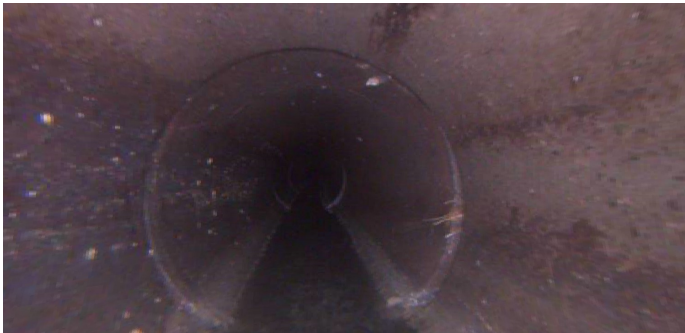
| Description: | Roots Fine Joint |

| Distance (ft): | 2.5 |
| O&M Grade: | 1 |
| Remarks: | wandering |

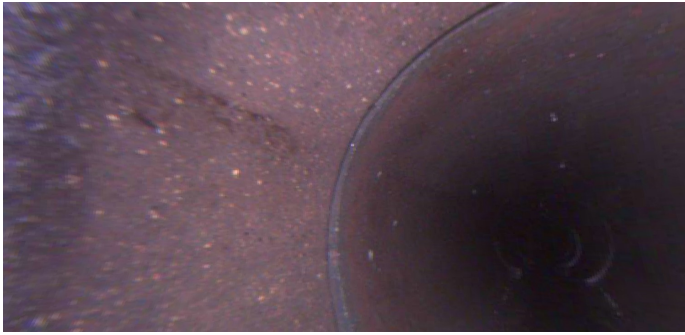
Code: **CL**
Description: **Crack Longitudinal**

Distance (ft): **15.3**
Structural Grade: **2**
O&M Grade: **0**
Clock Start/From: **10**
Clock To:
1st Value:
2nd Value:
Value Percent:
Continuous Index: **S02**
Within 8" of Joint: **YES**
Remarks:

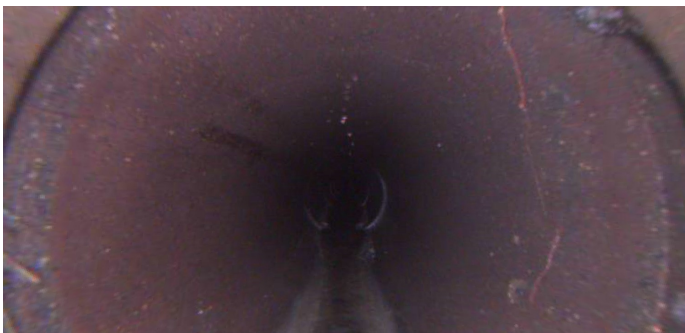
Code: **FS**
Description: **Fracture Spiral**

Distance (ft): **17.9**
Structural Grade: **3**
O&M Grade: **0**
Clock Start/From: **1**
Clock To: **4**
1st Value:
2nd Value:
Value Percent:
Continuous Index:
Within 8" of Joint: **YES**
Remarks:

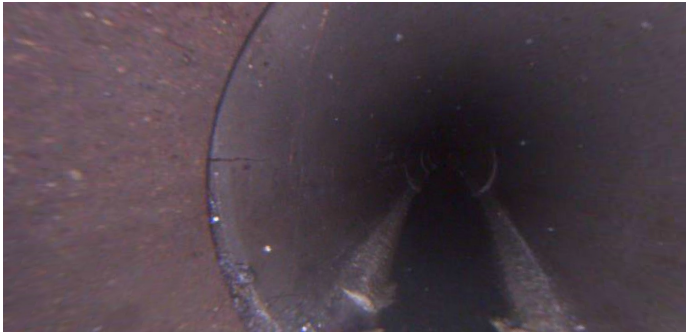
Code: **FM**
Description: **Fracture Multiple**

Distance (ft): **20.3**
Structural Grade: **4**
O&M Grade: **0**
Clock Start/From: **7**
Clock To: **11**
1st Value:
2nd Value:
Value Percent:
Continuous Index:
Within 8" of Joint: **YES**
Remarks:

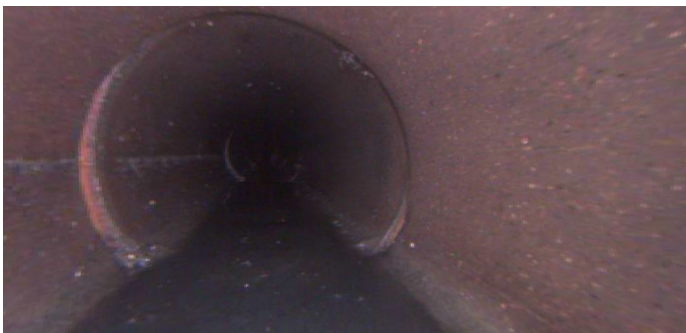
Code: **CL**
Description: **Crack Longitudinal**

Distance (ft): **25.2**
Structural Grade: **2**
O&M Grade: **0**
Clock Start/From: **10**
Clock To:
1st Value:
2nd Value:
Value Percent:
Continuous Index: **F02**
Within 8" of Joint: **YES**
Remarks:

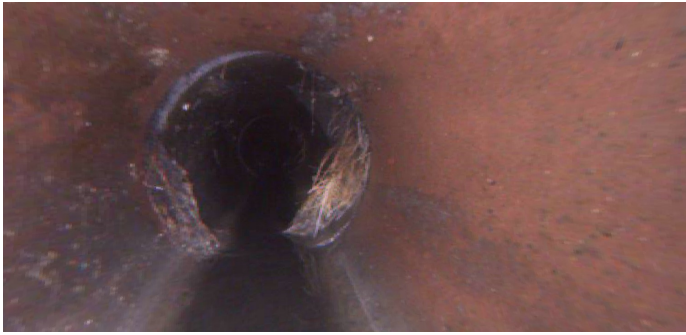
Code: **RMJ**
Description: **Roots Medium Joint**

Distance (ft): **35.0**
Structural Grade: **0**
O&M Grade: **3**
Clock Start/From: **7**
Clock To: **5**
1st Value:
2nd Value:
Value Percent: **5.000**
Continuous Index: **S03**
Within 8" of Joint: **YES**
Remarks: **wandering**

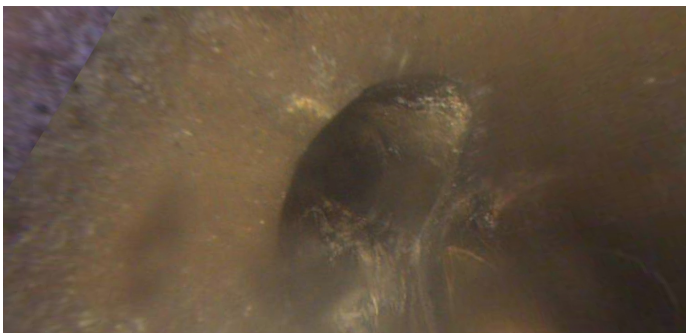
Code: **RFL**
Description: **Roots Fine Lateral**

Distance (ft): **37.4**
Structural Grade: **0**
O&M Grade: **1**
Clock Start/From: **9**
Clock To:
1st Value:
2nd Value:
Value Percent:
Continuous Index:
Within 8" of Joint: **NO**
Remarks:

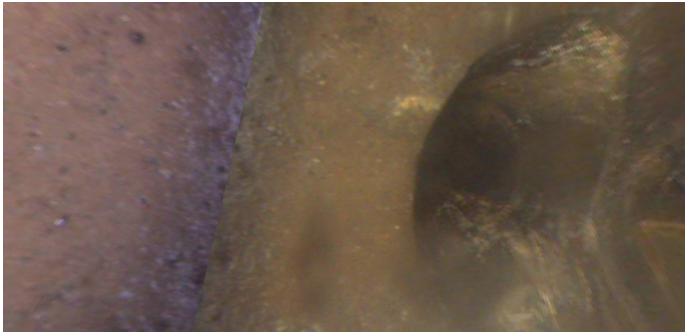
Code: **TFD**
Description: **Tap Factory Defective**

Distance (ft): **37.4**
Structural Grade: **0**
O&M Grade: **2**
Clock Start/From: **2**
Clock To:
1st Value: **4.000**
2nd Value:
Value Percent:
Continuous Index:
Within 8" of Joint: **YES**
Remarks: **partially blocked**

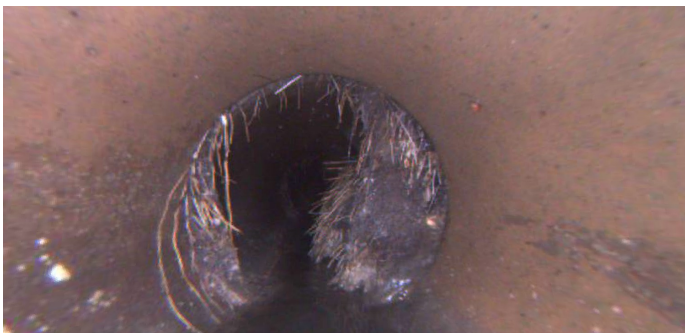
Code: **RMJ**
Description: **Roots Medium Joint**

Distance (ft): **73.7**
Structural Grade: **0**
O&M Grade: **3**
Clock Start/From: **8**
Clock To: **4**
1st Value:
2nd Value:
Value Percent: **30.000**
Continuous Index:
Within 8" of Joint: **YES**
Remarks:

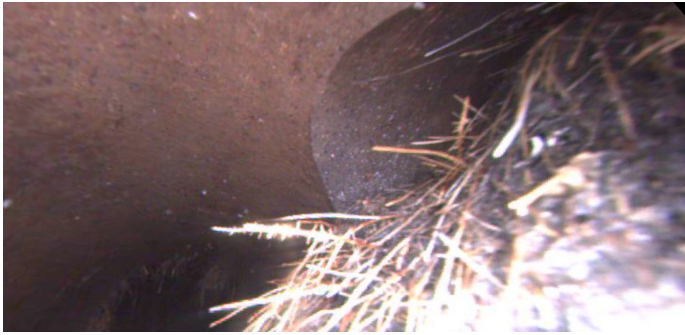
Code: **TFD**
Description: **Tap Factory Defective**

Distance (ft): **75.1**
Structural Grade: **0**
O&M Grade: **2**
Clock Start/From: **2**
Clock To:
1st Value: **4.000**
2nd Value:
Value Percent:
Continuous Index:
Within 8" of Joint:
Remarks: **roots**

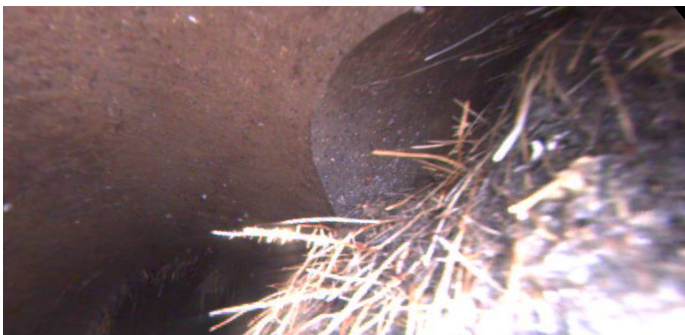
Code: **RML**
Description: **Roots Medium Lateral**

Distance (ft): **75.1**
Structural Grade: **0**
O&M Grade: **3**
Clock Start/From: **1**
Clock To: **4**
1st Value:
2nd Value:
Value Percent: **30.000**
Continuous Index:
Within 8" of Joint: **NO**
Remarks:

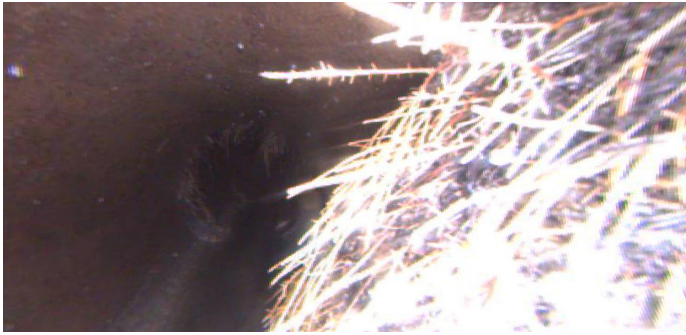
Code: **MSA**
Description: **Abandoned Survey**

Distance (ft): **75.4**
Structural Grade: **0**
O&M Grade: **0**
Clock Start/From:
Clock To:
1st Value:
2nd Value:
Value Percent:
Continuous Index:
Within 8" of Joint: **NO**
Remarks: **rbj**

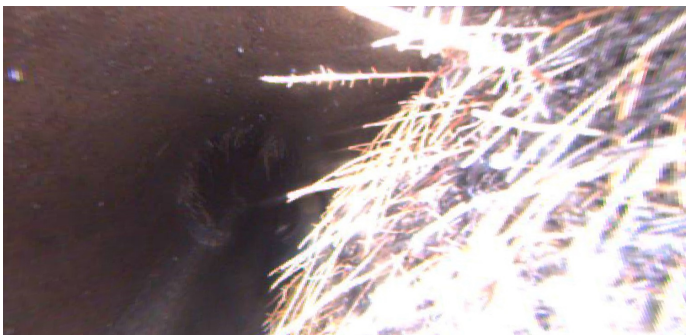
Code: **RFJ**
Description: **Roots Fine Joint**

Distance (ft): **75.4**
Structural Grade: **0**
O&M Grade: **1**
Clock Start/From: **3**
Clock To:
1st Value:
2nd Value:
Value Percent:
Continuous Index: **F01**
Within 8" of Joint: **YES**
Remarks: **wandering**

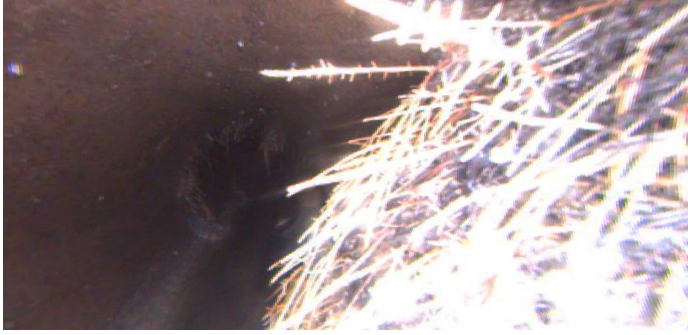
| Code: | RMJ |
| Description: | Roots Medium Joint |
| Distance (ft): | 75.4 |
| O&M Grade: | 3 |
| Value Percent: | 5.000 |
| Remarks: | wandering |
