## Profile/Photo Observation Report

Street:	<b>W HOME AVE</b>	Flow Control:	<b>Not Controlled</b>
City:	<b>Hobart, IN</b>	Year Renewed:	
Location:	<b>Light Highway</b>	Tape/Media #:	
Purpose:	<b>Not Known</b>	Dia/Height:	<b>12"</b>
Use:	<b>Sanitary</b>	Material:	<b>VCP</b>
Drain Area:	<b>NA</b>	Lining:	
Category:	<b>NA</b>		
Comment:

Location Details:		Direction of Survey:	<b>Upstream</b>
US MH:	<b>M-504-012</b>	DS MH:	<b>M-504-013</b>
		Total Length Surveyed (ft):	<b>40.9</b>

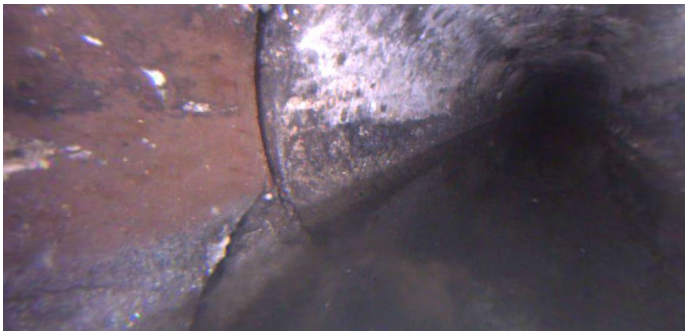
Code:	<b>FS</b>
Description:	<b>Fracture Spiral</b>

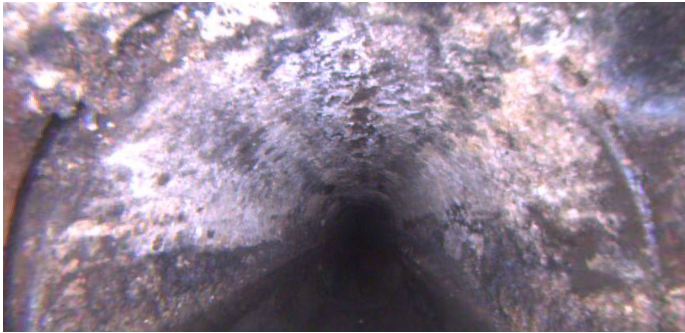
Code:	<b>DAE</b>
Description:	<b>Deposits Attached Encrustation</b>

Distance (ft):	<b>.0</b>
Structural Grade:	<b>0</b>
O&M Grade:	<b>2</b>
Clock Start/From:	<b>8</b>
Clock To:	<b>4</b>
1st Value:	
2nd Value:	
Value Percent:	<b>5.000</b>
Continuous Index:	<b>S01</b>
Within 8" of Joint:	<b>YES</b>
Remarks:

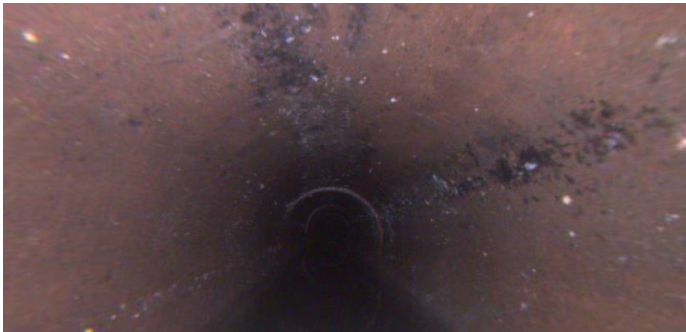
Code: **DAE**  
Description: **Deposits Attached Encrustation**

Distance (ft): **27.4**  
Structural Grade: **0**  
O&M Grade: **2**  
Clock Start/From: **8**  
Clock To: **4**  
1st Value:  
2nd Value:  
Value Percent: **5.000**  
Continuous Index: **F01**  
Within 8" of Joint: **YES**  
Remarks:

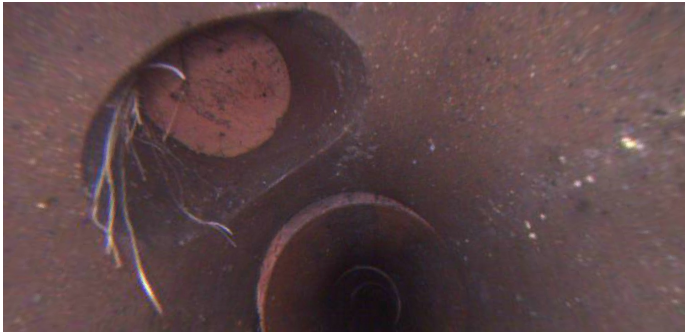
Code: **TFD**  
Description: **Tap Factory Defective**

Distance (ft): **31.2**  
Structural Grade: **0**  
O&M Grade: **2**  
Clock Start/From: **10**  
Clock To:  
1st Value: **4.000**  
2nd Value:  
Value Percent:  
Continuous Index:  
Within 8" of Joint:  
Remarks: **capped, roots**

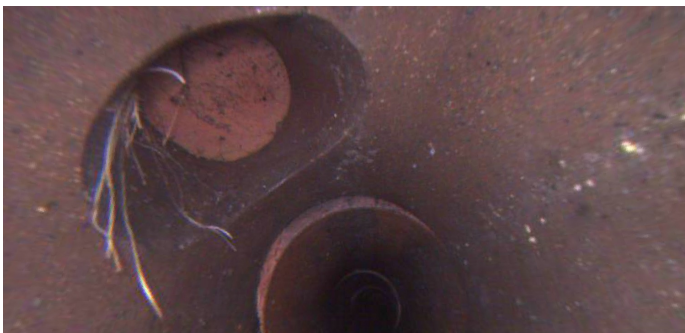
Code: **RFL**  
Description: **Roots Fine Lateral**

Distance (ft): **31.2**  
Structural Grade: **0**  
O&M Grade: **1**  
Clock Start/From: **10**  
Clock To:  
1st Value:  
2nd Value:  
Value Percent:  
Continuous Index:  
Within 8" of Joint: **NO**  
Remarks:

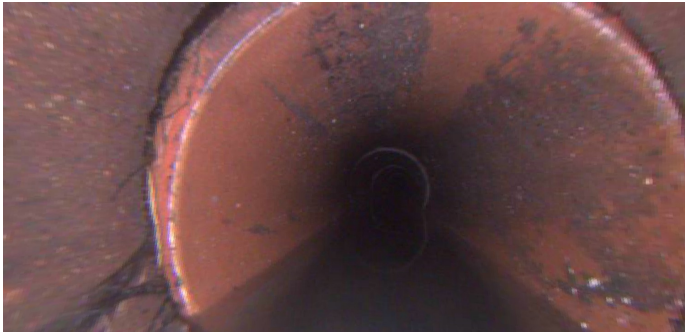
Code: **RFJ**  
Description: **Roots Fine Joint**

Distance (ft): **31.9**  
Structural Grade: **0**  
O&M Grade: **1**  
Clock Start/From: **7**  
Clock To: **10**  
1st Value:  
2nd Value:  
Value Percent:  
Continuous Index:  
Within 8" of Joint: **YES**  
Remarks:

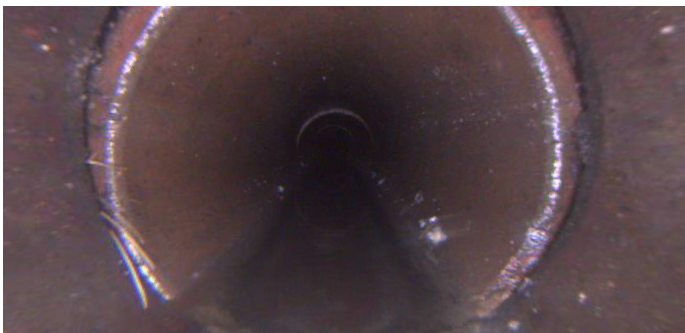
Code: **RFJ**  
Description: **Roots Fine Joint**

Distance (ft): **39.7**  
Structural Grade: **0**  
O&M Grade: **1**  
Clock Start/From: **8**  
Clock To: **4**  
1st Value:  
2nd Value:  
Value Percent:  
Continuous Index:  
Within 8" of Joint: **YES**  
Remarks:

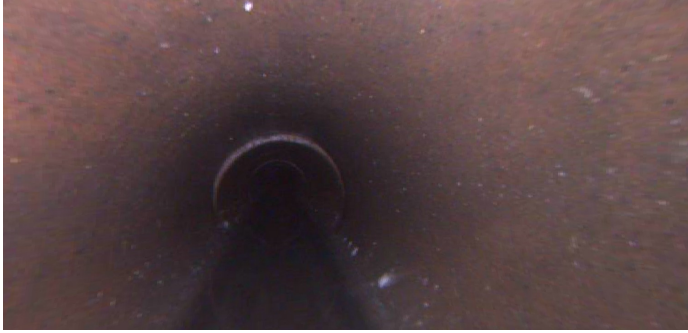
Code:	<b>MSA</b>
Description:	<b>Abandoned Survey</b>
Distance (ft):	<b>40.9</b>
Structural Grade:	<b>0</b>
O&M Grade:	<b>0</b>
Clock Start/From:	
Clock To:	
1st Value:	
2nd Value:	
Value Percent:	
Continuous Index:	
Within 8" of Joint:	<b>NO</b>
Remarks:	<b>no blockage</b>
