Profile/Photo Observation Report

Date:	04/18/2018	Weather:		Coding:	PACP 6.0
Pipe Length (ft):	150.4	Owner:	NA	Pre Clean:	Not Known
P.O.#:		Surveyor:	Byrd Fitzgerald	PSR:	P-504-013-012
Customer:		Clean Date:	01/01/1900	Shape:	C

Street:	Summerlin	Flow Control:	Not Controlled
City:	Hobart, IN	Year Renewed:	
Location:	Light Highway	Tape/Media #:	
Purpose:	Not Known	Dia/Height:	12"
Use:	Sanitary	Material:	VCP
Drain Area:	NA	Lining:	
Category:	NA		
Comment:

Location Details:		Direction of Survey:	Upstream
US MH:	M-504-012	DS MH:	M-504-013
		Total Length Surveyed (ft):	40.9

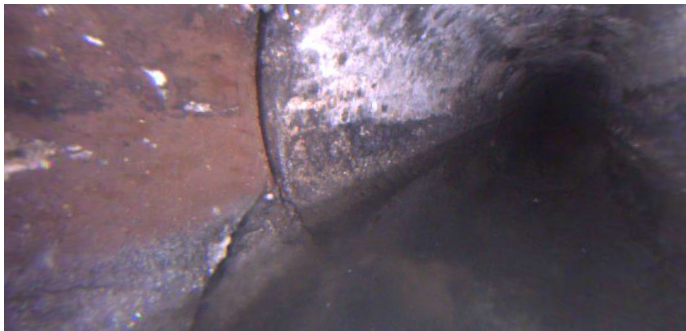
Code: **FS**
Description: **Fracture Spiral**

Distance (ft): **.0**
Structural Grade: **3**
O&M Grade: **0**
Clock Start/From: **7**
Clock To: **9**
1st Value:
2nd Value:
Value Percent:
Continuous Index:
Within 8" of Joint: **YES**
Remarks:

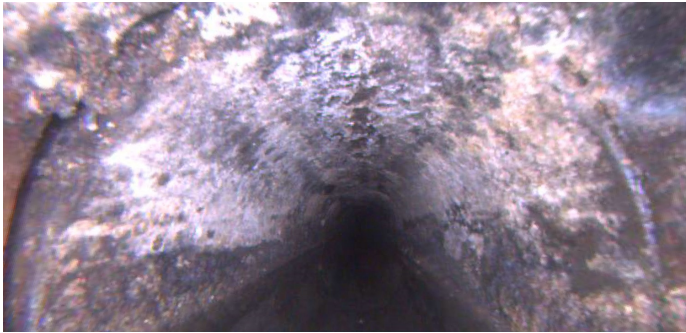
Code:	DAE
Description:	Deposits Attached Encrustation

Distance (ft):	.0
Structural Grade:	0
O&M Grade:	2
Clock Start/From:	8
Clock To:	4
1st Value:	
2nd Value:	
Value Percent:	5.000
Continuous Index:	S01
Within 8" of Joint:	YES
Remarks:

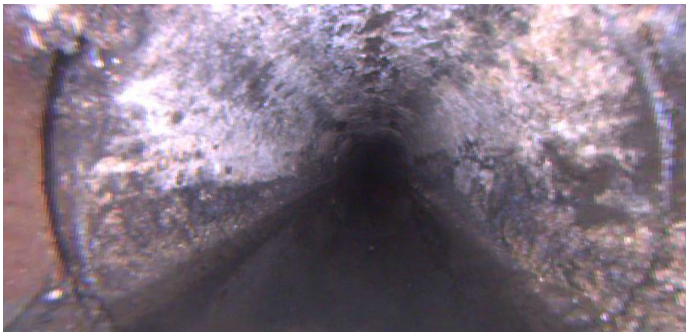
Code:	AMH
Description:	Manhole

Distance (ft):	.0
Structural Grade:	0
O&M Grade:	0
Clock Start/From:	
Clock To:	
1st Value:	
2nd Value:	
Value Percent:	
Continuous Index:	
Within 8" of Joint:	NO
Remarks:	M-504-012

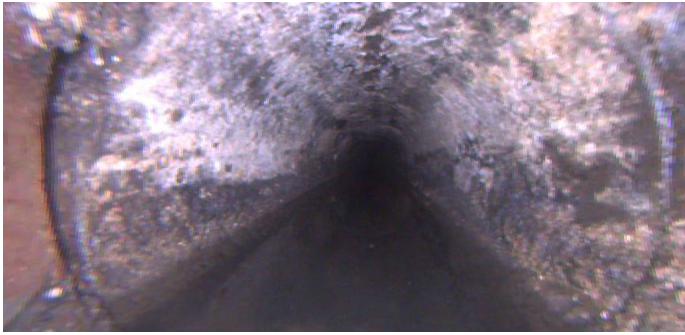
Code: **MWL**
Description: **Water Level**

Distance (ft): **.0**
Structural Grade: **0**
O&M Grade: **0**
Clock Start/From:
Clock To:
1st Value:
2nd Value:
Value Percent: **5.000**
Continuous Index:
Within 8" of Joint: **NO**
Remarks:

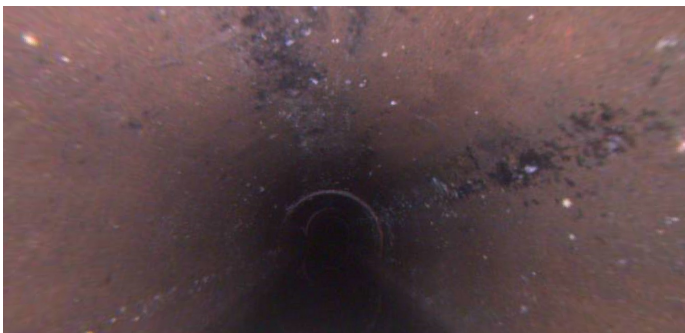
Code: **DAE**
Description: **Deposits Attached Encrustation**

Distance (ft): **27.4**
Structural Grade: **0**
O&M Grade: **2**
Clock Start/From: **8**
Clock To: **4**
1st Value:
2nd Value:
Value Percent: **5.000**
Continuous Index: **F01**
Within 8" of Joint: **YES**
Remarks:

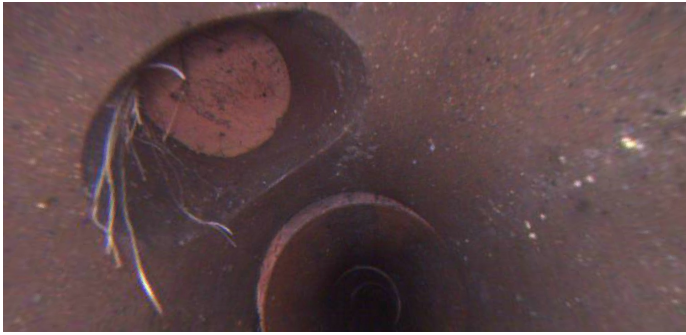
Code: **TFD**
Description: **Tap Factory Defective**

Distance (ft): **31.2**
Structural Grade: **0**
O&M Grade: **2**
Clock Start/From: **10**
Clock To:
1st Value: **4.000**
2nd Value:
Value Percent:
Continuous Index:
Within 8" of Joint:
Remarks: **capped, roots**

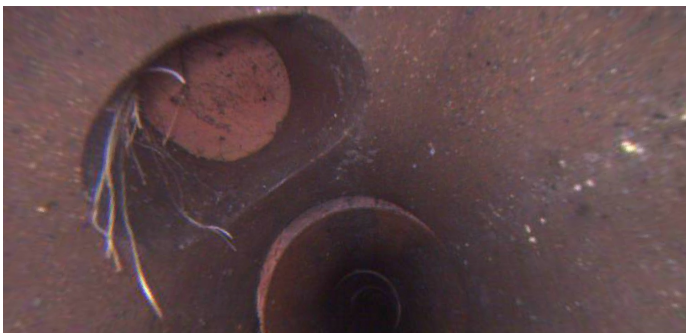
Code: **RFL**
Description: **Roots Fine Lateral**

Distance (ft): **31.2**
Structural Grade: **0**
O&M Grade: **1**
Clock Start/From: **10**
Clock To:
1st Value:
2nd Value:
Value Percent:
Continuous Index:
Within 8" of Joint: **NO**
Remarks:

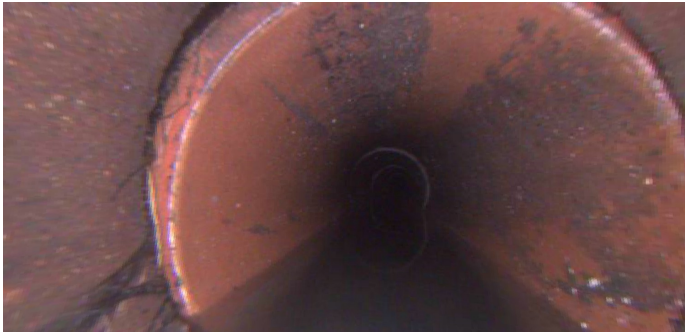
Code: **RFJ**
Description: **Roots Fine Joint**

Distance (ft): **31.9**
Structural Grade: **0**
O&M Grade: **1**
Clock Start/From: **7**
Clock To: **10**
1st Value:
2nd Value:
Value Percent:
Continuous Index:
Within 8" of Joint: **YES**
Remarks:

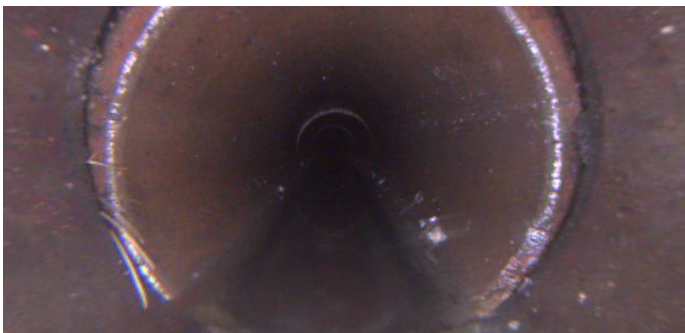
Code: **RFJ**
Description: **Roots Fine Joint**

Distance (ft): **39.7**
Structural Grade: **0**
O&M Grade: **1**
Clock Start/From: **8**
Clock To: **4**
1st Value:
2nd Value:
Value Percent:
Continuous Index:
Within 8" of Joint: **YES**
Remarks:

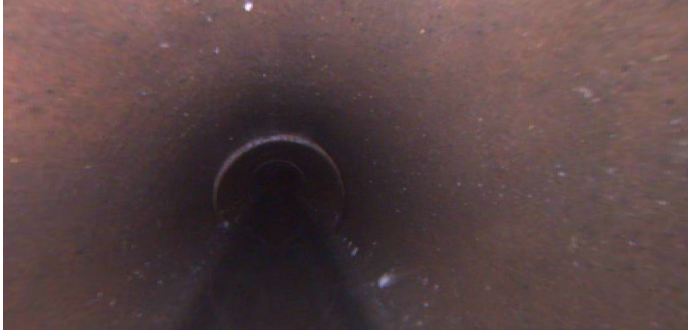
Code:	MSA
Description:	Abandoned Survey
Distance (ft):	40.9
Structural Grade:	0
O&M Grade:	0
Clock Start/From:	
Clock To:	
1st Value:	
2nd Value:	
Value Percent:	
Continuous Index:	
Within 8" of Joint:	NO
Remarks:	no blockage
