Profile/Photo Observation Report

Date:	11/01/2022	Weather:		Coding:	PACP 7.0
Pipe Length (ft):	150.0	Owner:	City of Hobart	Pre Clean:	Heavy Cleaning
P.O.#:	YES502259	Surveyor:	S. Bucklin	PSR:	P-504-013-012
Customer:	City of Hobart, IN (Red	Clean Date:	10/19/2022	Shape:	C

Street:	South Delaware Street	Flow Control:	Not Controlled
City:	Hobart, IN	Year Renewed:	
Location:	Alley	Tape/Media #:	
Purpose:	Routine Assessment	Dia/Height:	12"
Use:	Sanitary Sewage Pipe	Material:	VCP
Drain Area:		Lining:	None
Category:	NA		
Comment:			
Location Details:		Direction of Survey:	Upstream
US MH:	M-504-012	DS MH:	M-504-013
		Total Length Surveyed (ft):	149.0

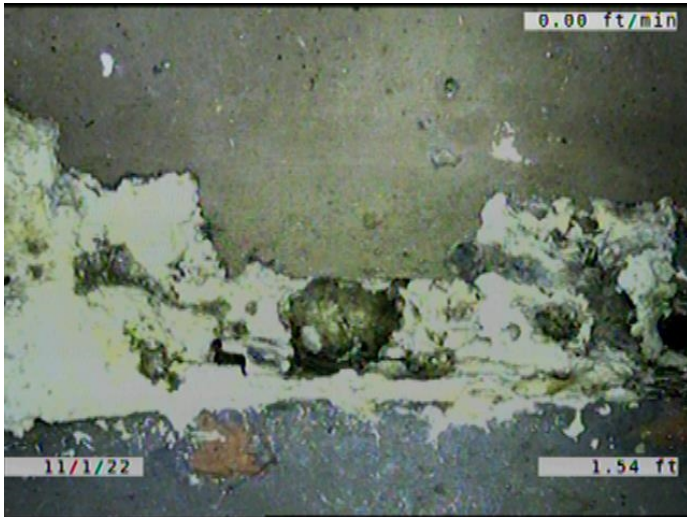
Code: **DAE**
 Description: **Deposits Attached Encrustation**

Distance (ft): **1.5**
 Structural Grade: **0**
 O&M Grade: **2**
 Clock Start/From: **8**
 Clock To: **4**
 1st Value:
 2nd Value:
 Value Percent: **5.000**
 Continuous Index: **S02**
 Within 8" of Joint: **YES**
 Remarks:

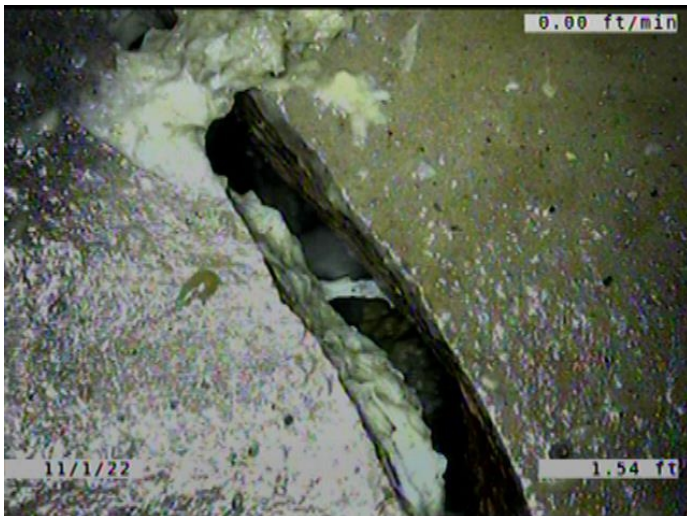
Code: **BSV**
 Description: **Broken Soil Visible**

Distance (ft): **1.5**
 Structural Grade: **5**
 O&M Grade: **0**
 Clock Start/From: **5**
 Clock To: **9**
 1st Value:
 2nd Value:
 Value Percent:
 Continuous Index:
 Within 8" of Joint: **YES**
 Remarks:

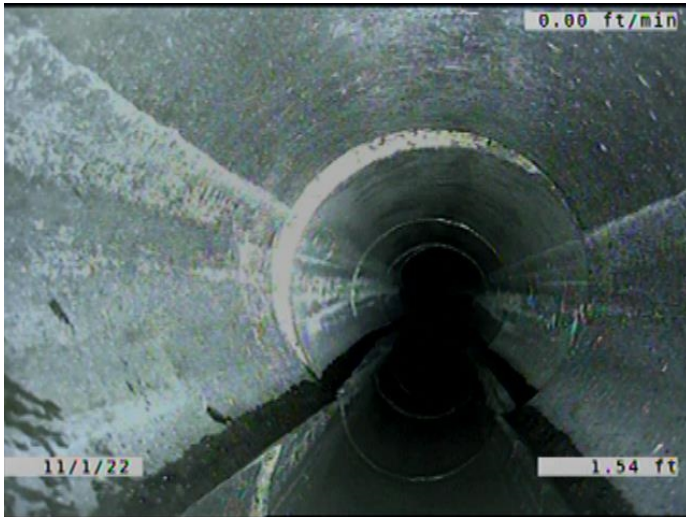
Code: **MWLS**
 Description: **Miscellaneous Water Level Sag**

Distance (ft): **1.5**
 Structural Grade: **2**
 O&M Grade: **0**
 Clock Start/From:
 Clock To:
 1st Value:
 2nd Value:
 Value Percent: **10.000**
 Continuous Index: **S01**
 Within 8" of Joint: **NO**
 Remarks:

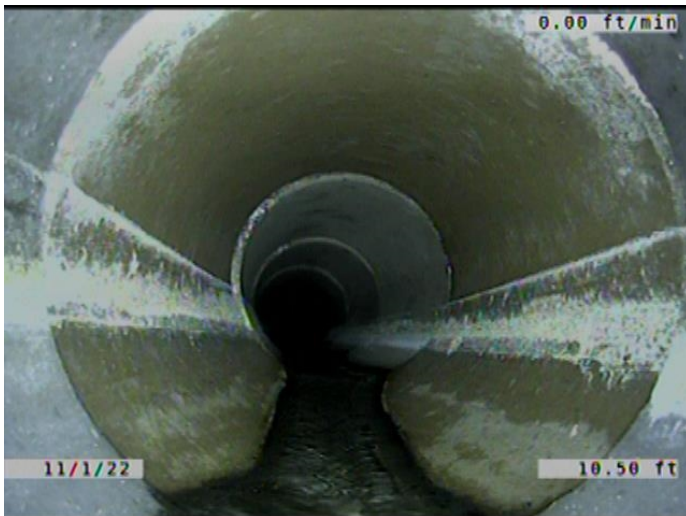
Code: **MWLS**
 Description: **Miscellaneous Water Level Sag**

Distance (ft): **10.5**
 Structural Grade: **2**
 O&M Grade: **0**
 Clock Start/From:
 Clock To:
 1st Value:
 2nd Value:
 Value Percent: **10.000**
 Continuous Index: **F01**
 Within 8" of Joint: **NO**
 Remarks:

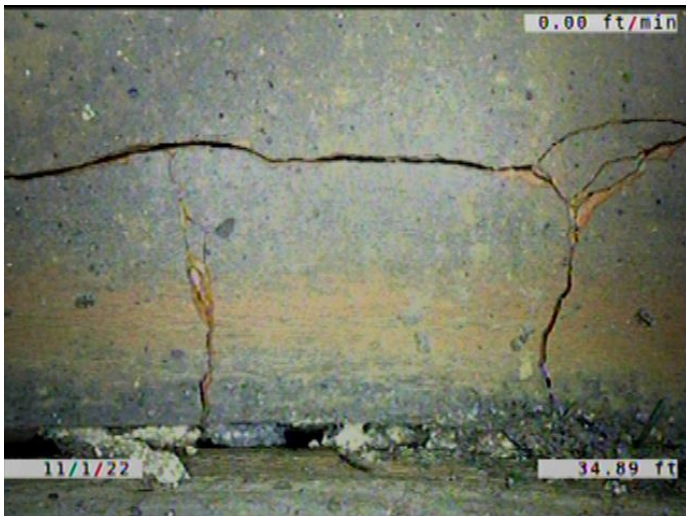
Code: **FM**
 Description: **Fracture Multiple**

Distance (ft): **34.9**
 Structural Grade: **4**
 O&M Grade: **0**
 Clock Start/From: **11**
 Clock To: **2**
 1st Value:
 2nd Value:
 Value Percent:
 Continuous Index:
 Within 8" of Joint: **YES**
 Remarks:

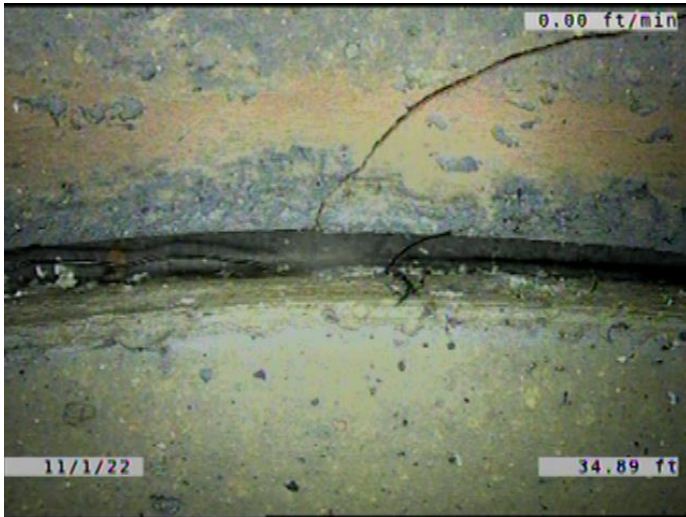
Code: **RFJ**
Description: **Roots Fine Joint**

Distance (ft): **34.9**
Structural Grade: **0**
O&M Grade: **1**
Clock Start/From: **10**
Clock To: **11**
1st Value:
2nd Value:
Value Percent:
Continuous Index:
Within 8" of Joint: **YES**
Remarks:

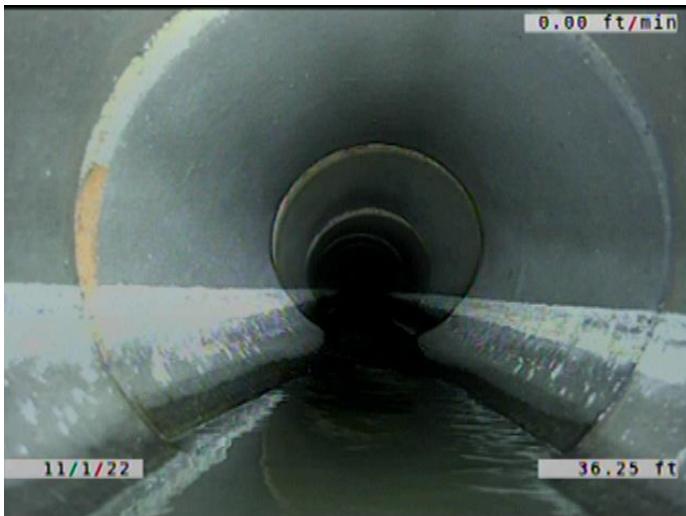
Code: **MWLS**
Description: **Miscellaneous Water Level Sag**

Distance (ft): **36.2**
Structural Grade: **2**
O&M Grade: **0**
Clock Start/From:
Clock To:
1st Value:
2nd Value:
Value Percent: **10.000**
Continuous Index:
Within 8" of Joint: **NO**
Remarks:

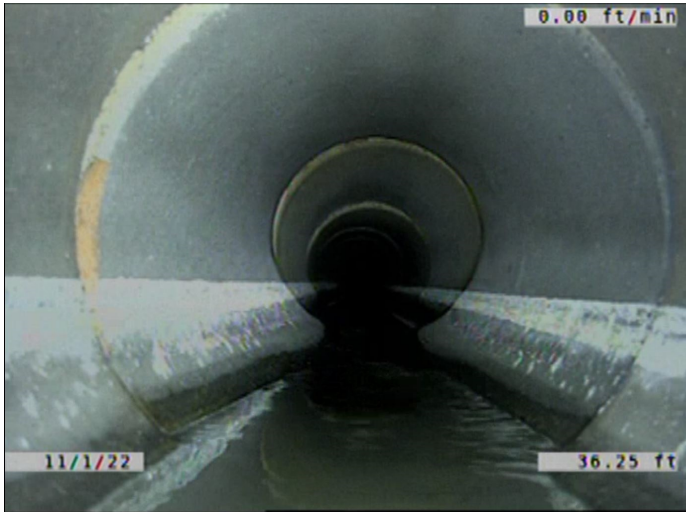
Code: **SSS**
Description: **Surface Damage Surface Spalling**

Distance (ft): **36.3**
Structural Grade: **2**
O&M Grade: **0**
Clock Start/From: **9**
Clock To: **10**
1st Value:
2nd Value:
Value Percent:
Continuous Index:
Within 8" of Joint: **YES**
Remarks:

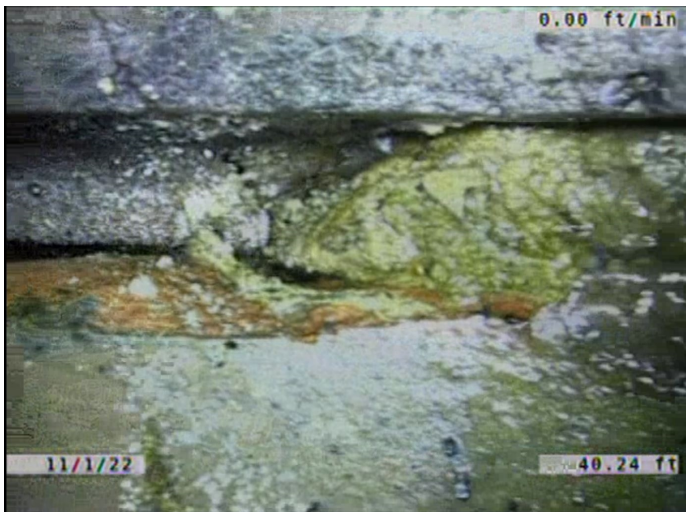
Code: **SSS**
Description: **Surface Damage Surface Spalling**

Distance (ft): **40.2**
Structural Grade: **2**
O&M Grade: **0**
Clock Start/From: **4**
Clock To: **5**
1st Value:
2nd Value:
Value Percent:
Continuous Index:
Within 8" of Joint: **YES**
Remarks:

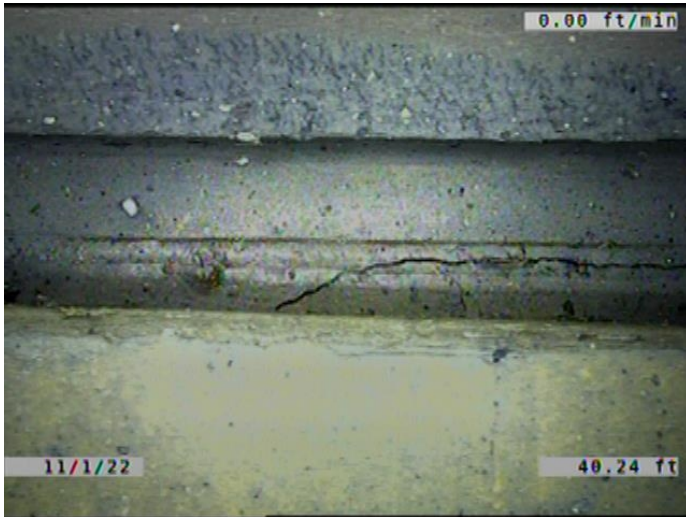
Code: **JAM**
Description: **Joint Angular Medium**

Distance (ft): **40.2**
Structural Grade: **3**
O&M Grade: **0**
Clock Start/From:
Clock To:
1st Value:
2nd Value:
Value Percent:
Continuous Index:
Within 8" of Joint: **NO**
Remarks:

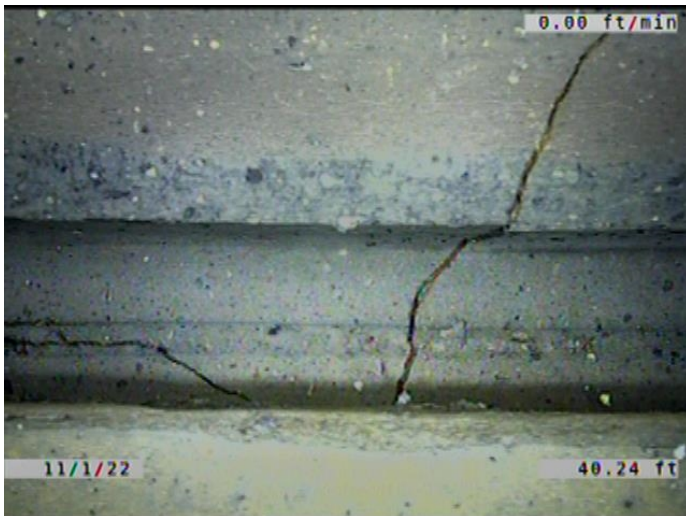
Code: **FM**
Description: **Fracture Multiple**

Distance (ft): **40.2**
Structural Grade: **4**
O&M Grade: **0**
Clock Start/From: **9**
Clock To: **4**
1st Value:
2nd Value:
Value Percent:
Continuous Index:
Within 8" of Joint: **YES**
Remarks:

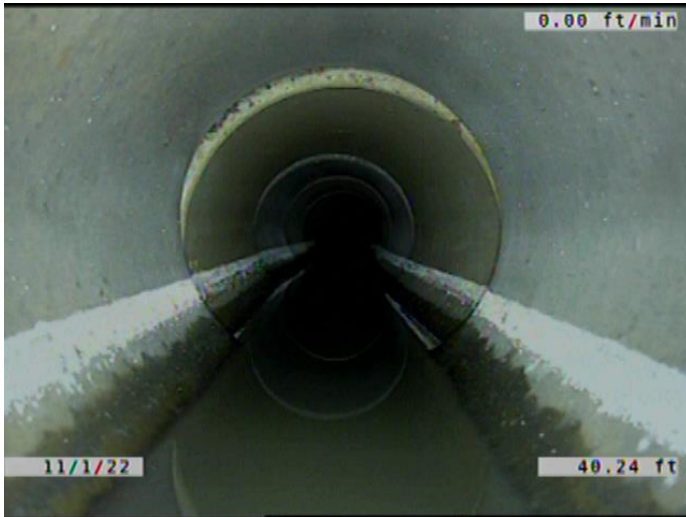
Code: **MWLS**
Description: **Miscellaneous Water Level Sag**

Distance (ft): **40.2**
Structural Grade: **2**
O&M Grade: **0**
Clock Start/From:
Clock To:
1st Value:
2nd Value:
Value Percent: **10.000**
Continuous Index: **S03**
Within 8" of Joint: **NO**
Remarks:

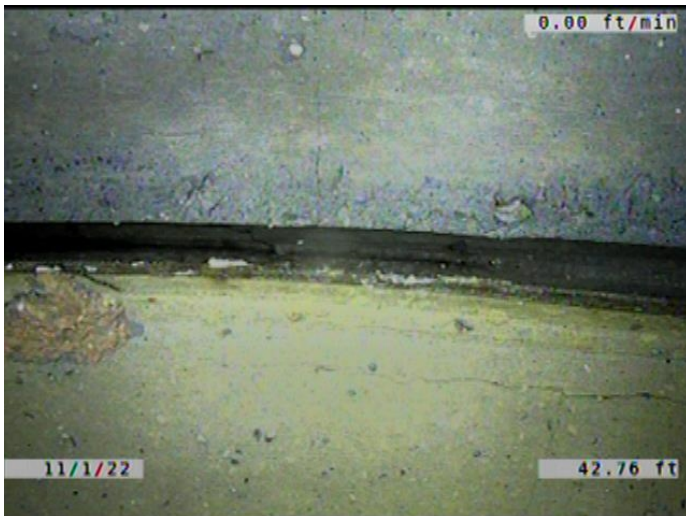
Code: **CM**
Description: **Crack Multiple**

Distance (ft): **42.8**
Structural Grade: **3**
O&M Grade: **0**
Clock Start/From: **1**
Clock To: **2**
1st Value:
2nd Value:
Value Percent:
Continuous Index:
Within 8" of Joint: **YES**
Remarks:

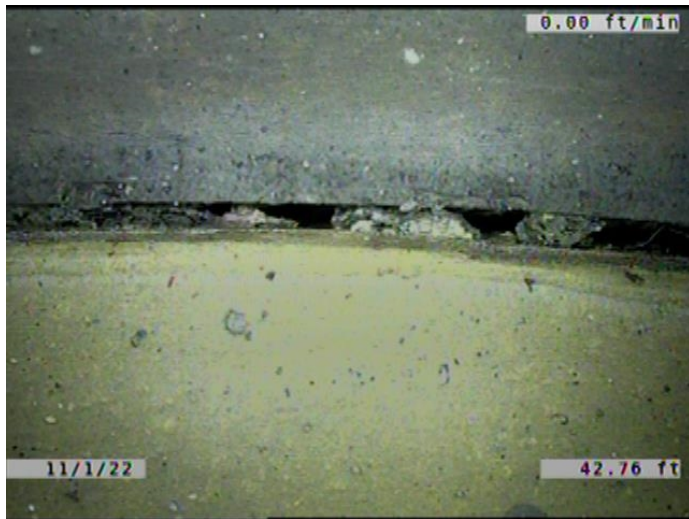
Code: **RFJ**
 Description: **Roots Fine Joint**

Distance (ft): **42.8**
 Structural Grade: **0**
 O&M Grade: **1**
 Clock Start/From: **10**
 Clock To: **2**
 1st Value:
 2nd Value:
 Value Percent:
 Continuous Index: **S04**
 Within 8" of Joint: **YES**
 Remarks:

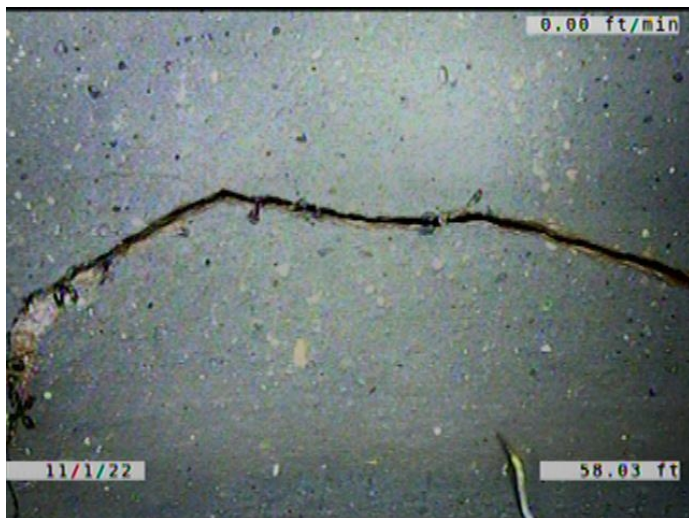
Code: **B**
 Description: **Broken**

Distance (ft): **58.0**
 Structural Grade: **4**
 O&M Grade: **0**
 Clock Start/From: **8**
 Clock To: **4**
 1st Value:
 2nd Value:
 Value Percent:
 Continuous Index:
 Within 8" of Joint: **YES**
 Remarks:

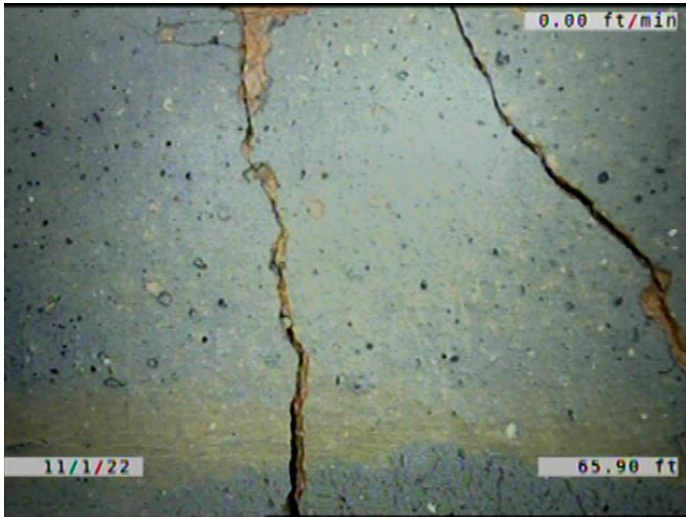
Code: **B**
Description: **Broken**

Distance (ft): **65.9**
Structural Grade: **4**
O&M Grade: **0**
Clock Start/From: **10**
Clock To: **4**
1st Value:
2nd Value:
Value Percent:
Continuous Index:
Within 8" of Joint: **YES**
Remarks:

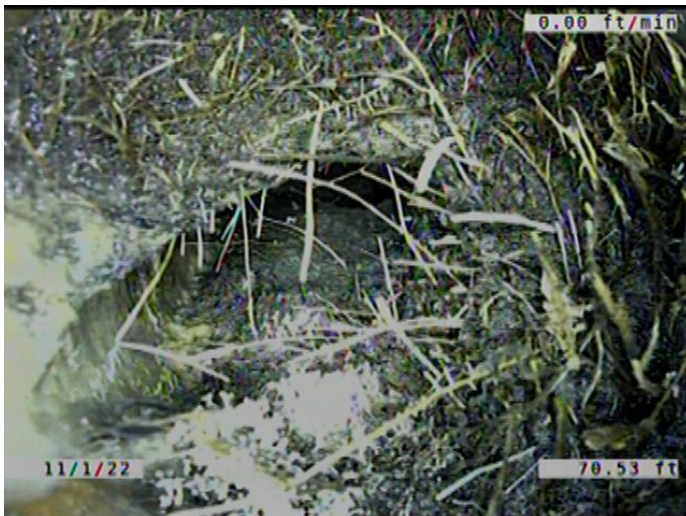
Code: **TFD**
Description: **Tap Factory Defective**

Distance (ft): **70.5**
Structural Grade: **0**
O&M Grade: **3**
Clock Start/From: **10**
Clock To:
1st Value: **4.000**
2nd Value:
Value Percent:
Continuous Index:
Within 8" of Joint: **YES**
Remarks: **95% PLUGGED WITH ROOTS.**

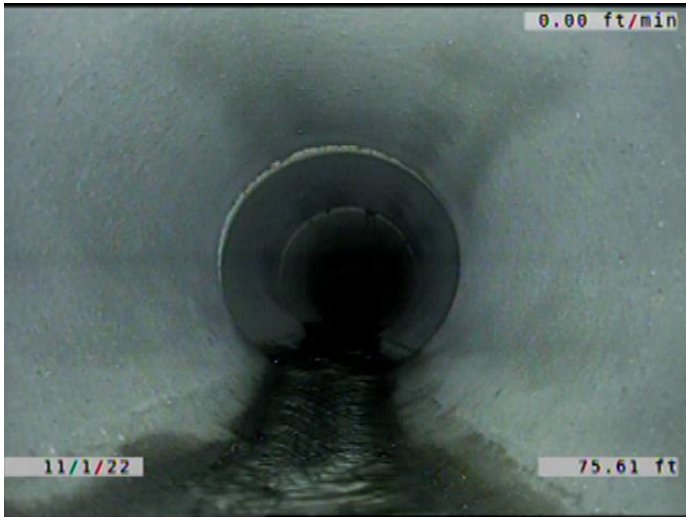
Code: **MWLS**
Description: **Miscellaneous Water Level Sag**

Distance (ft): **75.6**
Structural Grade: **2**
O&M Grade: **0**
Clock Start/From:
Clock To:
1st Value:
2nd Value:
Value Percent: **10.000**
Continuous Index: **F03**
Within 8" of Joint: **NO**
Remarks:

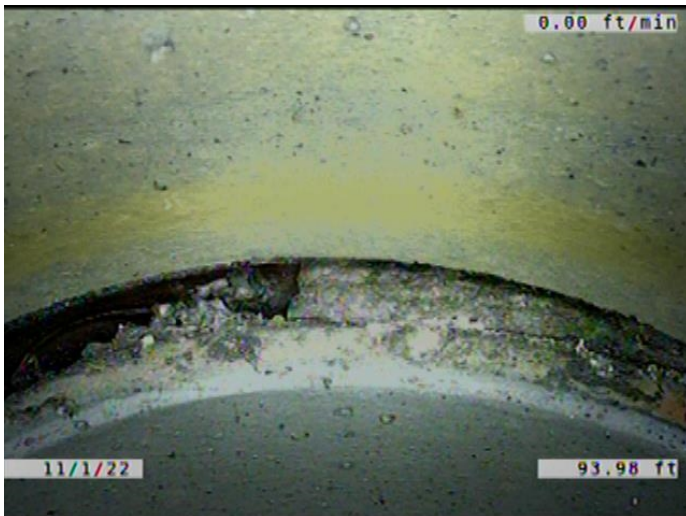
Code: **JOM**
Description: **Joint Offset Medium**

Distance (ft): **94.0**
Structural Grade: **3**
O&M Grade: **0**
Clock Start/From:
Clock To:
1st Value:
2nd Value:
Value Percent:
Continuous Index:
Within 8" of Joint: **NO**
Remarks:

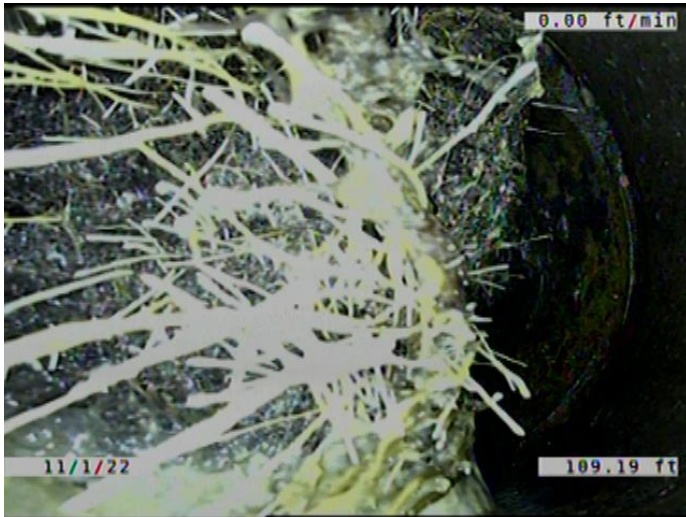
Code:	TFD
Description:	Tap Factory Defective
Distance (ft):	109.2
Structural Grade:	0
O&M Grade:	3
Clock Start/From:	10
Clock To:	
1st Value:	6.000
2nd Value:	
Value Percent:	
Continuous Index:	
Within 8" of Joint:	YES
Remarks:	90% PLUGGED WITH ROOTS. ROOTS GROWING FROM THE SERVICE INTO

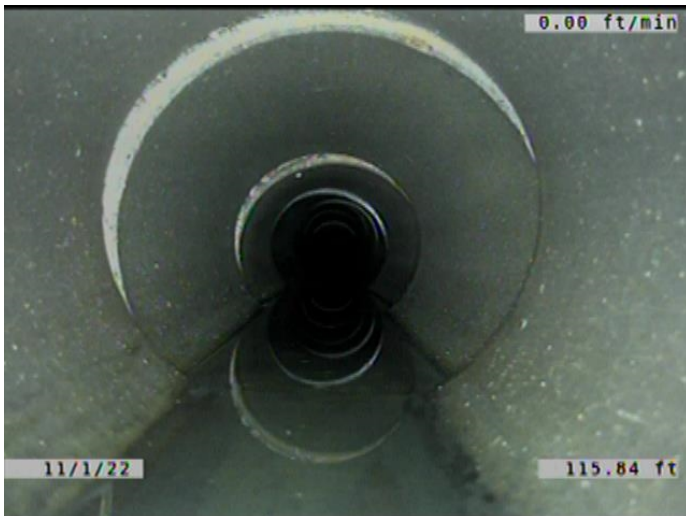
Code:	MWLS
Description:	Miscellaneous Water Level Sag
Distance (ft):	115.8
Structural Grade:	2
O&M Grade:	0
Clock Start/From:	
Clock To:	
1st Value:	
2nd Value:	
Value Percent:	10.000
Continuous Index:	S05
Within 8" of Joint:	NO
Remarks:

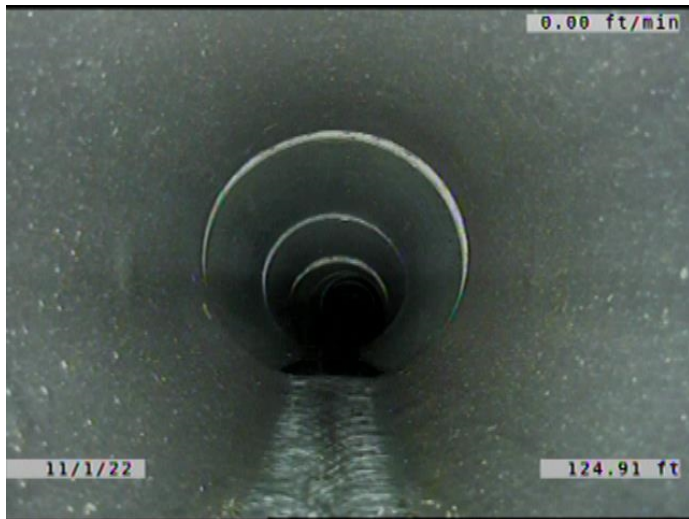
Code: **MWLS**
Description: **Miscellaneous Water Level Sag**

Distance (ft): **124.9**
Structural Grade: **2**
O&M Grade: **0**
Clock Start/From:
Clock To:
1st Value:
2nd Value:
Value Percent: **10.000**
Continuous Index: **F05**
Within 8" of Joint: **NO**
Remarks:

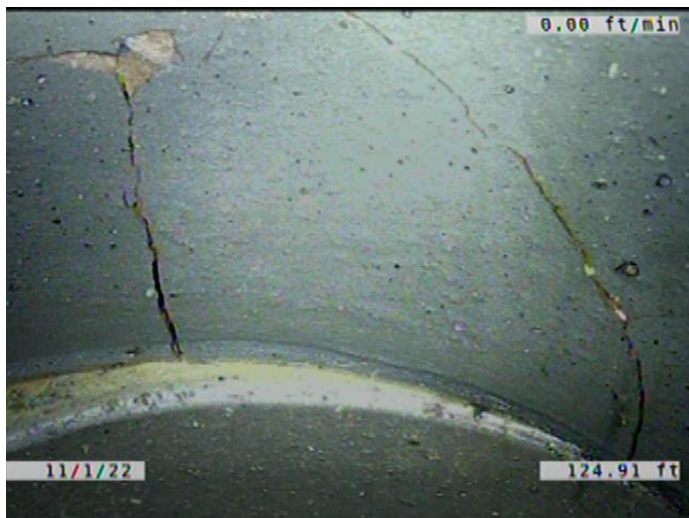
Code: **B**
Description: **Broken**

Distance (ft): **124.9**
Structural Grade: **4**
O&M Grade: **0**
Clock Start/From: **12**
Clock To: **5**
1st Value:
2nd Value:
Value Percent:
Continuous Index:
Within 8" of Joint: **YES**
Remarks:

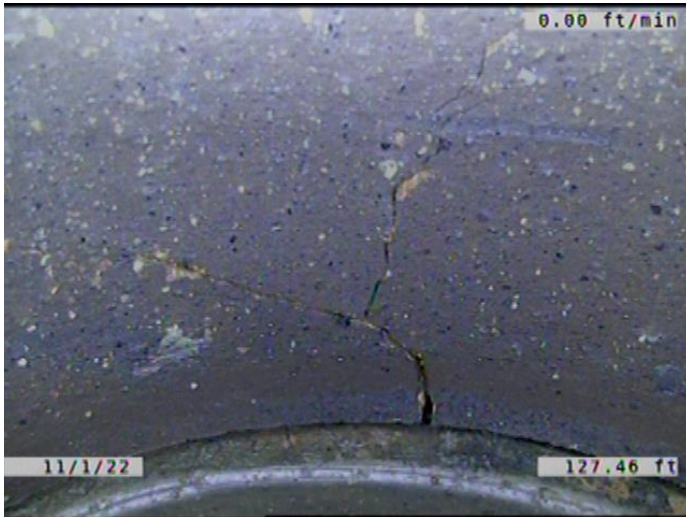
Code: **FM**
Description: **Fracture Multiple**

Distance (ft): **127.5**
Structural Grade: **4**
O&M Grade: **0**
Clock Start/From: **9**
Clock To: **3**
1st Value:
2nd Value:
Value Percent:
Continuous Index:
Within 8" of Joint: **YES**
Remarks:

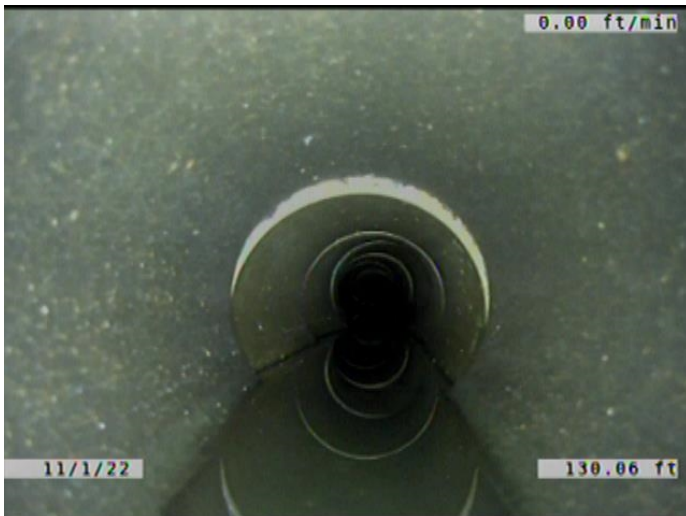
Code: **MWLS**
Description: **Miscellaneous Water Level Sag**

Distance (ft): **130.1**
Structural Grade: **2**
O&M Grade: **0**
Clock Start/From:
Clock To:
1st Value:
2nd Value:
Value Percent: **10.000**
Continuous Index: **S06**
Within 8" of Joint: **NO**
Remarks:

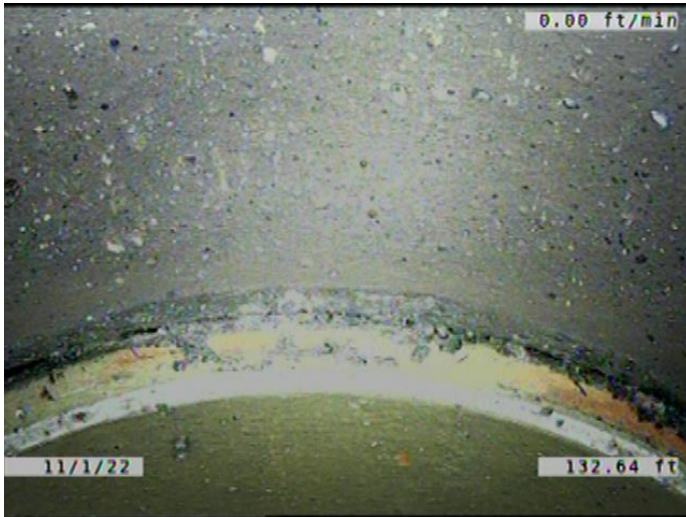
Code: **JOM**
 Description: **Joint Offset Medium**

Distance (ft): **132.6**
 Structural Grade: **3**
 O&M Grade: **0**
 Clock Start/From:
 Clock To:
 1st Value:
 2nd Value:
 Value Percent:
 Continuous Index:
 Within 8" of Joint: **NO**
 Remarks:

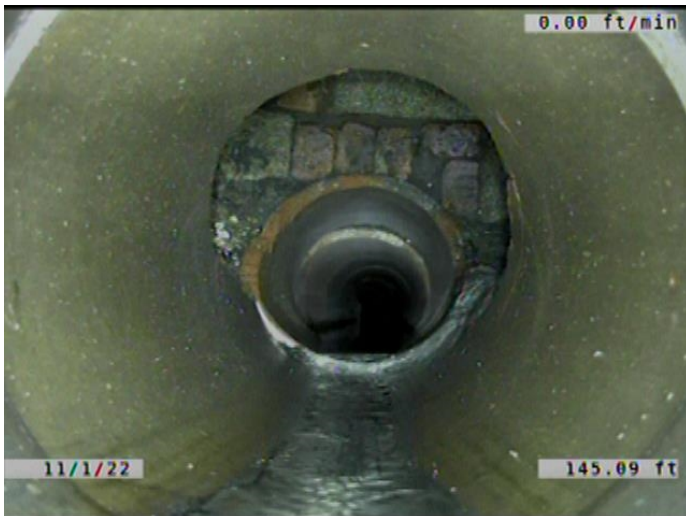
Code: **RFJ**
 Description: **Roots Fine Joint**

Distance (ft): **145.1**
 Structural Grade: **0**
 O&M Grade: **1**
 Clock Start/From: **10**
 Clock To: **2**
 1st Value:
 2nd Value:
 Value Percent:
 Continuous Index: **F04**
 Within 8" of Joint: **YES**
 Remarks:

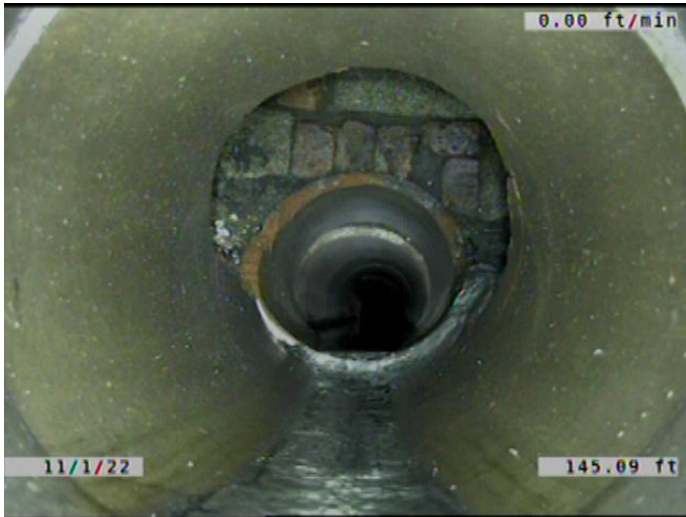
Code: **MWLS**
 Description: **Miscellaneous Water Level Sag**

Distance (ft): **145.1**
 Structural Grade: **2**
 O&M Grade: **0**
 Clock Start/From:
 Clock To:
 1st Value:
 2nd Value:
 Value Percent: **10.000**
 Continuous Index: **F06**
 Within 8" of Joint: **NO**
 Remarks:

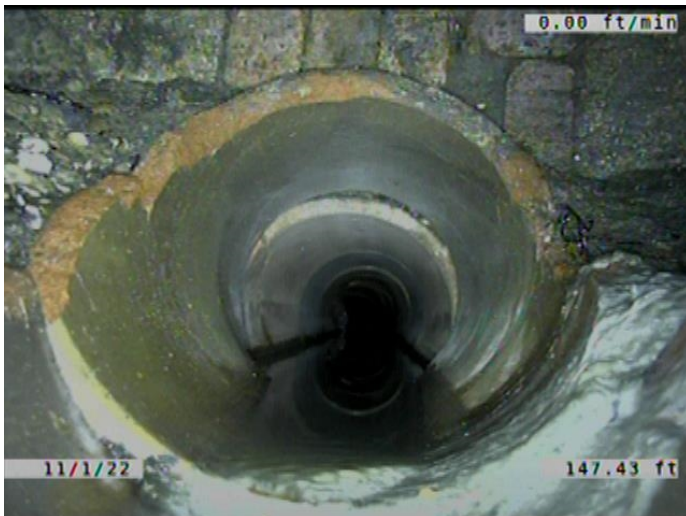
Code: **DAE**
 Description: **Deposits Attached Encrustation**

Distance (ft): **147.4**
 Structural Grade: **0**
 O&M Grade: **2**
 Clock Start/From: **8**
 Clock To: **4**
 1st Value:
 2nd Value:
 Value Percent: **5.000**
 Continuous Index: **F02**
 Within 8" of Joint: **YES**
 Remarks:
