Profile/Photo Observation Report

Date:	04/13/2018	Weather:		Coding:	PACP 6.0
Pipe Length (ft):		Owner:	City of Hobart	Pre Clean:	No Pre-Cleaning
P.O.#:	39-1	Surveyor:	M. Pielacha	PSR:	M-504-012-M-504-132
Customer:	City of Hobart	Clean Date:		Shape:	C

Street:	Off Virginia Street	Flow Control:	Not Controlled
City:	Hobart, IN	Year Renewed:	
Location:	Light Highway	Tape/Media #:	DEP 39
Purpose:	Routine Assessment	Dia/Height:	6"
Use:	Sanitary	Material:	VCP
Drain Area:		Lining:	
Category:	NA		
Comment:			
Location Details:		Direction of Survey:	Upstream
US MH:	M-504-012	DS MH:	M-504-132
		Total Length Surveyed (ft):	6.1

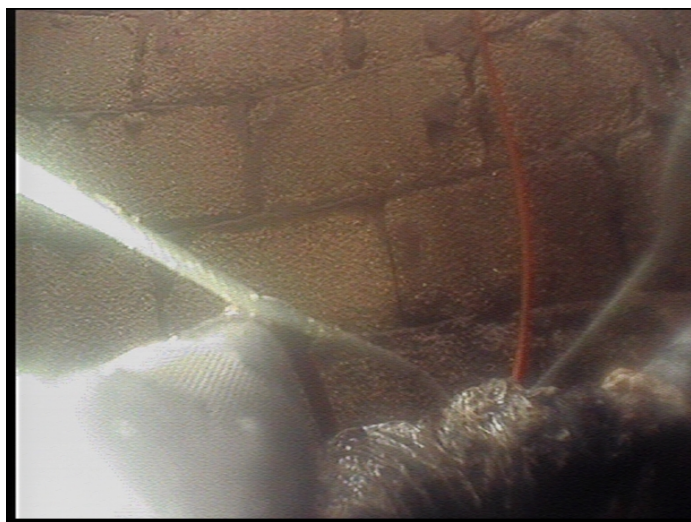
Code: **AMH**
Description: **Manhole**

Distance (ft): **.0**
Structural Grade: **0**
O&M Grade: **0**
Clock Start/From:
Clock To:
1st Value:
2nd Value:
Value Percent:
Continuous Index:
Within 8" of Joint: **NO**
Remarks: **M-504-132**

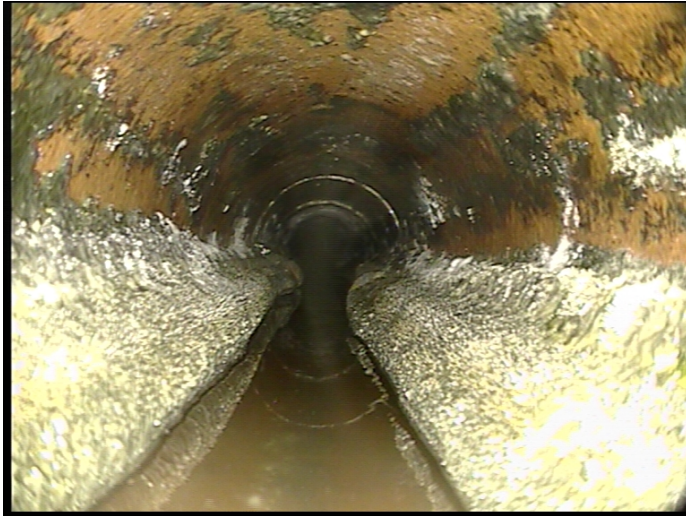
Code: **MWL**
Description: **Water Level**

Distance (ft): **.0**
Structural Grade: **0**
O&M Grade: **0**
Clock Start/From:
Clock To:
1st Value:
2nd Value:
Value Percent: **5.000**
Continuous Index:
Within 8" of Joint: **NO**
Remarks:

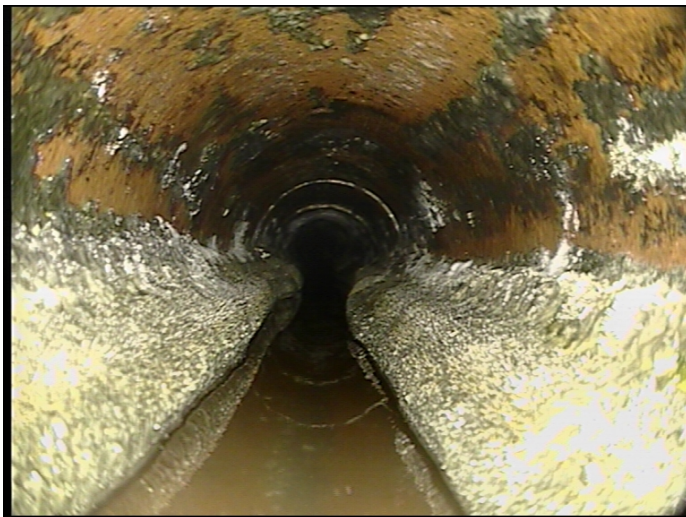
Code: **DAGS**
Description: **Deposits Attached Grease**

Distance (ft): **.1**
Structural Grade: **0**
O&M Grade: **3**
Clock Start/From: **8**
Clock To: **4**
1st Value:
2nd Value:
Value Percent: **20.000**
Continuous Index: **S01**
Within 8" of Joint: **YES**
Remarks:

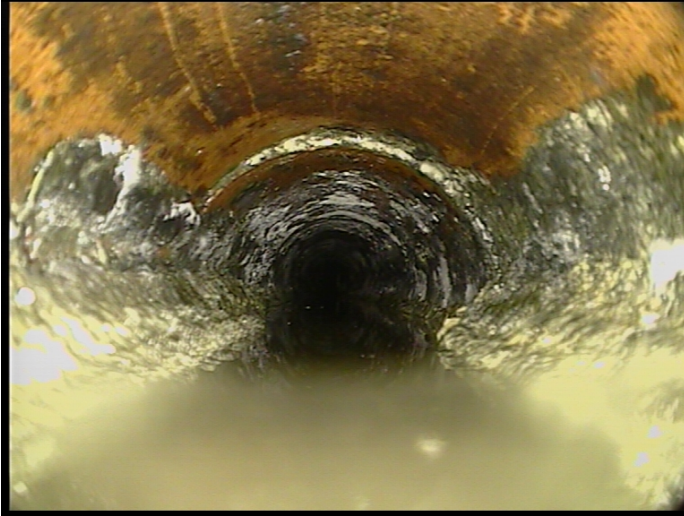
Code: **DAGS**
Description: **Deposits Attached Grease**

Distance (ft): **6.1**
Structural Grade: **0**
O&M Grade: **3**
Clock Start/From: **8**
Clock To: **4**
1st Value:
2nd Value:
Value Percent: **20.000**
Continuous Index: **F01**
Within 8" of Joint: **NO**
Remarks:

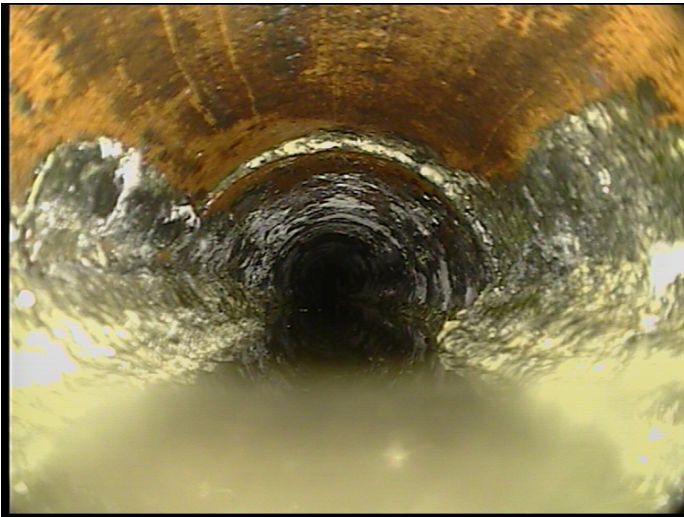
Code: **MSA**
Description: **Abandoned Survey**

Distance (ft): **6.1**
Structural Grade: **0**
O&M Grade: **0**
Clock Start/From:
Clock To:
1st Value:
2nd Value:
Value Percent:
Continuous Index:
Within 8" of Joint: **NO**
Remarks: **grease**
