Profile/Photo Observation Report

Date:	04/18/2018	Weather:		Coding:	PACP 6.0
Pipe Length (ft):	112.7	Owner:	NA	Pre Clean:	Not Known
P.O.#:		Surveyor:	Byrd Fitzgerald	PSR:	P-504-014-013
Customer:		Clean Date:	01/01/1900	Shape:	C

Street:	N DELAWARE ST	Flow Control:	Not Controlled
City:	Hobart, IN	Year Renewed:	
Location:	Light Highway	Tape/Media #:	
Purpose:	Not Known	Dia/Height:	12"
Use:	Sanitary	Material:	VCP
Drain Area:	NA	Lining:	
Category:	NA		
Comment:

Location Details:		Direction of Survey:	Downstream
US MH:	M-504-013	DS MH:	M-504-014
		Total Length Surveyed (ft):	20.0

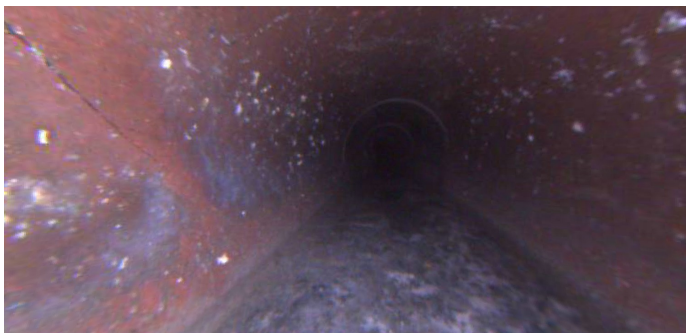
Code: **FS**
Description: **Fracture Spiral**

Distance (ft): **.0**
Structural Grade: **3**
O&M Grade: **0**
Clock Start/From: **7**
Clock To: **9**
1st Value:
2nd Value:
Value Percent:
Continuous Index:
Within 8" of Joint:
Remarks:

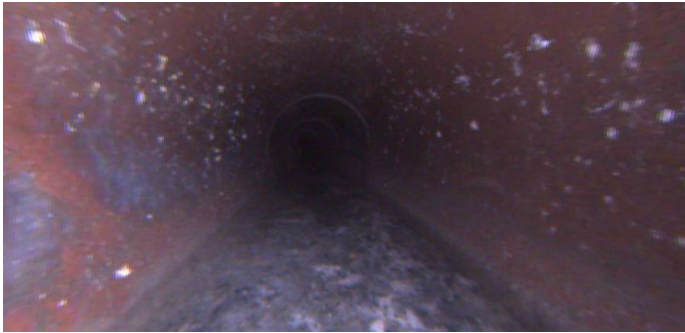
Code:	AMH
Description:	Manhole

Distance (ft):	.0
Structural Grade:	0
O&M Grade:	0
Clock Start/From:	
Clock To:	
1st Value:	
2nd Value:	
Value Percent:	
Continuous Index:	
Within 8" of Joint:	NO
Remarks:	M-504-013

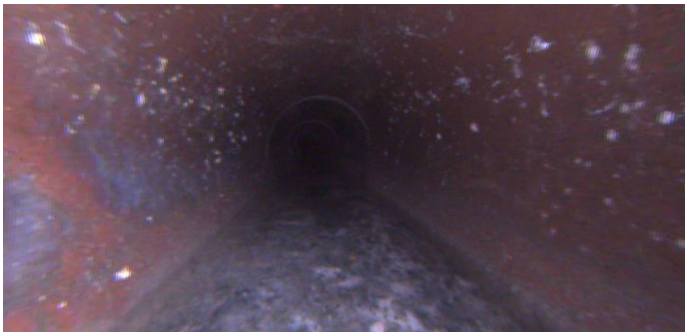
Code:	MWL
Description:	Water Level

Distance (ft):	.0
Structural Grade:	0
O&M Grade:	0
Clock Start/From:	
Clock To:	
1st Value:	
2nd Value:	
Value Percent:	5.000
Continuous Index:	
Within 8" of Joint:	NO
Remarks:

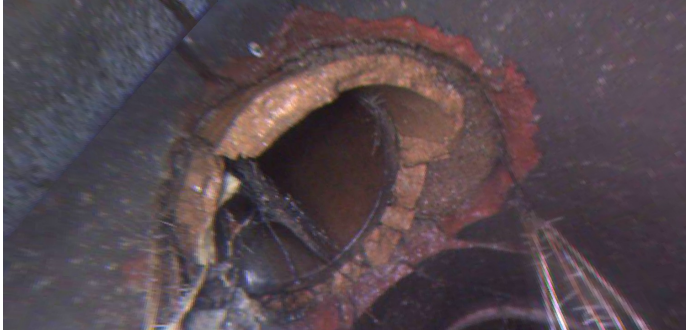
Code: **TBD**
Description: **Tap Break-in Defective**

Distance (ft): **9.4**
Structural Grade: **0**
O&M Grade: **3**
Clock Start/From: **11**
Clock To:
1st Value: **4.000**
2nd Value:
Value Percent:
Continuous Index:
Within 8" of Joint:
Remarks: **roots**

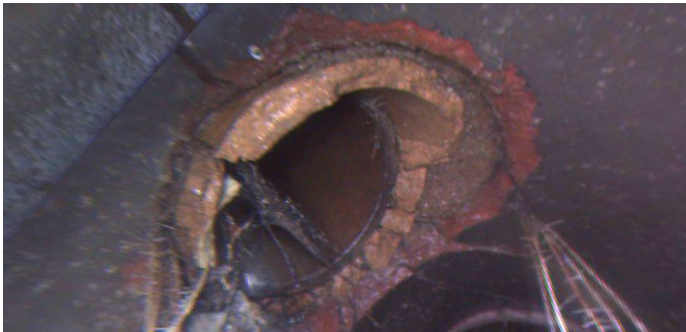
Code: **RFC**
Description: **Roots Fine Connection**

Distance (ft): **9.4**
Structural Grade: **0**
O&M Grade: **1**
Clock Start/From: **7**
Clock To: **5**
1st Value:
2nd Value:
Value Percent:
Continuous Index:
Within 8" of Joint: **NO**
Remarks:

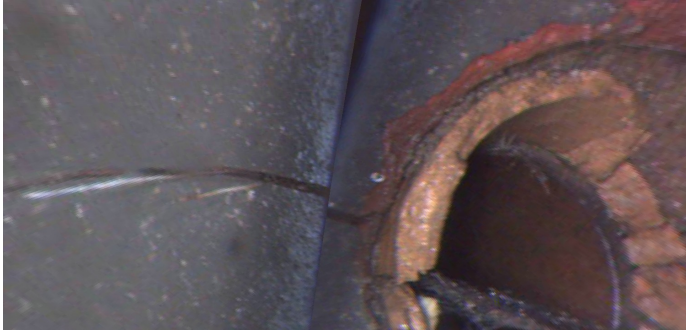
Code: **FL**
Description: **Fracture Longitudinal**

Distance (ft): **9.4**
Structural Grade: **3**
O&M Grade: **0**
Clock Start/From: **2**
Clock To:
1st Value:
2nd Value:
Value Percent:
Continuous Index:
Within 8" of Joint:
Remarks:

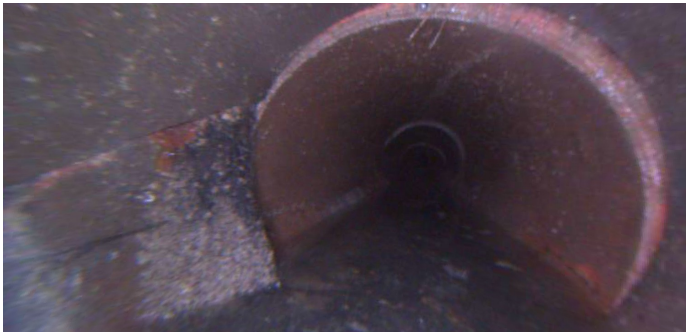
Code: **RMB**
Description: **Roots Medium Barrel**

Distance (ft): **10.4**
Structural Grade: **0**
O&M Grade: **4**
Clock Start/From: **7**
Clock To: **9**
1st Value:
2nd Value:
Value Percent: **5.000**
Continuous Index:
Within 8" of Joint: **NO**
Remarks:

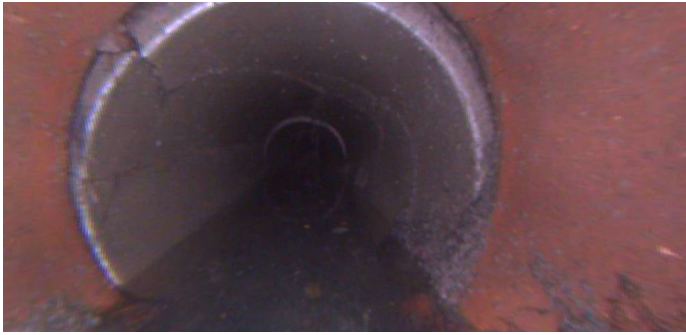
Code: **FM**
Description: **Fracture Multiple**

Distance (ft): **12.9**
Structural Grade: **4**
O&M Grade: **0**
Clock Start/From: **7**
Clock To: **5**
1st Value:
2nd Value:
Value Percent:
Continuous Index: **S01**
Within 8" of Joint: **YES**
Remarks: **wandering**

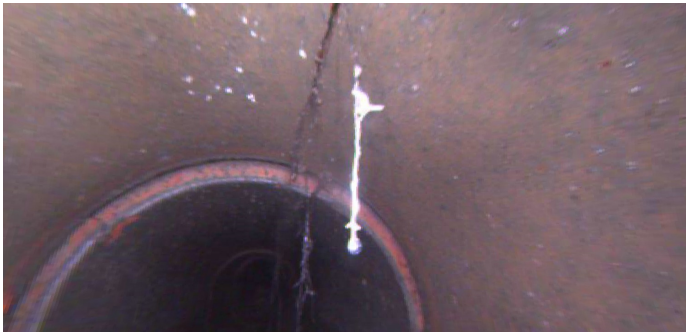
Code: **RFB**
Description: **Roots Fine Barrel**

Distance (ft): **15.3**
Structural Grade: **0**
O&M Grade: **2**
Clock Start/From: **12**
Clock To:
1st Value:
2nd Value:
Value Percent:
Continuous Index:
Within 8" of Joint: **NO**
Remarks:

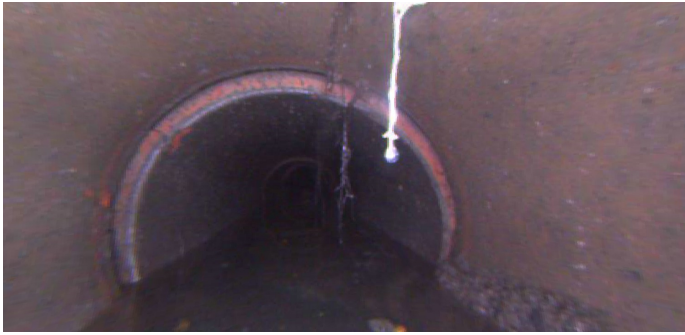
Code: **RFJ**
Description: **Roots Fine Joint**

Distance (ft): **15.3**
Structural Grade: **0**
O&M Grade: **1**
Clock Start/From: **1**
Clock To:
1st Value:
2nd Value:
Value Percent:
Continuous Index: **S02**
Within 8" of Joint: **YES**
Remarks: **wandering**

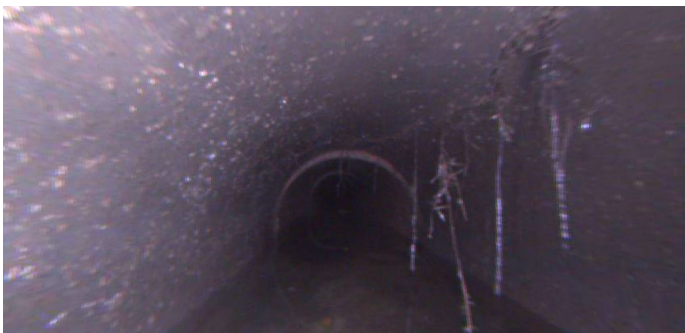
Code: **RFB**
Description: **Roots Fine Barrel**

Distance (ft): **17.0**
Structural Grade: **0**
O&M Grade: **2**
Clock Start/From: **1**
Clock To:
1st Value:
2nd Value:
Value Percent:
Continuous Index:
Within 8" of Joint: **NO**
Remarks:

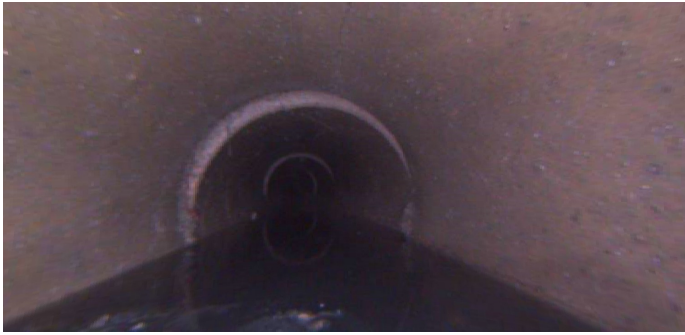
Code: **FM**
Description: **Fracture Multiple**

Distance (ft): **20.0**
Structural Grade: **4**
O&M Grade: **0**
Clock Start/From: **7**
Clock To: **5**
1st Value:
2nd Value:
Value Percent:
Continuous Index: **F01**
Within 8" of Joint: **YES**
Remarks: **wandering**

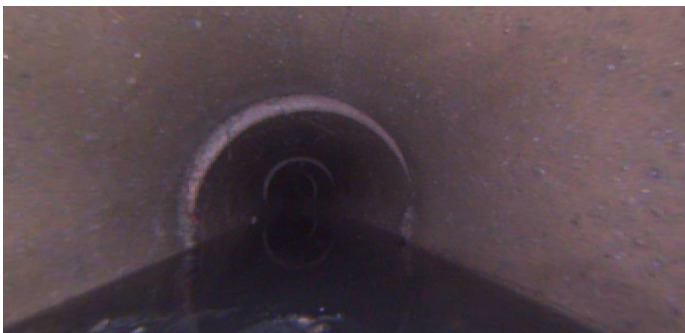
Code: **MSA**
Description: **Abandoned Survey**

Distance (ft): **20.0**
Structural Grade: **0**
O&M Grade: **0**
Clock Start/From:
Clock To:
1st Value:
2nd Value:
Value Percent:
Continuous Index:
Within 8" of Joint: **NO**
Remarks: **no blockage**

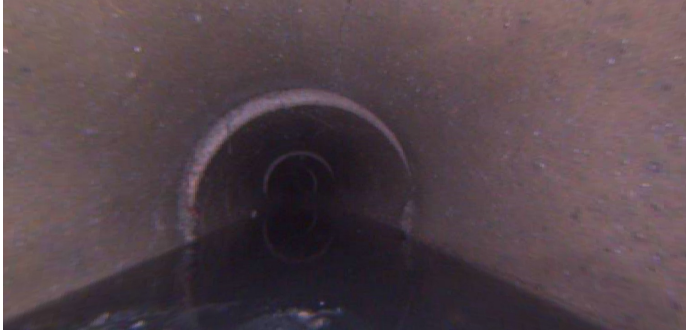
Code:	RFJ
Description:	Roots Fine Joint
Distance (ft):	20.0
Structural Grade:	0
O&M Grade:	1
Clock Start/From:	1
Clock To:	
1st Value:	
2nd Value:	
Value Percent:	
Continuous Index:	F02
Within 8" of Joint:	YES
Remarks:	wandering
