## Profile/Photo Observation Report

Date:	<b>04/18/2018</b>	Weather:		Coding:	<b>PACP 6.0</b>
Pipe Length (ft):	<b>112.7</b>	Owner:	<b>NA</b>	Pre Clean:	<b>Not Known</b>
P.O.#:		Surveyor:	<b>Byrd Fitzgerald</b>	PSR:	<b>P-504-014-013</b>
Customer:		Clean Date:	<b>01/01/1900</b>	Shape:	<b>C</b>

Location Details:		Direction of Survey:	<b>Downstream</b>
US MH:	<b>M-504-013</b>	DS MH:	<b>M-504-014</b>
		Total Length Surveyed (ft):	<b>20.0</b>

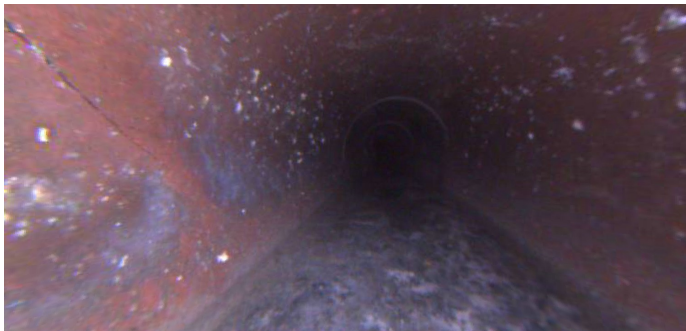
Code: **FS**  
Description: **Fracture Spiral**

Distance (ft): **.0**  
Structural Grade: **3**  
O&M Grade: **0**  
Clock Start/From: **7**  
Clock To: **9**  
1st Value:  
2nd Value:  
Value Percent:  
Continuous Index:  
Within 8" of Joint:  
Remarks:

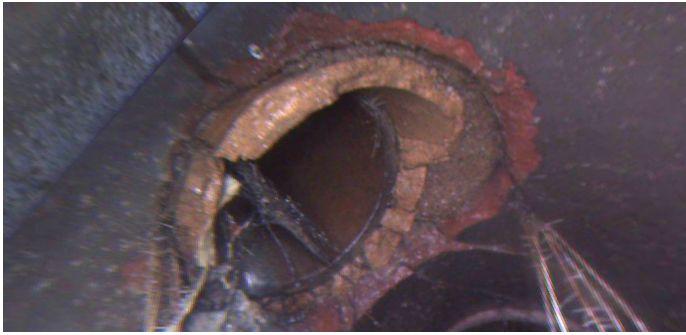
Code: **TBD**  
Description: **Tap Break-in Defective**

Distance (ft): **9.4**  
Structural Grade: **0**  
O&M Grade: **3**  
Clock Start/From: **11**  
Clock To:  
1st Value: **4.000**  
2nd Value:  
Value Percent:  
Continuous Index:  
Within 8" of Joint:  
Remarks: **roots**

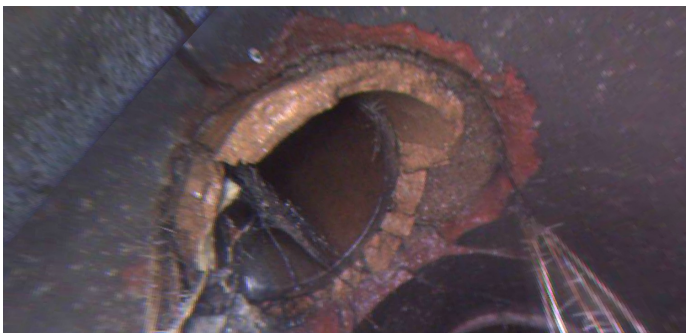
Code: **RFC**  
Description: **Roots Fine Connection**

Distance (ft): **9.4**  
Structural Grade: **0**  
O&M Grade: **1**  
Clock Start/From: **7**  
Clock To: **5**  
1st Value:  
2nd Value:  
Value Percent:  
Continuous Index:  
Within 8" of Joint: **NO**  
Remarks:

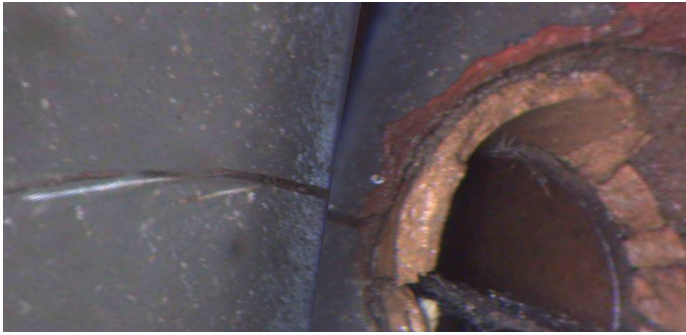
Code: **FL**  
Description: **Fracture Longitudinal**

Distance (ft): **9.4**  
Structural Grade: **3**  
O&M Grade: **0**  
Clock Start/From: **2**  
Clock To:  
1st Value:  
2nd Value:  
Value Percent:  
Continuous Index:  
Within 8" of Joint:  
Remarks:

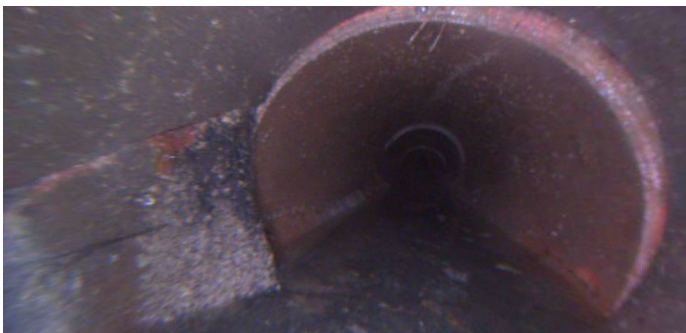
Code: **RMB**  
Description: **Roots Medium Barrel**

Distance (ft): **10.4**  
Structural Grade: **0**  
O&M Grade: **4**  
Clock Start/From: **7**  
Clock To: **9**  
1st Value:  
2nd Value:  
Value Percent: **5.000**  
Continuous Index:  
Within 8" of Joint: **NO**  
Remarks:

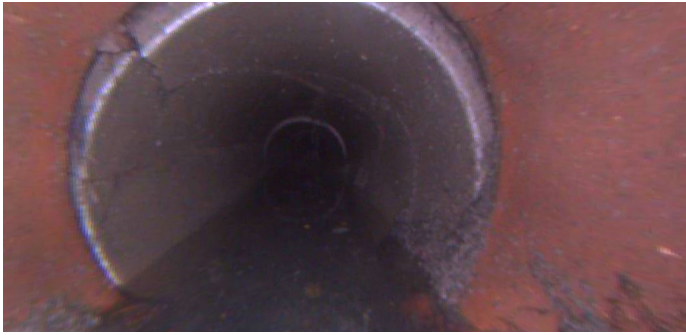
Code: **FM**  
Description: **Fracture Multiple**

Distance (ft): **12.9**  
Structural Grade: **4**  
O&M Grade: **0**  
Clock Start/From: **7**  
Clock To: **5**  
1st Value:  
2nd Value:  
Value Percent:  
Continuous Index: **S01**  
Within 8" of Joint: **YES**  
Remarks: **wandering**

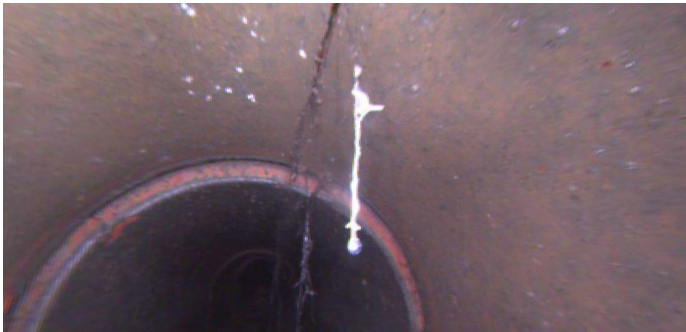
Code: **RFB**  
Description: **Roots Fine Barrel**

Distance (ft): **15.3**  
Structural Grade: **0**  
O&M Grade: **2**  
Clock Start/From: **12**  
Clock To:  
1st Value:  
2nd Value:  
Value Percent:  
Continuous Index:  
Within 8" of Joint: **NO**  
Remarks:

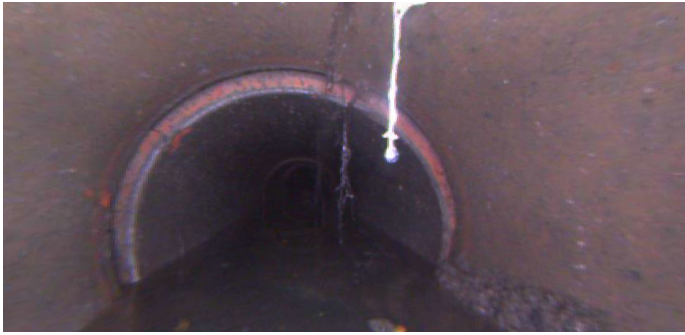
Code: **RFJ**  
Description: **Roots Fine Joint**

Distance (ft): **15.3**  
Structural Grade: **0**  
O&M Grade: **1**  
Clock Start/From: **1**  
Clock To:  
1st Value:  
2nd Value:  
Value Percent:  
Continuous Index: **S02**  
Within 8" of Joint: **YES**  
Remarks: **wandering**

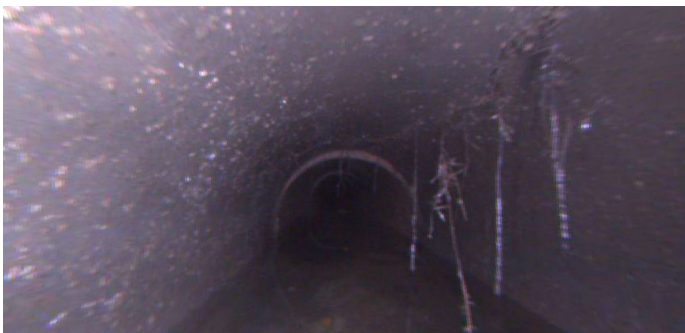
Code: **RFB**  
Description: **Roots Fine Barrel**

Distance (ft): **17.0**  
Structural Grade: **0**  
O&M Grade: **2**  
Clock Start/From: **1**  
Clock To:  
1st Value:  
2nd Value:  
Value Percent:  
Continuous Index:  
Within 8" of Joint: **NO**  
Remarks:

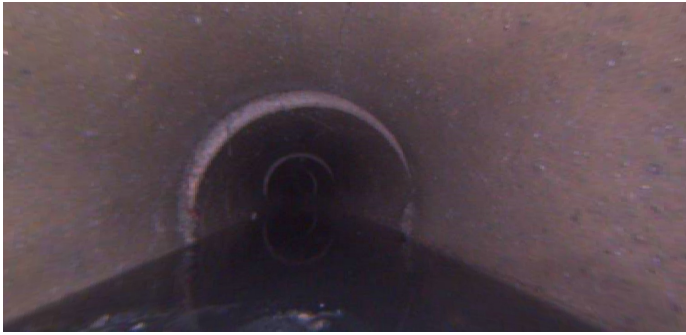
Code: **FM**  
Description: **Fracture Multiple**

Distance (ft): **20.0**  
Structural Grade: **4**  
O&M Grade: **0**  
Clock Start/From: **7**  
Clock To: **5**  
1st Value:  
2nd Value:  
Value Percent:  
Continuous Index: **F01**  
Within 8" of Joint: **YES**  
Remarks: **wandering**

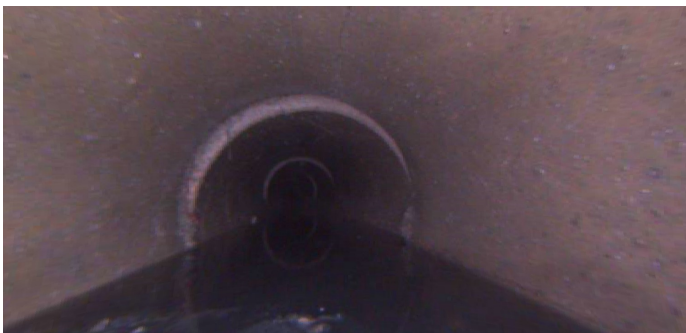
Code: **MSA**  
Description: **Abandoned Survey**

Distance (ft): **20.0**  
Structural Grade: **0**  
O&M Grade: **0**  
Clock Start/From:  
Clock To:  
1st Value:  
2nd Value:  
Value Percent:  
Continuous Index:  
Within 8" of Joint: **NO**  
Remarks: **no blockage**

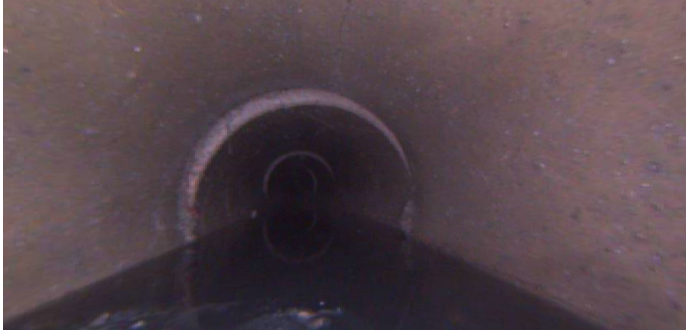
Code:	<b>RFJ</b>
Description:	<b>Roots Fine Joint</b>
Distance (ft):	<b>20.0</b>
Structural Grade:	<b>0</b>
O&M Grade:	<b>1</b>
Clock Start/From:	<b>1</b>
Clock To:	
1st Value:	
2nd Value:	
Value Percent:	
Continuous Index:	<b>F02</b>
Within 8" of Joint:	<b>YES</b>
Remarks:	<b>wandering</b>
