Profile/Photo Observation Report

Date:	11/01/2022	Weather:		Coding:	PACP 7.0
Pipe Length (ft):	113.0	Owner:	City of Hobart	Pre Clean:	Heavy Cleaning
P.O.#:	YES502259	Surveyor:	S. Bucklin	PSR:	P-504-014-013
Customer:	City of Hobart, IN (Red	Clean Date:	10/19/2022	Shape:	C

Street:	South Delaware Street	Flow Control:	Not Controlled
City:	Hobart, IN	Year Renewed:	
Location:	Alley	Tape/Media #:	
Purpose:	Routine Assessment	Dia/Height:	12"
Use:	Sanitary Sewage Pipe	Material:	VCP
Drain Area:		Lining:	None
Category:	NA		
Comment:			
Location Details:		Direction of Survey:	Upstream
US MH:	M-504-013	DS MH:	M-504-014
		Total Length Surveyed (ft):	105.2

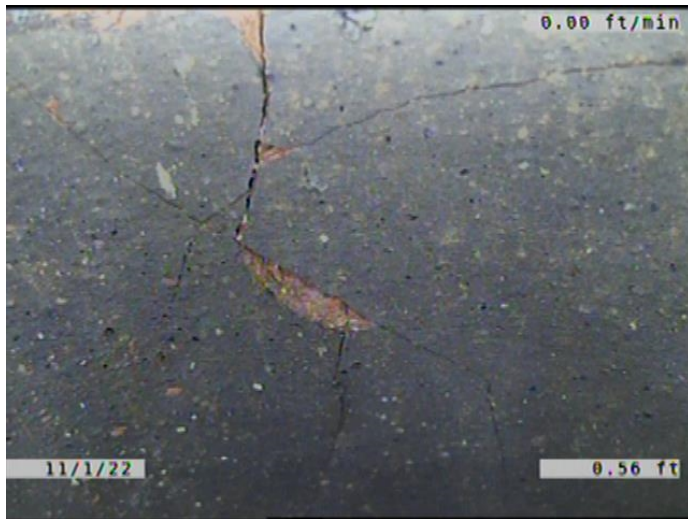
Code: **B**
 Description: **Broken**

Distance (ft): **.6**
 Structural Grade: **4**
 O&M Grade: **0**
 Clock Start/From: **12**
 Clock To: **12**
 1st Value:
 2nd Value:
 Value Percent:
 Continuous Index: **S01**
 Within 8" of Joint: **YES**
 Remarks: **Wandering**

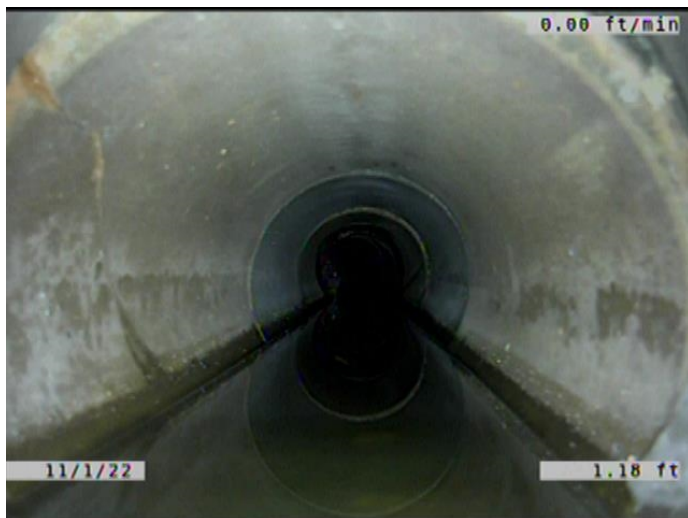
Code: **MWLS**
 Description: **Miscellaneous Water Level Sag**

Distance (ft): **1.2**
 Structural Grade: **2**
 O&M Grade: **0**
 Clock Start/From:
 Clock To:
 1st Value:
 2nd Value:
 Value Percent: **10.000**
 Continuous Index: **S02**
 Within 8" of Joint: **NO**
 Remarks:

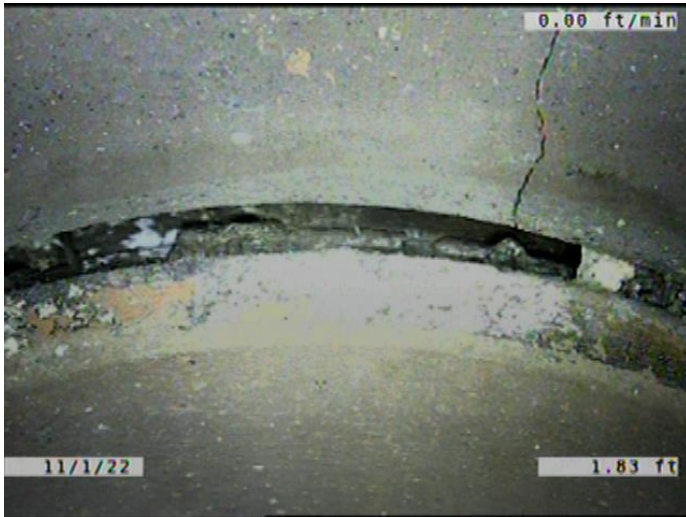
Code: **JOMD**
Description: **Joint Offset Medium Defective**

Distance (ft): **1.8**
Structural Grade: **3**
O&M Grade: **0**
Clock Start/From:
Clock To:
1st Value:
2nd Value:
Value Percent:
Continuous Index:
Within 8" of Joint: **NO**
Remarks:

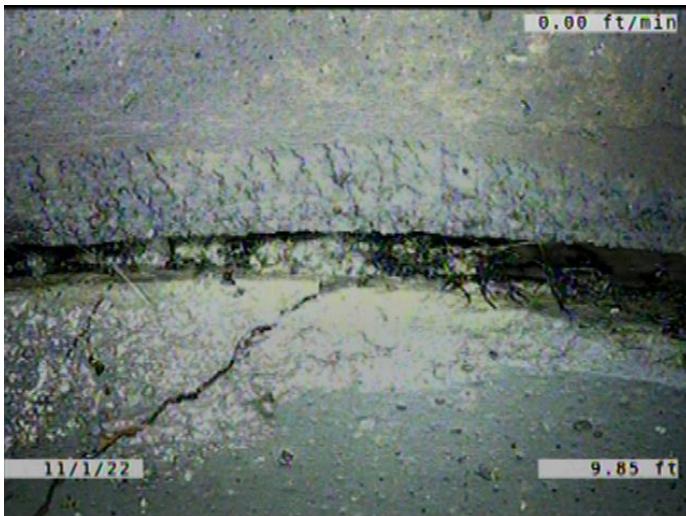
Code: **RFJ**
Description: **Roots Fine Joint**

Distance (ft): **9.8**
Structural Grade: **0**
O&M Grade: **1**
Clock Start/From: **9**
Clock To: **3**
1st Value:
2nd Value:
Value Percent:
Continuous Index: **S03**
Within 8" of Joint: **YES**
Remarks:

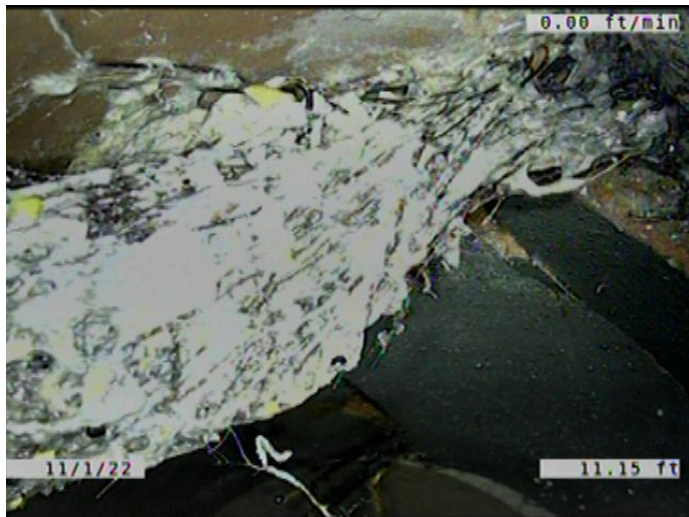
Code: **RMC**
 Description: **Roots Medium Connection**

Distance (ft): **11.2**
 Structural Grade: **0**
 O&M Grade: **3**
 Clock Start/From: **9**
 Clock To: **11**
 1st Value:
 2nd Value:
 Value Percent: **5.000**
 Continuous Index:
 Within 8" of Joint: **NO**
 Remarks:

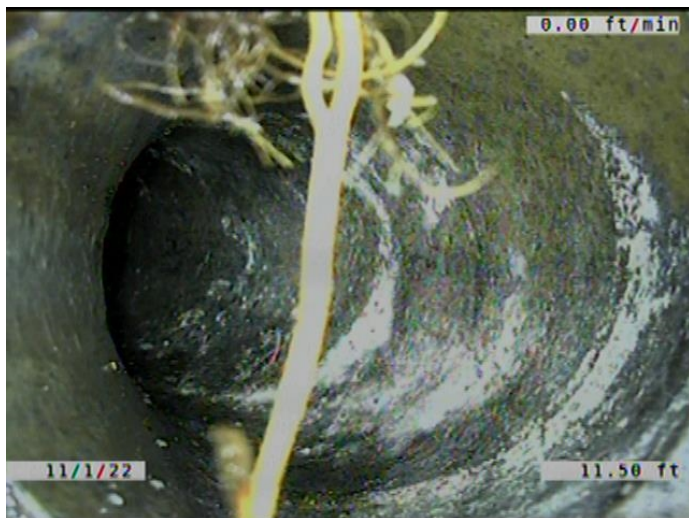
Code: **TBD**
 Description: **Tap Break-in/Hammer Defective**

Distance (ft): **11.5**
 Structural Grade: **0**
 O&M Grade: **3**
 Clock Start/From: **11**
 Clock To:
 1st Value: **4.000**
 2nd Value:
 Value Percent:
 Continuous Index:
 Within 8" of Joint: **YES**
 Remarks: **ROOTS GROWING IN THE JONTS OF THE SERVICE AND FROM THE CONNE**

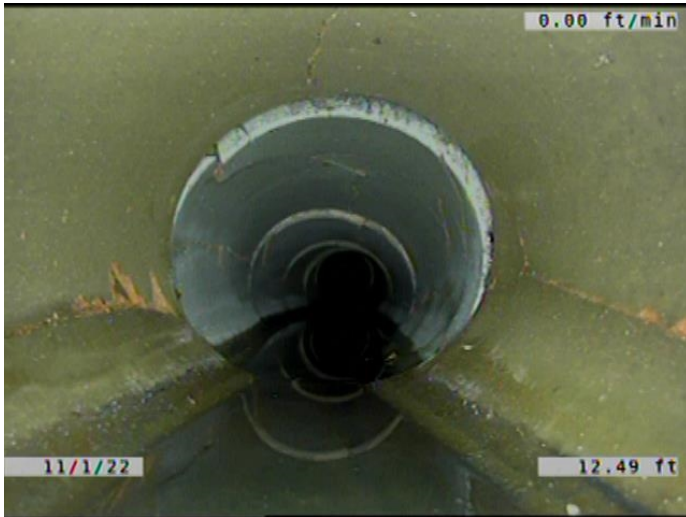
Code: **DR**
Description: **Deformed Rigid**

Distance (ft): **12.5**
Structural Grade: **4**
O&M Grade: **0**
Clock Start/From:
Clock To:
1st Value:
2nd Value:
Value Percent: **5.000**
Continuous Index: **S04**
Within 8" of Joint: **NO**
Remarks:

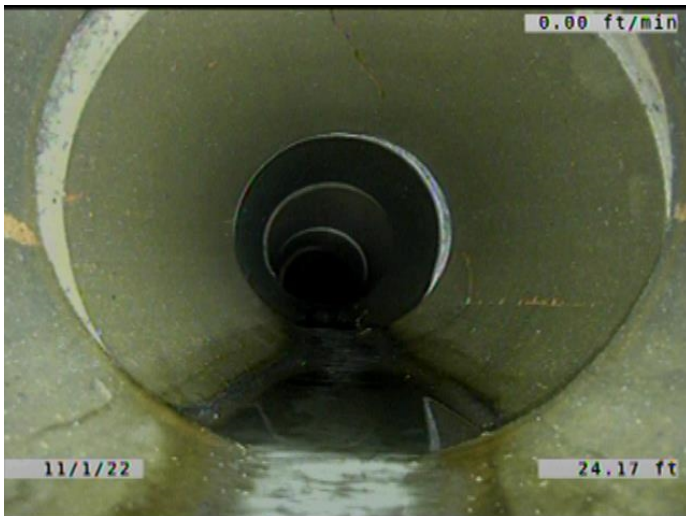
Code: **MWLS**
Description: **Miscellaneous Water Level Sag**

Distance (ft): **24.2**
Structural Grade: **2**
O&M Grade: **0**
Clock Start/From:
Clock To:
1st Value:
2nd Value:
Value Percent: **10.000**
Continuous Index: **F02**
Within 8" of Joint: **NO**
Remarks:

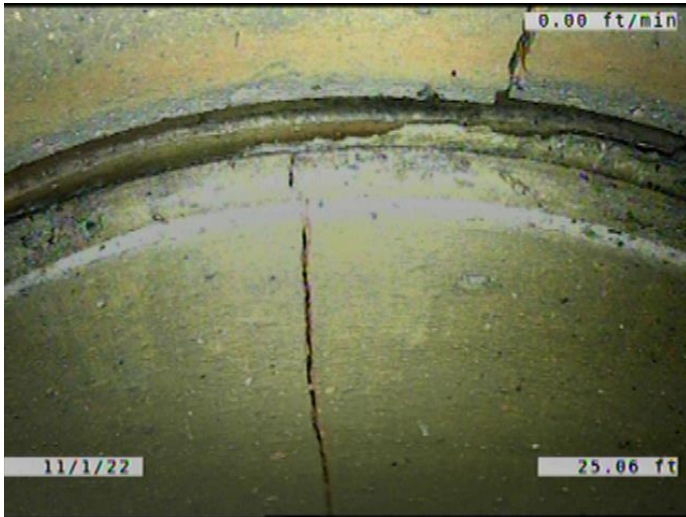
Code: **JOMD**
 Description: **Joint Offset Medium Defective**

Distance (ft): **25.1**
 Structural Grade: **3**
 O&M Grade: **0**
 Clock Start/From:
 Clock To:
 1st Value:
 2nd Value:
 Value Percent:
 Continuous Index:
 Within 8" of Joint: **NO**
 Remarks:

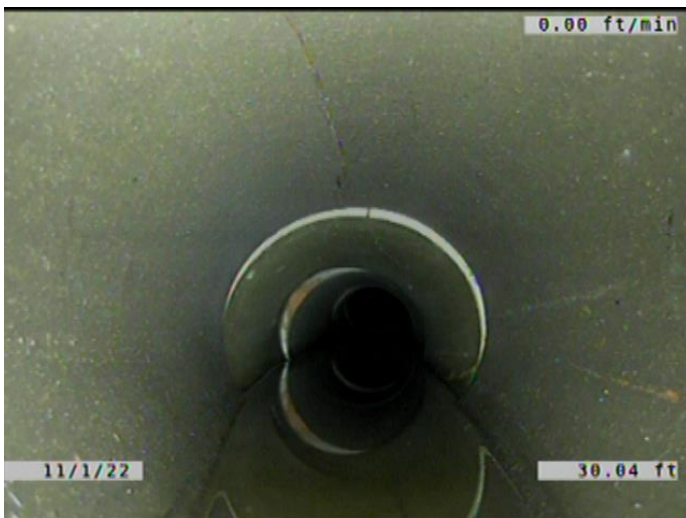
Code: **DR**
 Description: **Deformed Rigid**

Distance (ft): **30.0**
 Structural Grade: **4**
 O&M Grade: **0**
 Clock Start/From:
 Clock To:
 1st Value:
 2nd Value:
 Value Percent: **5.000**
 Continuous Index: **F04**
 Within 8" of Joint: **NO**
 Remarks:

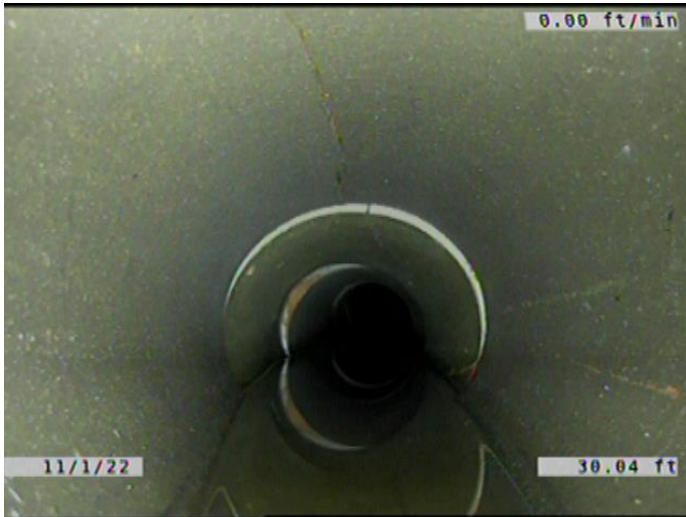
Code: **MWLS**
Description: **Miscellaneous Water Level Sag**

Distance (ft): **30.0**
Structural Grade: **2**
O&M Grade: **0**
Clock Start/From:
Clock To:
1st Value:
2nd Value:
Value Percent: **20.000**
Continuous Index: **S05**
Within 8" of Joint: **NO**
Remarks:

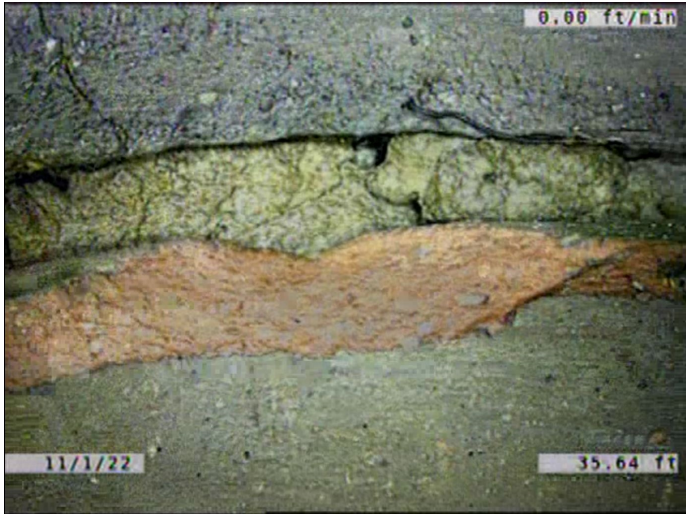
Code: **SSS**
 Description: **Surface Damage Surface Spalling**

Distance (ft): **35.6**
 Structural Grade: **2**
 O&M Grade: **0**
 Clock Start/From: **8**
 Clock To: **10**
 1st Value:
 2nd Value:
 Value Percent:
 Continuous Index:
 Within 8" of Joint: **YES**
 Remarks:

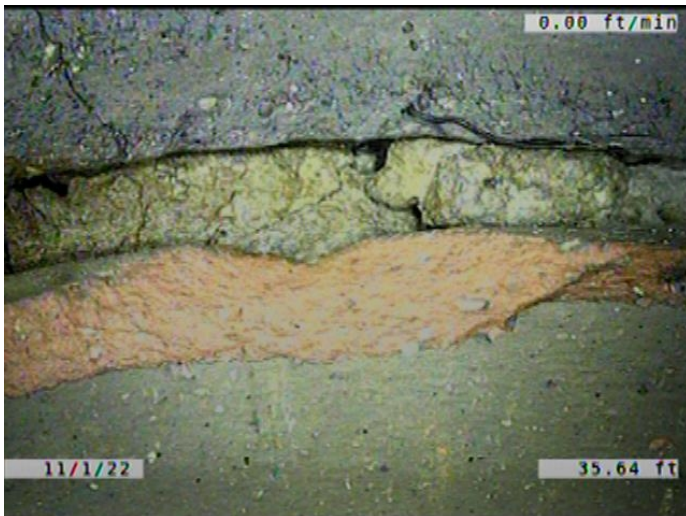
Code: **JOMD**
 Description: **Joint Offset Medium Defective**

Distance (ft): **35.6**
 Structural Grade: **3**
 O&M Grade: **0**
 Clock Start/From:
 Clock To:
 1st Value:
 2nd Value:
 Value Percent:
 Continuous Index:
 Within 8" of Joint: **NO**
 Remarks:

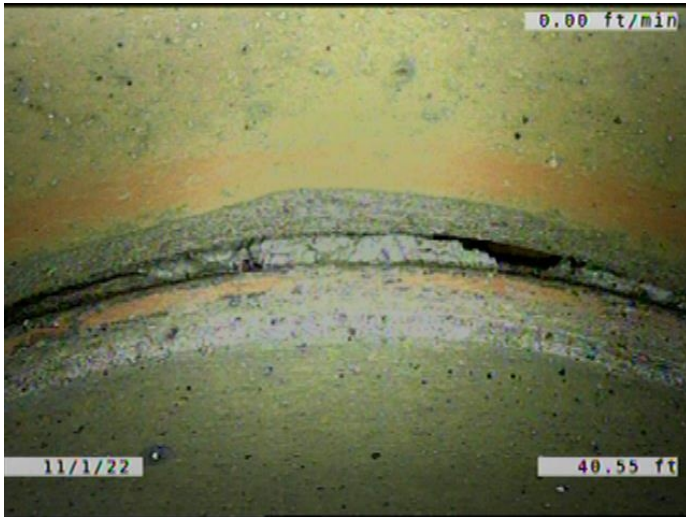
Code: **JOM**
Description: **Joint Offset Medium**

Distance (ft): **40.5**
Structural Grade: **3**
O&M Grade: **0**
Clock Start/From:
Clock To:
1st Value:
2nd Value:
Value Percent:
Continuous Index:
Within 8" of Joint: **NO**
Remarks:

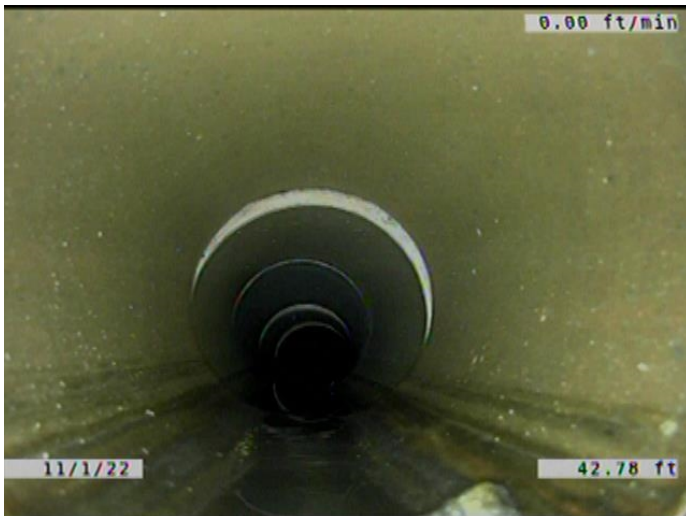
Code: **MWLS**
Description: **Miscellaneous Water Level Sag**

Distance (ft): **42.8**
Structural Grade: **2**
O&M Grade: **0**
Clock Start/From:
Clock To:
1st Value:
2nd Value:
Value Percent: **20.000**
Continuous Index: **F05**
Within 8" of Joint: **NO**
Remarks:

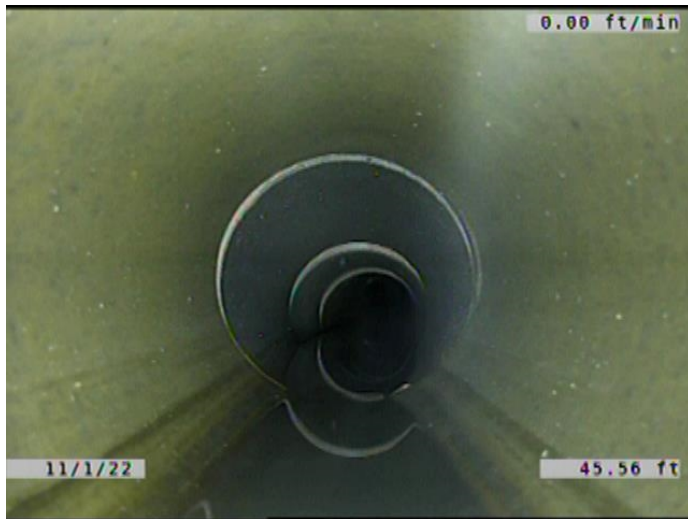
Code: **MWLS**
Description: **Miscellaneous Water Level Sag**

Distance (ft): **45.6**
Structural Grade: **2**
O&M Grade: **0**
Clock Start/From:
Clock To:
1st Value:
2nd Value:
Value Percent: **15.000**
Continuous Index: **S06**
Within 8" of Joint: **NO**
Remarks:

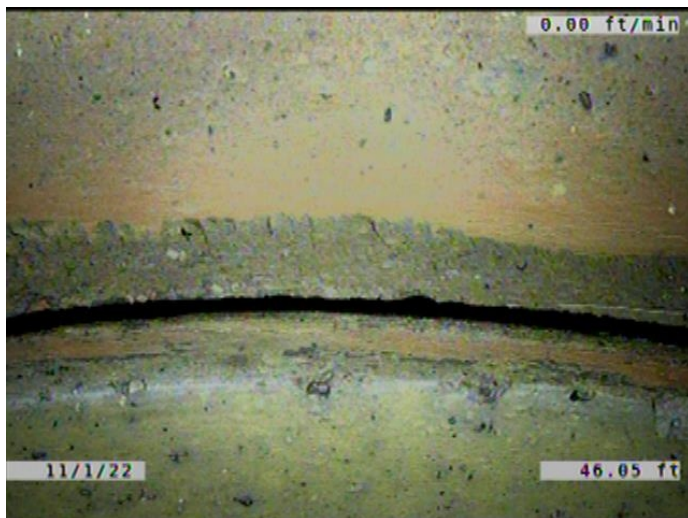
Code: **JOM**
Description: **Joint Offset Medium**

Distance (ft): **46.1**
Structural Grade: **3**
O&M Grade: **0**
Clock Start/From:
Clock To:
1st Value:
2nd Value:
Value Percent:
Continuous Index:
Within 8" of Joint: **NO**
Remarks:

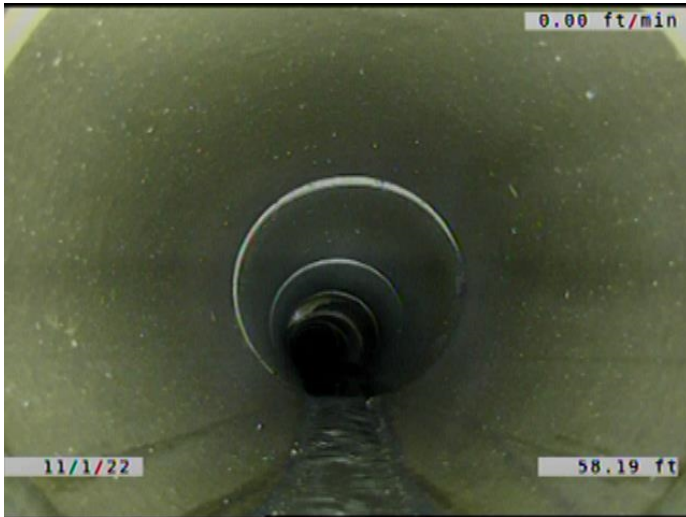
Code: **MWLS**
Description: **Miscellaneous Water Level Sag**

Distance (ft): **58.2**
Structural Grade: **2**
O&M Grade: **0**
Clock Start/From:
Clock To:
1st Value:
2nd Value:
Value Percent: **15.000**
Continuous Index: **F06**
Within 8" of Joint: **NO**
Remarks:

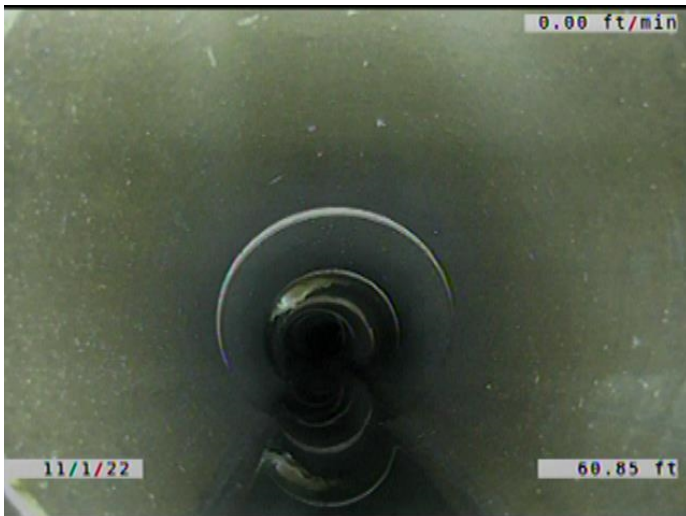
Code: **MWLS**
Description: **Miscellaneous Water Level Sag**

Distance (ft): **60.8**
Structural Grade: **2**
O&M Grade: **0**
Clock Start/From:
Clock To:
1st Value:
2nd Value:
Value Percent: **10.000**
Continuous Index: **S07**
Within 8" of Joint: **NO**
Remarks:

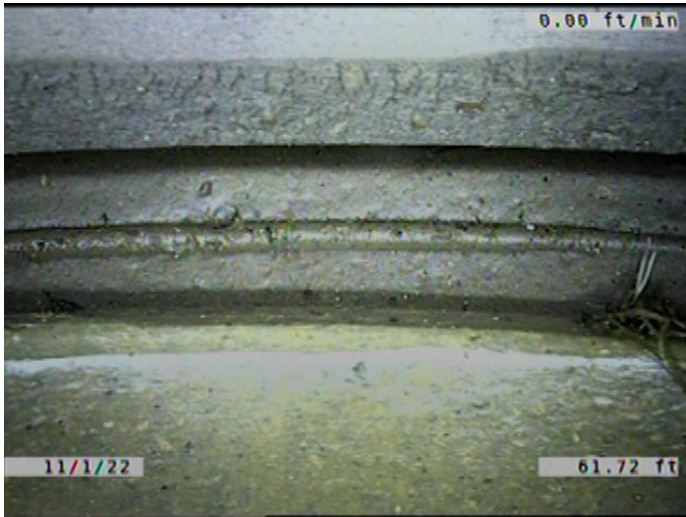
Code: **JAM**
 Description: **Joint Angular Medium**

Distance (ft): **61.7**
 Structural Grade: **3**
 O&M Grade: **0**
 Clock Start/From:
 Clock To:
 1st Value:
 2nd Value:
 Value Percent:
 Continuous Index:
 Within 8" of Joint: **NO**
 Remarks:

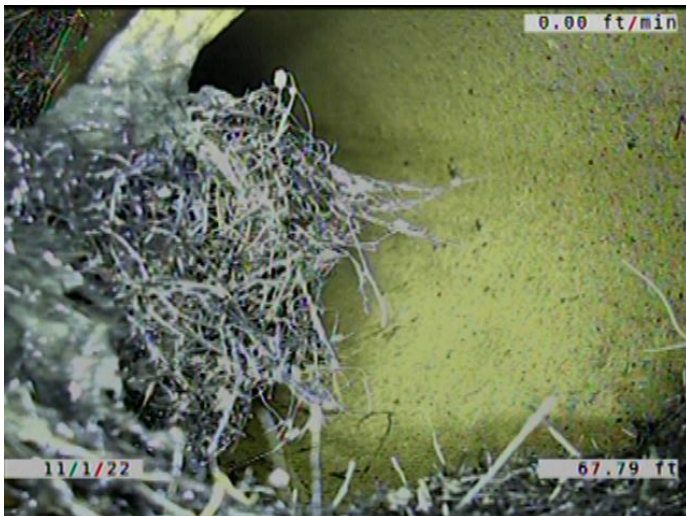
Code: **TBI**
 Description: **Tap Break-in Intruding**

Distance (ft): **67.8**
 Structural Grade: **0**
 O&M Grade: **2**
 Clock Start/From: **11**
 Clock To:
 1st Value: **4.000**
 2nd Value: **2.000**
 Value Percent:
 Continuous Index:
 Within 8" of Joint: **YES**
 Remarks: **ROOTS GROWING FROM THE JOINTS AND THE SERVICE TO MAIN CONNEC**

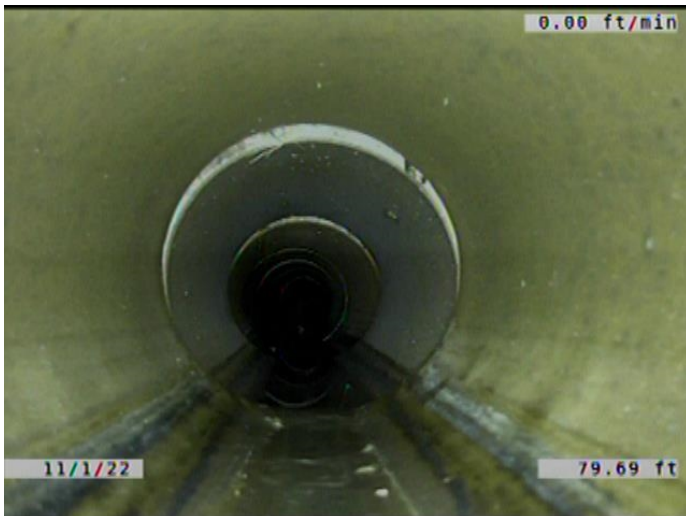
Code: **MWLS**
 Description: **Miscellaneous Water Level Sag**

Distance (ft): **79.7**
 Structural Grade: **2**
 O&M Grade: **0**
 Clock Start/From:
 Clock To:
 1st Value:
 2nd Value:
 Value Percent: **10.000**
 Continuous Index: **F07**
 Within 8" of Joint: **NO**
 Remarks:

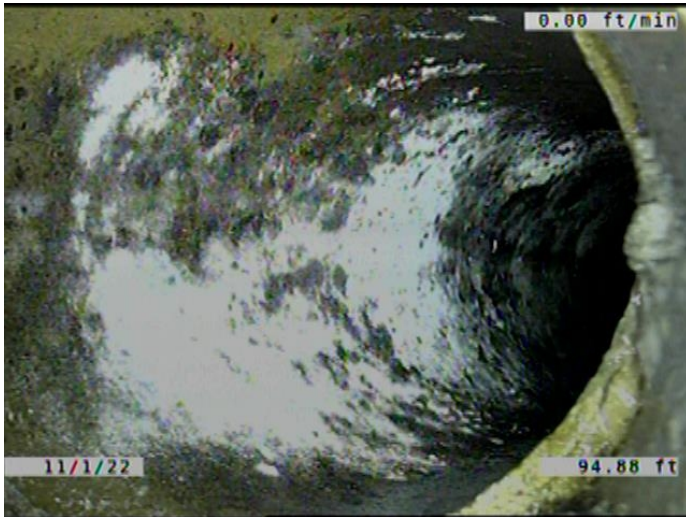
Code: **TBI**
Description: **Tap Break-in Intruding**

Distance (ft): **94.9**
Structural Grade: **0**
O&M Grade: **2**
Clock Start/From: **1**
Clock To:
1st Value: **4.000**
2nd Value: **1.000**
Value Percent:
Continuous Index:
Within 8" of Joint: **YES**
Remarks: **CONSTANTLY RUNNING WATER.**

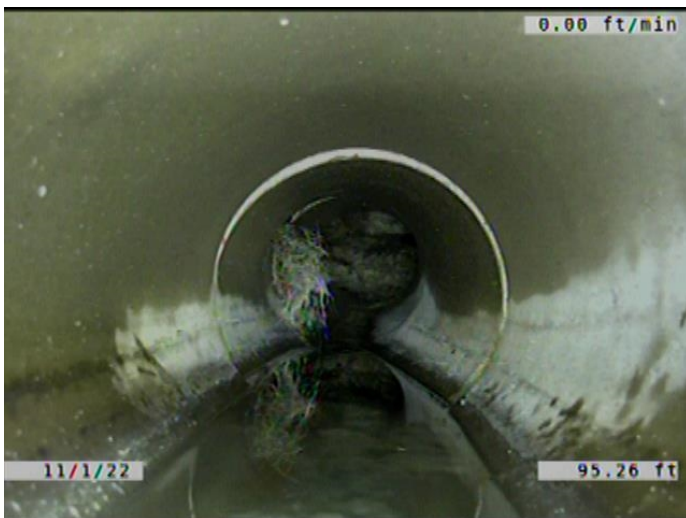
Code: **MWLS**
Description: **Miscellaneous Water Level Sag**

Distance (ft): **95.3**
Structural Grade: **2**
O&M Grade: **0**
Clock Start/From:
Clock To:
1st Value:
2nd Value:
Value Percent: **10.000**
Continuous Index: **S08**
Within 8" of Joint: **NO**
Remarks:

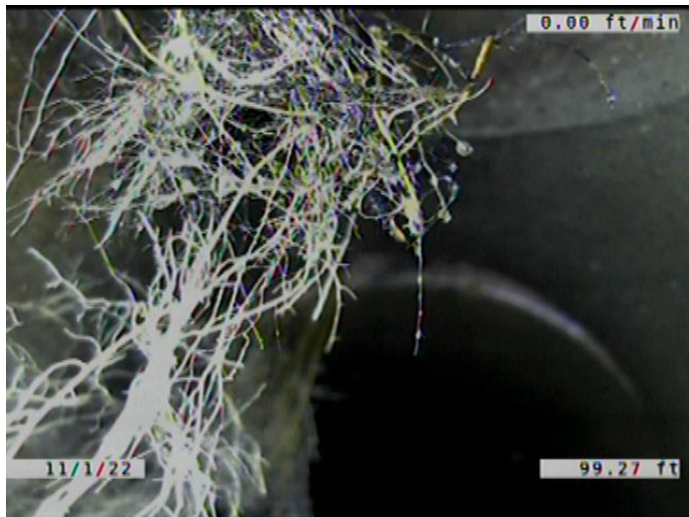
Code: **RML**
 Description: **Roots Medium Lateral**

Distance (ft): **99.3**
 Structural Grade: **0**
 O&M Grade: **3**
 Clock Start/From: **10**
 Clock To: **11**
 1st Value:
 2nd Value:
 Value Percent: **5.000**
 Continuous Index:
 Within 8" of Joint: **NO**
 Remarks:

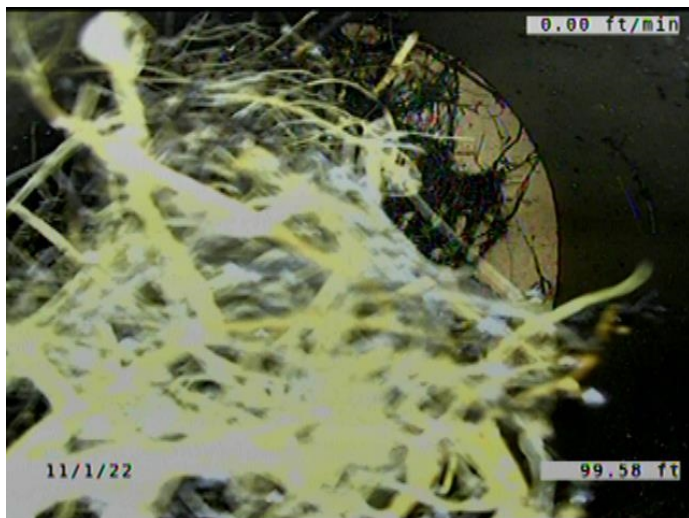
Code: **TFD**
 Description: **Tap Factory Defective**

Distance (ft): **99.6**
 Structural Grade: **0**
 O&M Grade: **3**
 Clock Start/From: **11**
 Clock To:
 1st Value: **4.000**
 2nd Value:
 Value Percent:
 Continuous Index:
 Within 8" of Joint: **YES**
 Remarks: **CAPPED. ROOTS GROWING AROUND THE CAP INTO THE MAIN.**

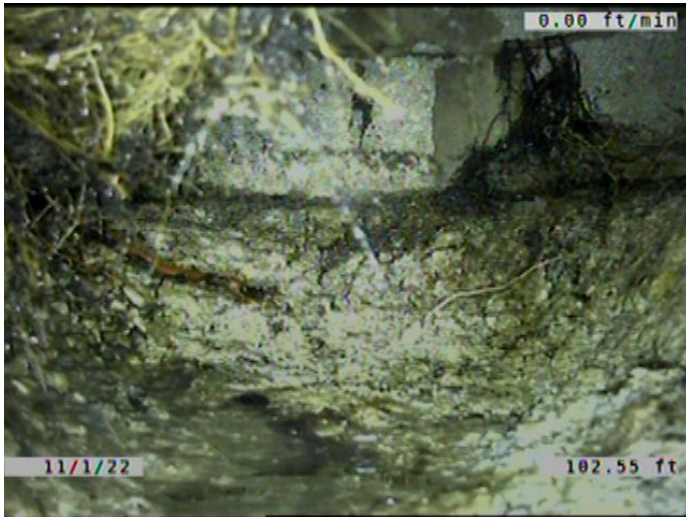
Code: **MWLS**
 Description: **Miscellaneous Water Level Sag**

Distance (ft): **102.5**
 Structural Grade: **2**
 O&M Grade: **0**
 Clock Start/From:
 Clock To:
 1st Value:
 2nd Value:
 Value Percent: **10.000**
 Continuous Index: **F08**
 Within 8" of Joint: **NO**
 Remarks:

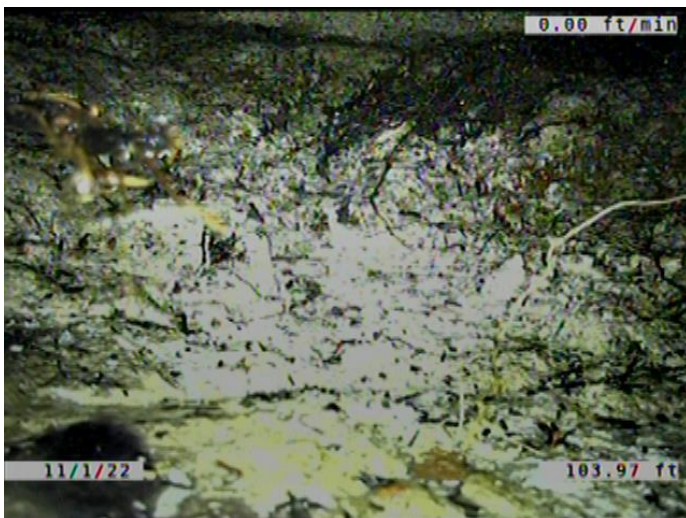
Code: **B**
 Description: **Broken**

Distance (ft): **104.0**
 Structural Grade: **4**
 O&M Grade: **0**
 Clock Start/From: **12**
 Clock To: **12**
 1st Value:
 2nd Value:
 Value Percent:
 Continuous Index: **F01**
 Within 8" of Joint: **YES**
 Remarks: **Wandering**

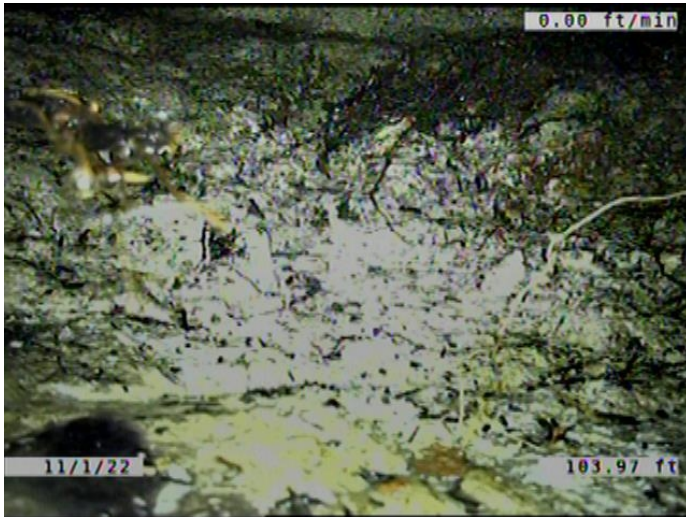
Code: **RFJ**
 Description: **Roots Fine Joint**

Distance (ft): **104.0**
 Structural Grade: **0**
 O&M Grade: **1**
 Clock Start/From: **9**
 Clock To: **3**
 1st Value:
 2nd Value:
 Value Percent:
 Continuous Index: **F03**
 Within 8" of Joint: **YES**
 Remarks:
